AEDC-TR-72-161

**RESEARCH AND DEVELOPMENT TESTING  
OF YTTRIA/RARE EARTH  
STABILIZED ZIRCONIA MATRIX BRICKS  
IN THE PILOT TEST UNIT (PTU) AT AEDC**

**ARO, Inc.**

**November 1972**

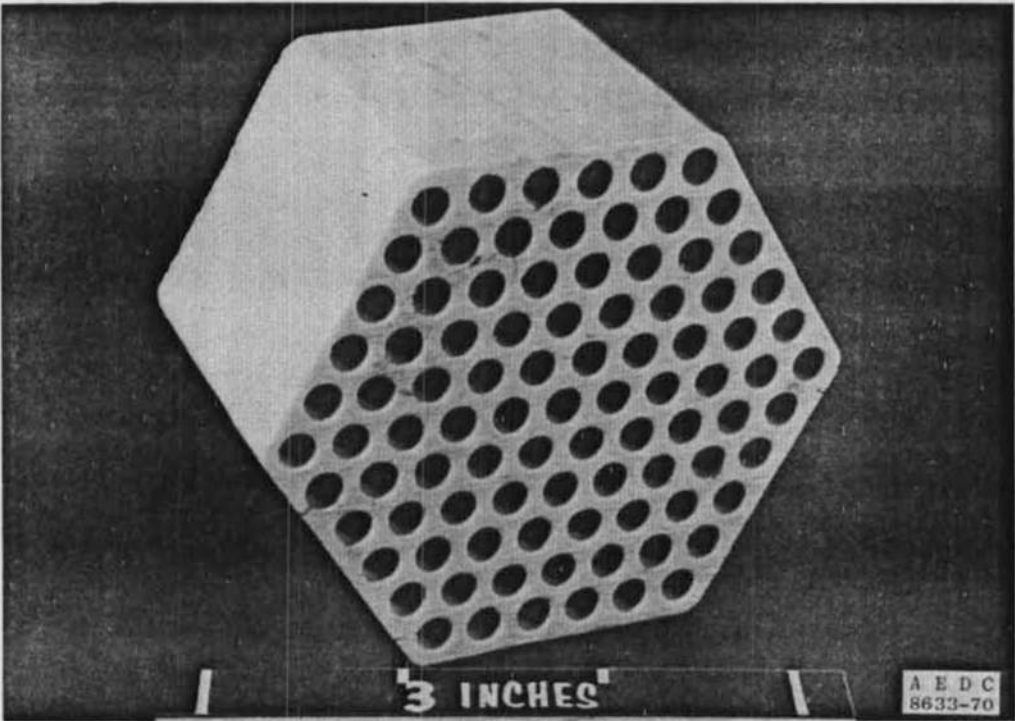
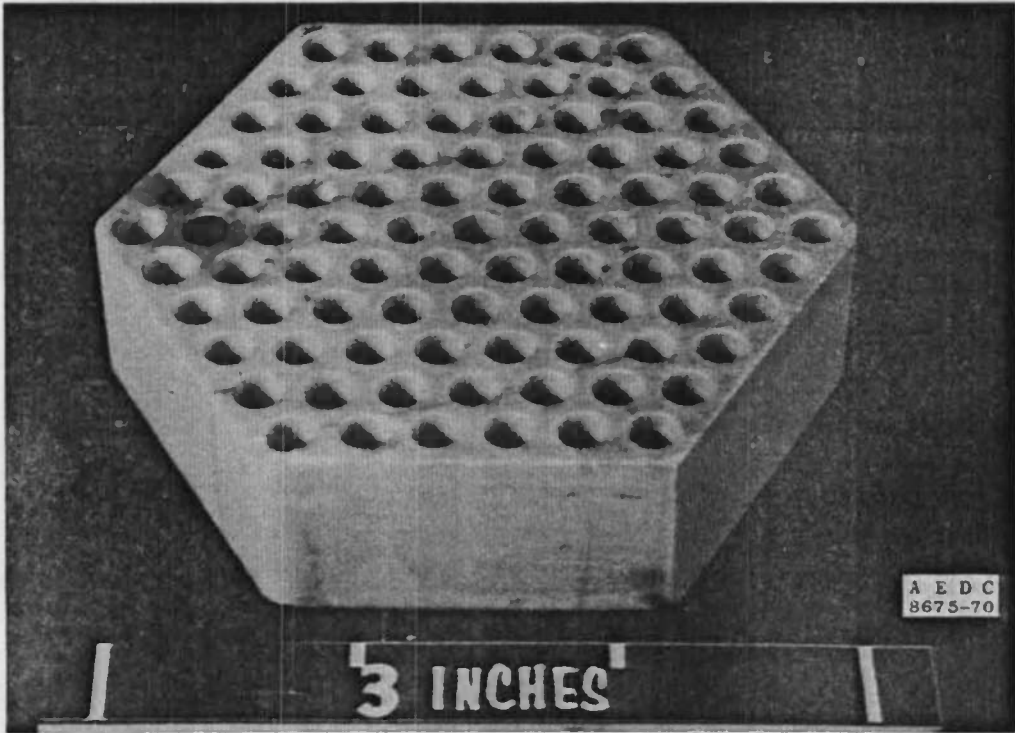
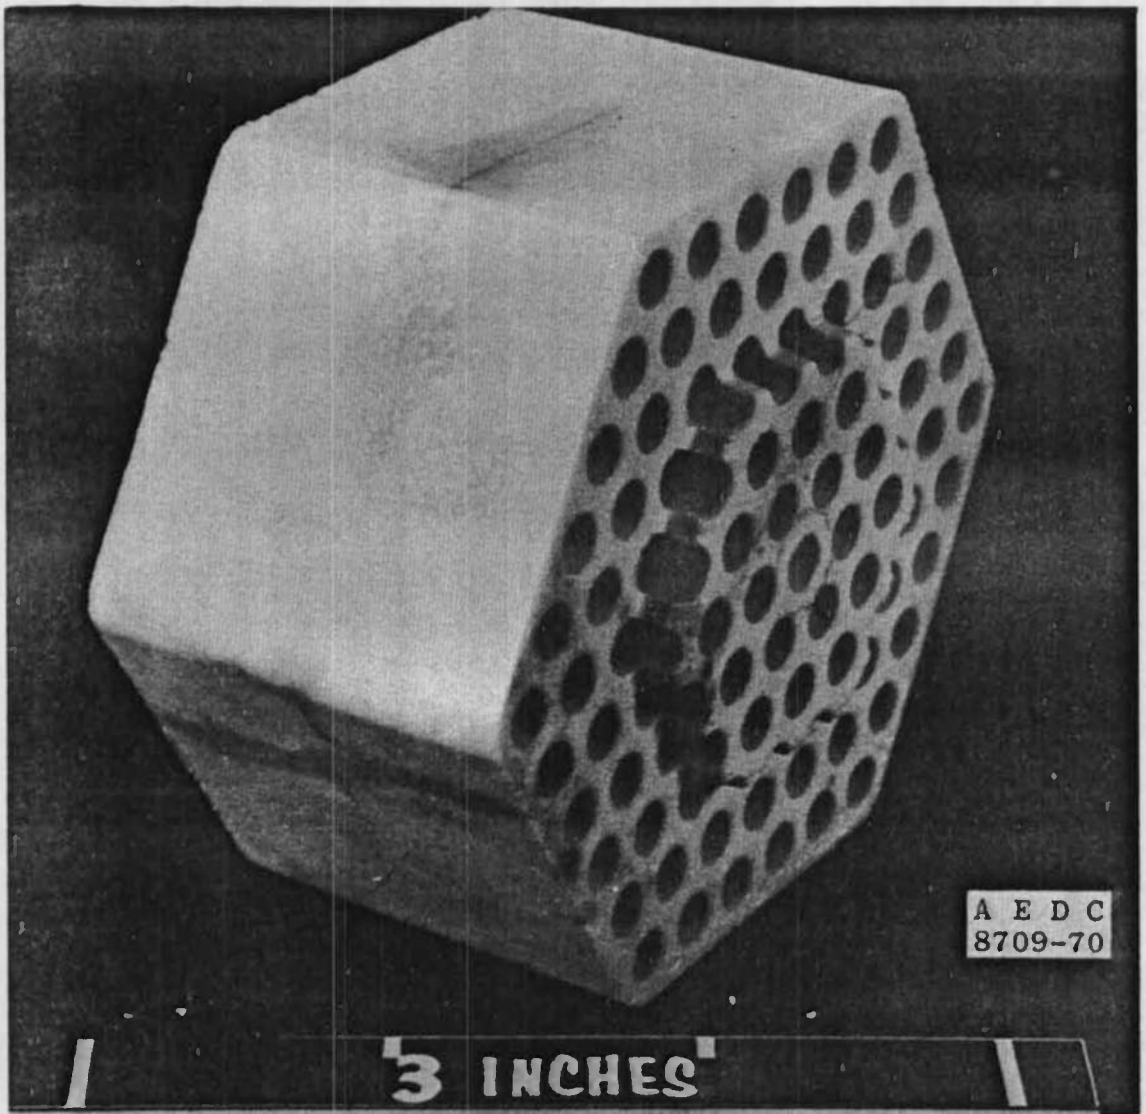
The second major inspection of the matrix refractories was conducted after run 69. Inspections revealed that a water leak had developed at the burner tube tip exterior; therefore, a complete examination was made of all sample matrix bricks placed into the heater before run 45. All high density sample bricks were found to contain hairline cracks. Coors high-density sample bricks in one column beneath the burner were all fractured into small pieces as a result of the water leak. All sample bricks remained stabilized throughout the test series. However, in general, the high density bricks appeared to be more susceptible to vertical fracture with increasing yttria content.

Presented in Fig. 19 are photographs typical of the various high density bricks removed from the heater for inspection. It may be noted that practically all cracks are in the vertical (longitudinal) direction.

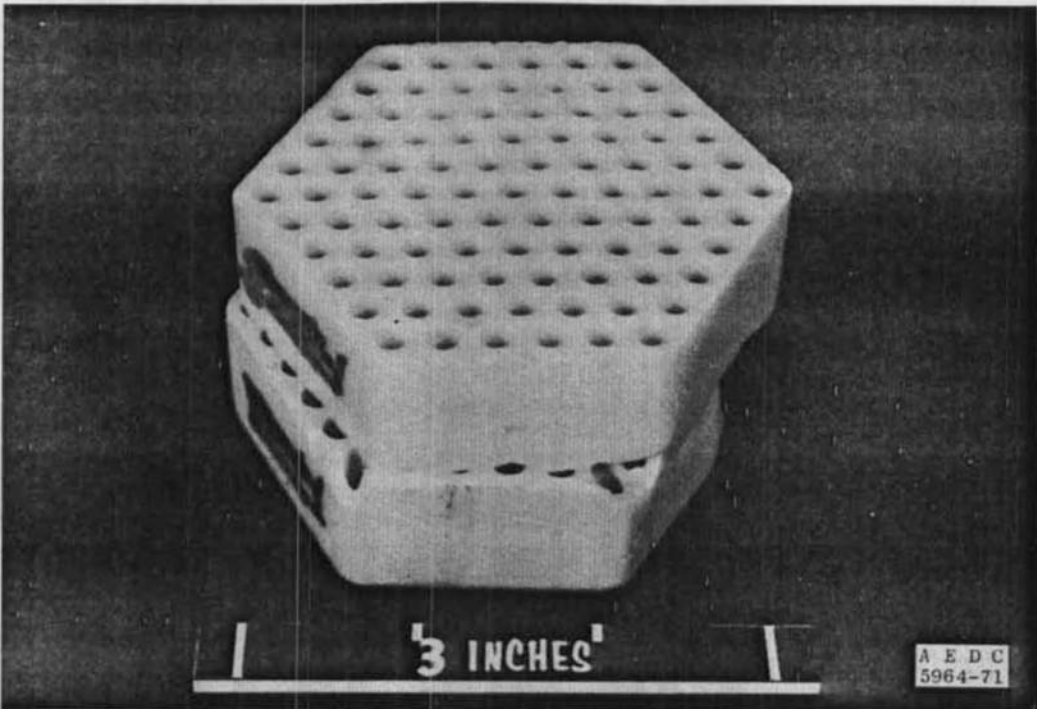
Fig. 30 Misalignment in Non-Keyed Bricks, Post-Run 85

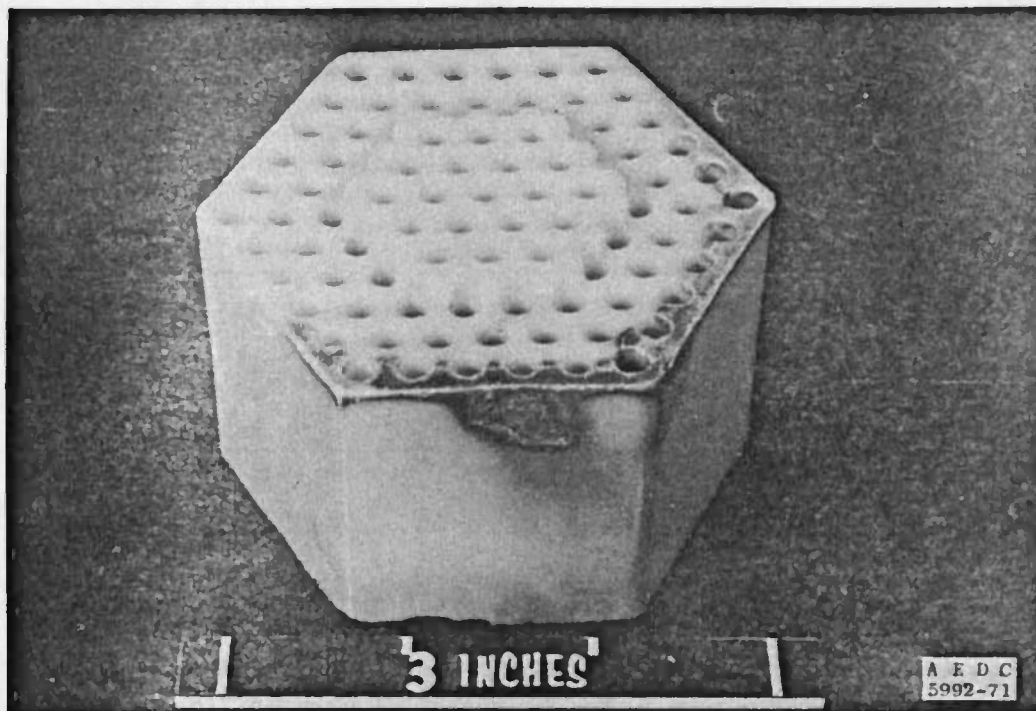
b. Zircoa, 10.8 w/o, Location 13-6

Fig. 31 Bricks Exhibiting Localized Fusion and/or Material Deposits, Post-Run 85
