WING LEADING EDGE FUEL TANK IMPACT TESTS

Federal Aviation Administration

Report No. FAA-RD-72-83

### FINAL REPORT

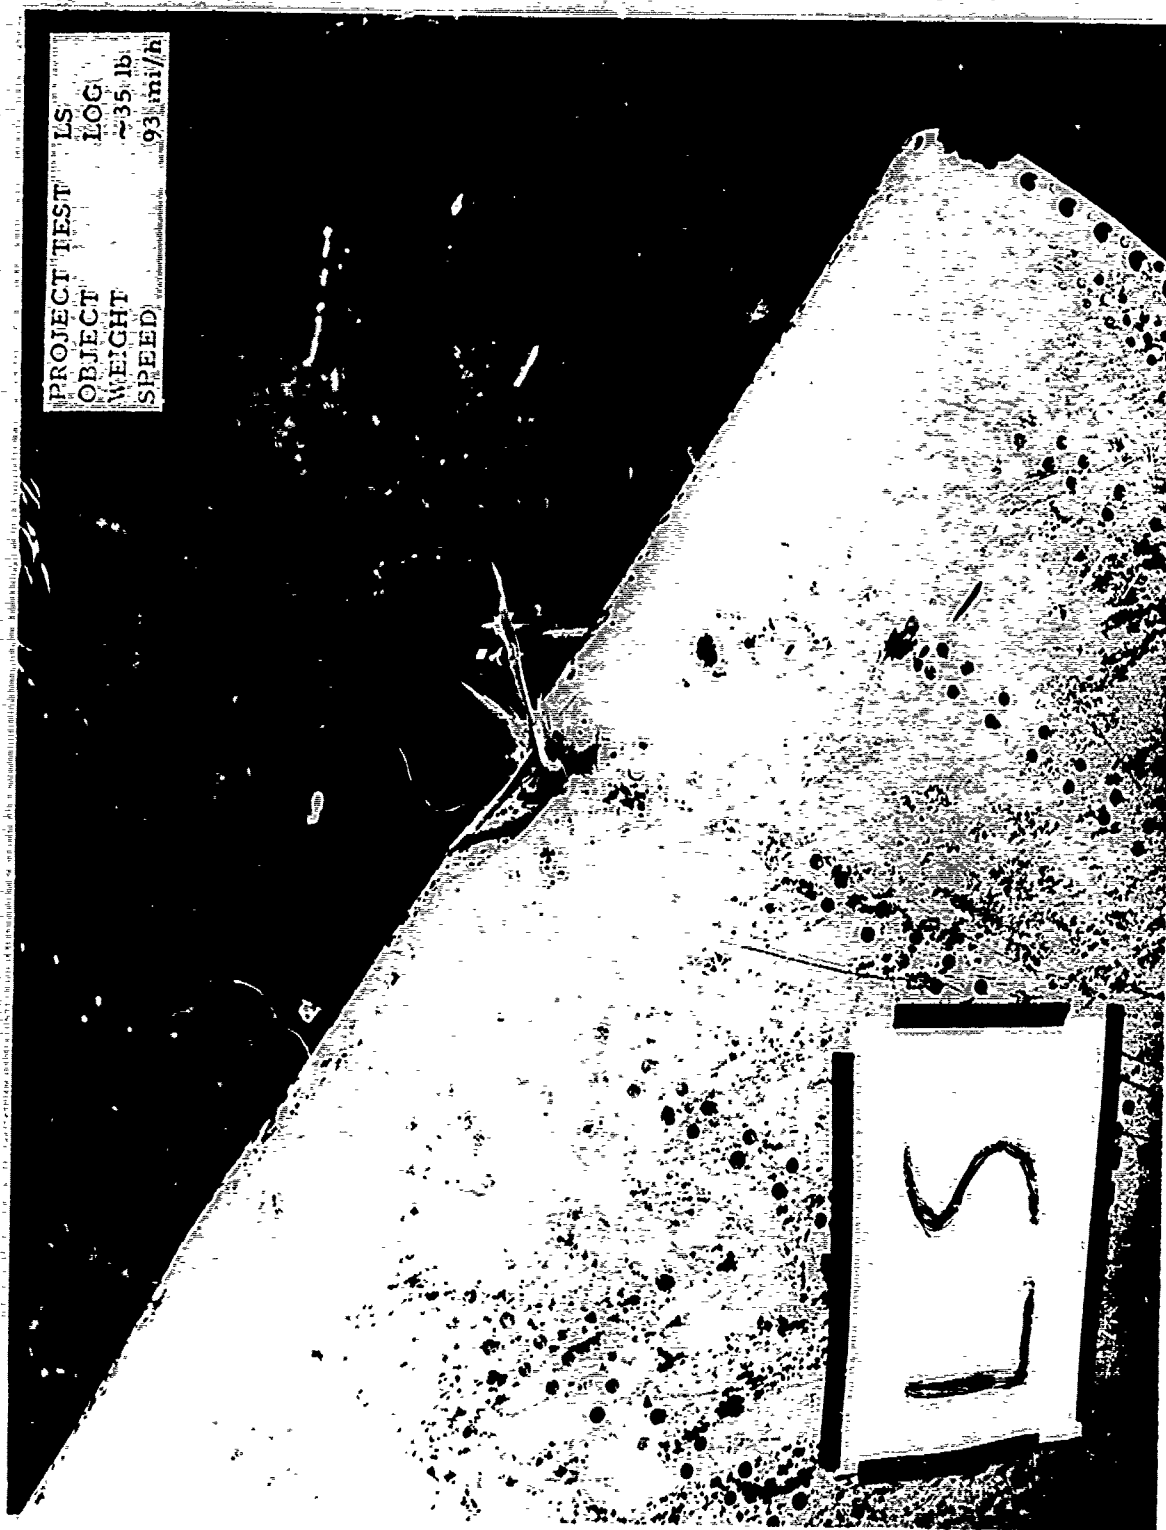
| Project Test | Test | Predicted Impact Speed (mi/h) | Actual Impact Speed (mi/h) | Test Obstacle | Comment |
|---|---|---|---|---|---|
| LS | 2 | 120 | 93.0 | Log | 6-inch rupture along rivet line |

FIGURE 7. DAMAGE TO WING - TEST 2, 93.0 MI/H - LOG

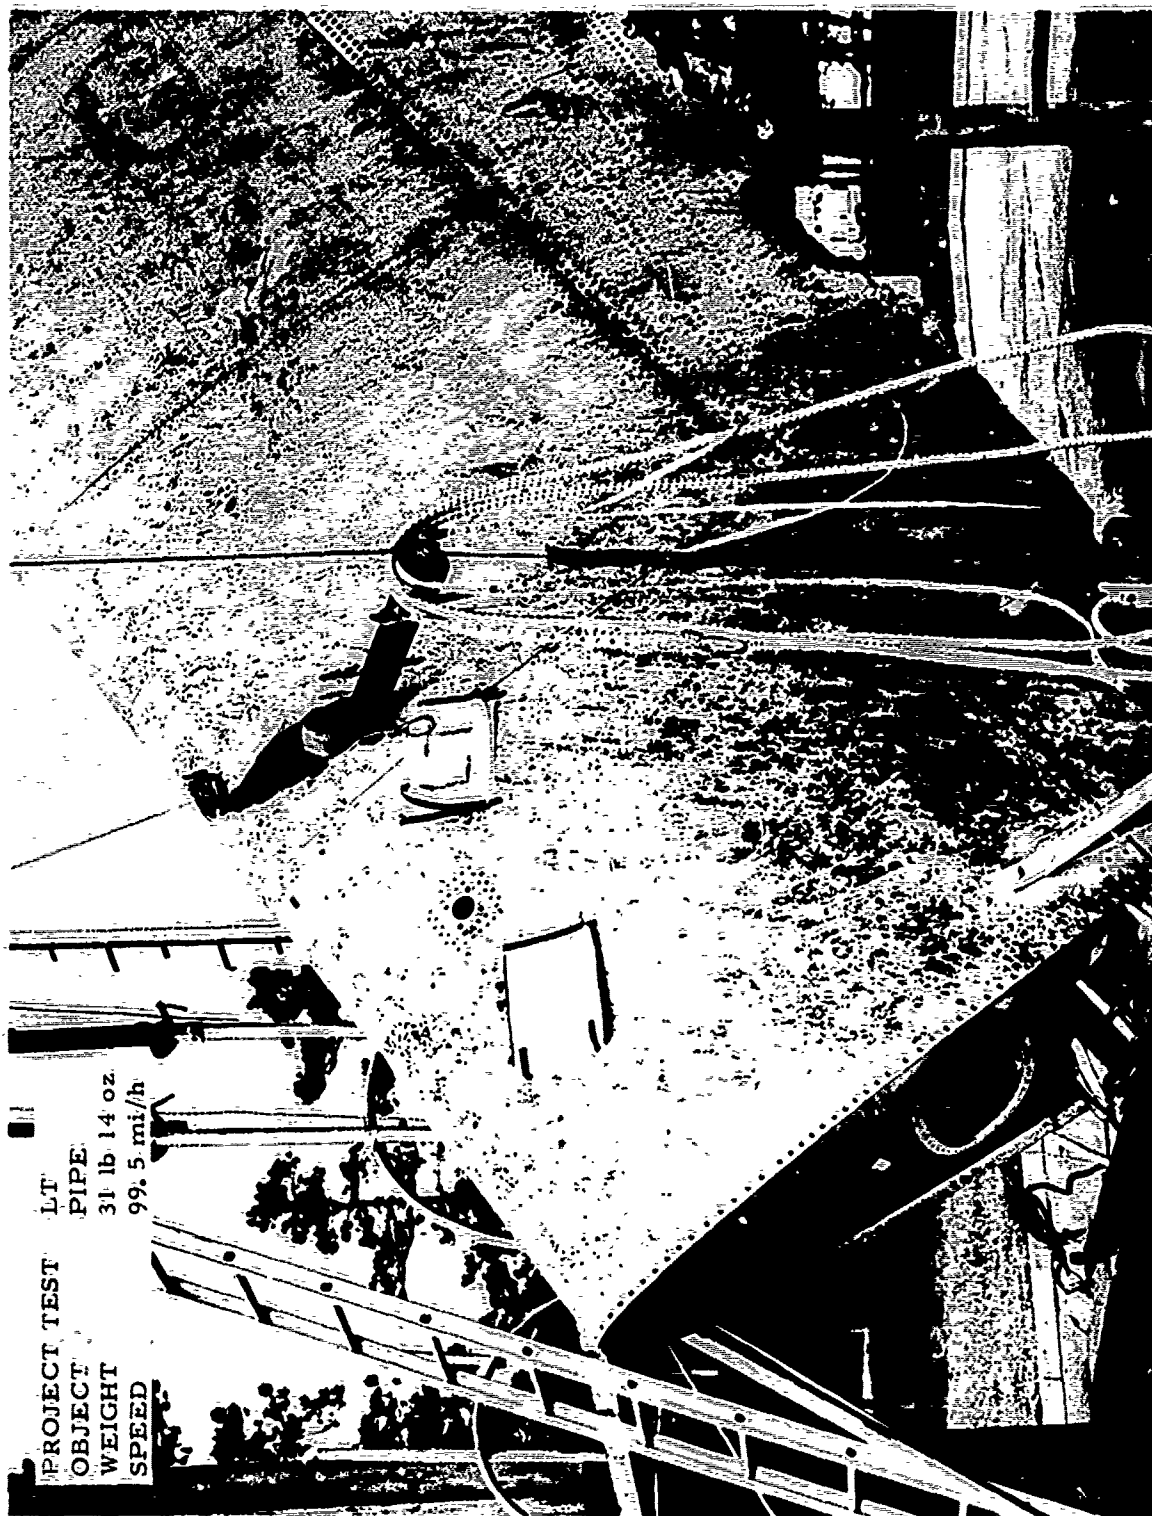
| Project Test | Test | Predicted Impact Speed (mi/h) | Actual Impact Speed (mi/h) | Test Obstacle | Comment |
|---|---|---|---|---|---|
| LT | 3 | 102 | 99.5 | Pipe | Rupture 6 inches wide, 1.5 ft long on one side and 1.1 ft long on the other |

FIGURE 9. DAMAGE TO WING - TEST 3, 99.5 MI/H - PIPE

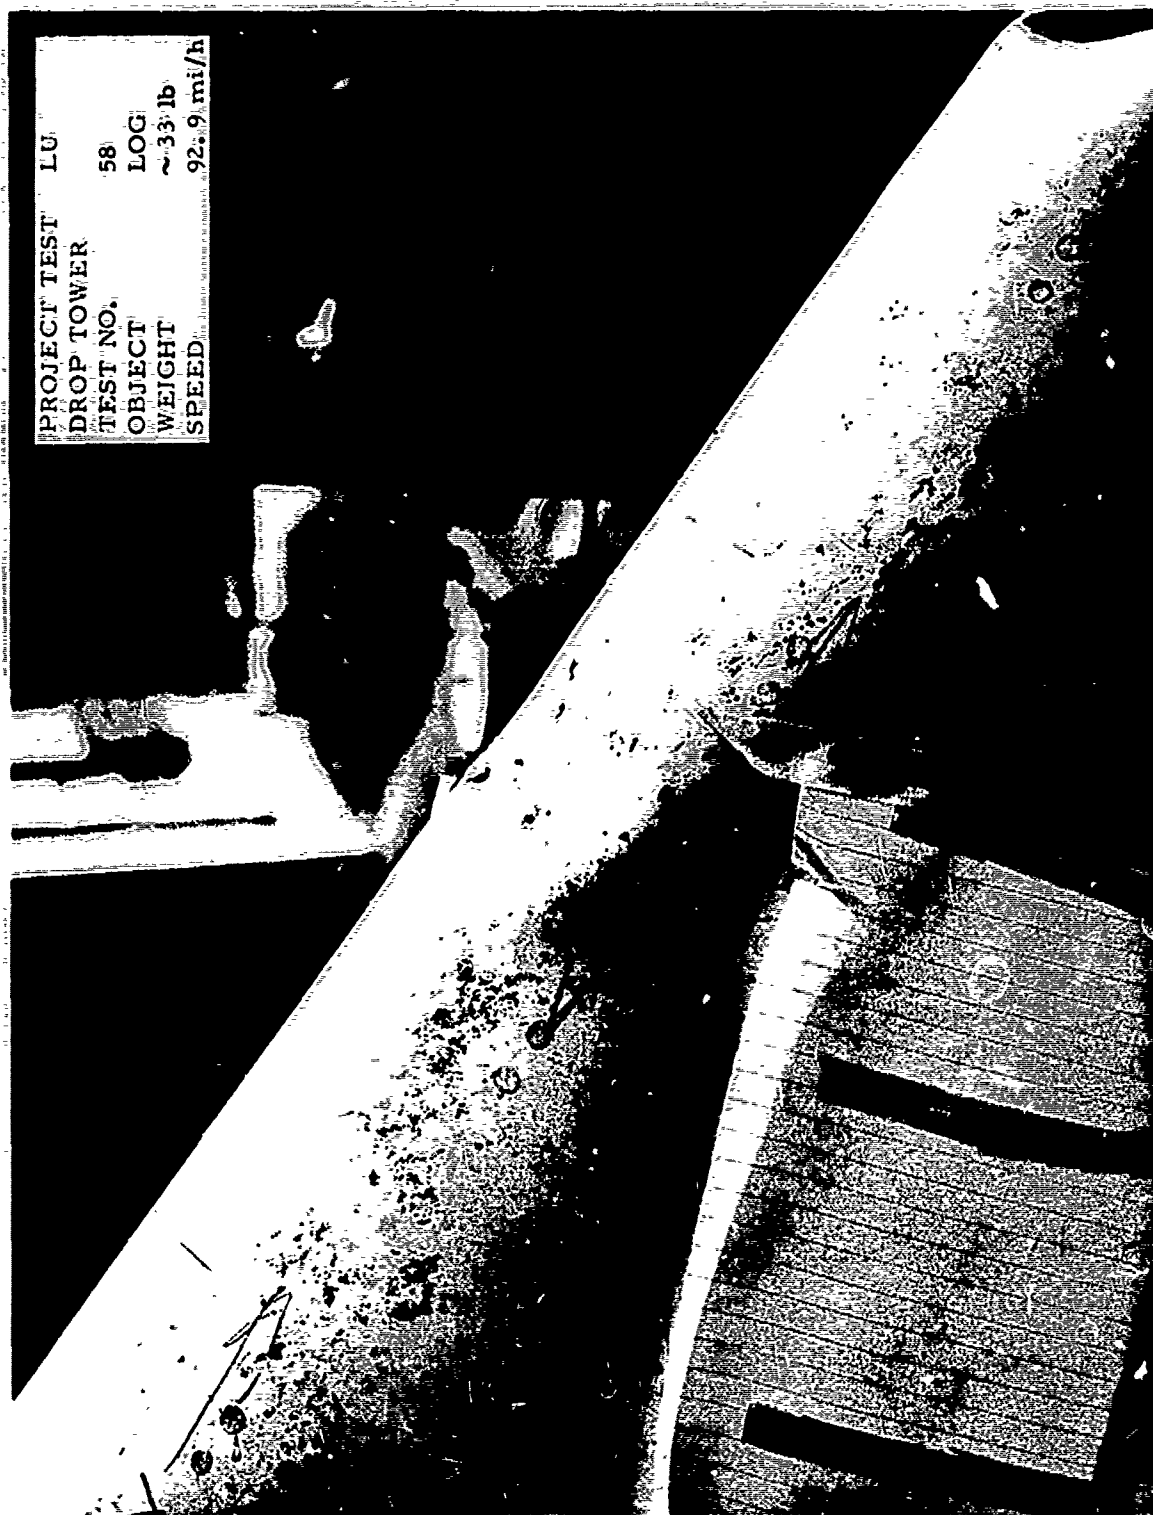
| Project Test | Test | Predicted Impact Speed (mi/h) | Actual Impact Speed (mi/h) | Test Obstacle | Comment |
|---|---|---|---|---|---|
| LU | 4 | 116 | 92.9 | Log | No rupture |

FIGURE 10. DAMAGE TO WING - TEST 4, 92.9 MI/H - LOG

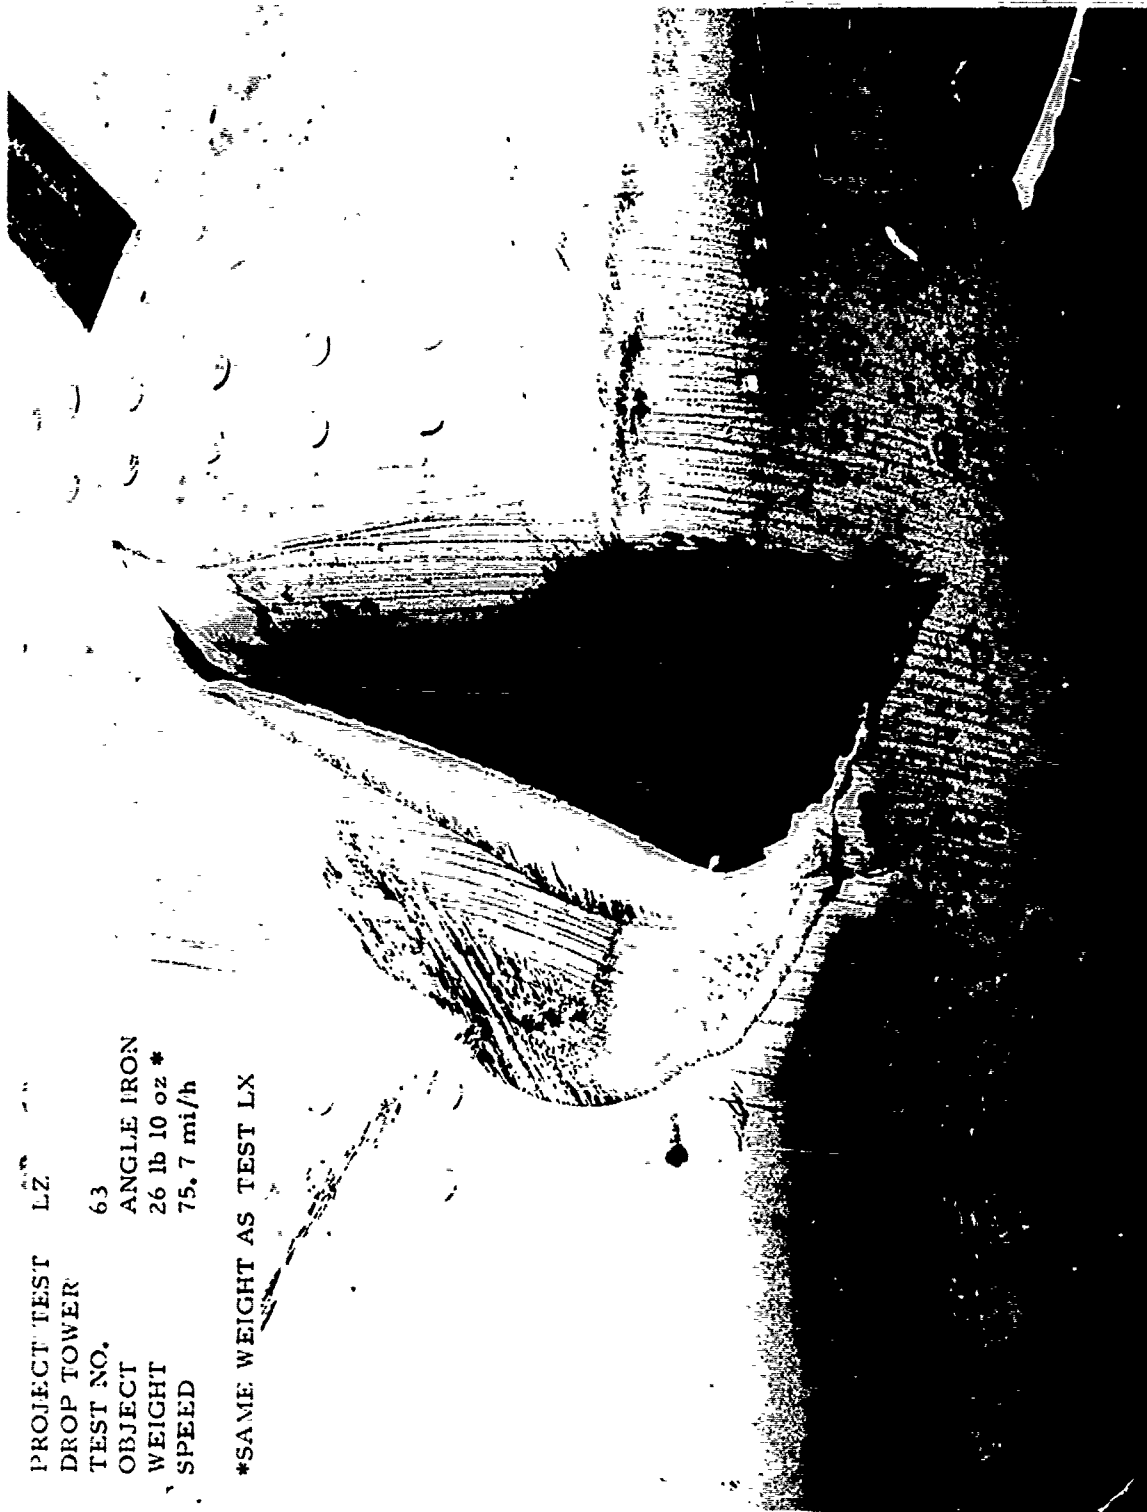
PROJECT TEST LZ  
DROP TOWER  
TEST NO. 63  
OBJECT ANGLE IRON  
WEIGHT 26 lb 10 oz \*  
SPEED 75.7 mi/h

| Project Test | Test | Predicted Impact Speed (mi/h) | Actual Impact Speed (mi/h) | Test Obstacle | Comment |
|---|---|---|---|---|---|
| LZ | 9 | 75 | 75.7 | Angle Iron | 9-inch rupture along rivet line |

FIGURE 15. DAMAGE TO WING - TEST 9, 75.7 MI/H - ANGLE IRON

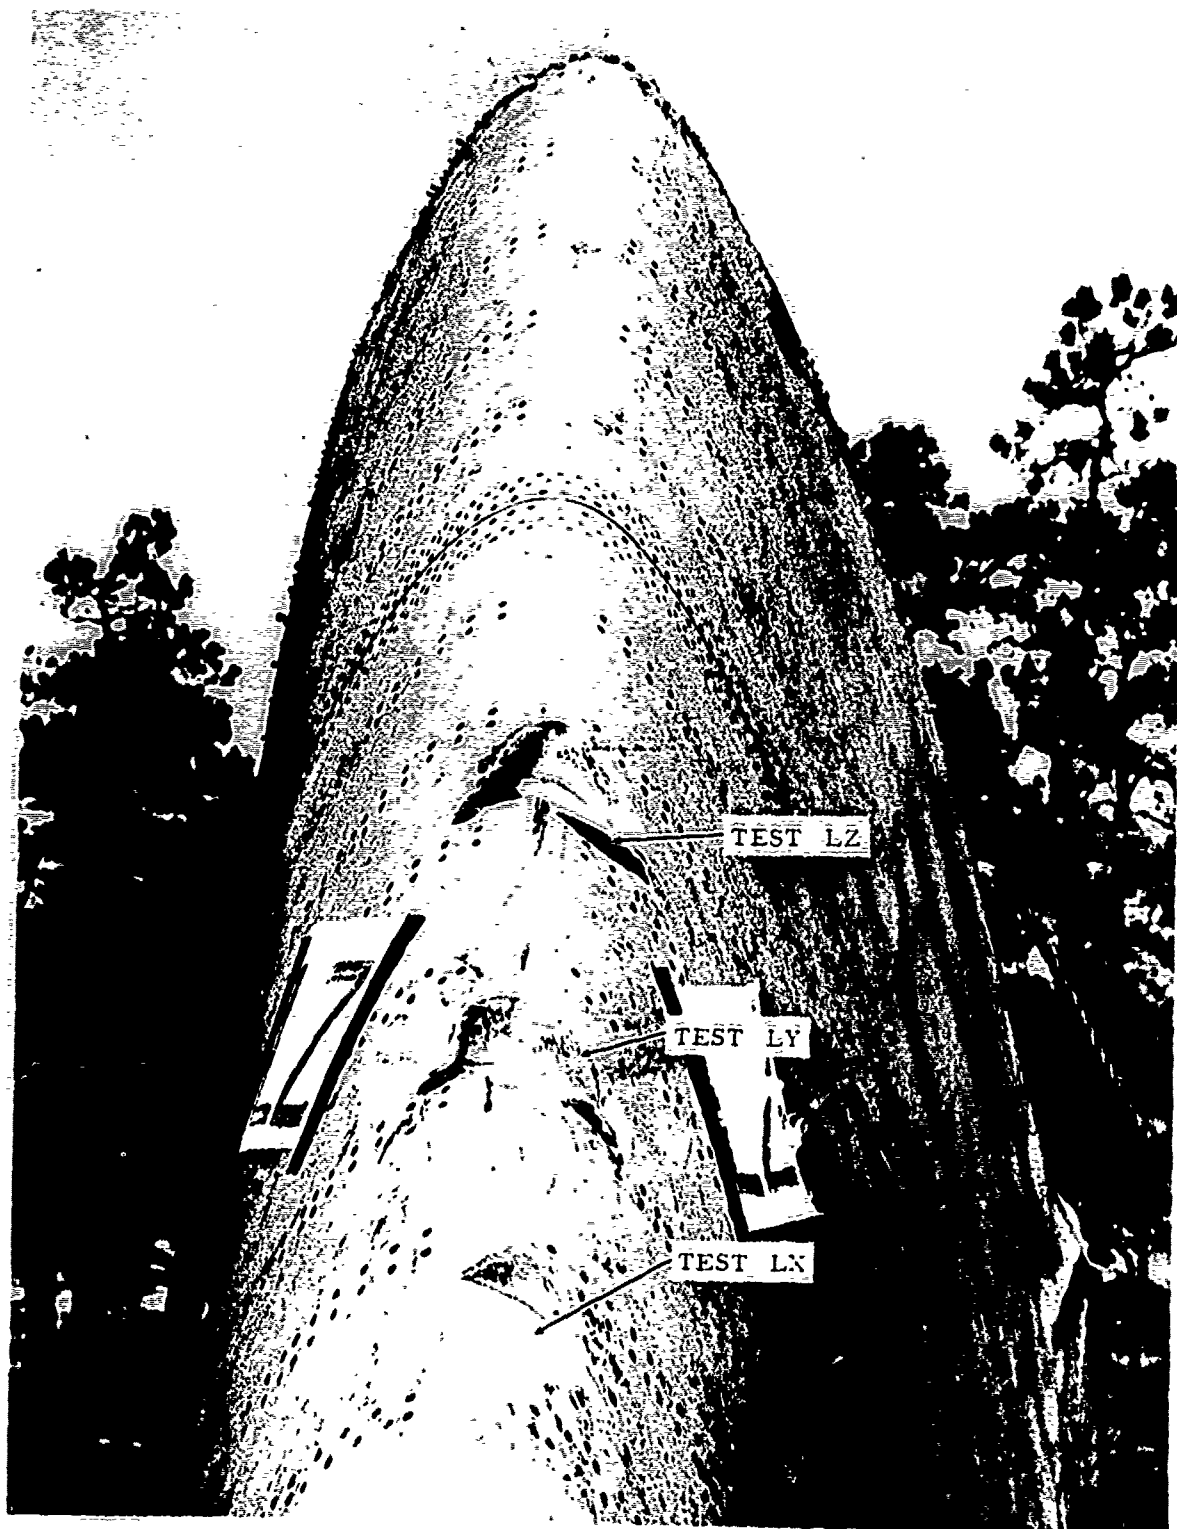
FIGURE 16. DAMAGE TO WING - TEST 7, 8, 9 - ANGLE IRON
