MIGRATION OF SILVER THROUGH GOLD PLATING  
ON ELECTRICAL CONTACTS

Army Missile Command  
Redstone Arsenal, Alabama

19 December 1972

TECHNICAL REPORT  
RL-72-19

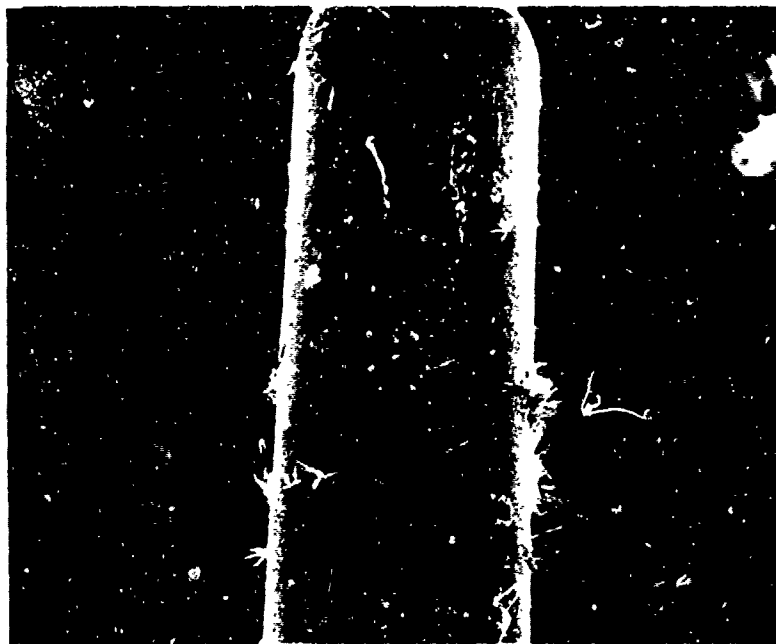
Another connector from the severely contaminated set of 12 was disassembled and a pin severed from the mounting. This pin was not as badly contaminated as the ones originally examined. Figure 49 depicts various crystalline protrusions of migrated silver. The caterpillar-like projection on the right side of the pin was enlarged to 350X magnification to show a flower-like appearance, Figure 50.

**FIGURE 49. ELECTRON MICROGRAPH. CONTAMINATED CONNECTOR PIN SHOWING THE SCATTERED MIGRATED CRYSTALS OF SILVER/SILVER SALTS, ESPECIALLY THE CATERPILLAR-LIKE PROTRUSION ON THE RIGHT SIDE. MAGNIFICATION 32X.**
