**LONG-TERM STORAGE TESTING OF PROPELLANT  
TANKAGE**

Howard M. White

Air Force Rocket Propulsion Laboratory  
Edwards Air Force Base, California

**AFRPL-TR-72-126**

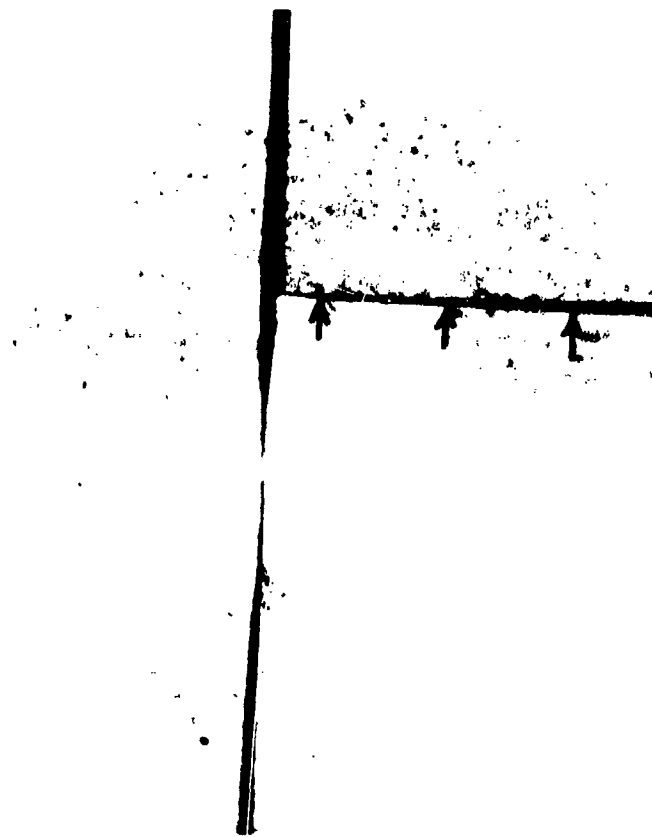
**Figure B-2. Same Location as Figure 1, With  
Corrosion Products Removed and the Region  
Sectioned. Arrows at Cross-Section  
That was Examined**

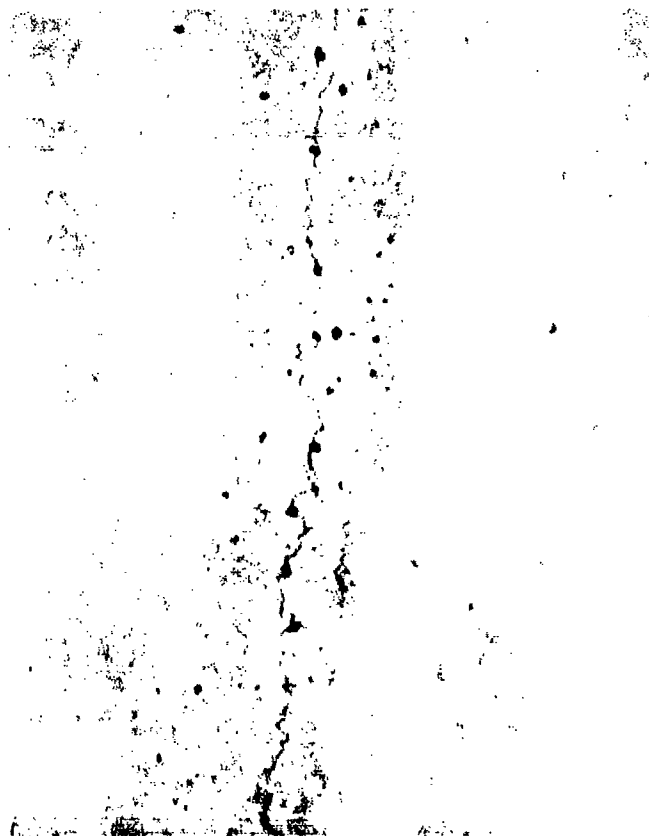
**Figure B-3. Crack in HAZ;  
Parallel to Girth Weld**

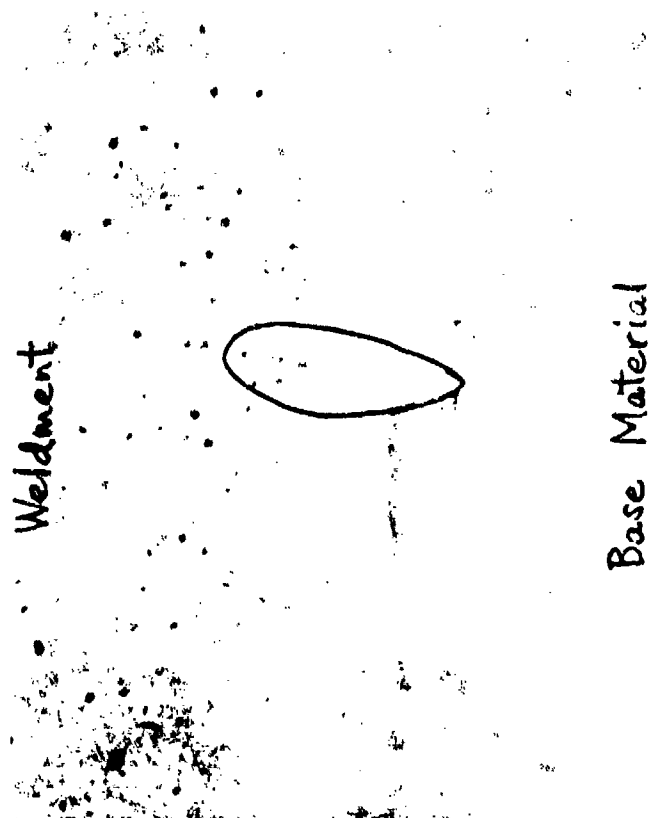
Figure B-4. Crack Emanating from HAZ;  
Perpendicular to Girth Weld

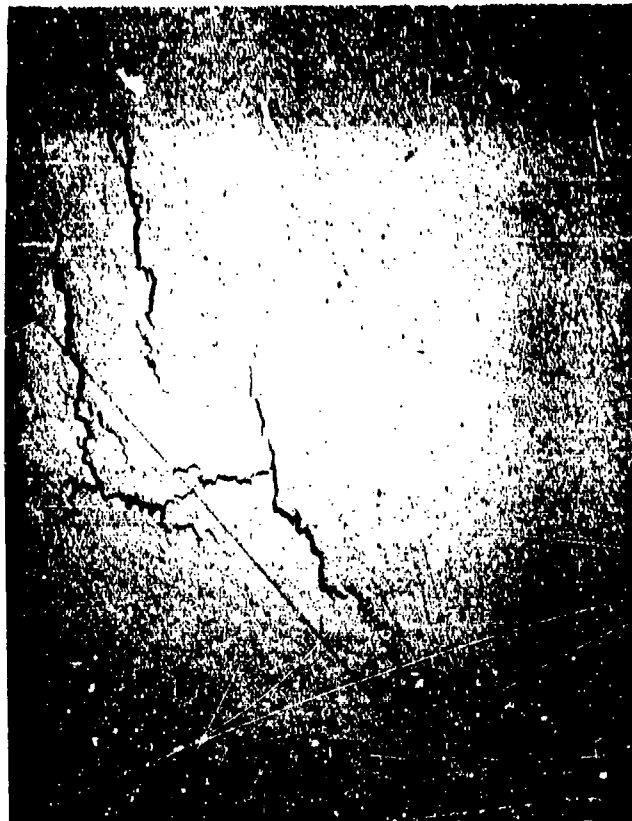
Figure B-6. Cross Section of Crack in  
Figure B-4 and B-5. General  
Corrosion and Pitting Observable at  
Exterior Surface (Left)

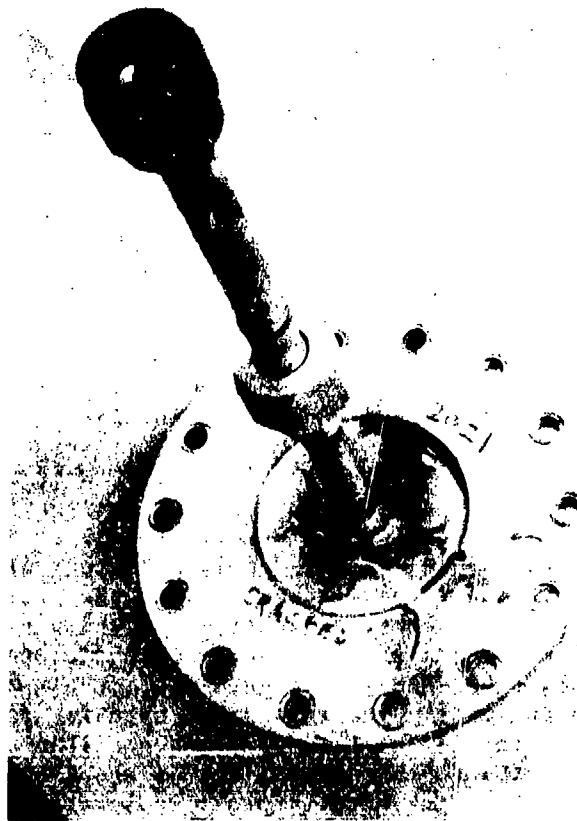
Figure C-1. 6061 Al Alloy Pipe Welded  
to 2021 Al Alloy Head Plate (From  
a Propellant Storage Tank)

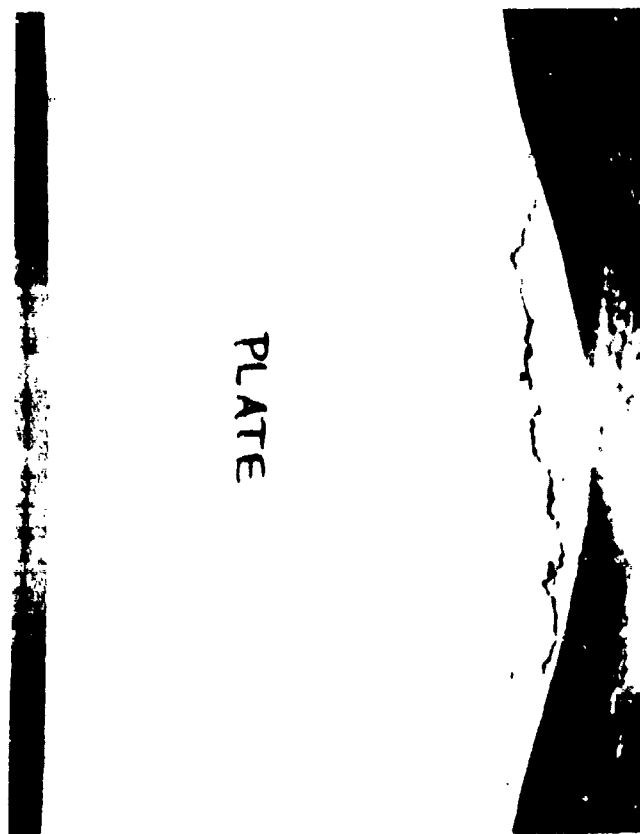
Figure C-4. First Cross-Section of Crack.  
(Plane of Cross-Section is Parallel to  
Long Axis of Pipe)

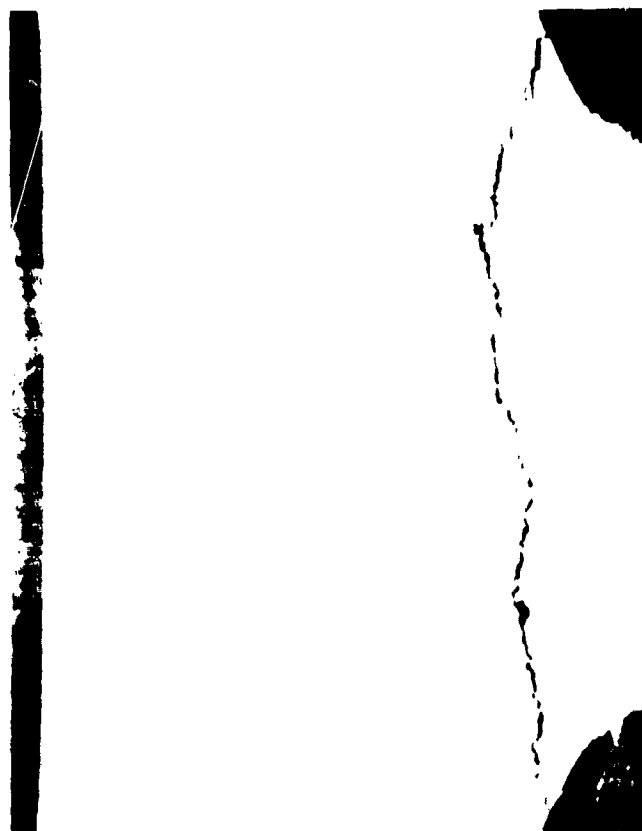
**Figure C-5. Second Cross-Section of Crack.  
(0.03 in. Deeper Than First)**

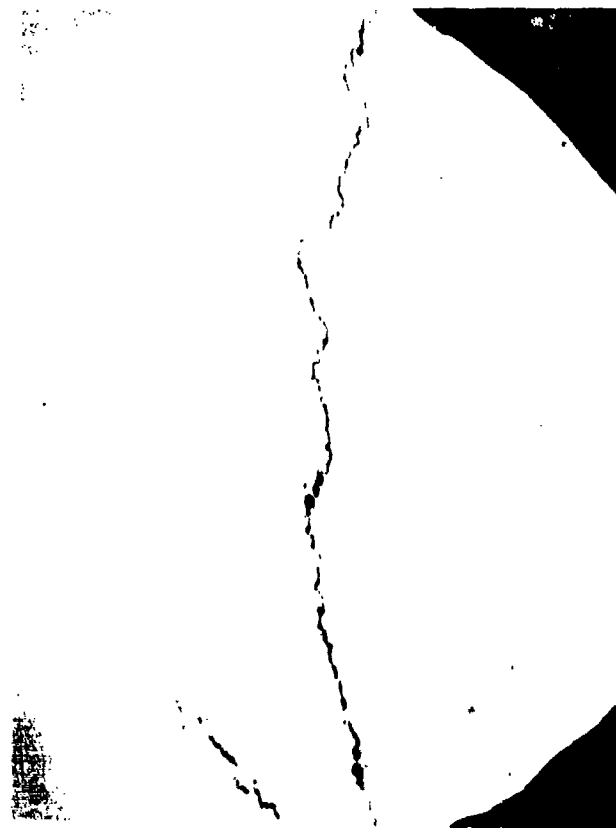
Figure C-6. Third Cross-Section of Crack.  
(0.07 in. Deeper Than Second)

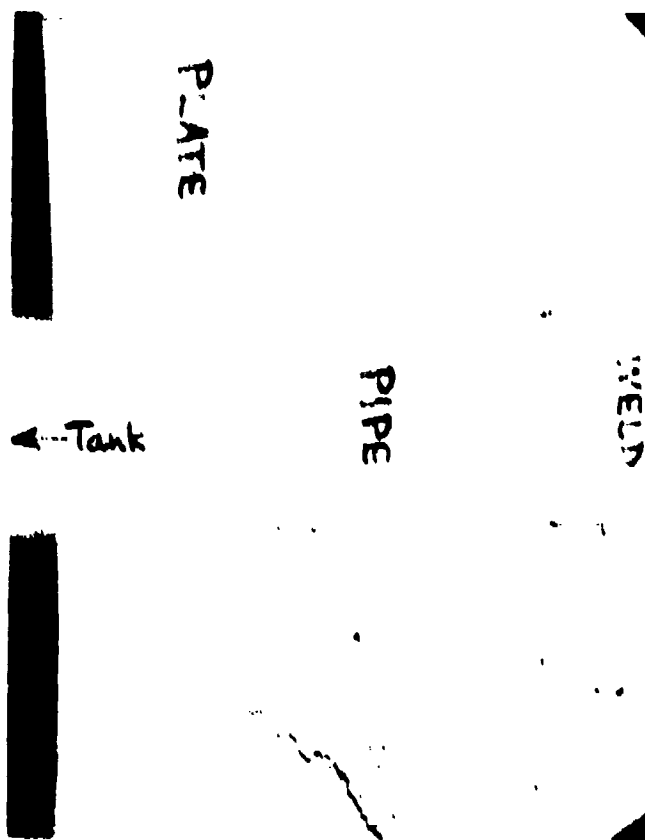
Figure C-8. Fifth Cross-Section of Crack.  
Pipe in Center. Tank to Left. Weld at  
Right. (0.01 Deeper Than Fourth)
