THICKNESS REQUIREMENTS FOR SOILS BENEATH  
LANDING MATS; BARE BASE SUPPORT

MISCELLANEOUS PAPER S-71-3

Project 3782-64

Conducted by U. S. Army Engineer Waterways Experiment Station, Vicksburg, Mississippi

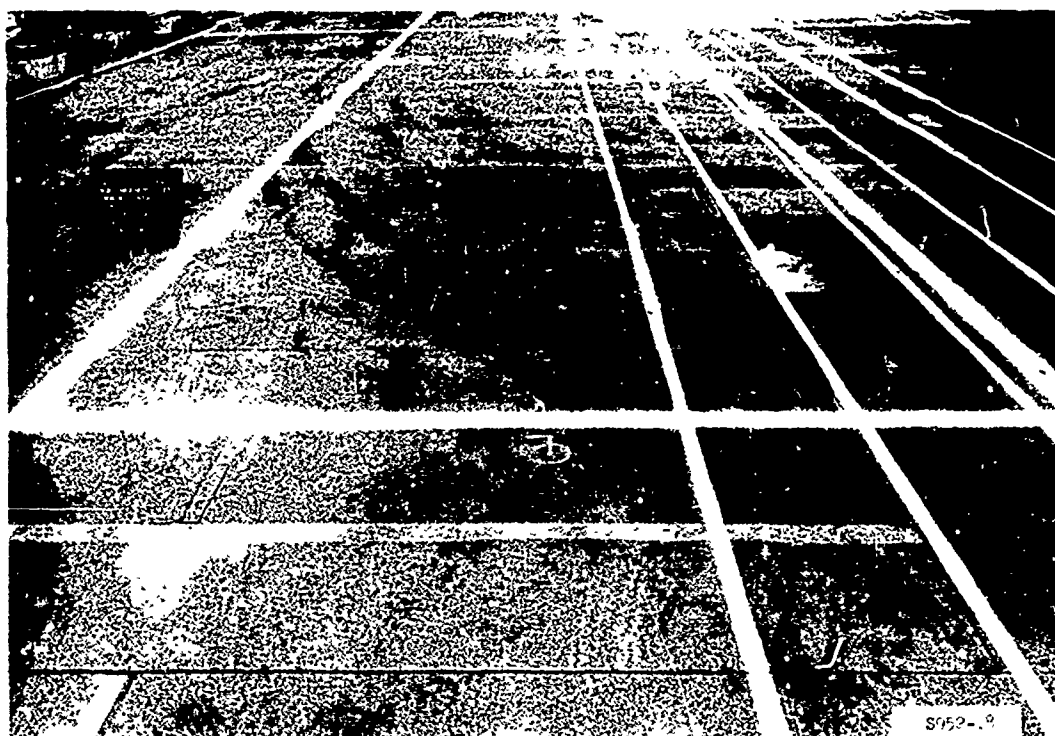
37. Item 2. A view of item 2 prior to traffic is shown in photograph A56. No distress was noted in item 2 until surface depressions, indications of internal rib failures, developed in panels 51 and 54 at 400 coverages. At 477 coverages, a top skin tear developed at a location corresponding to an internal rib failure in panel 51. Photograph A57 shows the skin tear at 528 coverages. Panels 51 and 54 were considered failed at 569 coverages and were replaced. Several additional panels had developed evidence of internal rib failures at this time; however, the damage was slight, and the panels were not considered hazardous to tires during aircraft operations. At 720 coverages, top skin tears and depressions from internal rib failures in panel 48 became a serious tire hazard, as shown in photograph A58. The top lip of the underlapping end joint in panel 47 had also sheared off at this time, and both panels were replaced. Traffic was continued to 884 coverages before the entire test item was considered failed. Photographs A59 and A60, respectively, show depressions from internal rib failures and top skin tears of typical failed panels. Failure of item 2 was attributed to excessive mat breakage (rib failures and skin tears). An overall view of item 2 at failure is shown in photograph A61.

Photograph A61. Test section III, lane 1, item 2,  
after failure at 884 coverages

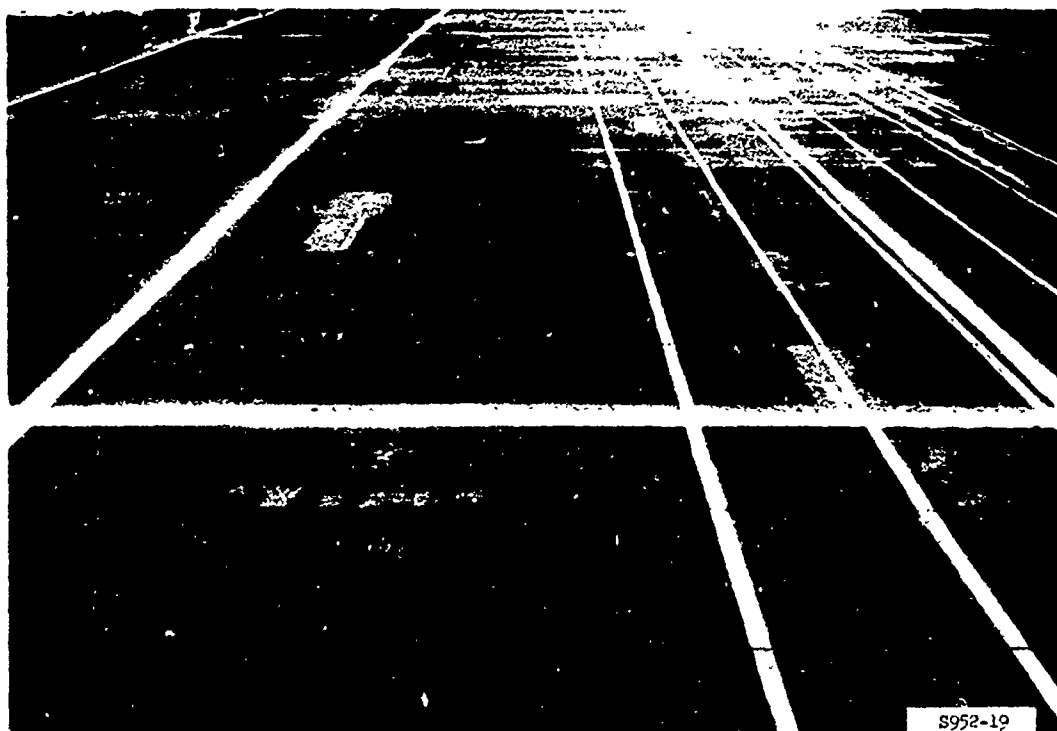
Photograph A65. Test section III, lane 2, item 1,  
after failure at 56 coverages

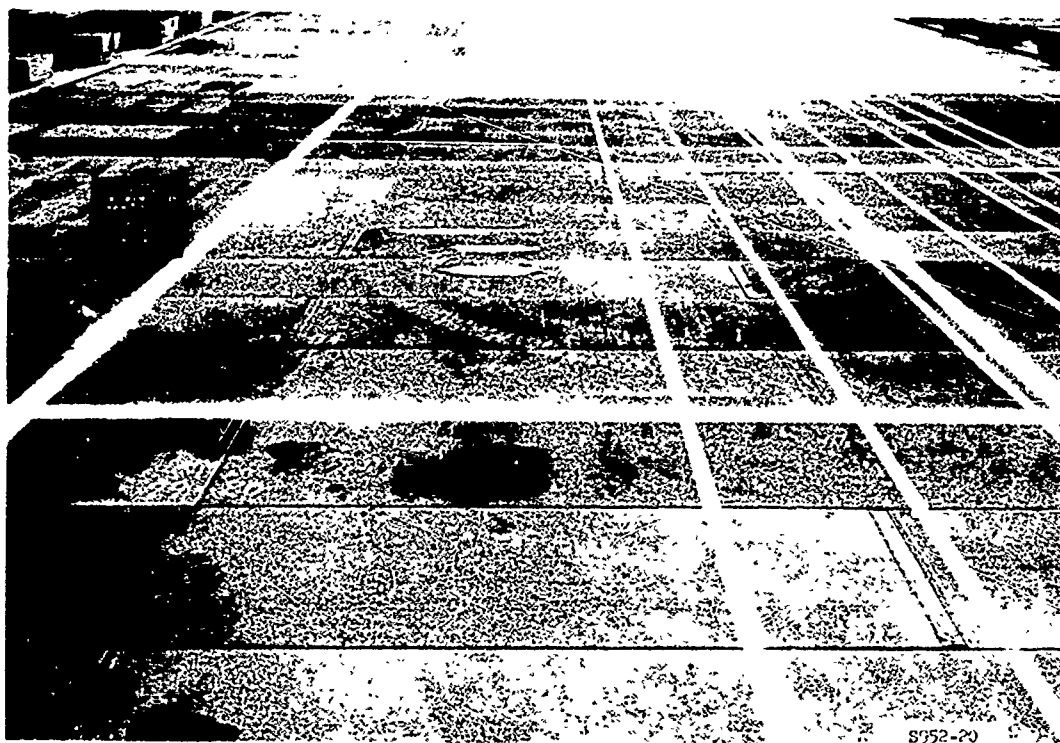
Photograph A67. Test section III, lane 2, item 2,  
after failure at 72 coverages

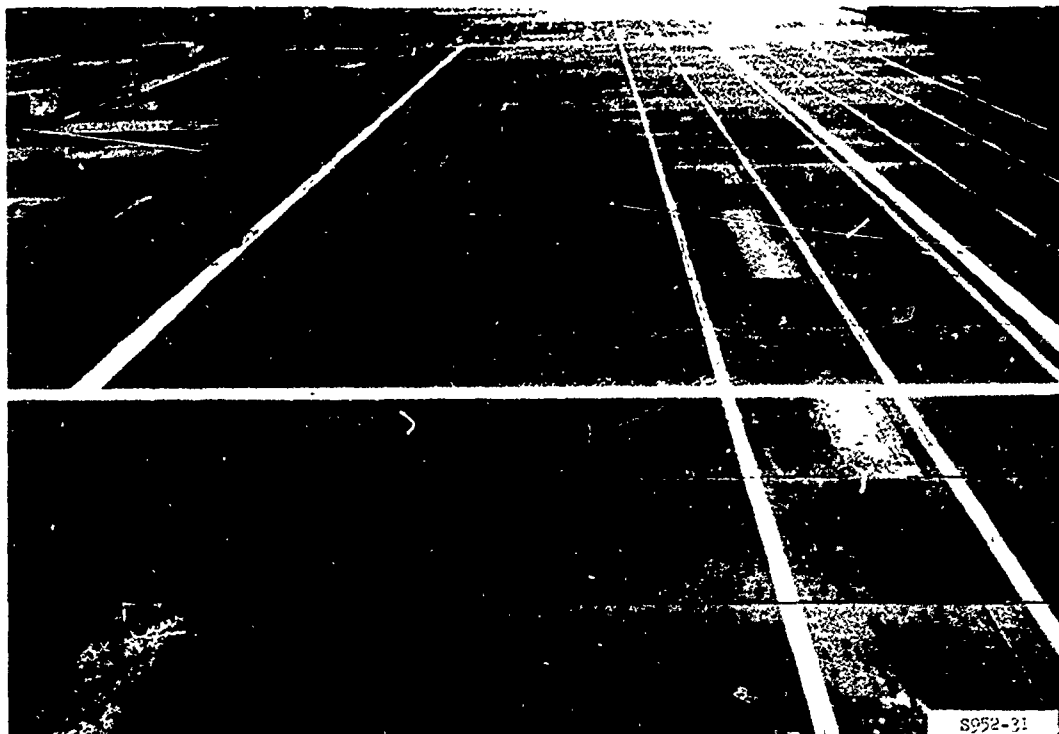
Photograph A70. Test section III, lane 2, item 3, at failure after 92 coverages

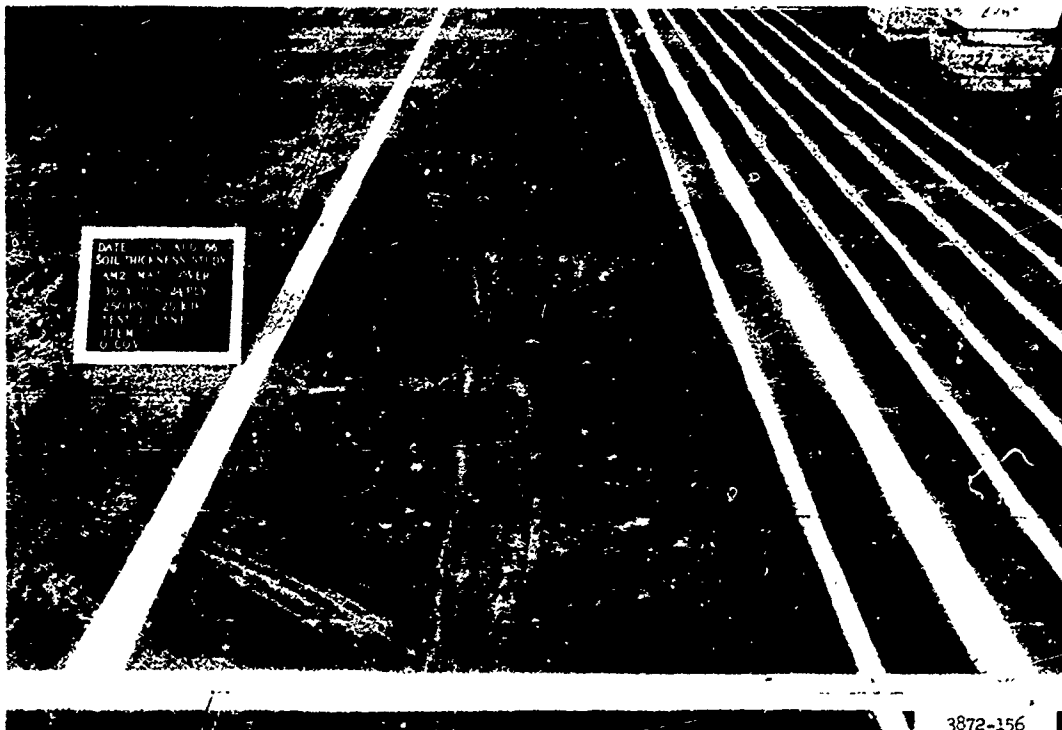
Photograph A74. Test section IV after failure at 348 coverages
