CONDITION SURVEYS OF PAVEMENTS SUBJECTED  
TO CHANNELIZED TRAFFIC, DAVIS-MONTHAN  
AIR FORCE BASE, TUCSON, ARIZONA

Army Engineer Waterways Experiment Station  
Vicksburg, Mississippi

April 1957

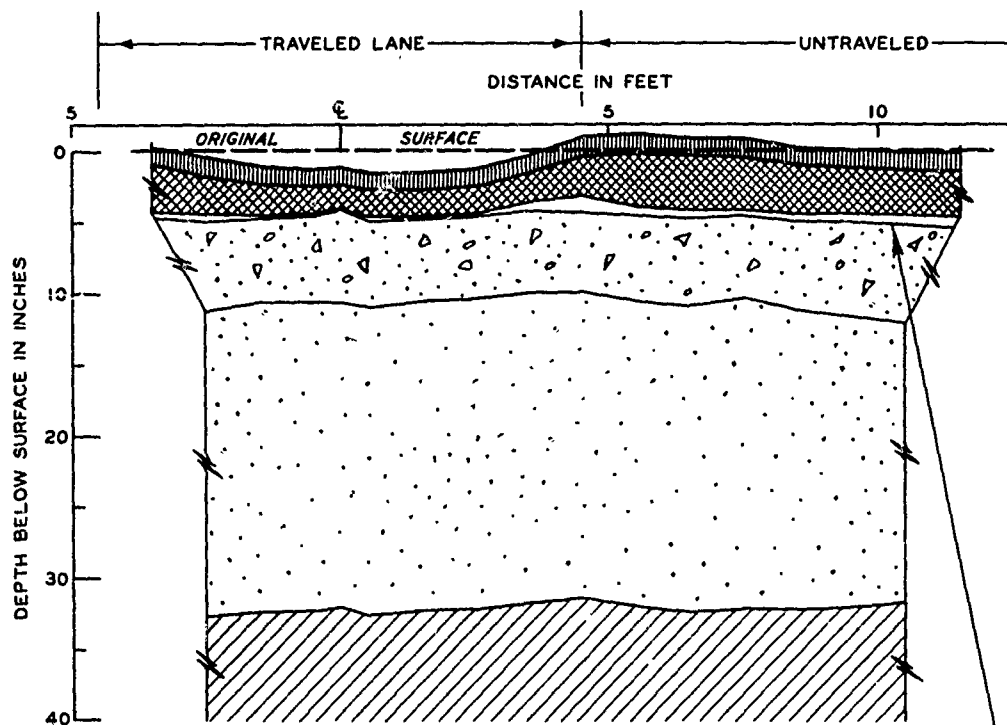
PROFILE OF TEST TRENCH  
TAXIWAY 14

Analysis of the above data indicates that conditions are generally the same in the wearing course in both the traveled (pits 1, 4, and 5T) and untraveled (pits 2, 3, and 5U) areas. The data for the binder course showed about the same conditions in traveled and untraveled areas except for voids in the total mix and voids filled with asphalt. In the traveled areas voids averaged about 1.3% and voids filled averaged 91.2%; in the untraveled areas voids averaged 2.2% and voids filled 84.7%. Laboratory tests performed on the cored specimens indicated that at all locations tested, except the binder course in the traveled area of trench 5, the stability of the asphaltic concrete was above the 1000 lb required for high-pressure tires at the time of the design of these pavements. Flow values for the wearing course were all below the maximum allowable of 16 except for the traveled area of test trench 5; those for the binder course were higher than 16 except at test pit 3. Voids in the total mix were well below the minimum allowable of 3% for wearing courses and 5% for binder courses in both traveled and untraveled areas. Conversely, the voids filled with asphalt were well above the maximum allowable in all cases. Observation of the sawed face of the asphaltic concrete at test trench 5 indicated that the major part of the loss in grade at that location was due to movement in the binder course (plate 2). The movement in the binder course is believed to be partially due to low shear

resistance between the binder course and the base course. About 1/8 in. of fine material had cemented together forming a hard, slick surface on the base course. Engineers at the field stated that this probably resulted from slush rolling. The prime did not penetrate this hard surface and, therefore, provided little bond to the base course. The stability of the rich binder course was not sufficient to resist movement when the temperature of the pavement became high during the summer months. No plastic flow was apparent in the wearing course.

FINE MATERIAL CEMENTED  
TOGETHER FORMING A SLICK  
SURFACE ON TOP OF THE  
BASE COURSE.

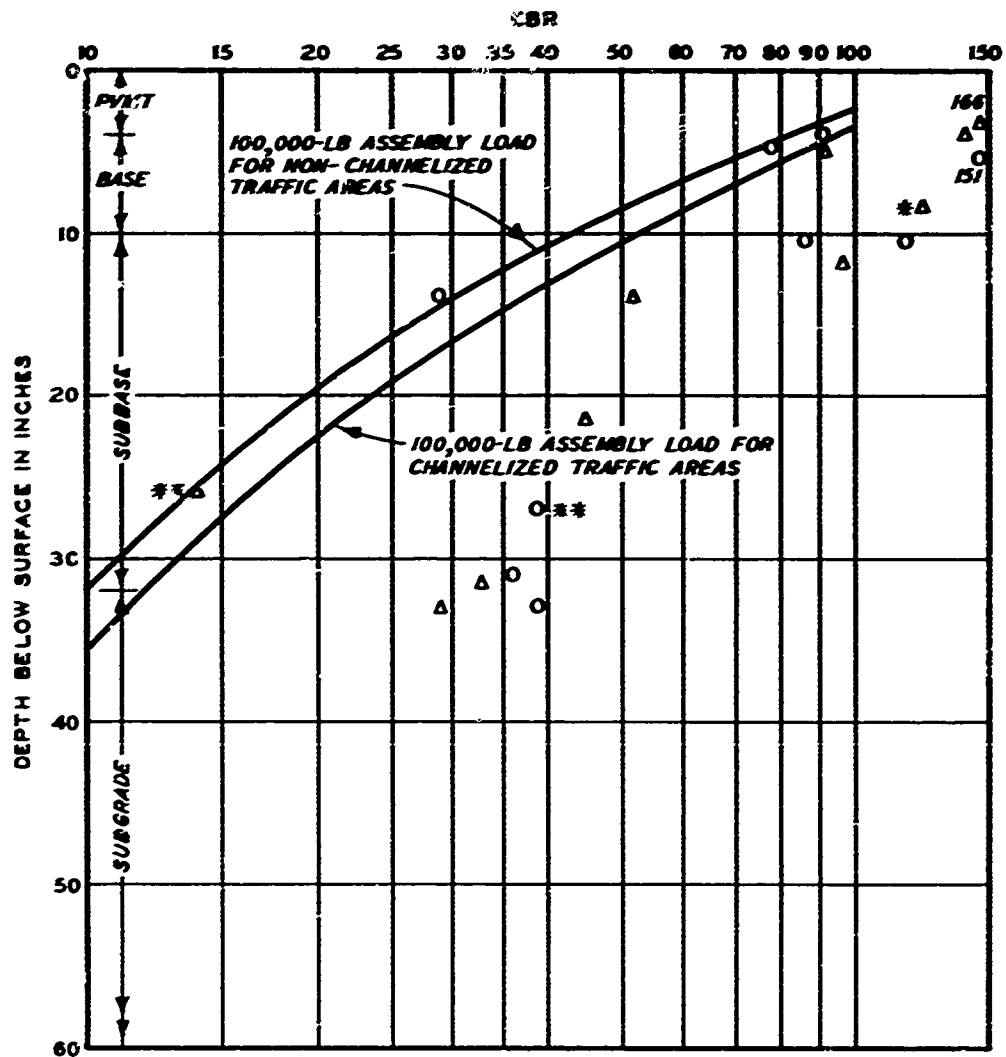
IN-PLACE CBR VS DEPTH  
TAXIWAY 14

27. A comparison of the in-place CBR values with the design curve for nonchannelized traffic on plate 11 shows that three points fall on the curve and the remainder are well below it. Comparison of the points with the curve for channelized traffic areas shows that three points are appreciably above the line, two fall about on the curve, and the remainder lie well below the curve. From this analysis it appears that a few areas may be approaching a critical condition, and could cause trouble if the moisture content increased. Most of the points represent conditions of ample strength; however, it should be noted that the materials are at low moisture content and that an increase in moisture content could cause a drop in strength. The points fall on or below the curve for nonchannelized traffic and, although some of the points represent channelized areas, no distress was found in the base course, subbase, or subgrade. Although the curve for channelized traffic areas indicates that some areas should have evidenced distress, it may be that the planes operate at assembly loads above 100,000 lb so infrequently that the effects of overloads are not evidenced.
