THE FEASIBILITY OF BURNER-CAN BURN-
THROUGH THERMAL DETECTION PRIOR TO
ENGINE CASE RUPTURE

Richard Hill

National Aviation Facilities Experimental Center

Report No. **FAA-RD-72-134**

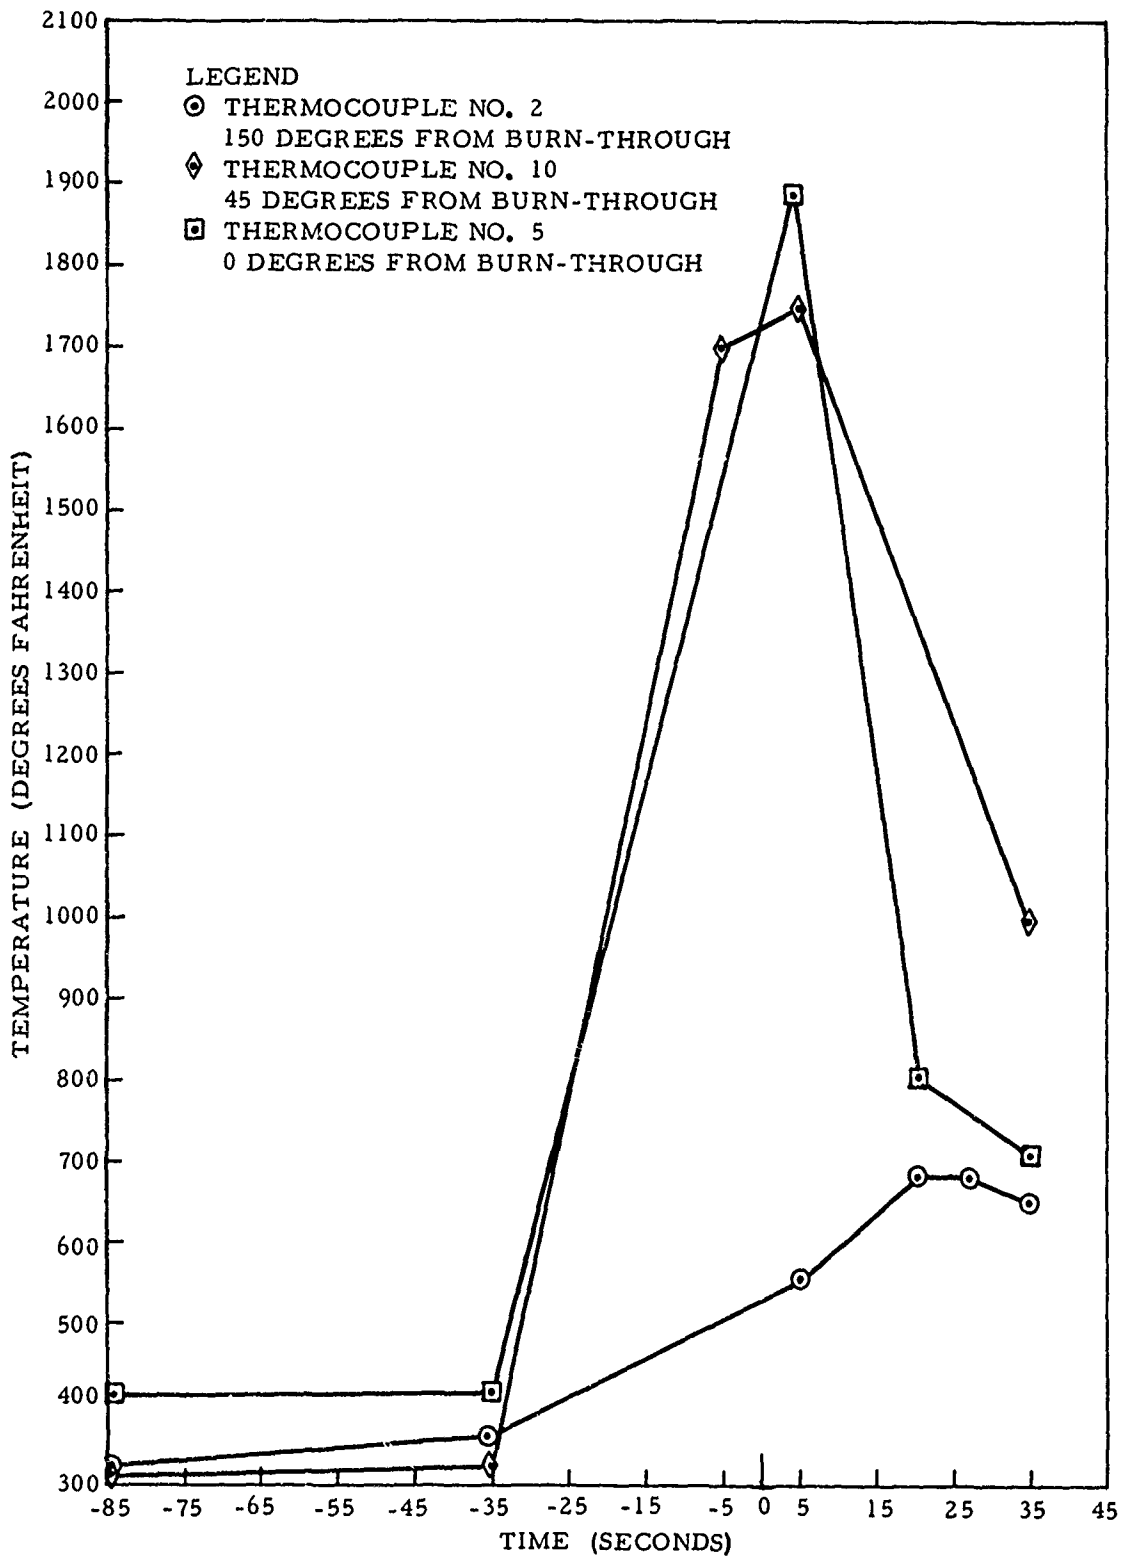
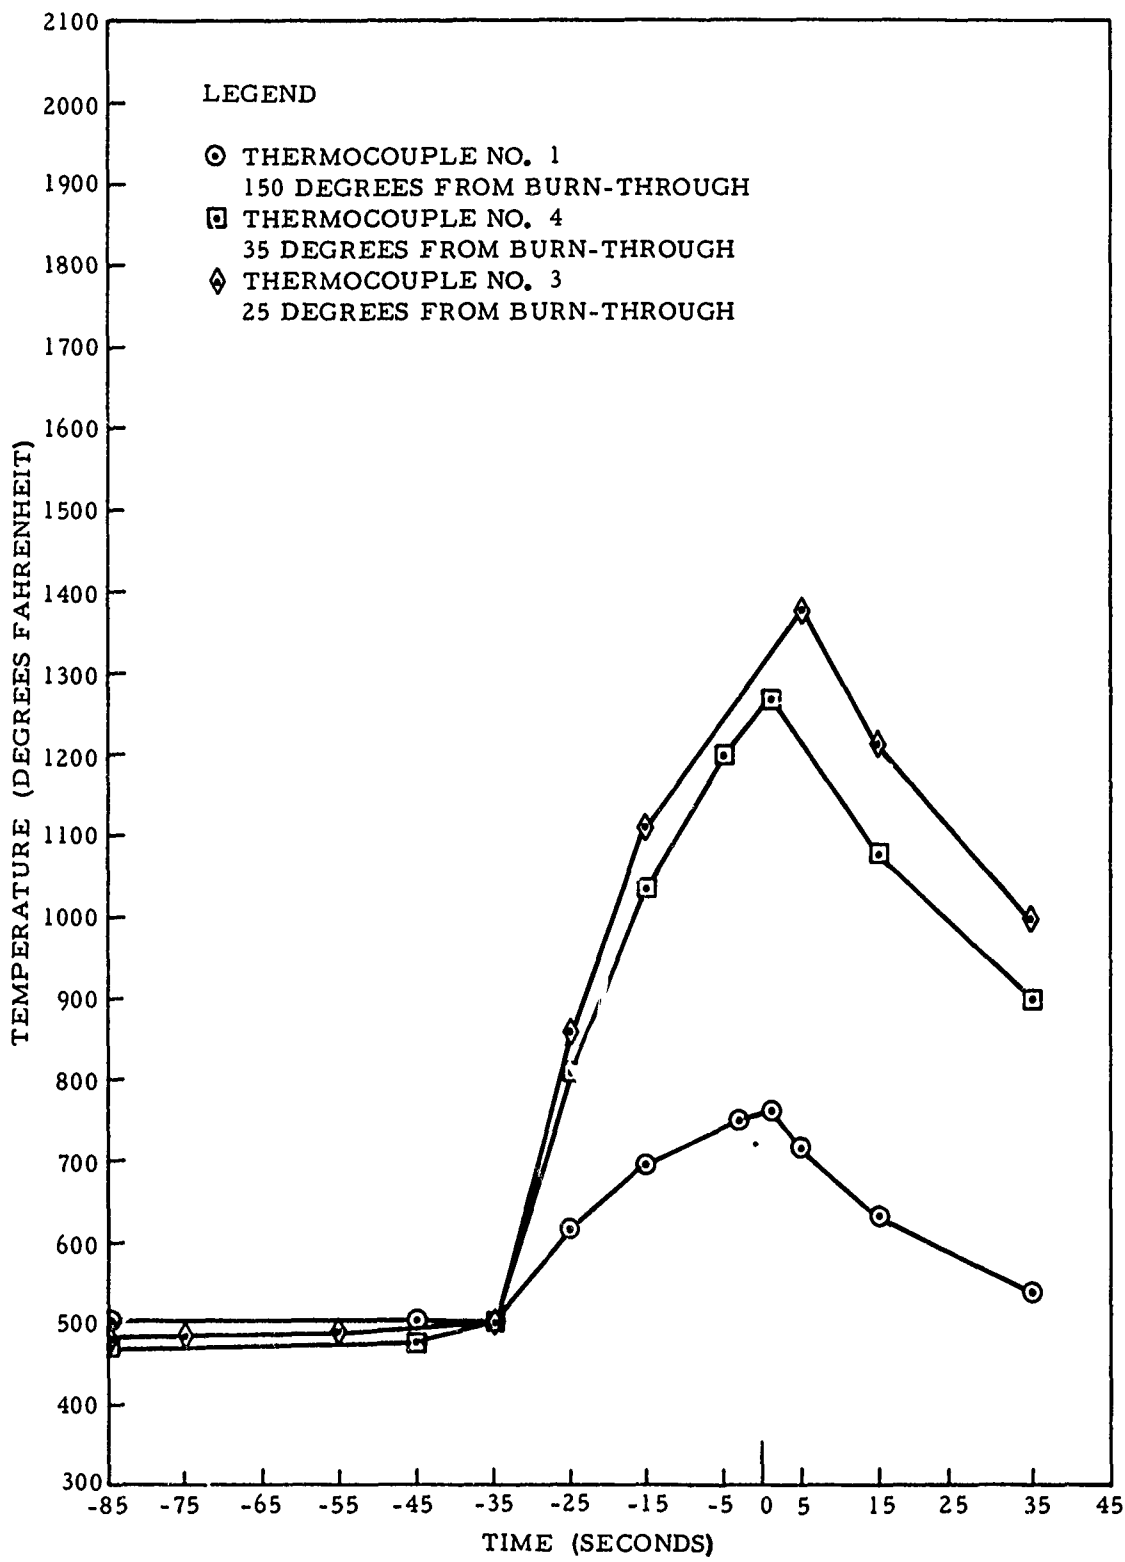
Test No. 1. Figures 17 and 18 show the temperature profile of selected thermocouples on the diffuser case and the burner can case prior to, during and after a burn-through. The thermocouples in the general proximity (within 45°) showed a rapid and large increase in temperature beginning 40 seconds prior to burn-through. The thermocouples located approximately 150° around the engine from the burn-through also showed an increase in skin temperature, but of a much lower magnitude.

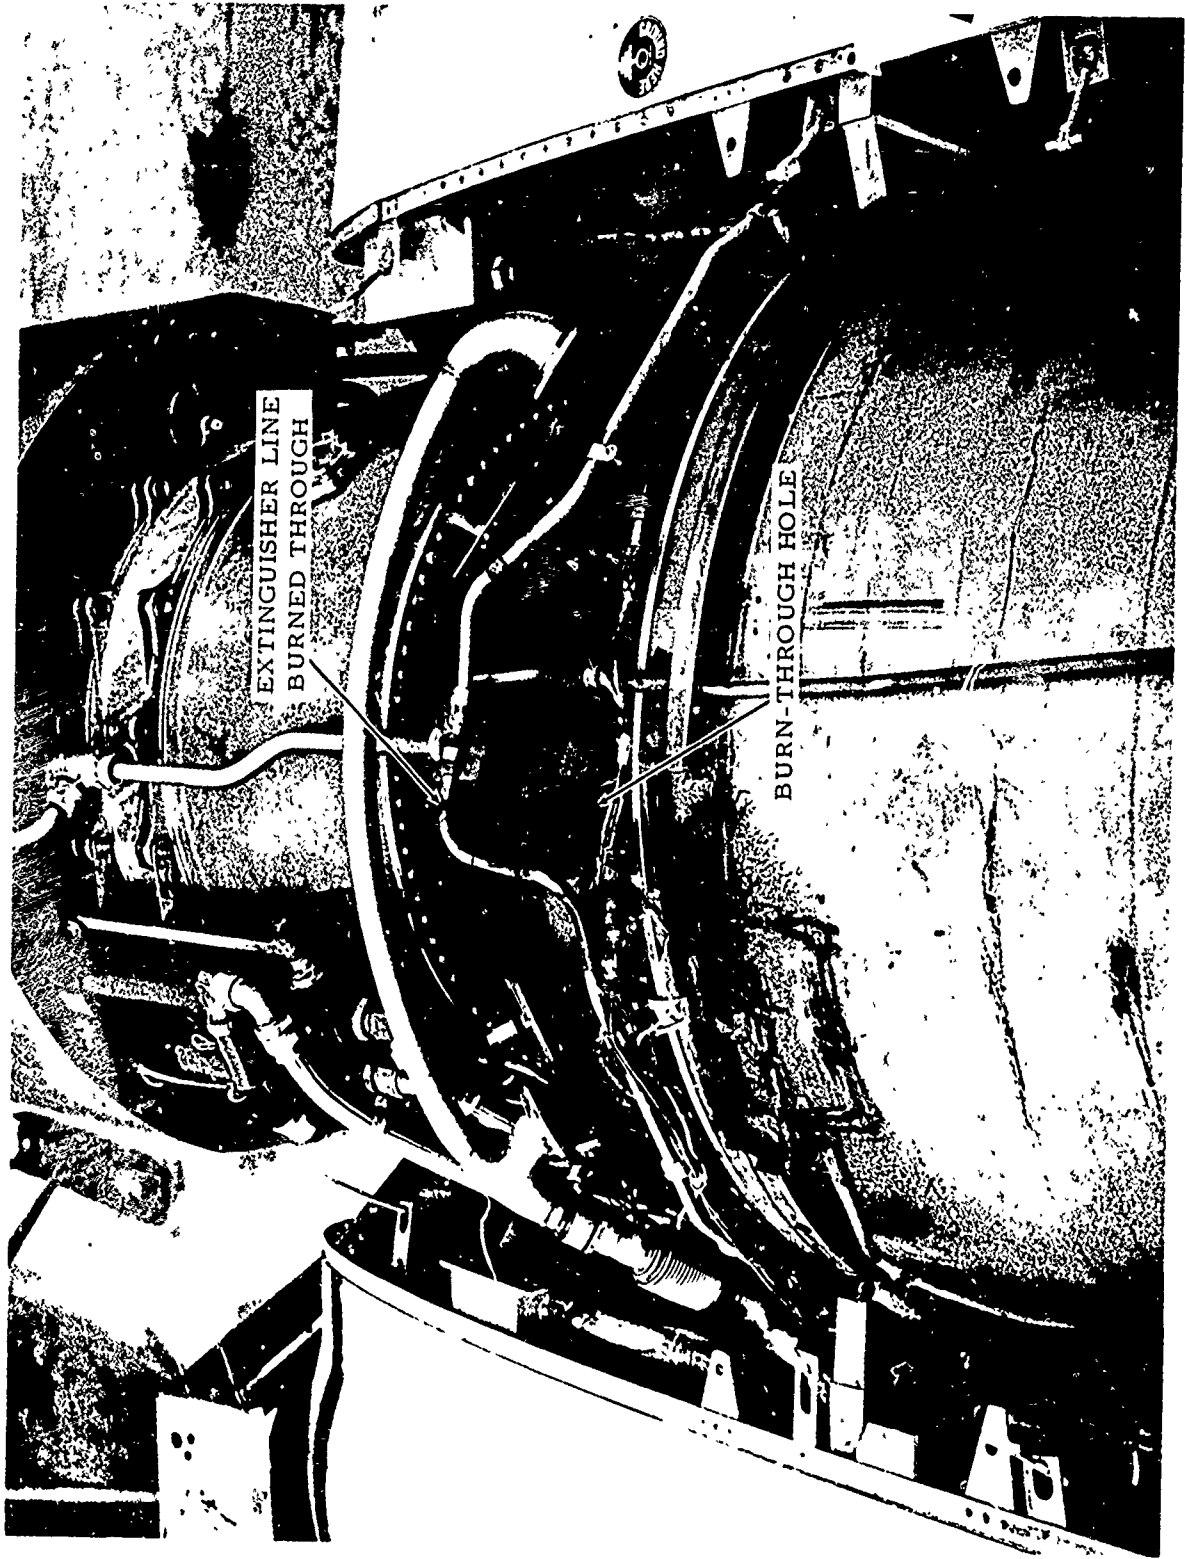
FIGURE 19. J57 BURN-THROUGH DAMAGE, TOP VIEW

Figures 19 and 20 show the damage, from this burn-through, to the diffuser case. The size of the hole was approximately 3 X 4 inches. (Note the holes in the stainless steel fire extinguisher discharge line.) Burn-through time for the 0.030-wall tubing was approximately 1 second.

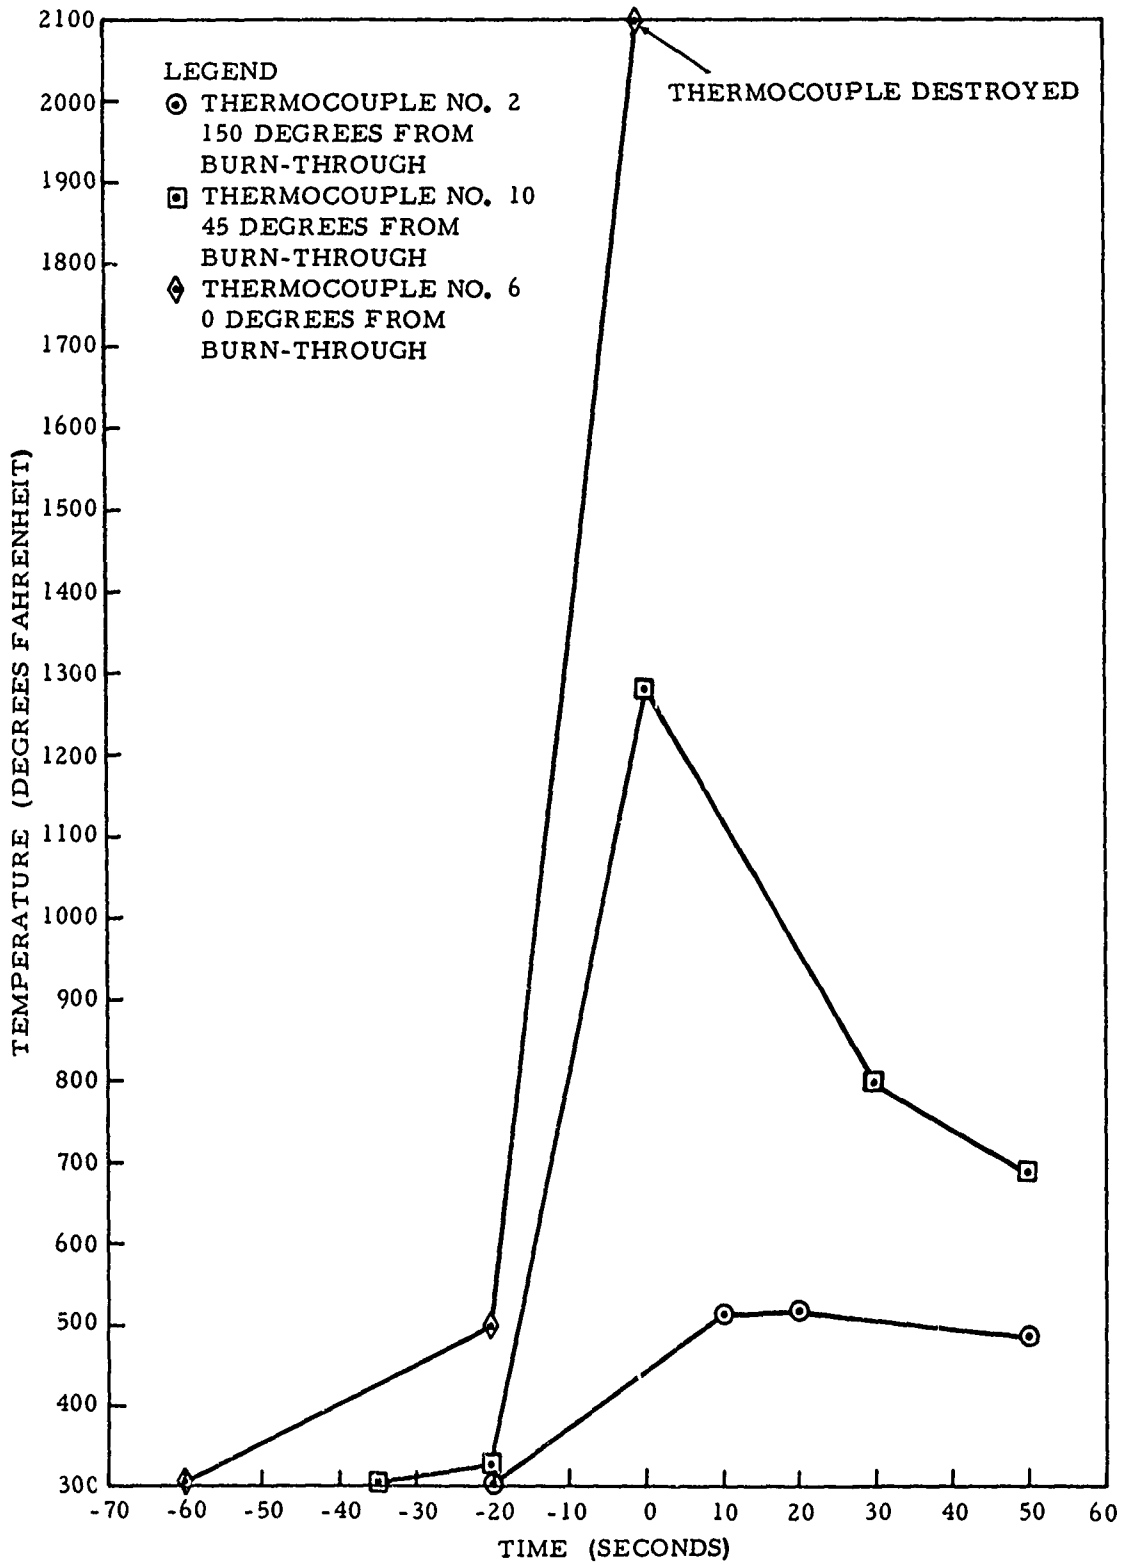
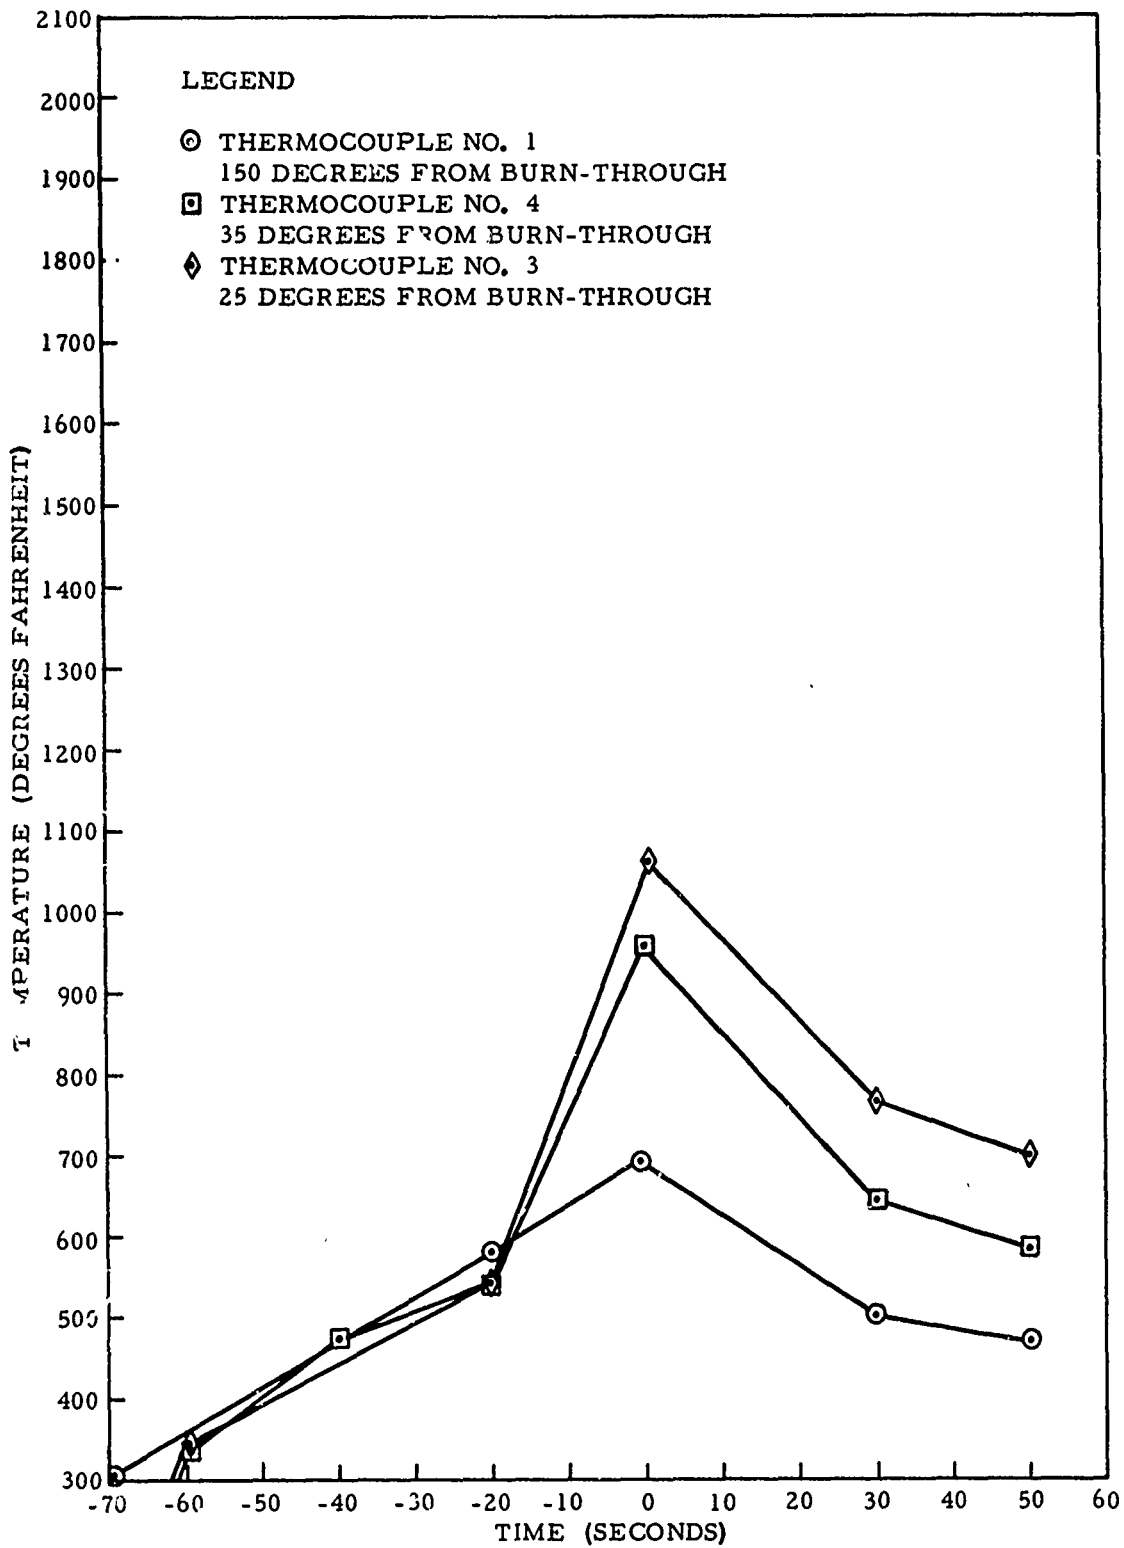
Test No. 2. The results of Test No. 2 can be seen in Figures 21 and 22 and the resultant damage from the burn-through in Figure 23. The burn-through hole in Test No. 2 was slightly larger than that in Test No. 1. The results of the test was similar to the first test, except the magnitude of the temperatures was not as high. This could have been caused by an earlier rupture of the diffuser case due to its weakened condition.

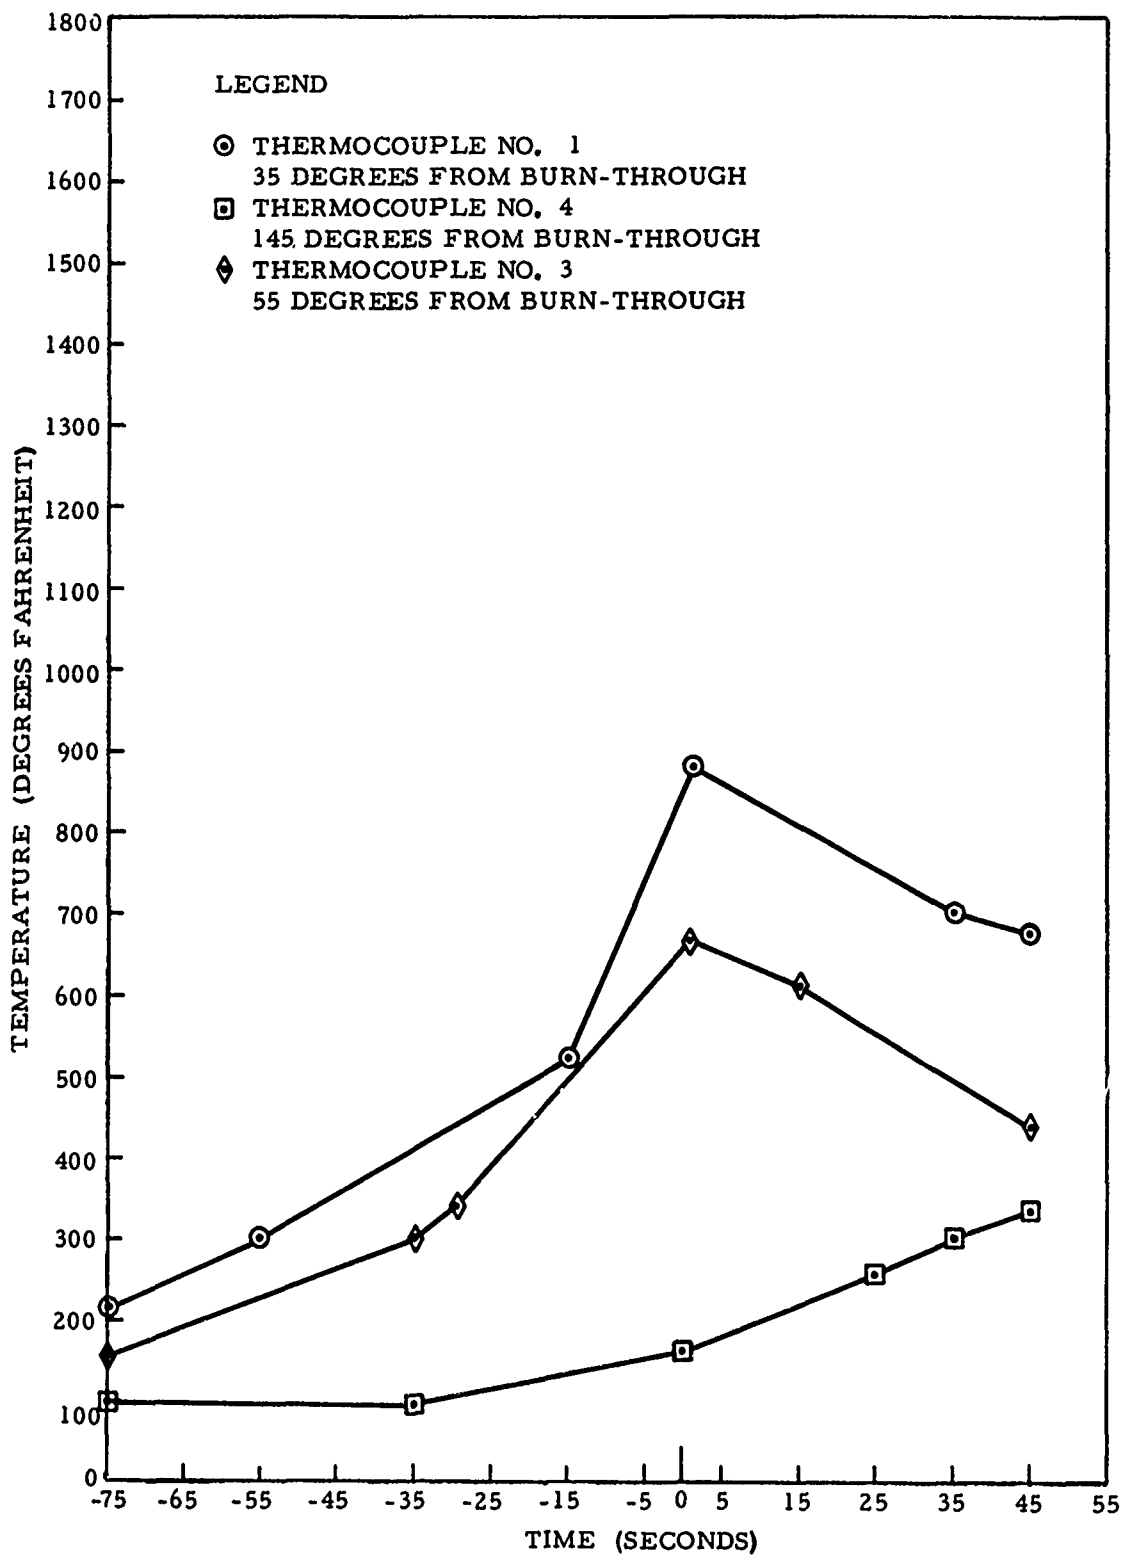
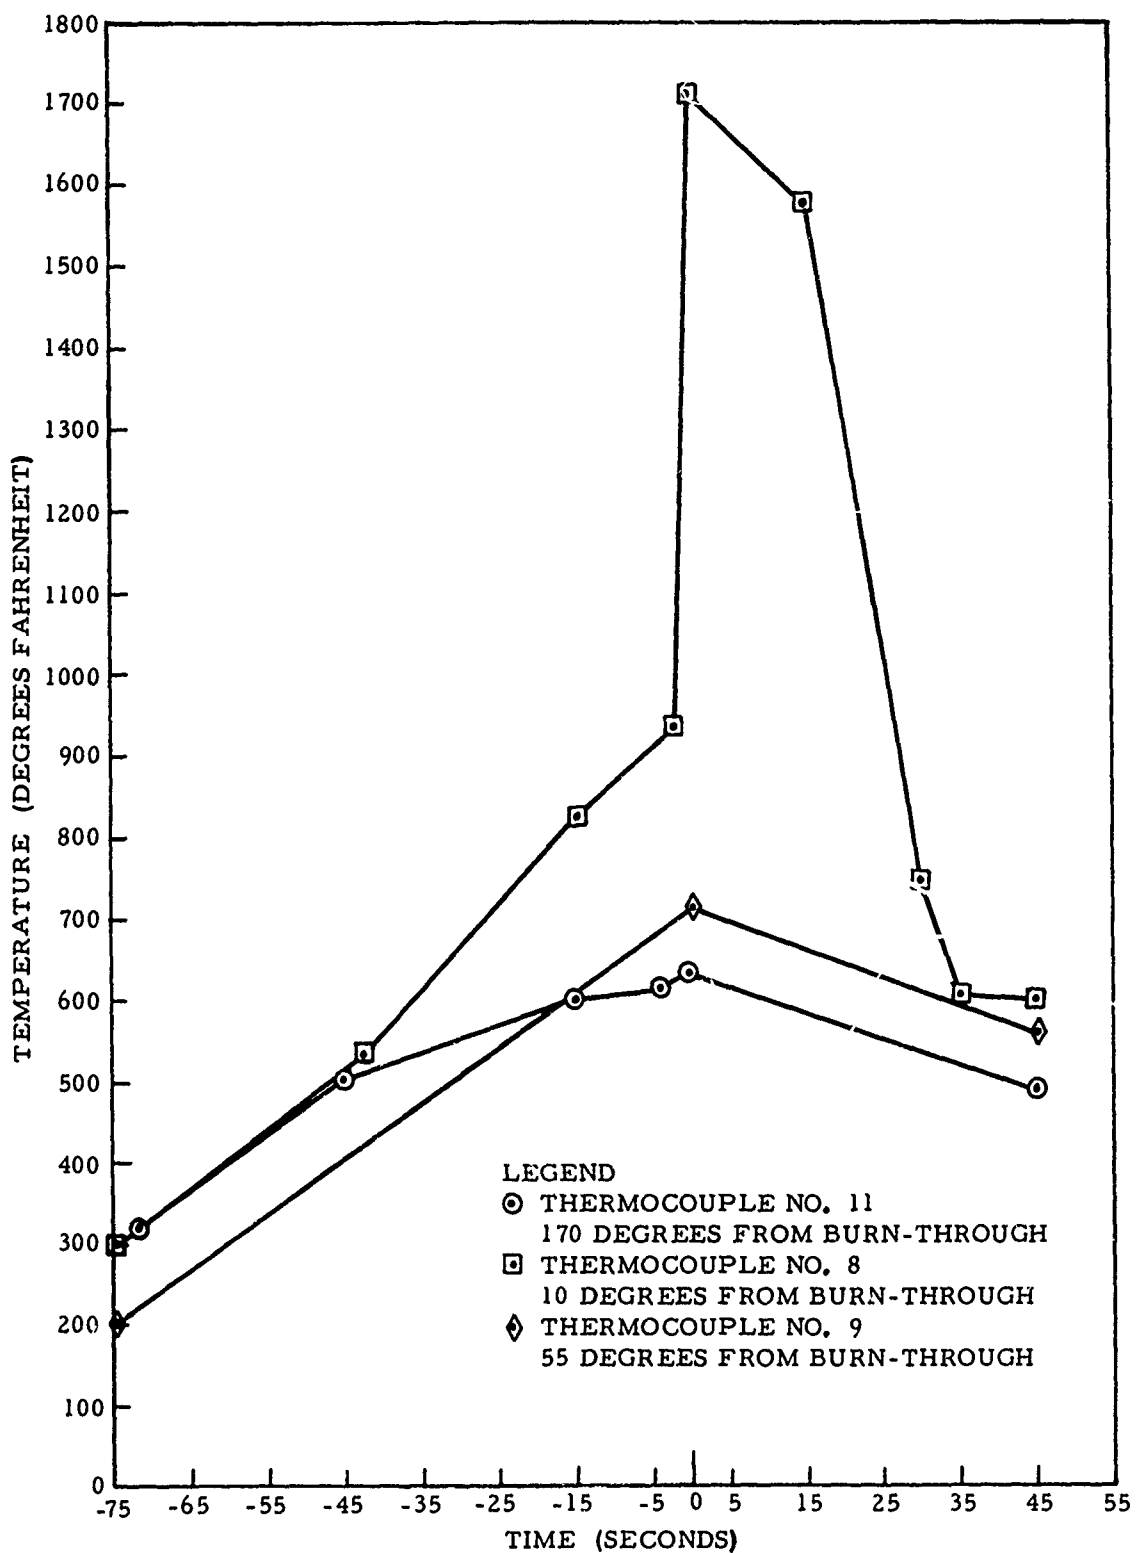
Test No. 3. The results of this fully-cowled-engine test is shown in Figures 24 and 25. Figures 26 through 28 show the damage caused by the burn-through. Unlike the prior two tests, the burn-through occurred in the burner can case an inch or so aft of the split line. A smaller secondary burn-through did occur just forward of the split line in the diffuser case. As a result of the location of the burn-through, the burner can case showed a much higher peak temperature than the diffuser case, whereas, the diffuser case still showed a much larger area of temperature rise.

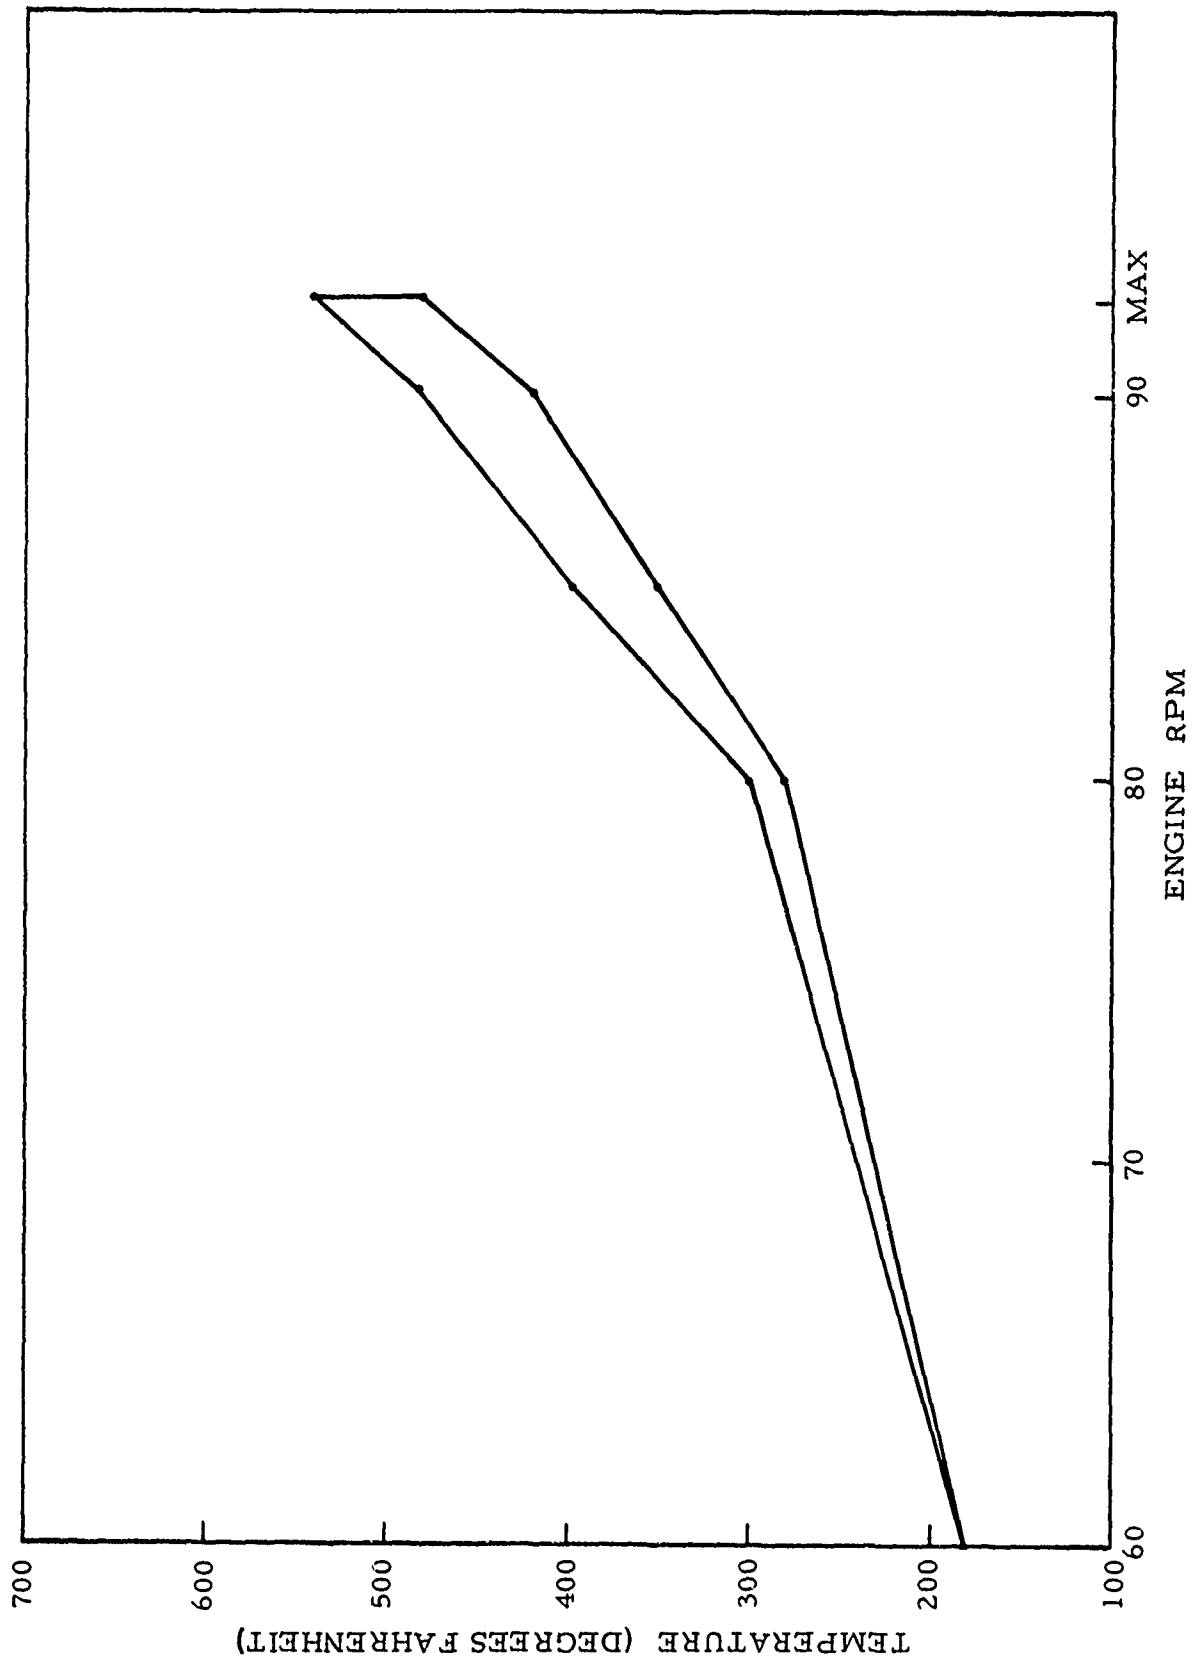
FIGURE 29. J57 ENGINE DIFFUSER CASE TEMPERATURE RANGE

The results of the background test are shown in Figures 29 and 30. The two lines on each graph represent the highest and lowest temperatures measured on the diffuser case (Figure 29) and burner can case (Figure 30) at various locations 360° around the engine.
