**NORWEGIAN SEISMIC ARRAY**

TECHNICAL REPORT

Field Maintenance Report

1 January - 30 September 1971

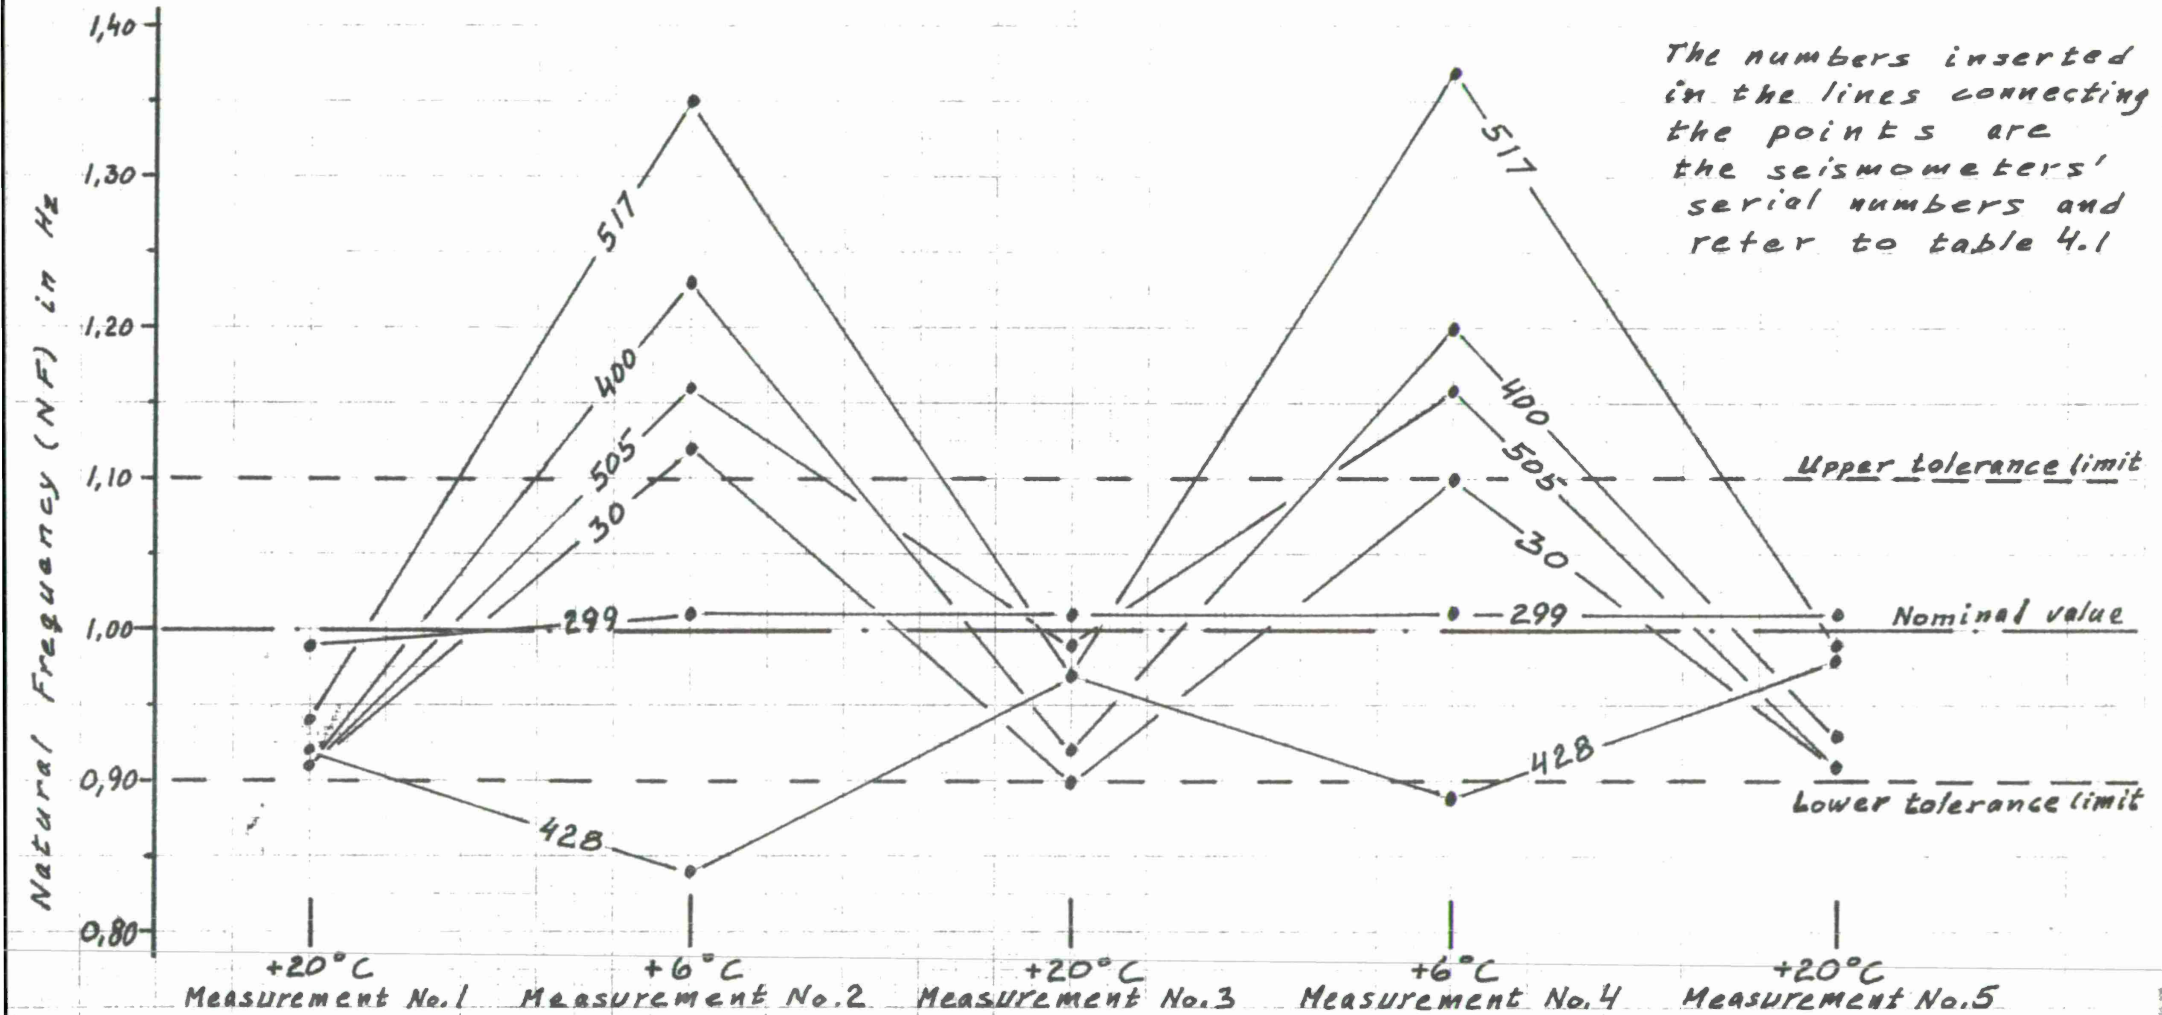
Figure 4.5 Natural Frequency of SP-seismometers in relation to environmental temperature.

The numbers inserted in the lines connecting the points are the seismometers' serial numbers and refer to table 4.1

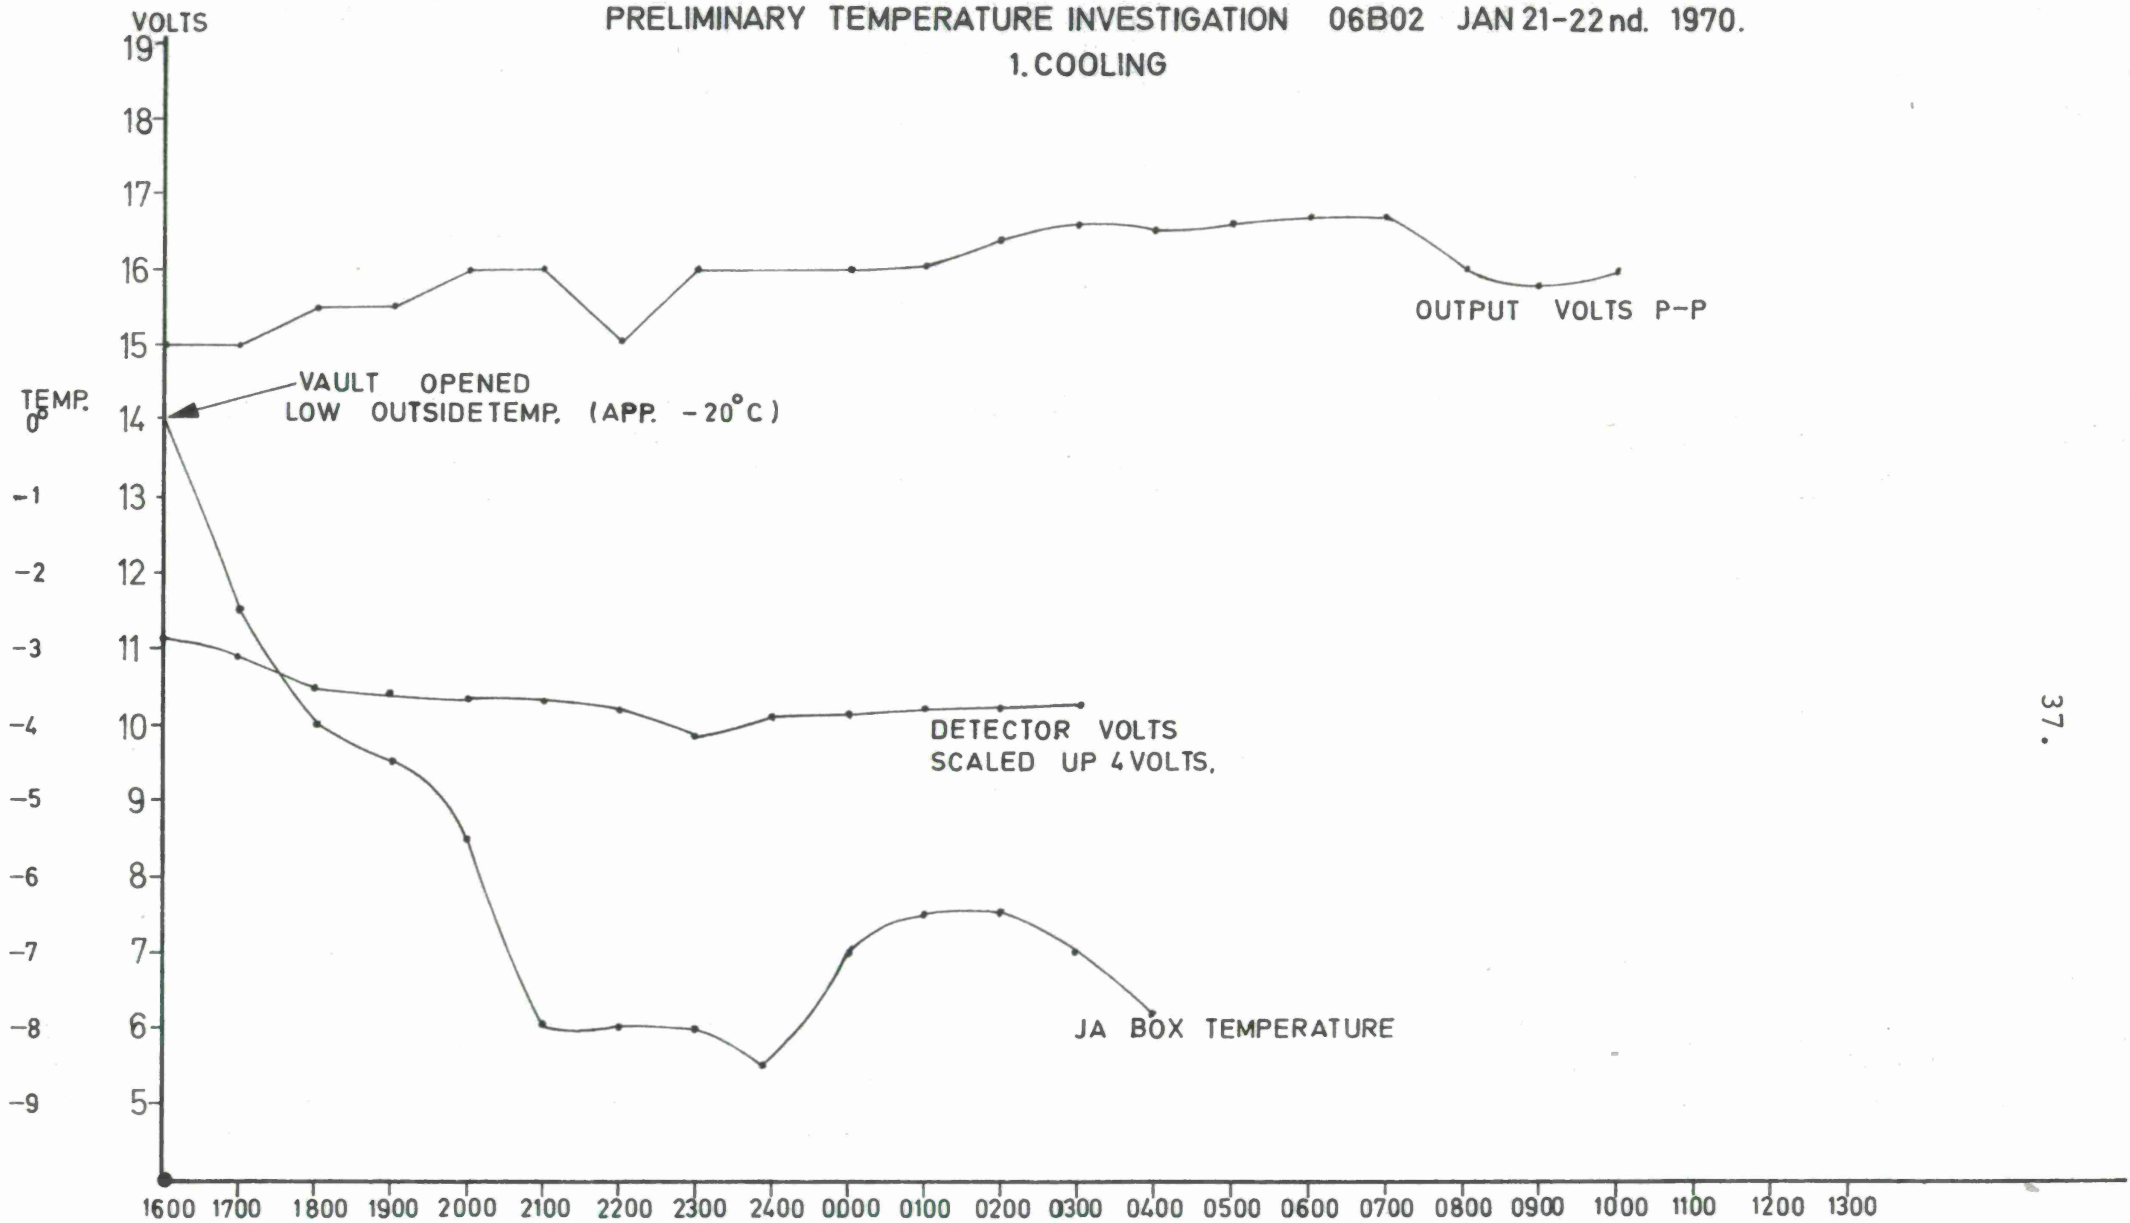
Figure 5.2

NORSAR  
PRELIMINARY TEMPERATURE INVESTIGATION 06B02 JAN 21-22nd. 1970.  
1. COOLING

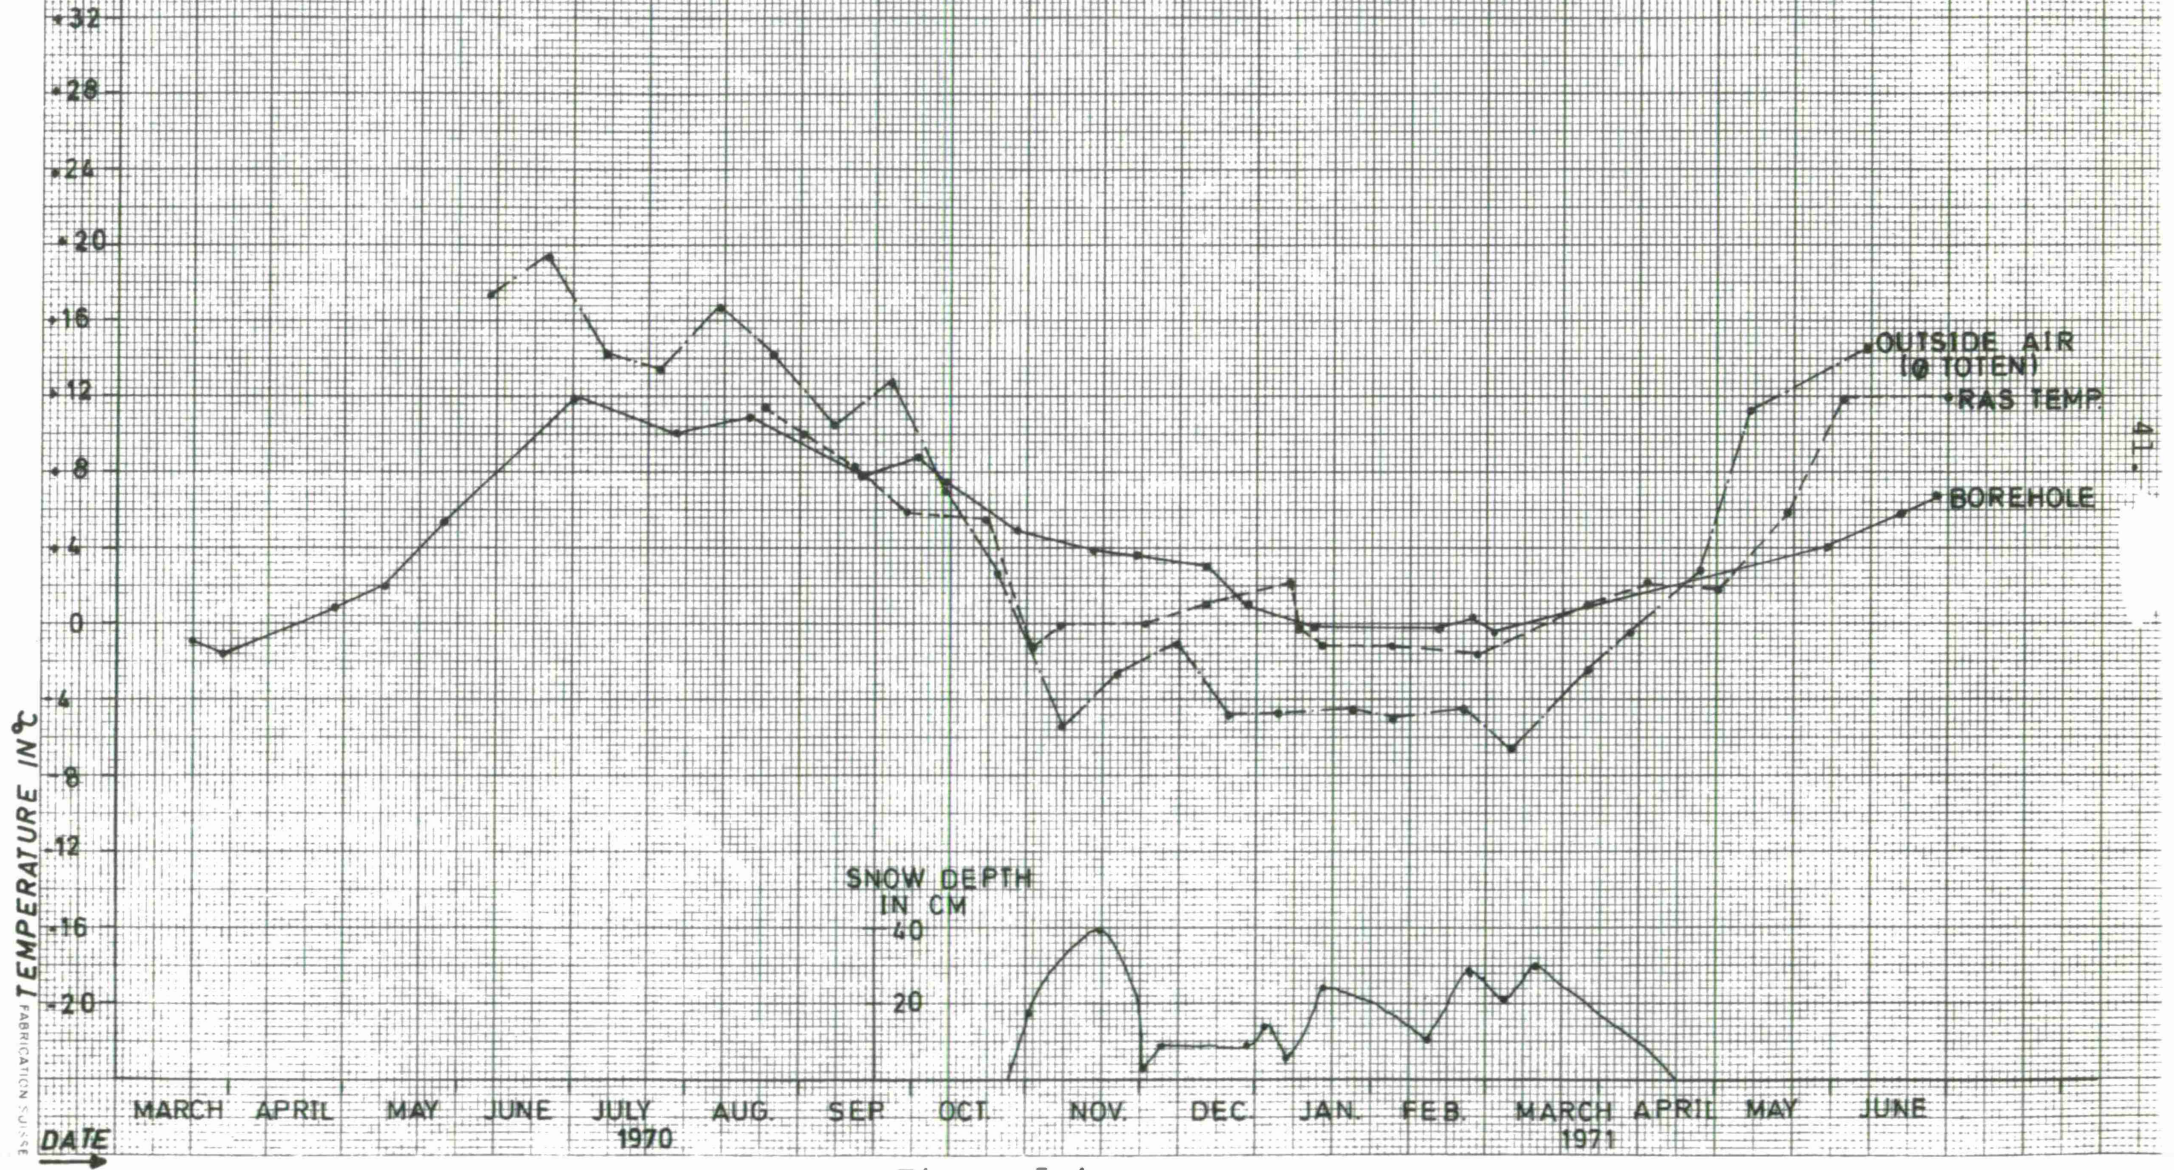
Figure 5.4

ALLOVER VIEW OF TEMPERATURE REGISTRATION PERIOD 06B-02 1970-1971

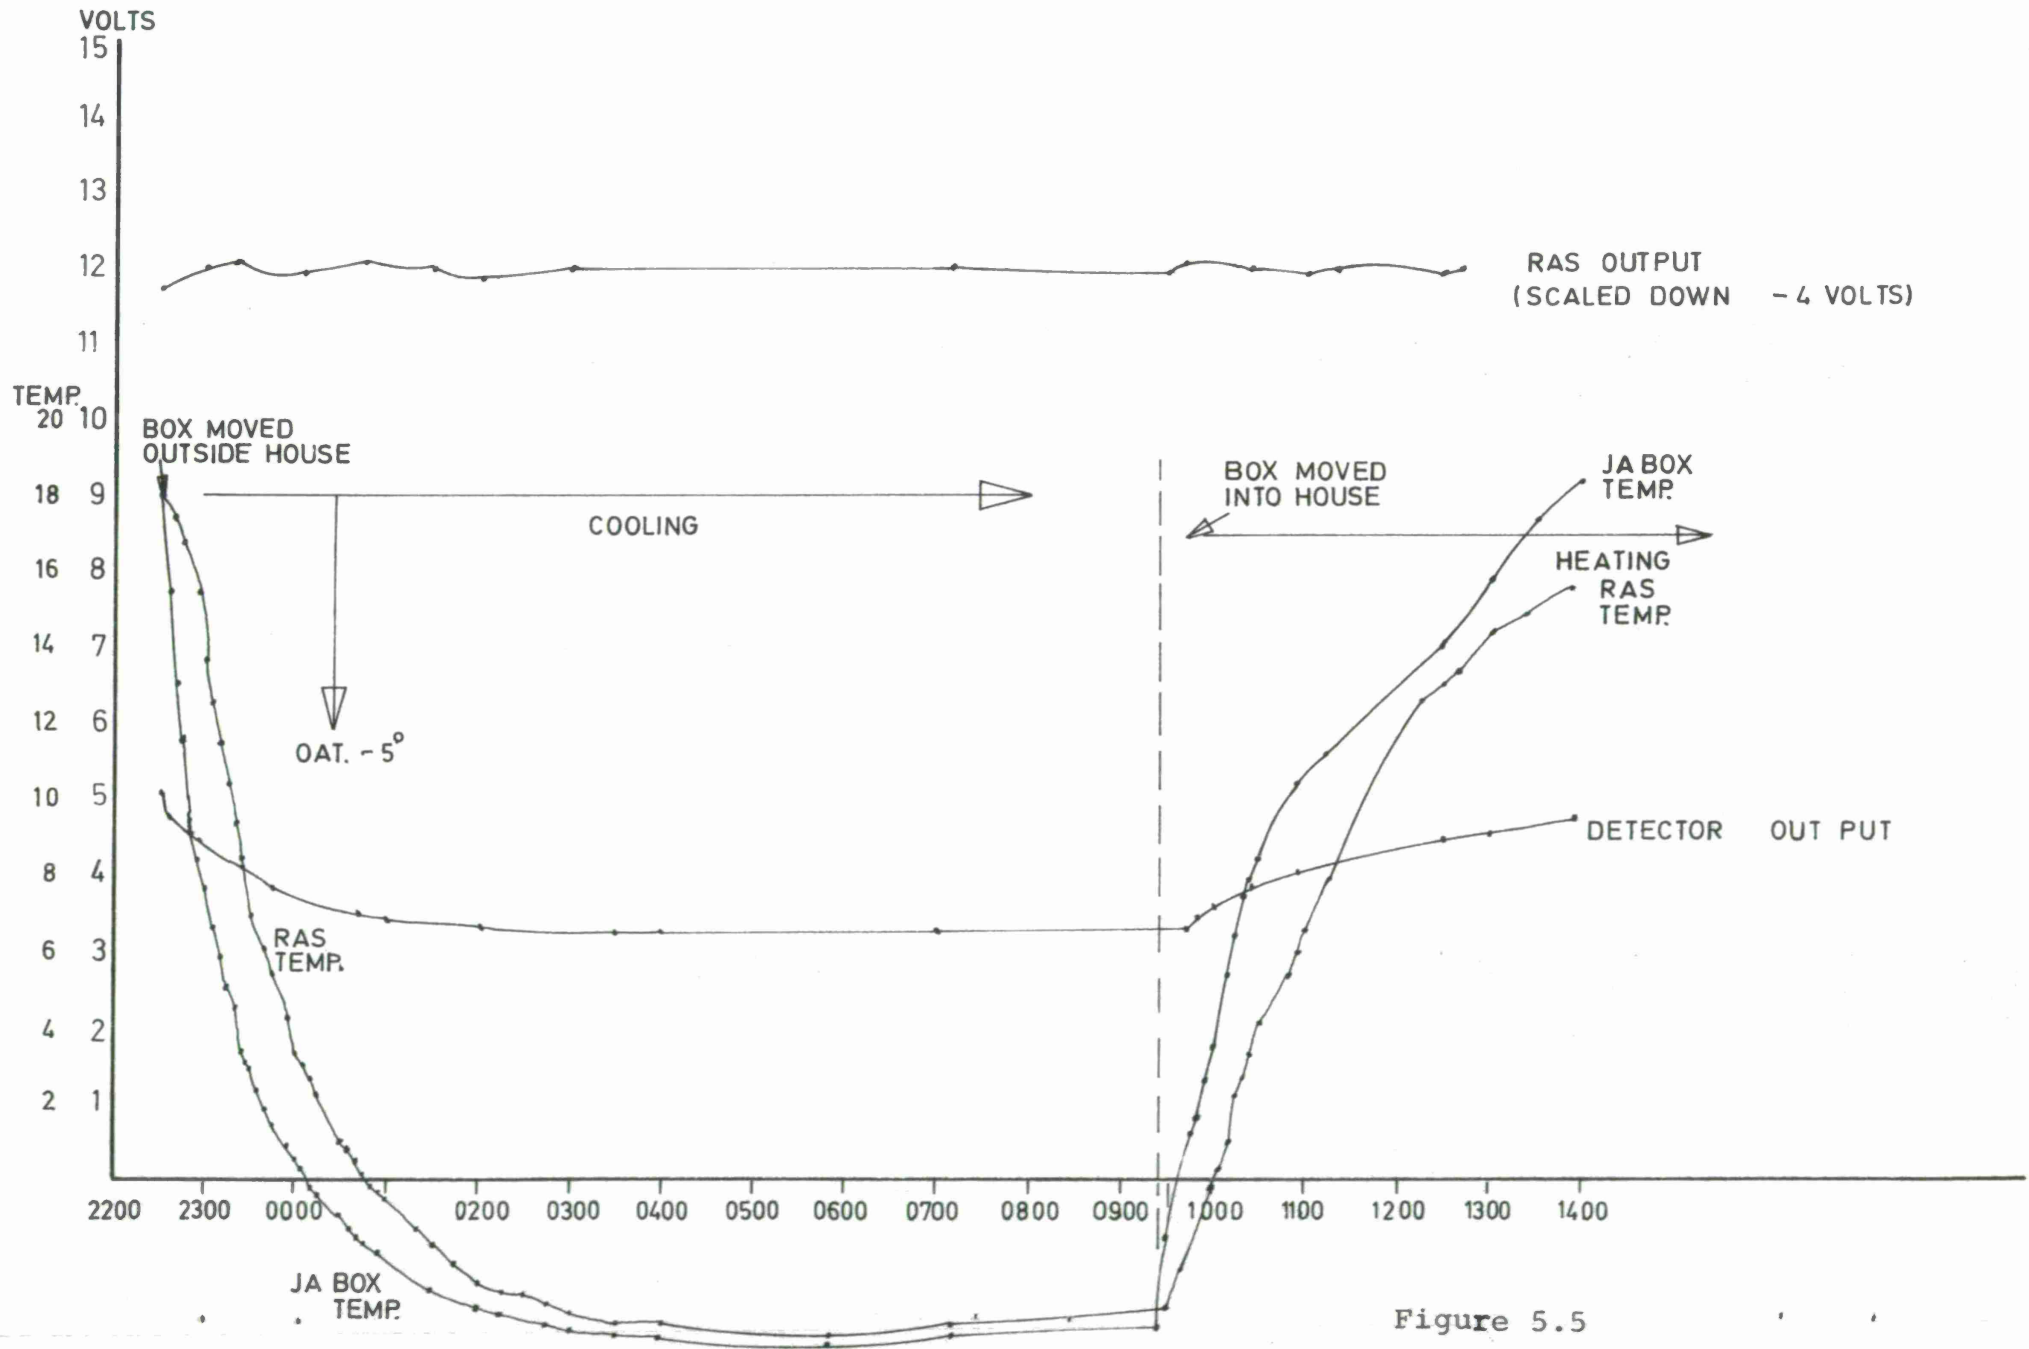
Figure 5.5

length of cable and the JA box moved outside to cool down. The amplifier and box were therefore subject to a slow decrease in temperature. Measurements were made every 5 minutes with longer intervals towards the end of the period. The results are plotted on Figure 5.5, and are listed in Table 5.3.

NORSAR  
TEMPERATURE INVESTIGATION VILLA SOLE JAN 14-15-1970.
