**NORWEGIAN SEISMIC ARRAY**

NORSAR Report No. 40  
Budget Bureau No. 22-RO293

ARRAY MONITORING AND FIELD  
MAINTENANCE REPORT

1/10-1971 - 30/6-1972

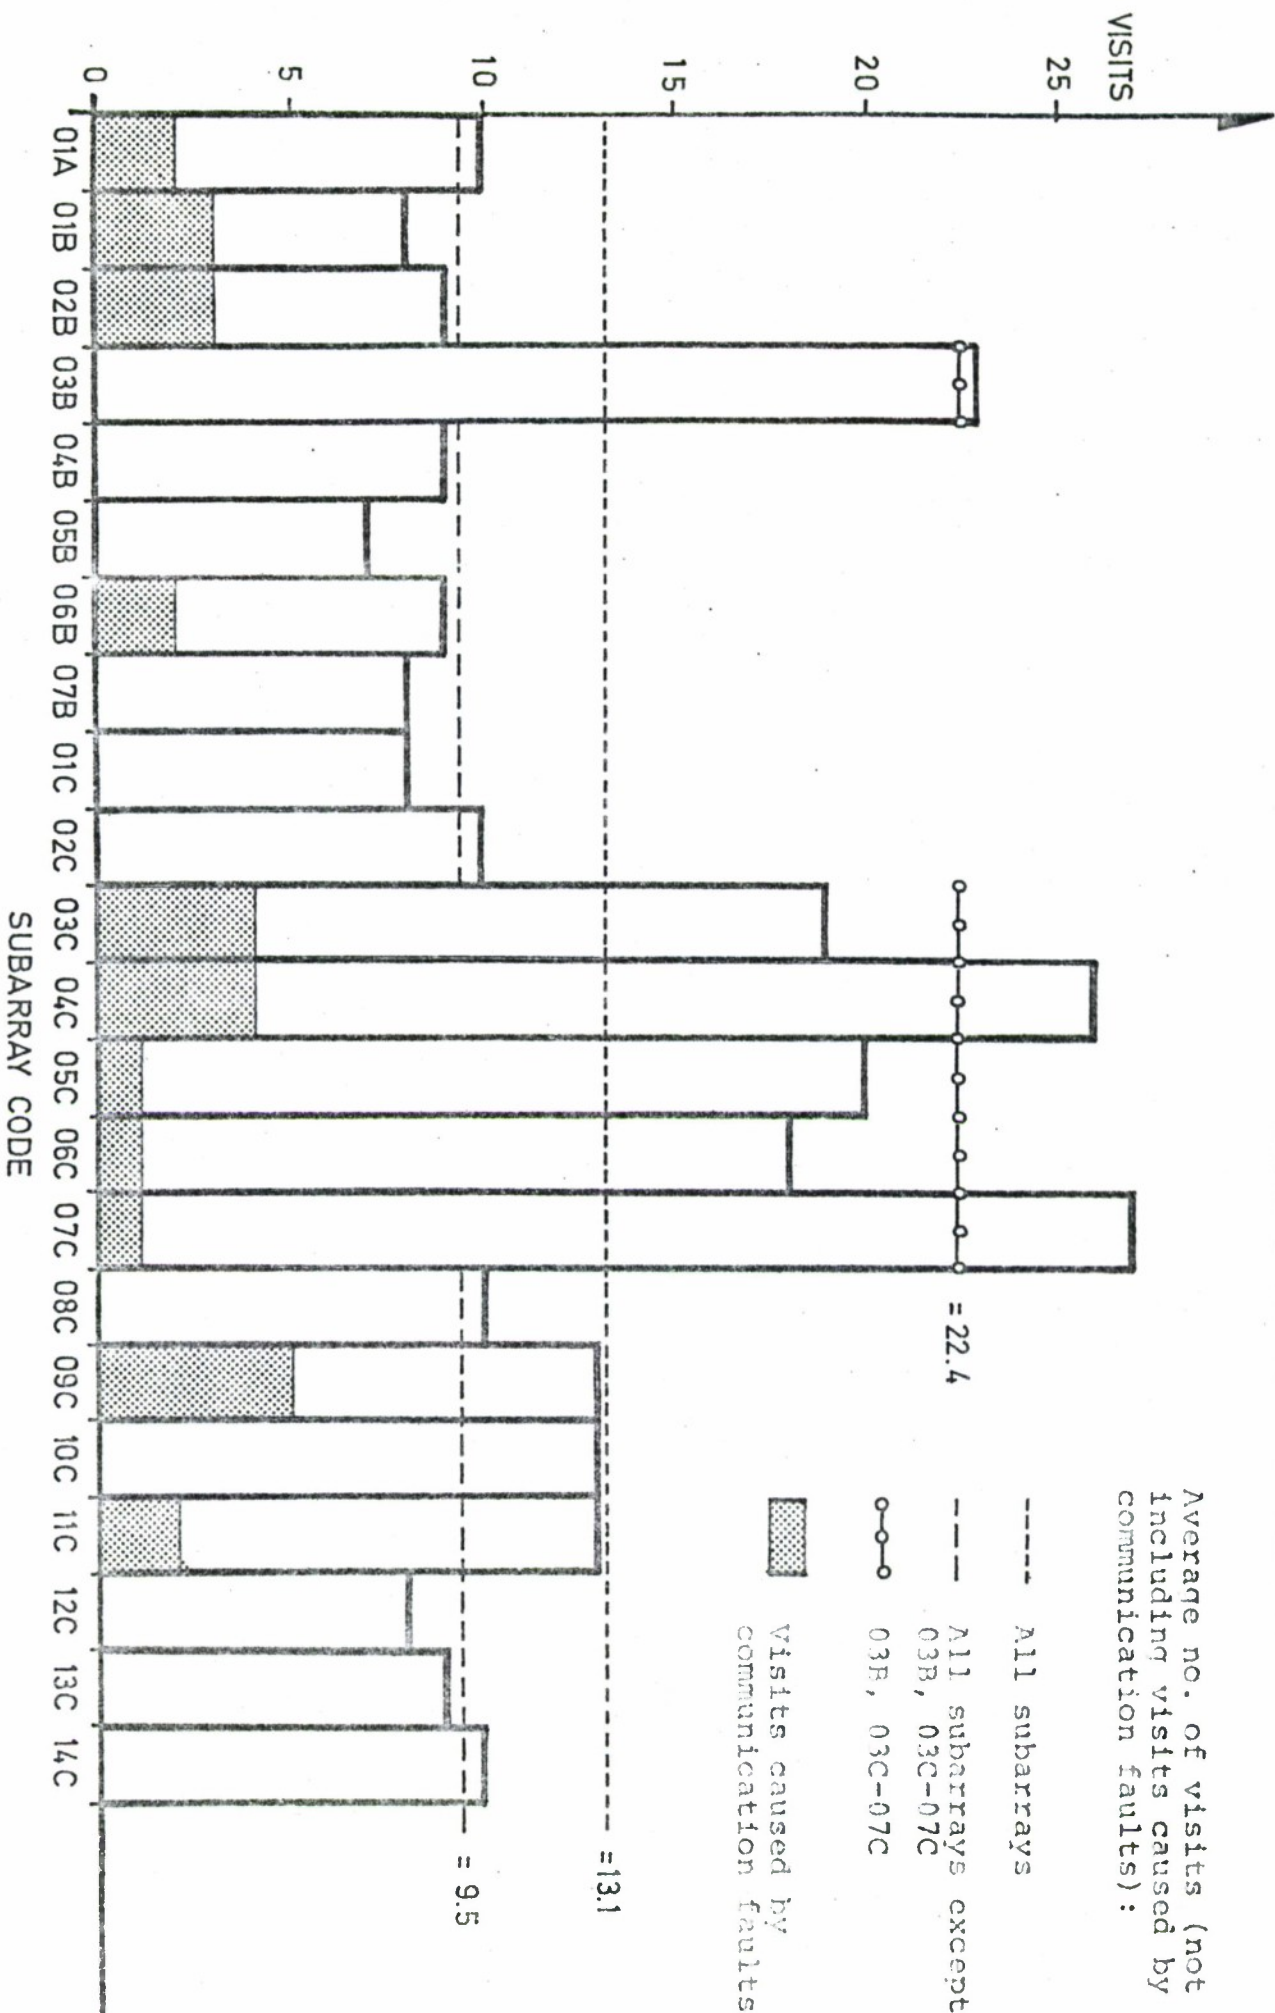
Fig. 3.23 Number of maintenance visits to the NORSTAR subarrays

Figure 3.23 shows the number of visits to the different subarrays in the 9-month period. Not including visits caused by troubles in the communication system, the subarrays - subarrays 03B and 03C-07C excluded - have in average been visited 9.5 times. The same number for the subgroup is 22.4. However, an investigation of the tasks accomplished at these subarrays discloses that the difference is not explained by more maintenance caused by a significantly greater instability in operating parts or a more frequent degrading of performance compared with the other. For the most part the difference was caused by maintenance of the CTV/LPV facilities (accomplished at 01A-03B and 03C-07C) and evaluation research on the LP sensors (accomplished at 01B, 03B, 04B, 03C-07C and 14C). The discrepancy between subarrays of the subgroup and the rest of the array is explained in more detail in Table 3.2.

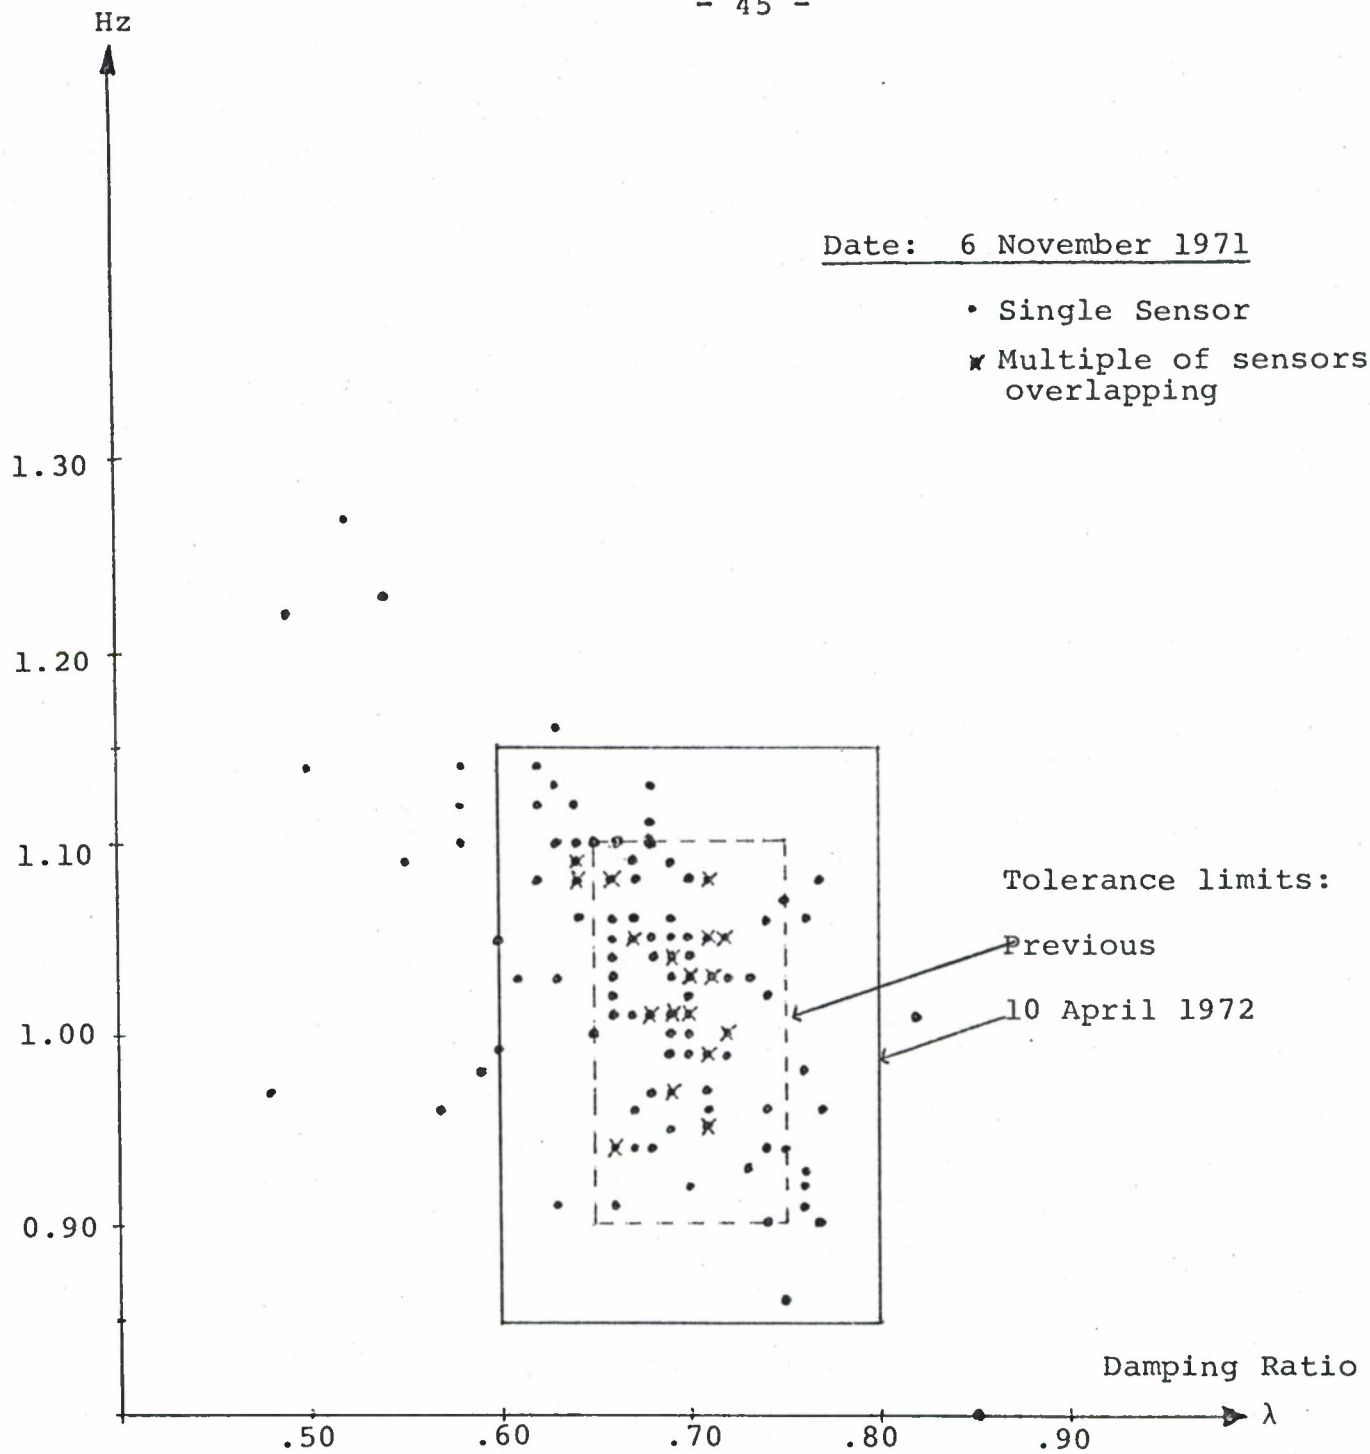
Figure 3.24

Because of this change and replacements of sensors accomplished during spring/summer 1972, the number outside tolerance limits of damping and/or nat. frequency were reduced to 7 sensors at the end of the period. The status of the SP sensors concerning these characteristics as of November 1971 and June 1972 is shown in Figures 3.24 and 3.25 respectively.

Damping and nat. frequency of  
SP seismometer.

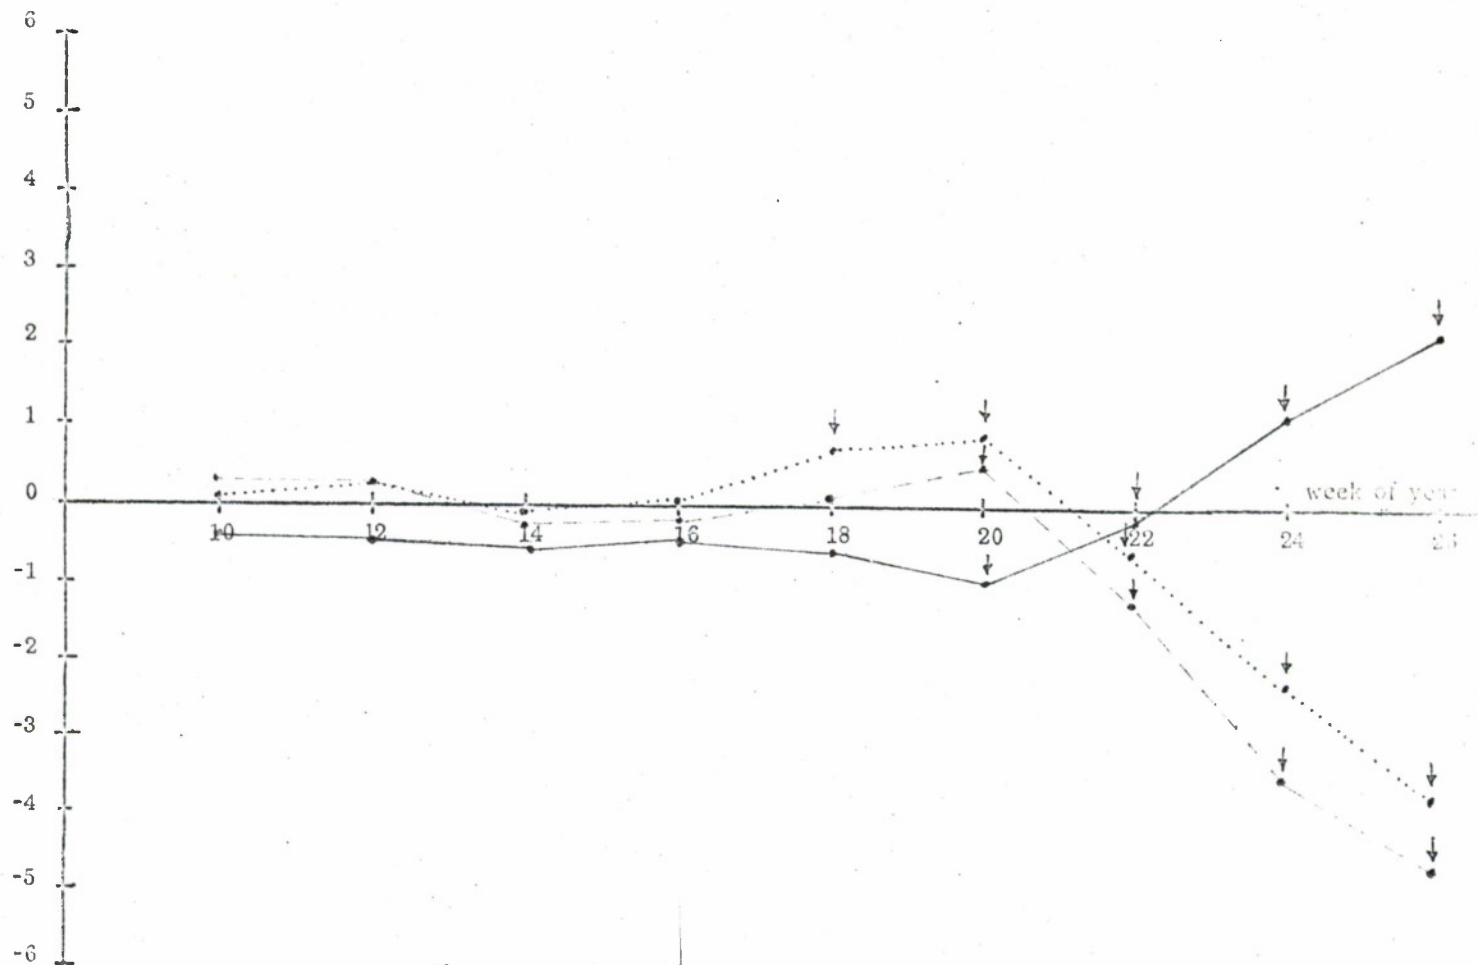
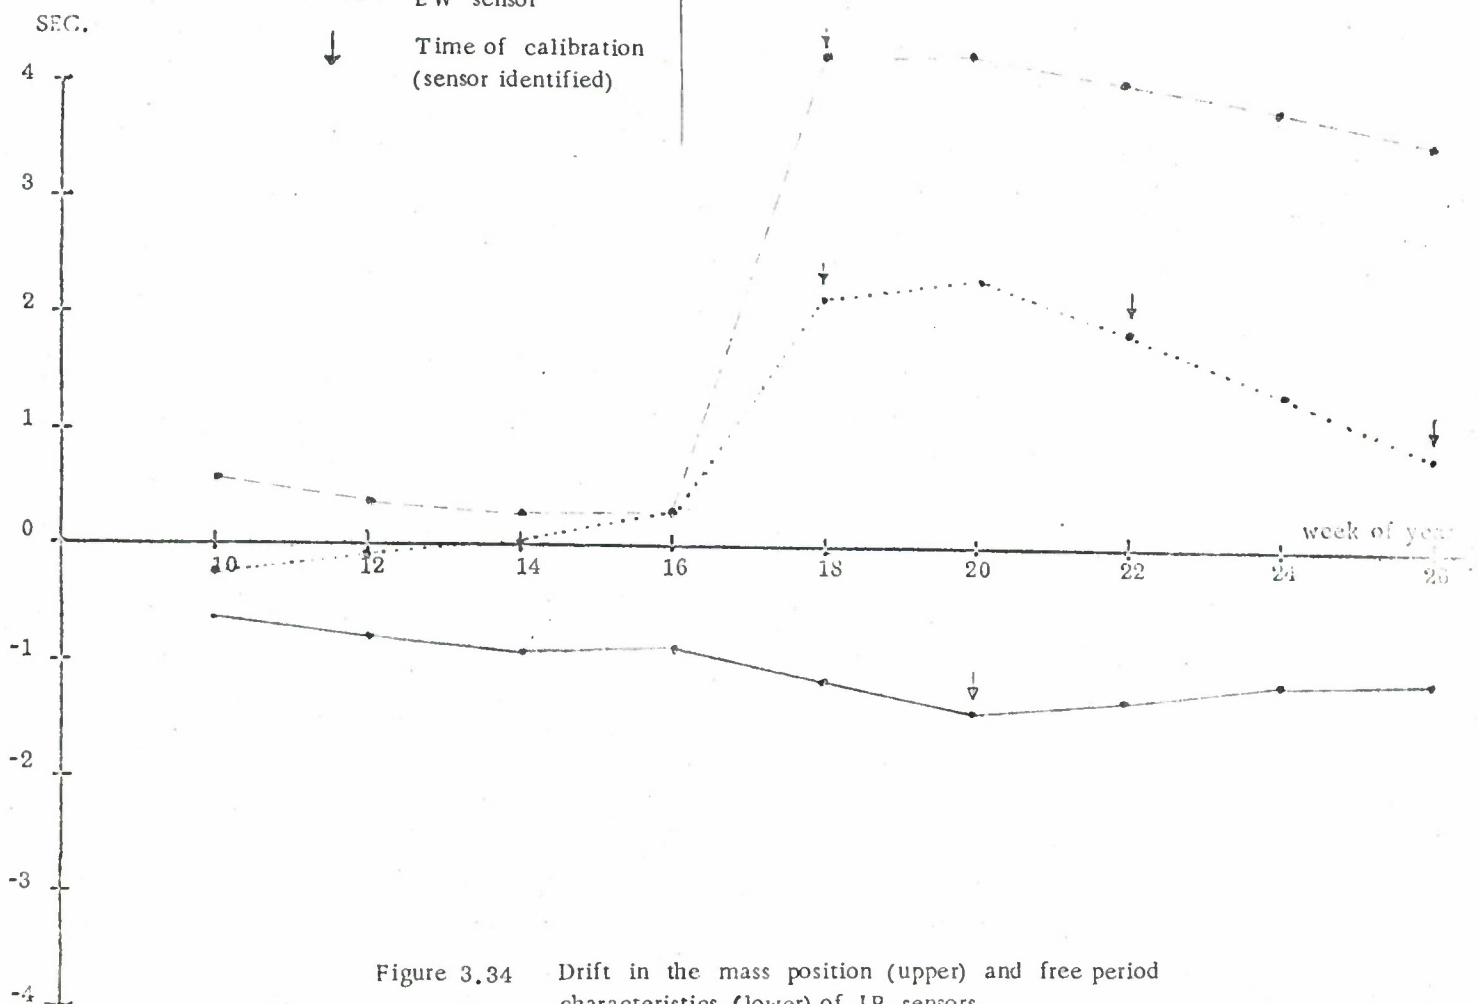
Figure 3.34 Drift in the mass position (upper) and free period characteristics (lower) of LP sensors.

The drift in mass position and free period of the LP sensors has been plotted. A few typical examples are shown in Figures 3.34 to 3.39. As would be expected, an abnormal drift, if any, occurs during the early spring due to tilting in the underground. No anomalies have been observed in the drift of characteristics previously discussed in this report.
