IMPROVED LONG-TERM PRESERVATION  
SYSTEM FOR SHIPS' TOPSIDES AND  
SUPERSTRUCTURES

Harold E. Achilles

Naval Ship Research and Development Center  
Annapolis, Maryland

Report 3927

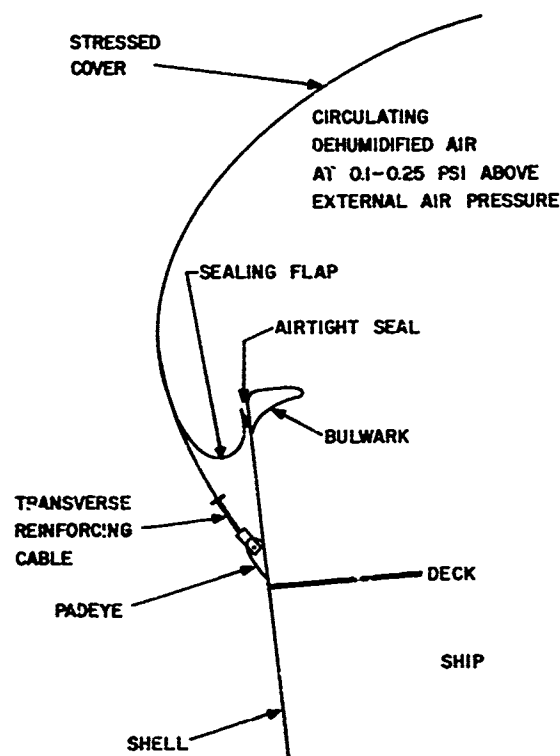
Figure 1  
Topside Encapsulation Concept

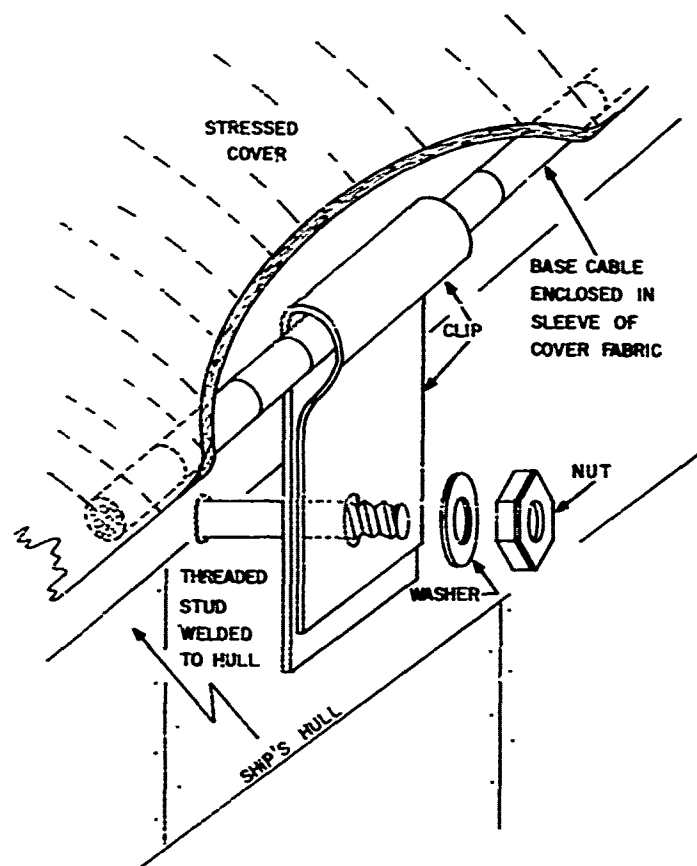
Figure 2  
Attachment of Base Cable to Ship's Hull

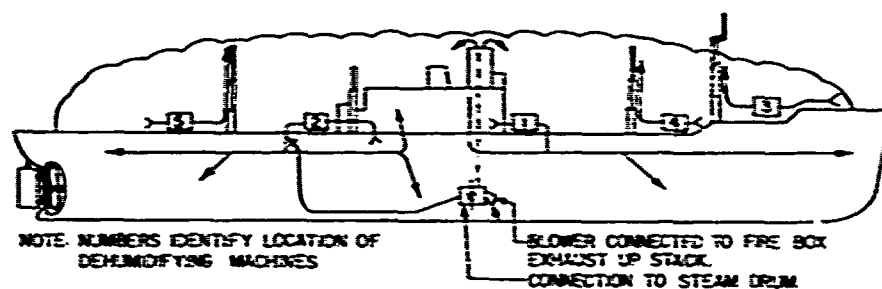
Figure 3  
Circulation of Dehumidified Air Through USS BETELGEUSE (AK 260)

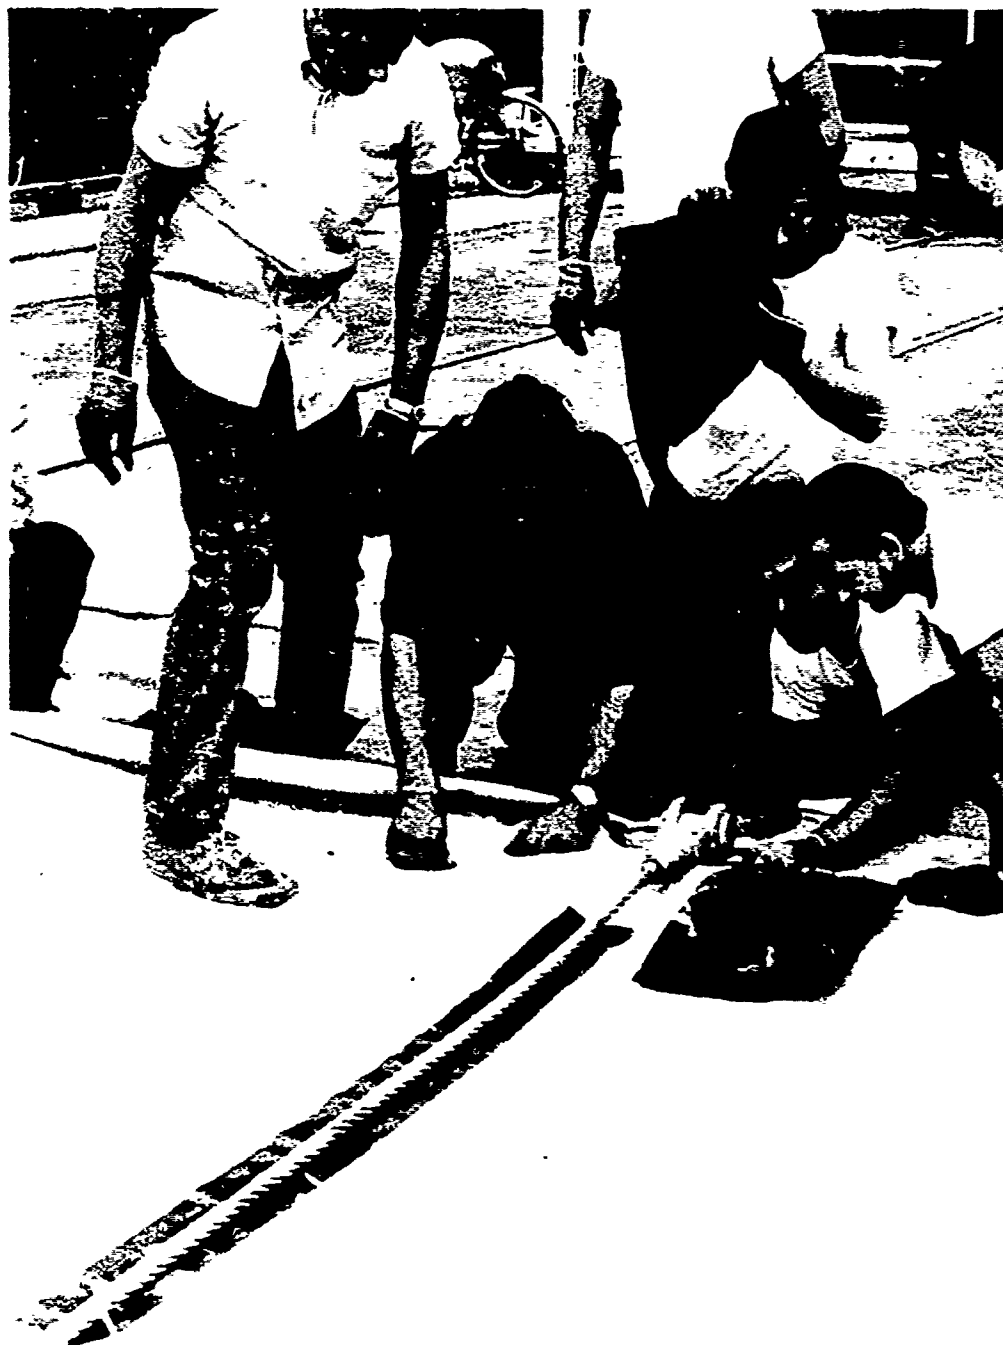
Figure 3-M  
Positioning Transverse Cable on Cover

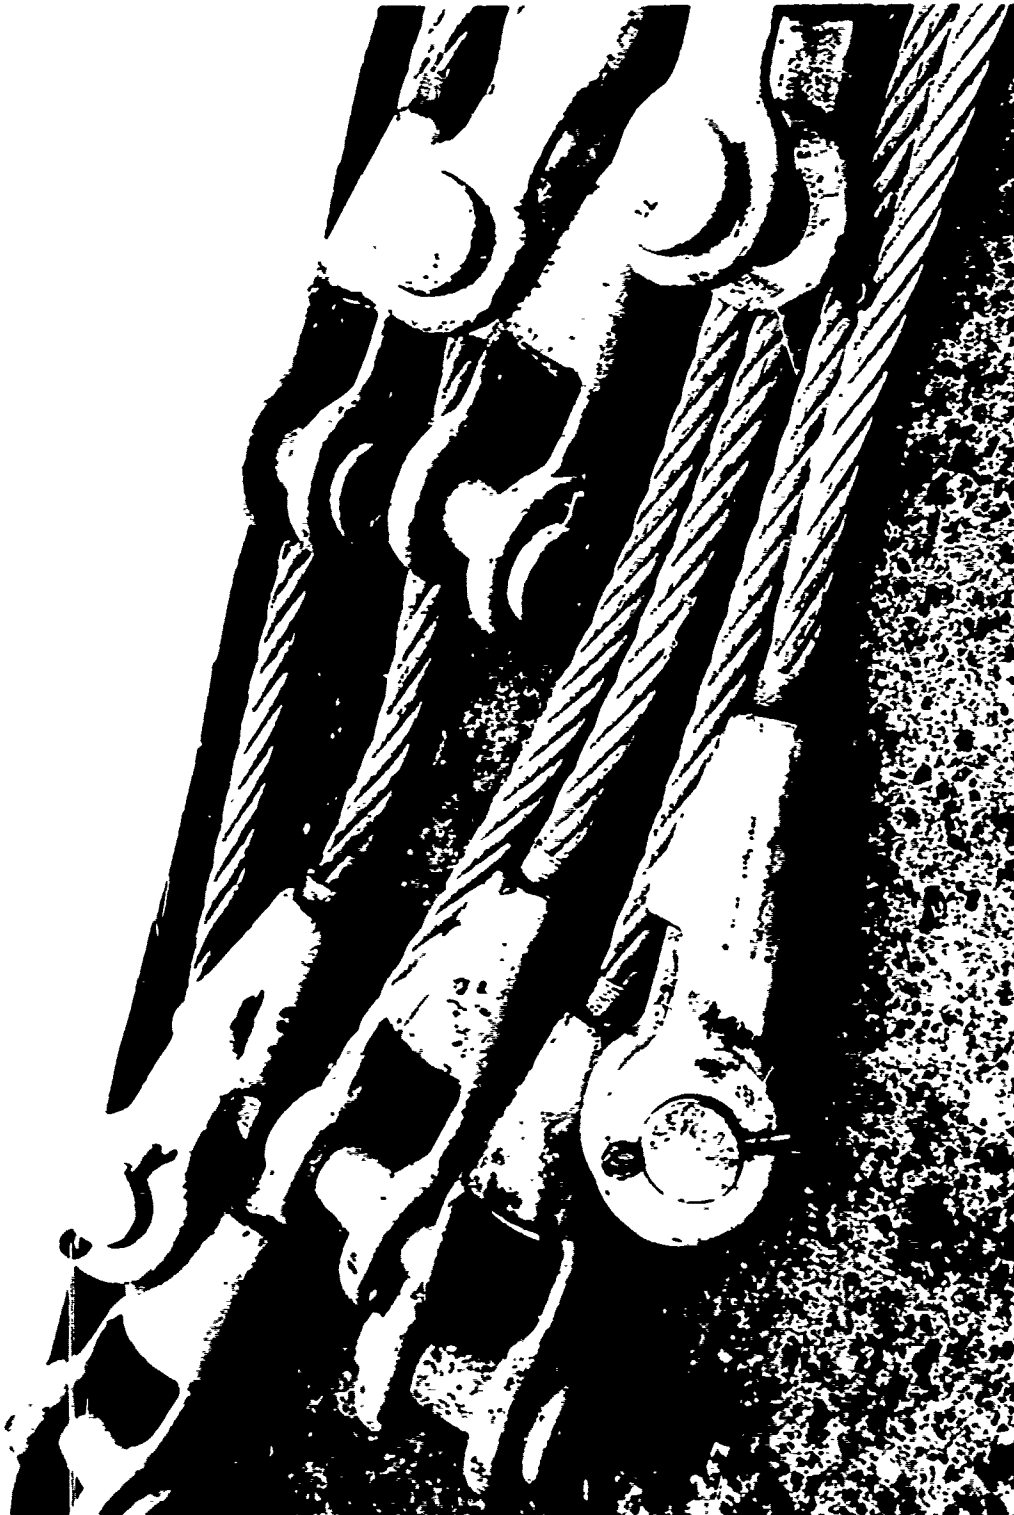
Figure 6-M  
Transverse Cables Fitted into Sockets of Clevis Assemblies

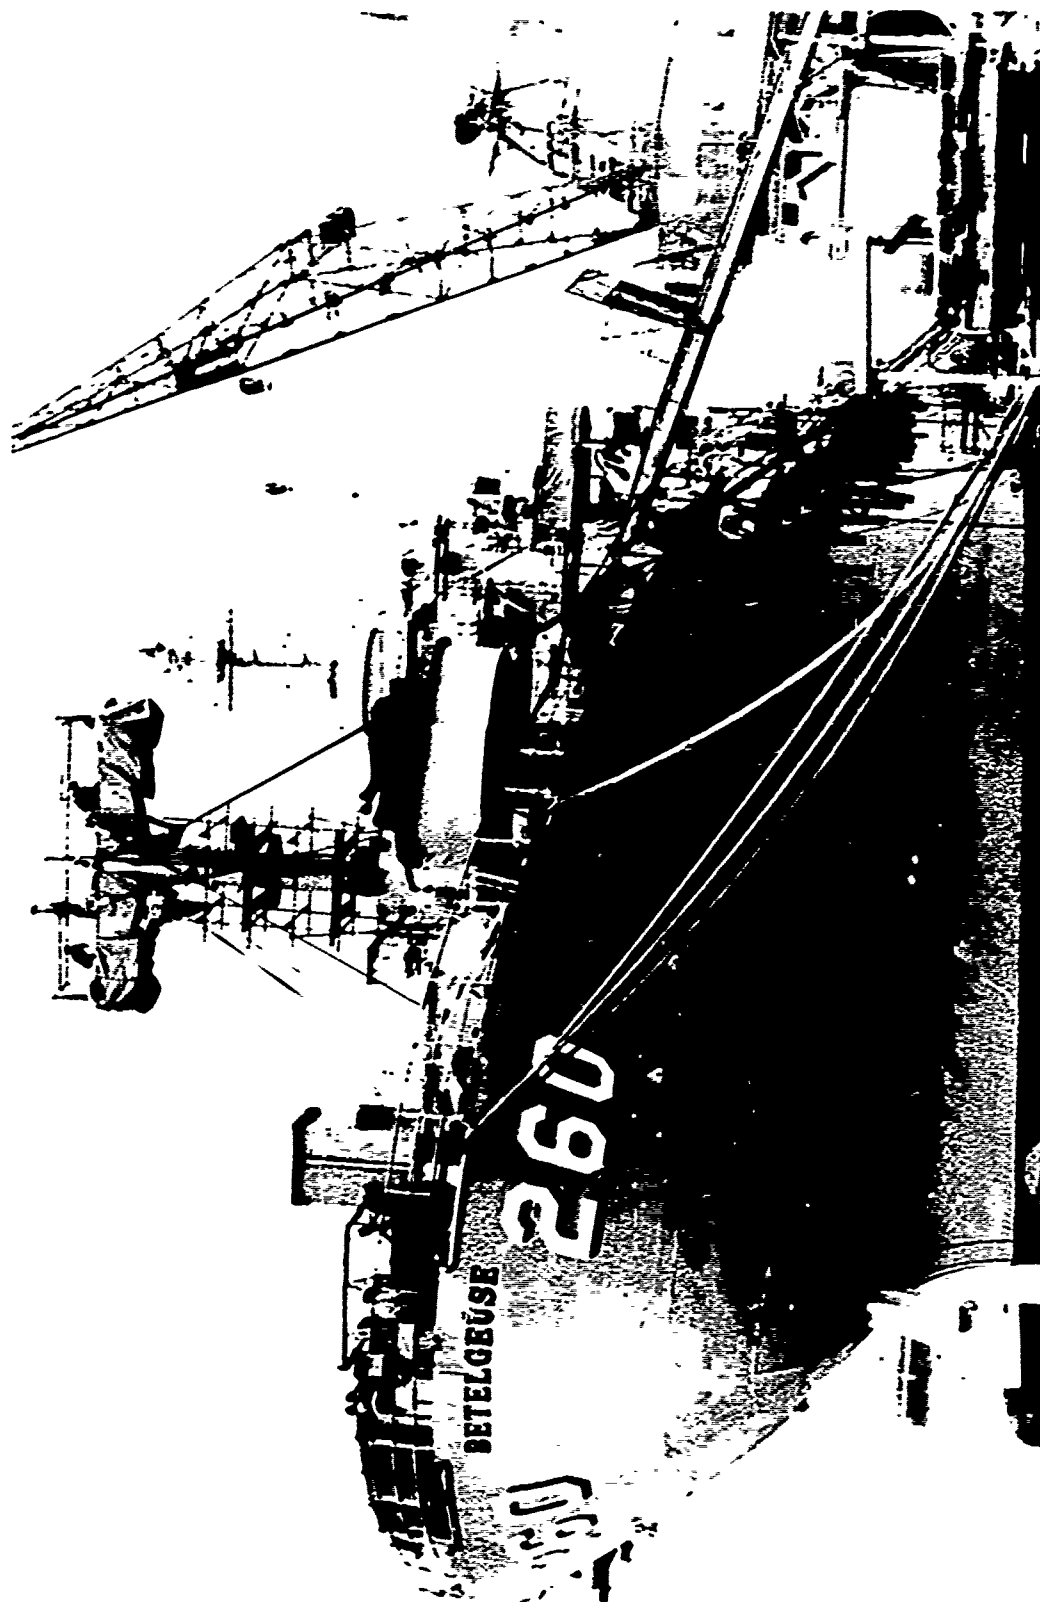
Figure 8-M - Padding Installed on Crosstree of Aftermost Mast,  
Aft Starboard Gun Tub, and Starboard Bridge Wing of AK 260

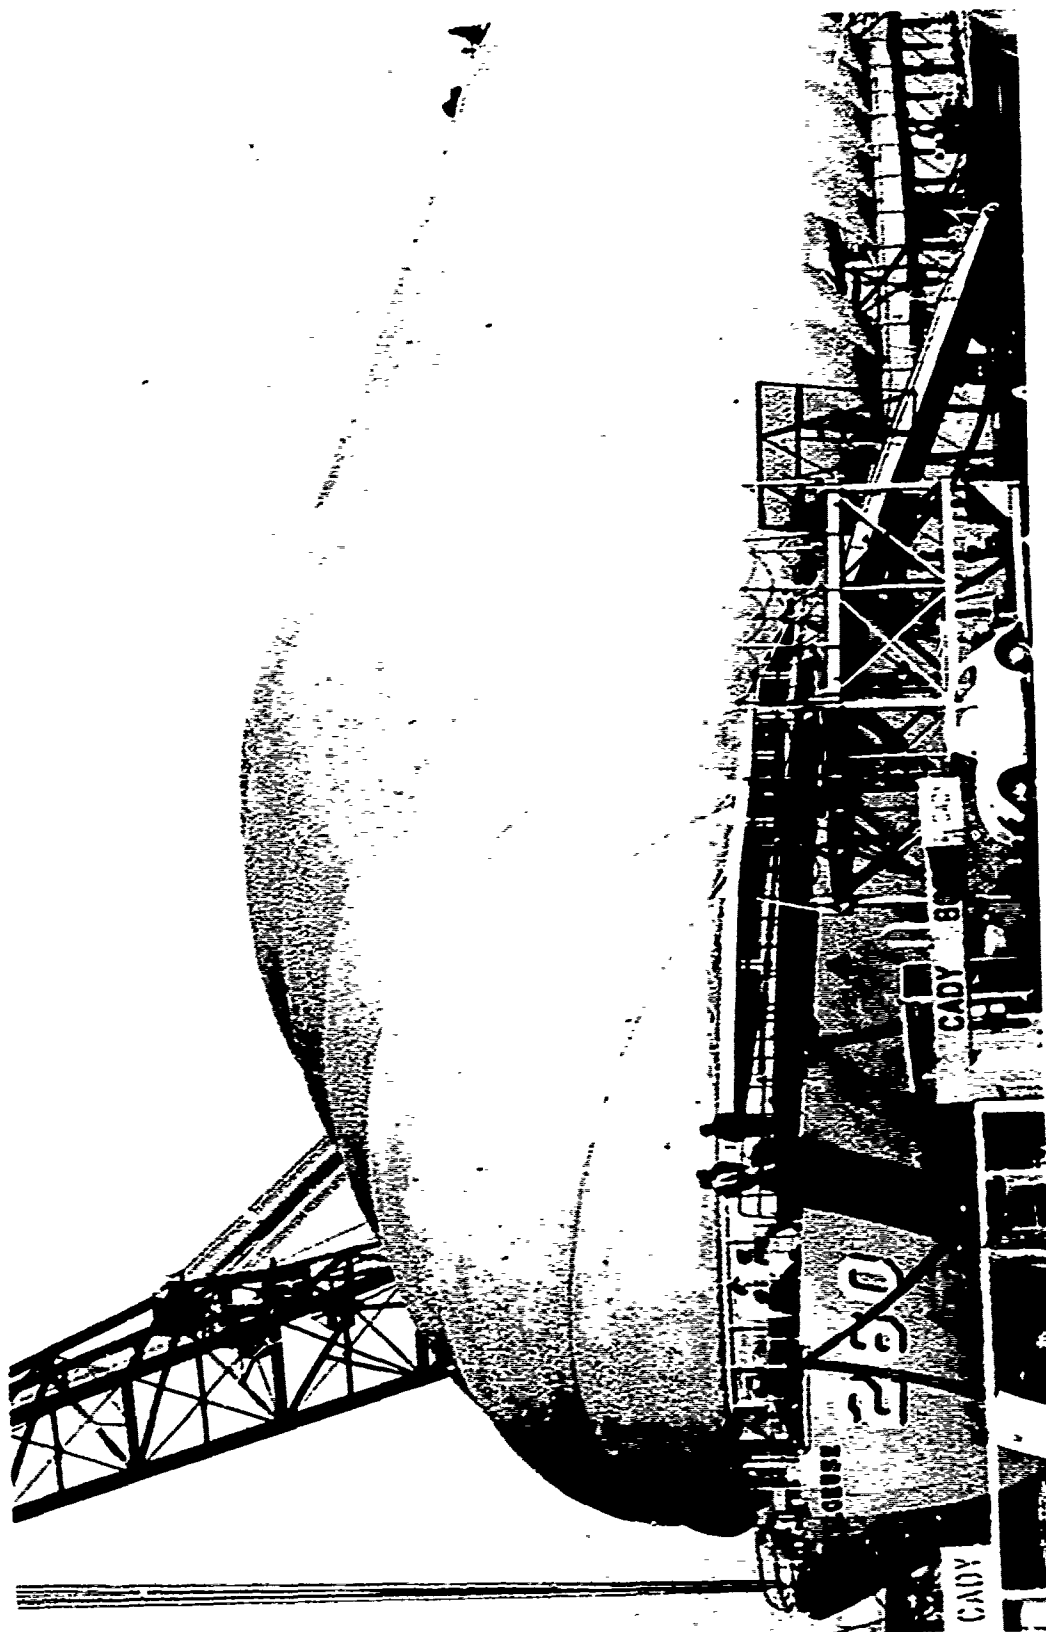
Figure 19-M  
Stern view of Ship with Inflated Cover
