RAPID ROAD CONSTRUCTION USING MEMBRANE-  
ENVELOPED SOIL LAYERS

MISCELLANEOUS PAPER S-73-5

February 1973

Conducted by U. S. Army Engineer Waterways Experiment Station  
Soils and Pavements Laboratory  
Vicksburg, Mississippi

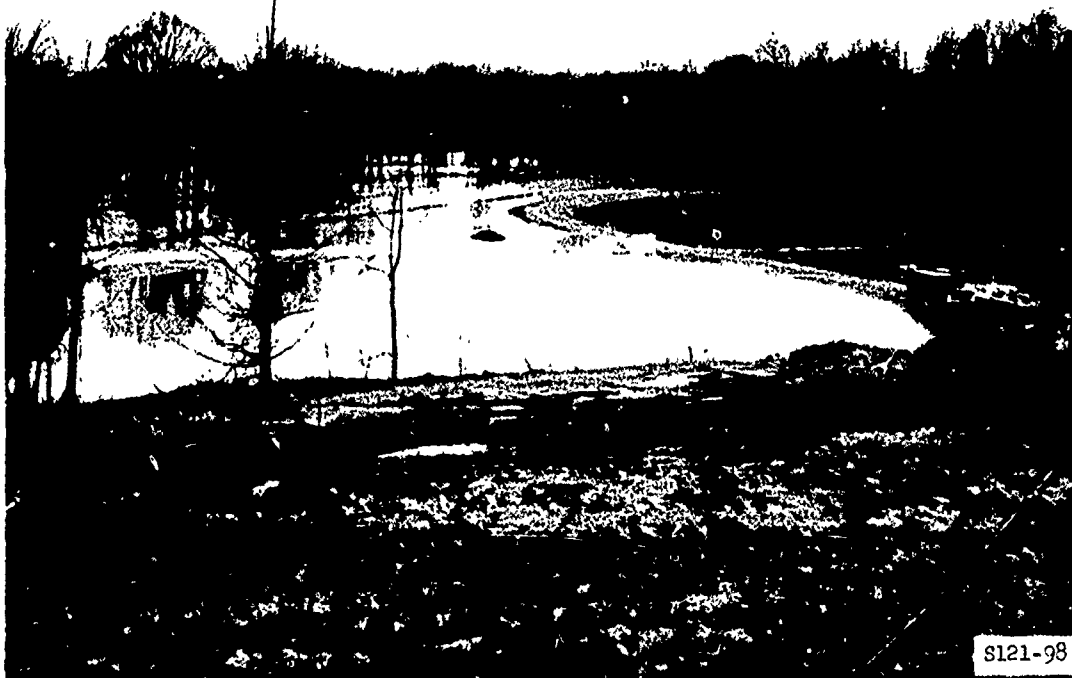
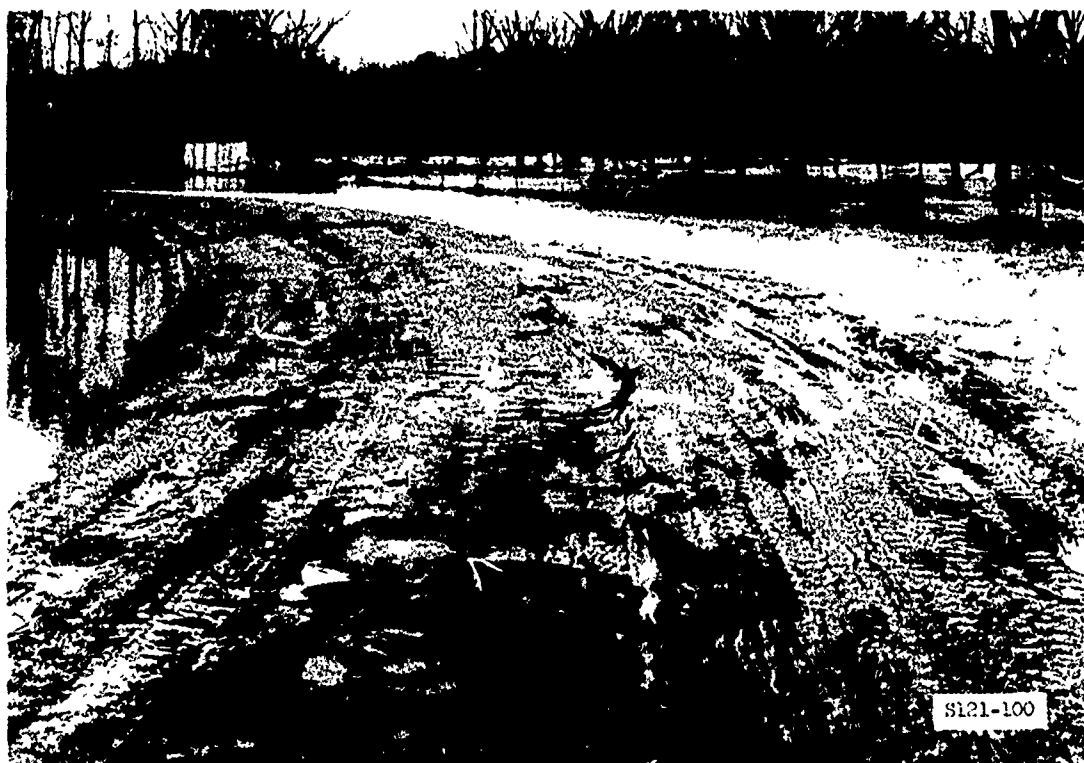
73. Of the 12.09 in. of rainfall during October, 7.37 in. fell over a two-day period. This caused complete flooding of the low-lying area where part of the road was located. The road, except for the hill portion, was almost completely submerged for several hours during the peak runoff period. A drainage pipe in the east loop was stopped up, and the loop remained full of water for two days. Photos 46-49 show the road during flood conditions. The photographs were taken after the water level had receded approximately 1 ft.

Photo 46. Test road as seen from hill at sta 7+00 during flood

Photo 47. Test road from sta 8+00 to 10+50 during flood

Photo 48. Test road from sta 10+50 to 9+00 during flood

Photo 49. View from sta 2+50 showing east loop during flood
