Naval Underwater Systems Center

Technical Note N-1284

ANALYSIS OF THE CONDITION OF ECHO TOWER,
AZORES FIXED ACOUSTIC RANGE, AFTER ONE
YEAR AT 1500 FEET OF DEPTH

Naval Civil Engineering Laboratory
Port Hueneme, California 93043

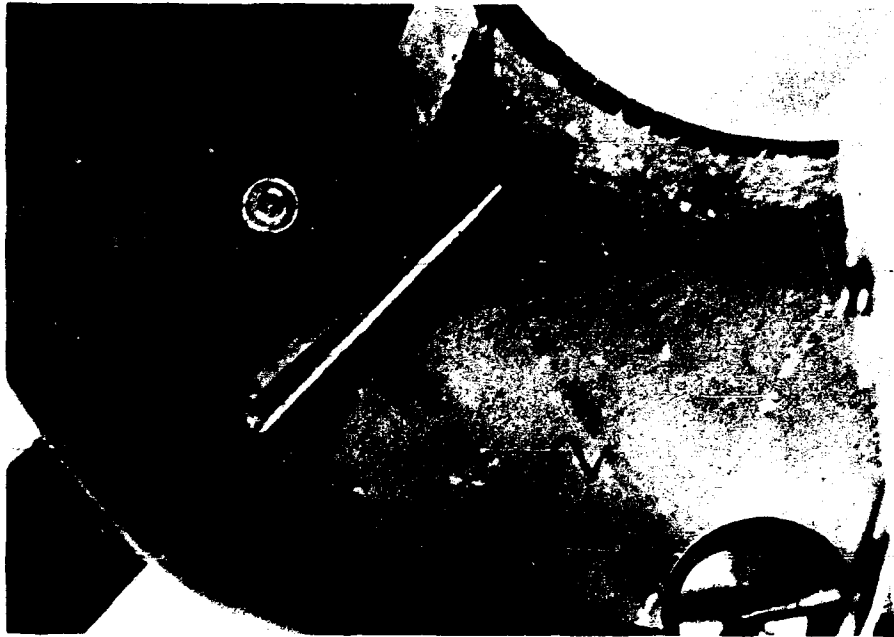
The gas generator support structure, as shown in Figure 9, had loose flaky red rust at the edges of the metal frame members. Only superficial corrosion was found associated with this rusting. The titanium cathode on the electrolytic generator, as shown in Figure 10, was unattacked. The platinum anode was also unattacked. The remaining fouling on the platinum anode was easily removed by fresh water rinsing.

Figure 10. Electrolytic gas generator cathode.

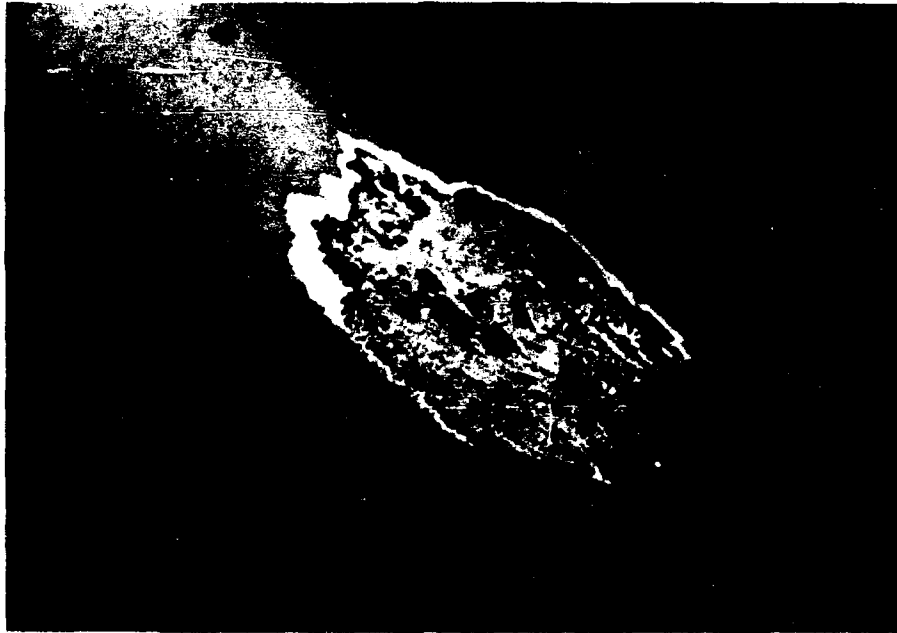
Figures 11 through 14 show the results of inspection of a typical rusted area on the middle frequency antenna. Figure 11 shows the area covered with a loose flaky red rust deposit. Figure 12 shows the area after removal of the deposit. Figure 13 shows the defects in the coating which resulted in the attack. Figure 14 shows the area after removing the coating. Note the feathered edge of the coating in Figure 14. Only three coats of paint are present. A red primer, white second coat and gray topcoat. No zinc rich primer was used on this or any other rusted areas of the compliant tubes. Brushmarks in the coatings at the rusted areas indicated that the coatings had been "touched up" at these locations without using the zinc rich primer. Removal of the upper coats of paint in an unattacked area of the low frequency antenna showed that the zinc rich primer was present.

Figure 14. Same area as in Figure 11 with coating removed.

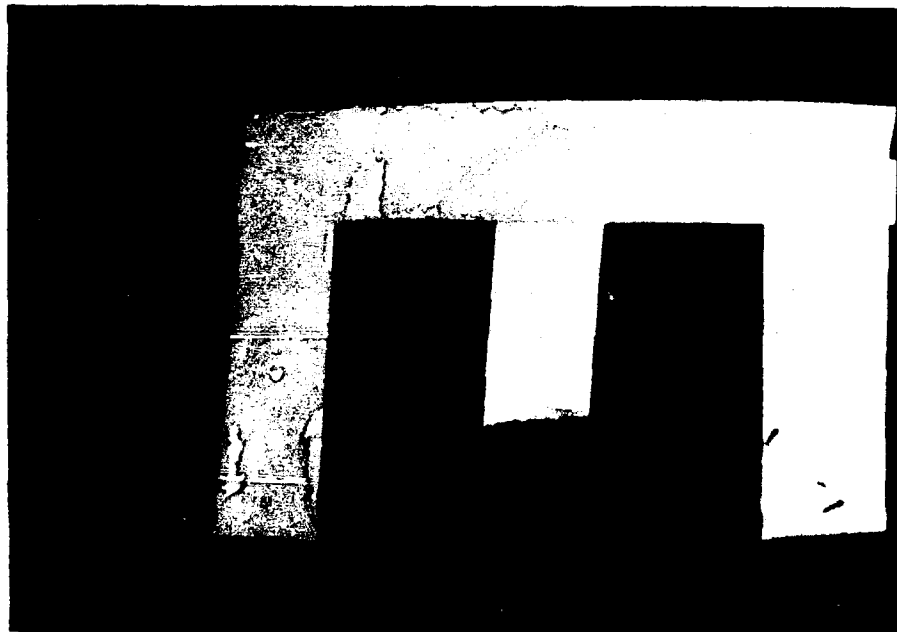
The condition of the syntactic foam blocks of the foam tower is illustrated in Figure 15. Although the coating at the identifying letter had failed, the underlying material was unattacked. No signs of water absorption or deformation of the foam blocks of the foam tower, low frequency antenna or gas generator support was noted. The main lifting eye at the top of the foam tower, as shown in Figure 16, was covered with a thin film of loose flaky red rust but no significant corrosion was noted underneath the rust layer.

Figure 15. Portion of foam tower.

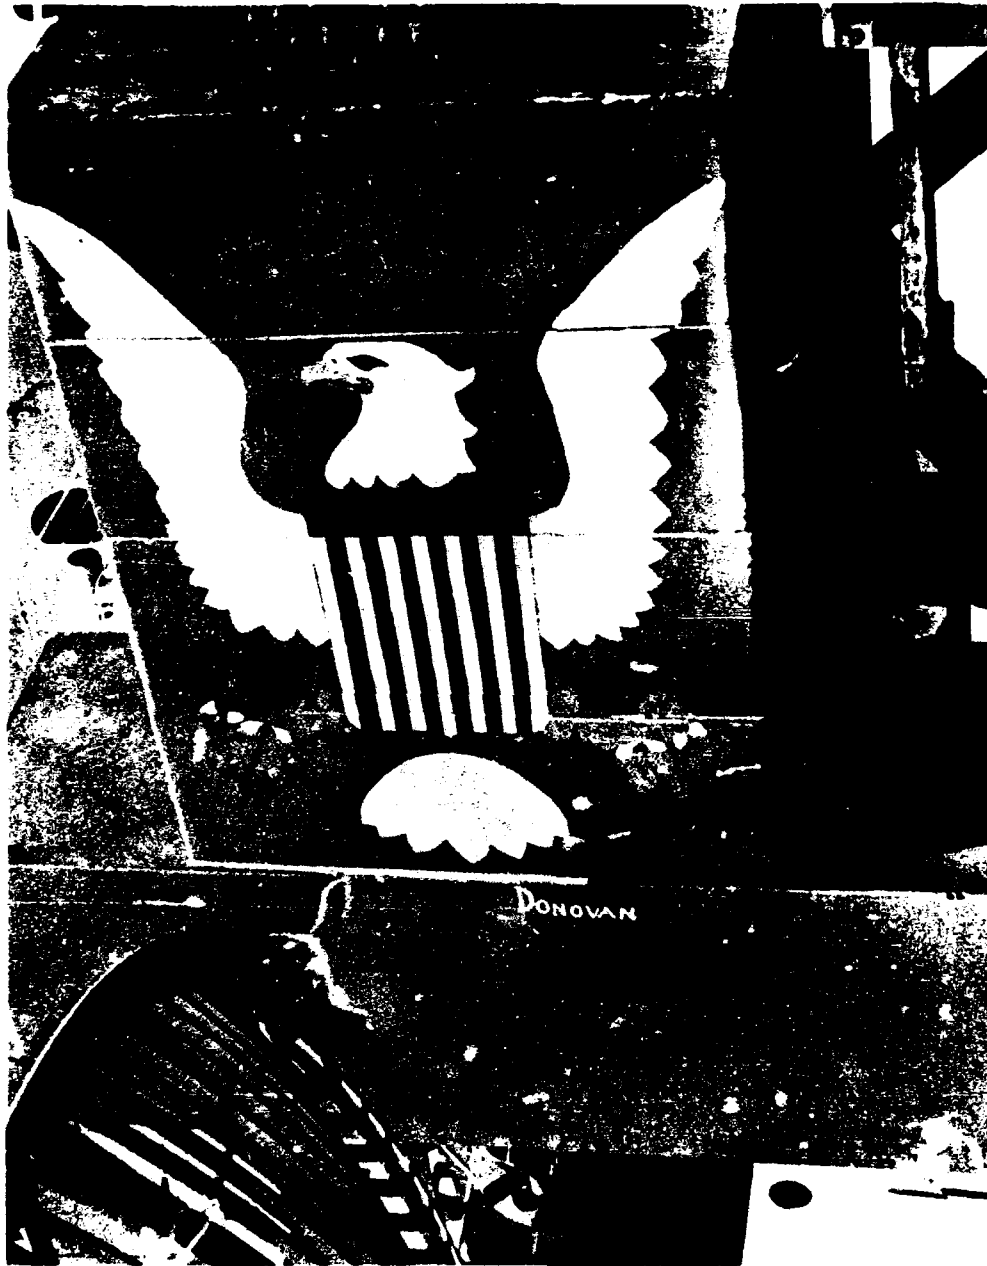
Figure 19. Foam tower after recoating.

Echo tower was to be reemplaced if its condition permitted. As the damage resulting from emplacement and retrieval was minimal and the amount of corrosion found did not preclude reemplacement, the tower was repaired. The four shock absorbers were replaced with similar units. However, the tips on these units were screwed into place in contrast to the pressed-in units originally used. These screwed-in tips were further secured by welding and are shown in Figure 17. The universal joint was relubricated. The tower base, universal joint, main column and buoyancy sphere were cleaned by an air powered high pressure water jet and recoated with a copper oxide-pigmented rubber-based antifouling topcoat. The yellow enamel identifying marks were reapplied after the antifouling coat had cured. The condition of the buoyancy sphere after repair is shown in Figure 18. The fasteners used to secure the cable conduit to the main column were recoated as required with a rubber based sealing compound. Rusted areas on the steering carriage and antenna support arms were cleaned and recoated with a two coat, polyamide-cured epoxy paint system. The gas generators were replaced. The attacked areas on the antennas were carefully sanded and cleaned before recoating with the same paint system. The gas connections between the ends of the compliant tubes and the gas manifolds were cleaned, the clamps and tubing replaced as necessary and recoated with a two component sealing compound where any rust staining of the connections was noted. Areas of paint failure on the foam tower were repaired using the topcoat of the polyamide cured epoxy paint system. Identifying marks were reapplied to the foam tower. The recoated foam tower is shown in Figure 19. The main lifting eye was cleaned, and then recoated with the two coat polyamide cured epoxy system. The tower was then considered to be ready for reemplacement.
