ARRAY MONITORING AND FIELD MAINTENANCE
REPORT

NORSAR Report No. 60
Budget Bureau No. 22-RO293

1 January - 30 June 1973

O. Steinert and A. Nilsen

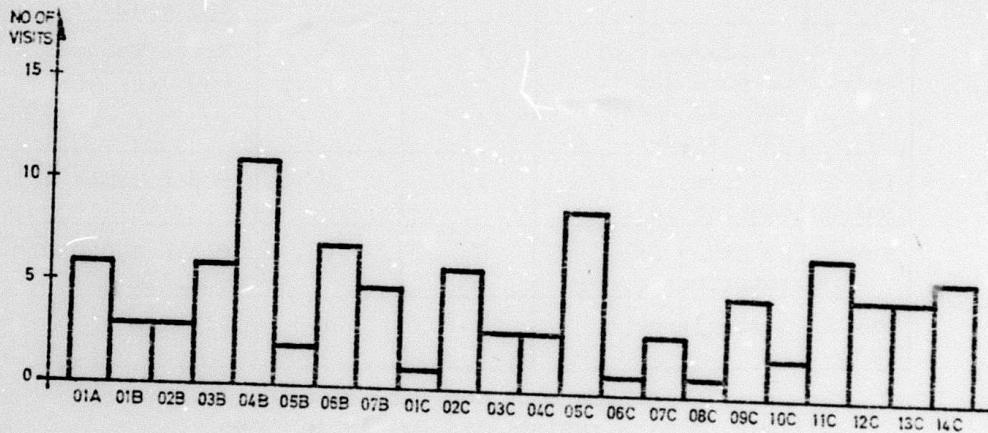
Figure 3.1 shows the number of visits to the different subarrays in the period. Excluding visits caused by troubles in the communications system, the subarrays have in average been visited 4.5 times. The larger number of visits to 04B and 05C are due to the accomplishment of different types of experiments (04B) and routine maintenance of the NAS seismic instrumentation (05C).

Figure 3.1 Number of maintenance visits to the NORSAR Subarrays (visits caused by faults in the NORSAR/NDPC communications system are not included).
