HELICOPTER SECONDARY STRUCTURES  
RELIABILITY AND MAINTAINABILITY  
INVESTIGATION

Kaman Aerospace Corporation

Army Air Mobility Research and Development  
Laboratory

January 1974

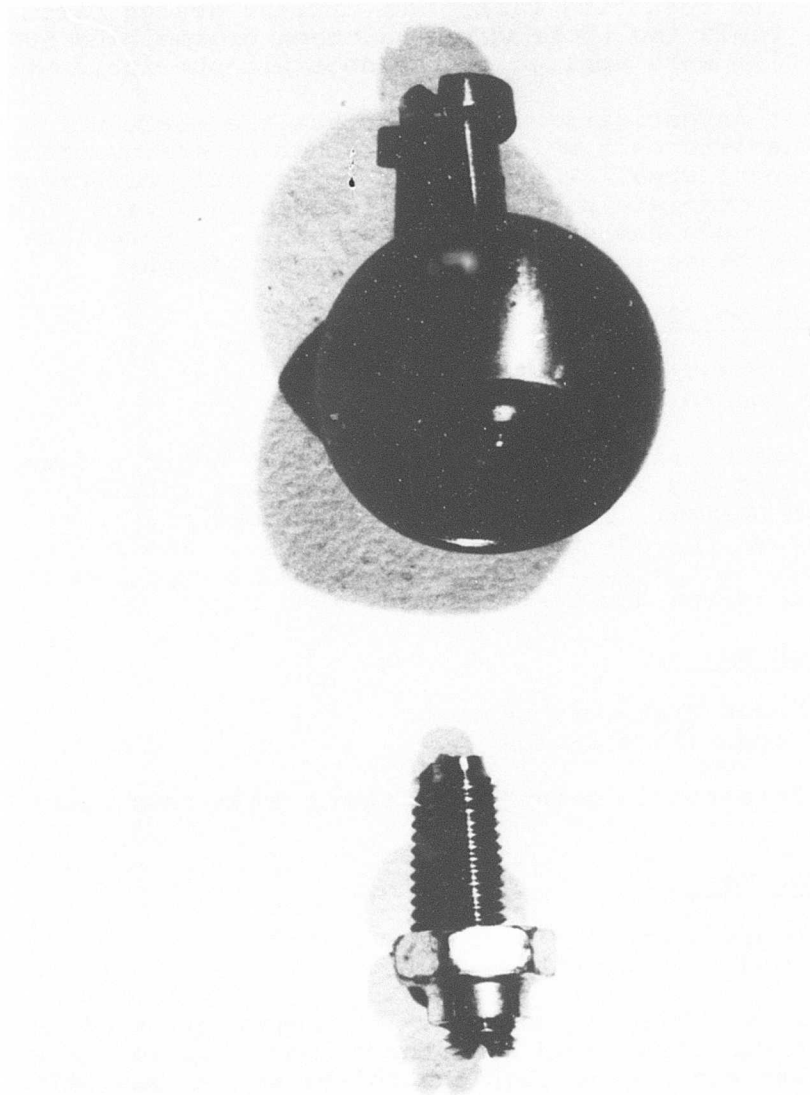
During the open-close cycling, the aft upper roller shaft broke on the 88th cycle. This permitted the door to move aft past the stop and to become disengaged from the tracks. The aft lower roller support bracket, which is a casting, was fractured in the resulting fall. New current design parts were installed, replacing those which had been broken, and 500 open-close cycles were applied to the door without incident.

Figure 7. Failure of Undercut Roller Shaft on Pilot Rescue Door.

In order to improve the condition on the roller shaft, it was decided to eliminate the cause of the cantilever loadings to which it is subjected in service. This was done by eliminating the door stop from the track and relocating it. Since it was now understood that the door could be expected to be frequently slammed against the stop, its design and location were given careful consideration. It was finally decided to locate the stop at the approximate waterline location of the C.G. of the door. This location minimizes any cocking action experienced by the door upon impact against the stop. The stop structure, which is illustrated in Figure 13, consists of two tapered channel section members located externally on the fuselage in a waterline plane. Located between these channels and attached to their webs is a tapered box-section member with a generous sized rubber bumper attached to it. One of the channels picks up an existing row of intercostal rivets, and an angle-section intercostal was added to provide backup structure for the other channel. A steel striker plate was attached to the stop contact area on the aft edge of the door (Figure 15) to protect the door sheet-metal structure.

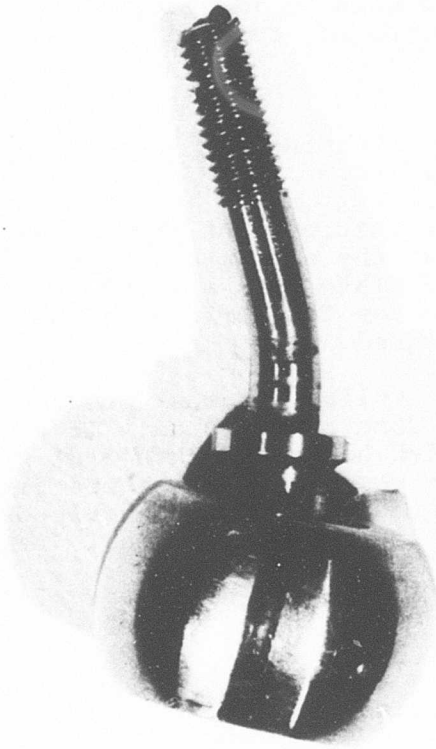
At the beginning of the open-close cycling for this test block, considerable resistance was encountered to door motion. The upper rollers were disassembled, and it was found that the forward roller had such a large flat spot that it would no longer roll (Figure 9). The aft roller had several large spots (Figure 8), its roller shaft was severely bent (Figure 8), and its spacer showed considerable deformation (Figure 11).

Figure 8. Bent Roller Shaft and Flat Areas on Upper  
Aft Roller on Pilot Rescue Door.

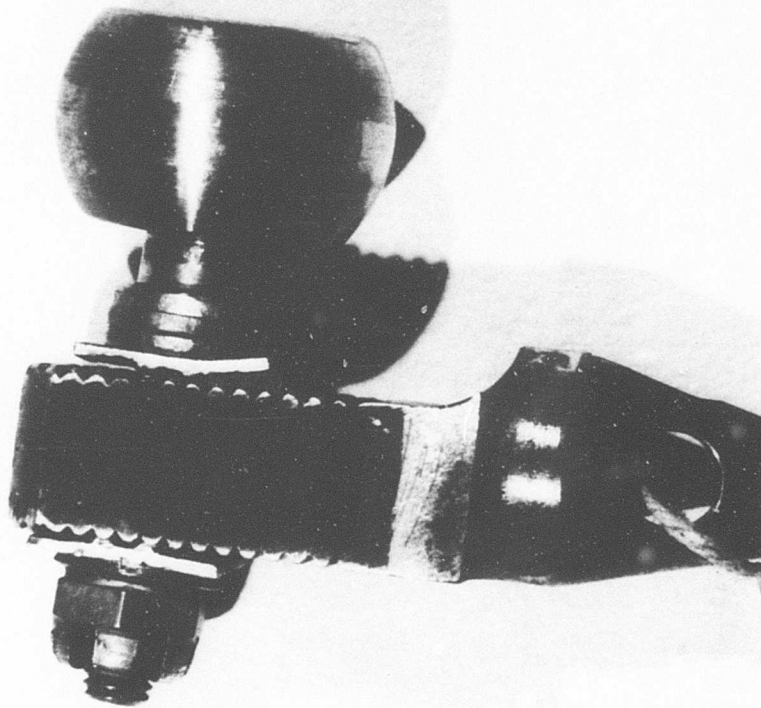
Figure 10. Upper Aft Roller Assembly Showing Deformation of Serrated Washer and Wear Pattern on Roller.

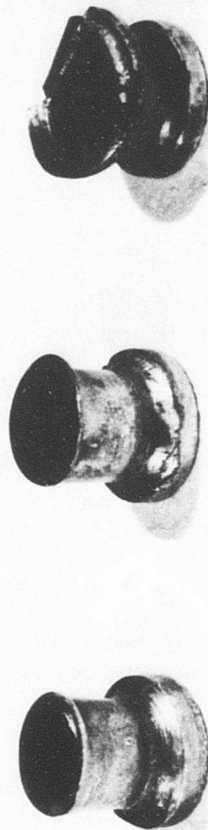
Figure 11. Progression of Failure in Roller Spacer.

In consonance with normal field procedure, these components were replaced with the exception of the spacer, for which an NAS-75-3-10 bushing was substituted for the reason noted in Test Block No. 5 above.

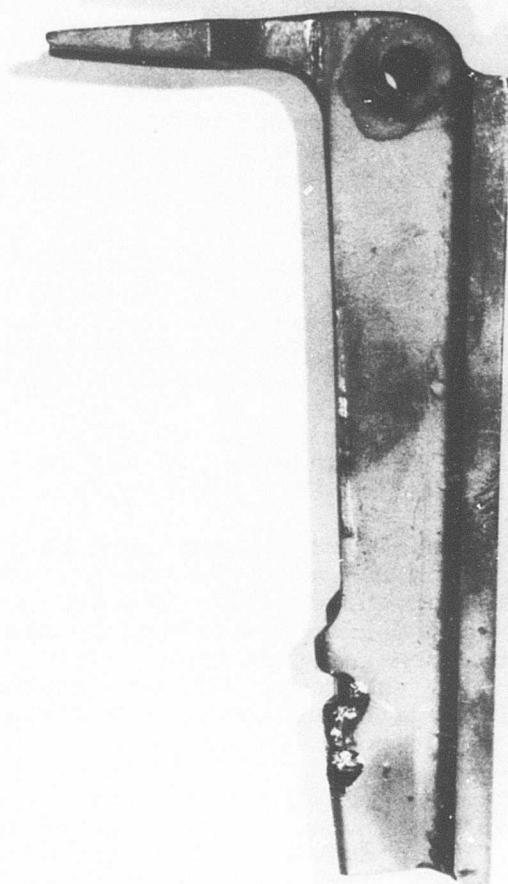
Figure 17. Modified Aft Latch After Test Showing  
Local Impact Damage.

The current design latches are flat steel plate sections, and in order to strengthen them, they were converted to Tee-section configurations by welding a cross-bar to their outer vertical edges. The modified latches are shown in Figures 17 and 18.
