HOL-GAR MODEL SP-HF-15, 15-KW,
400-HERTZ ENGINE GENERATOR SET

Army Mobility Equipment Research and
Development Center
Fort Belvoir, Virginia

May 1969

Report 1951

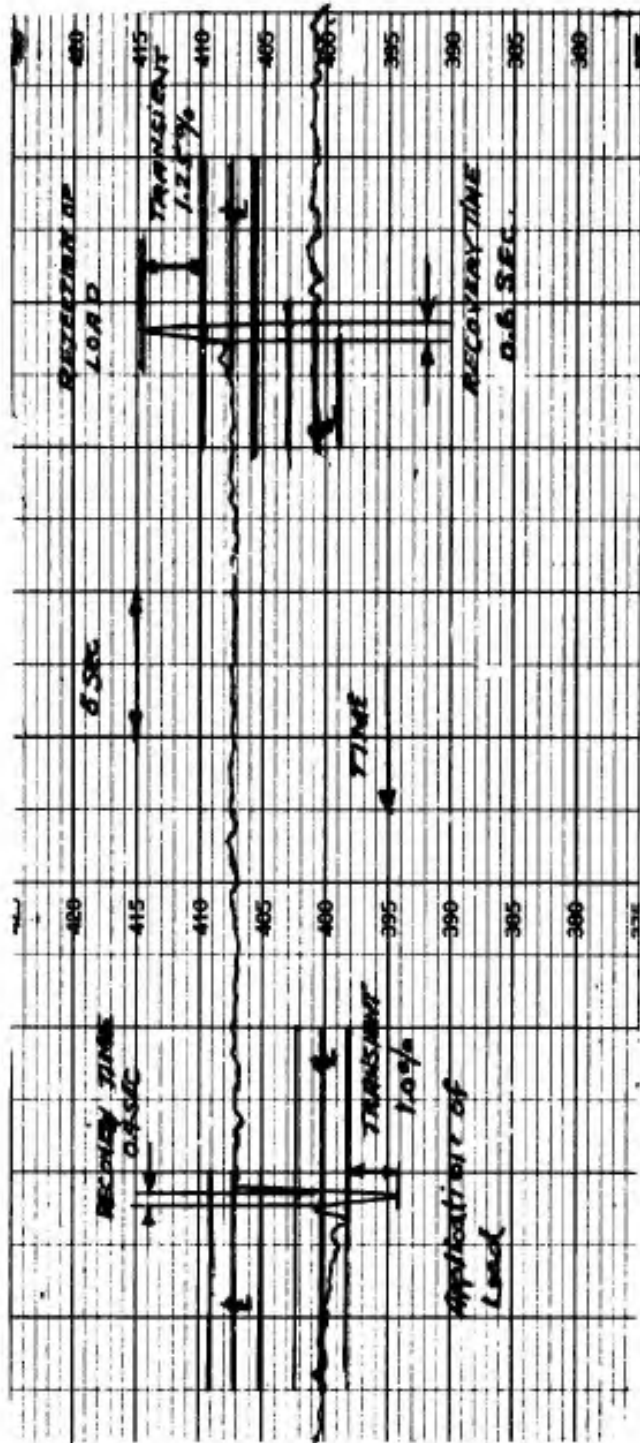
Fig. 4. Frequency stability and transient response at rated load, sea level, minus 25° F.

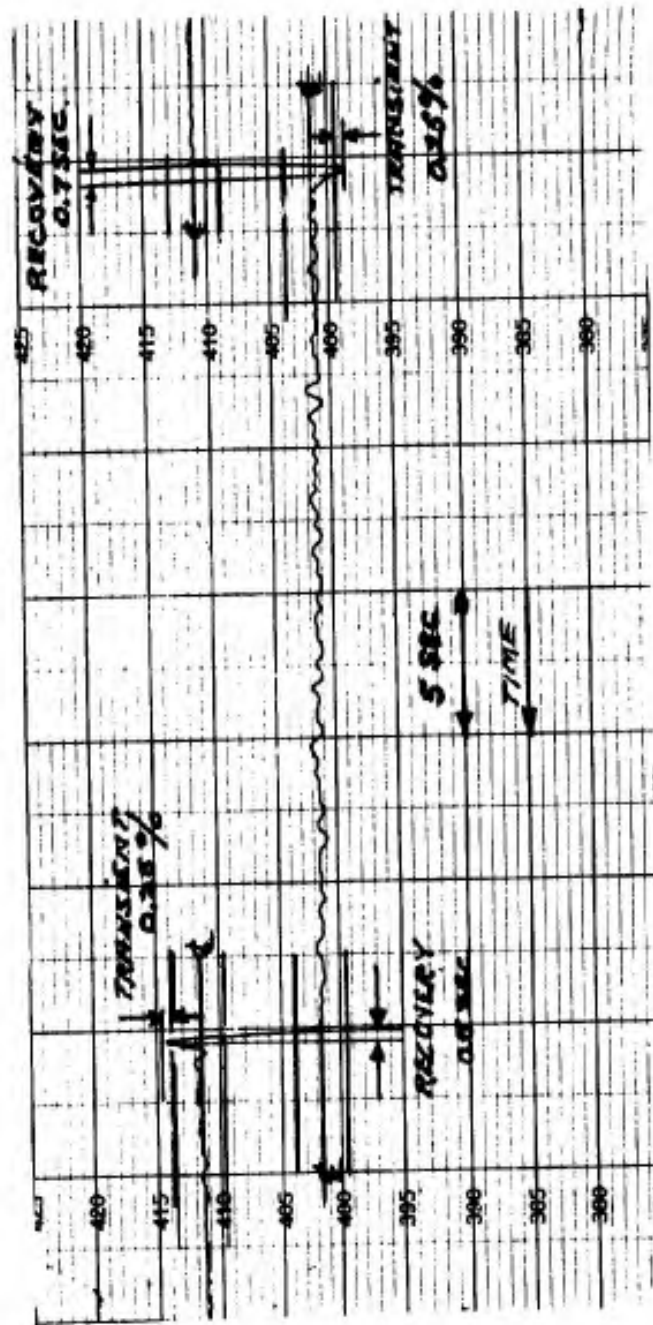
Fig. 5. Frequency stability and transient response at rated load, 8,000 Ft, 95° F.

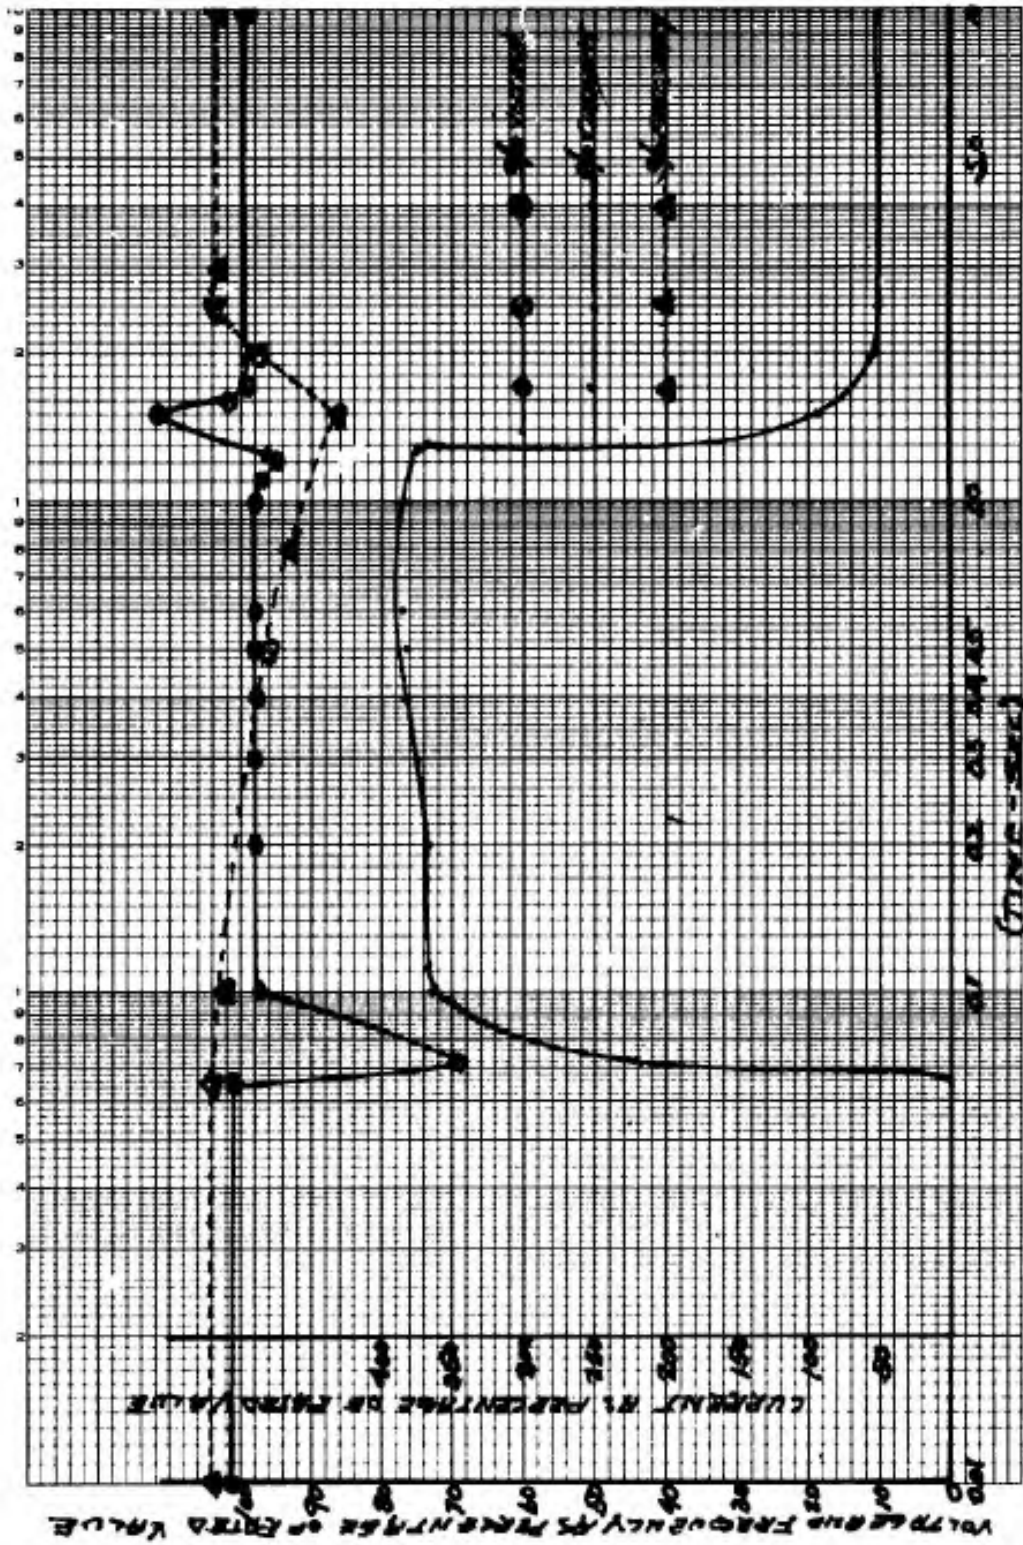
Figures 6, 7, and 8 present the results of this test. As seen in each figure, the voltage initially dropped to approximately 70 percent of rated voltage. As more inertia load was added to the motor, the frequency transient increased. The engine generator set was able to recover under all conditions without having any protective devices actuate. Also, the recovery time increased with an increase in motor load as shown in the figures. Since no requirement was specified in the Purchase Description, this test was conducted for information only.

Fig. 6. motor-start test---no load on motor.

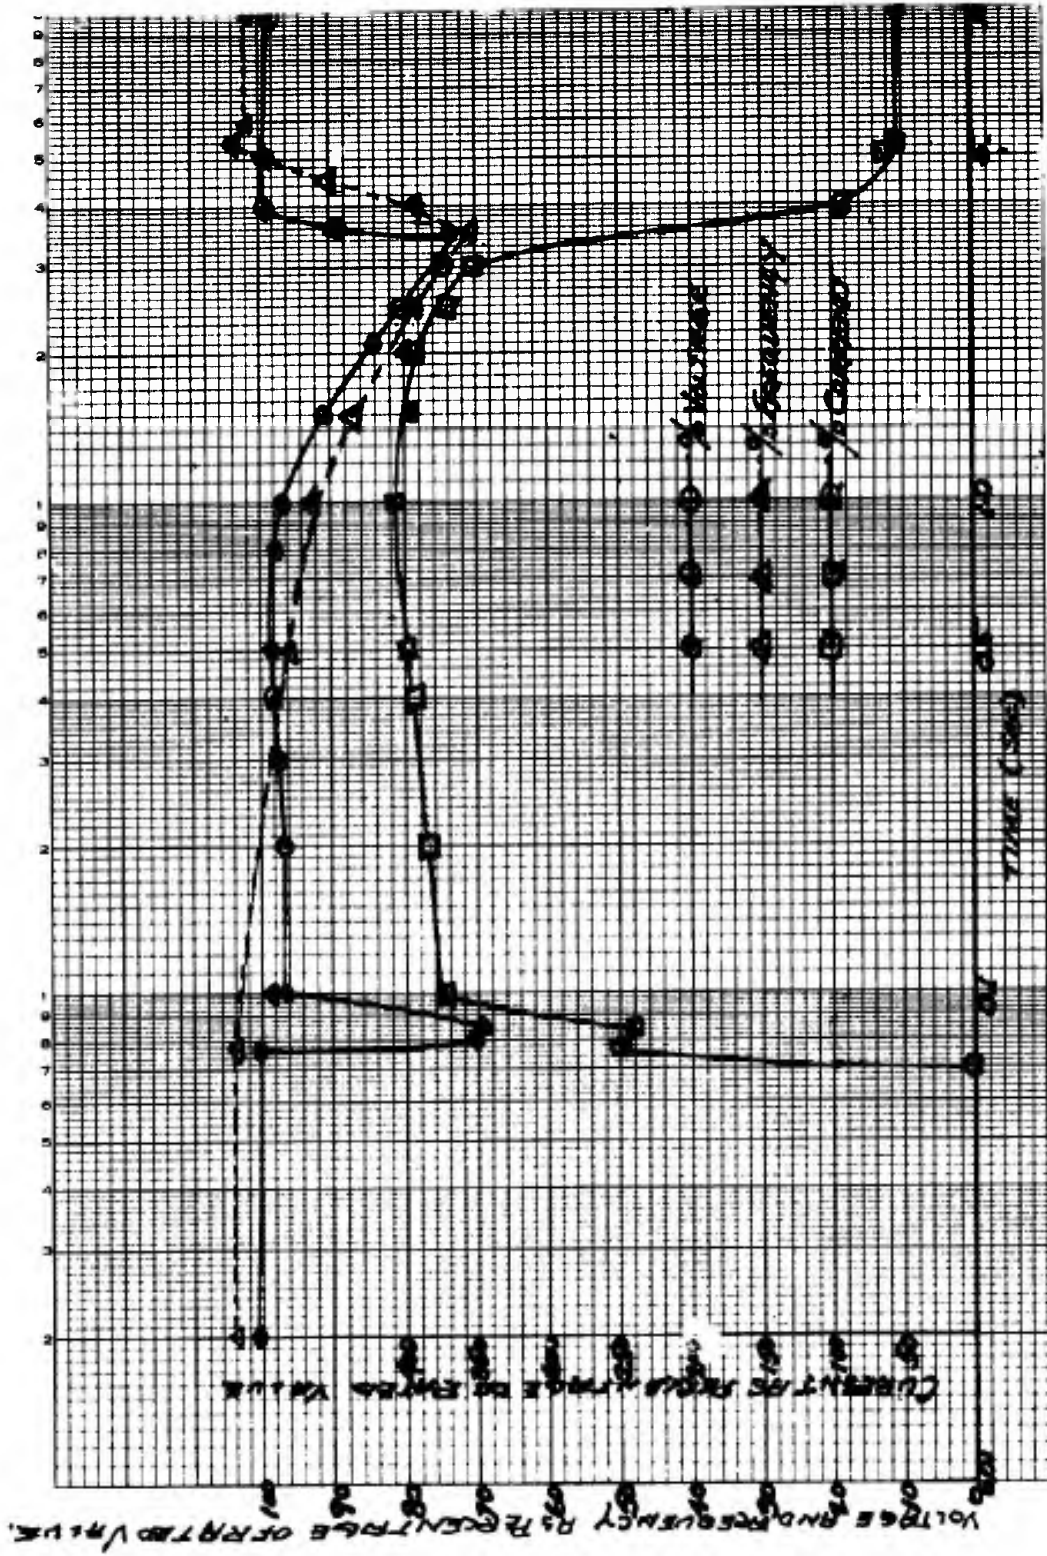
Fig. 7. Motor-start test— inertia load equal to motor inertia.

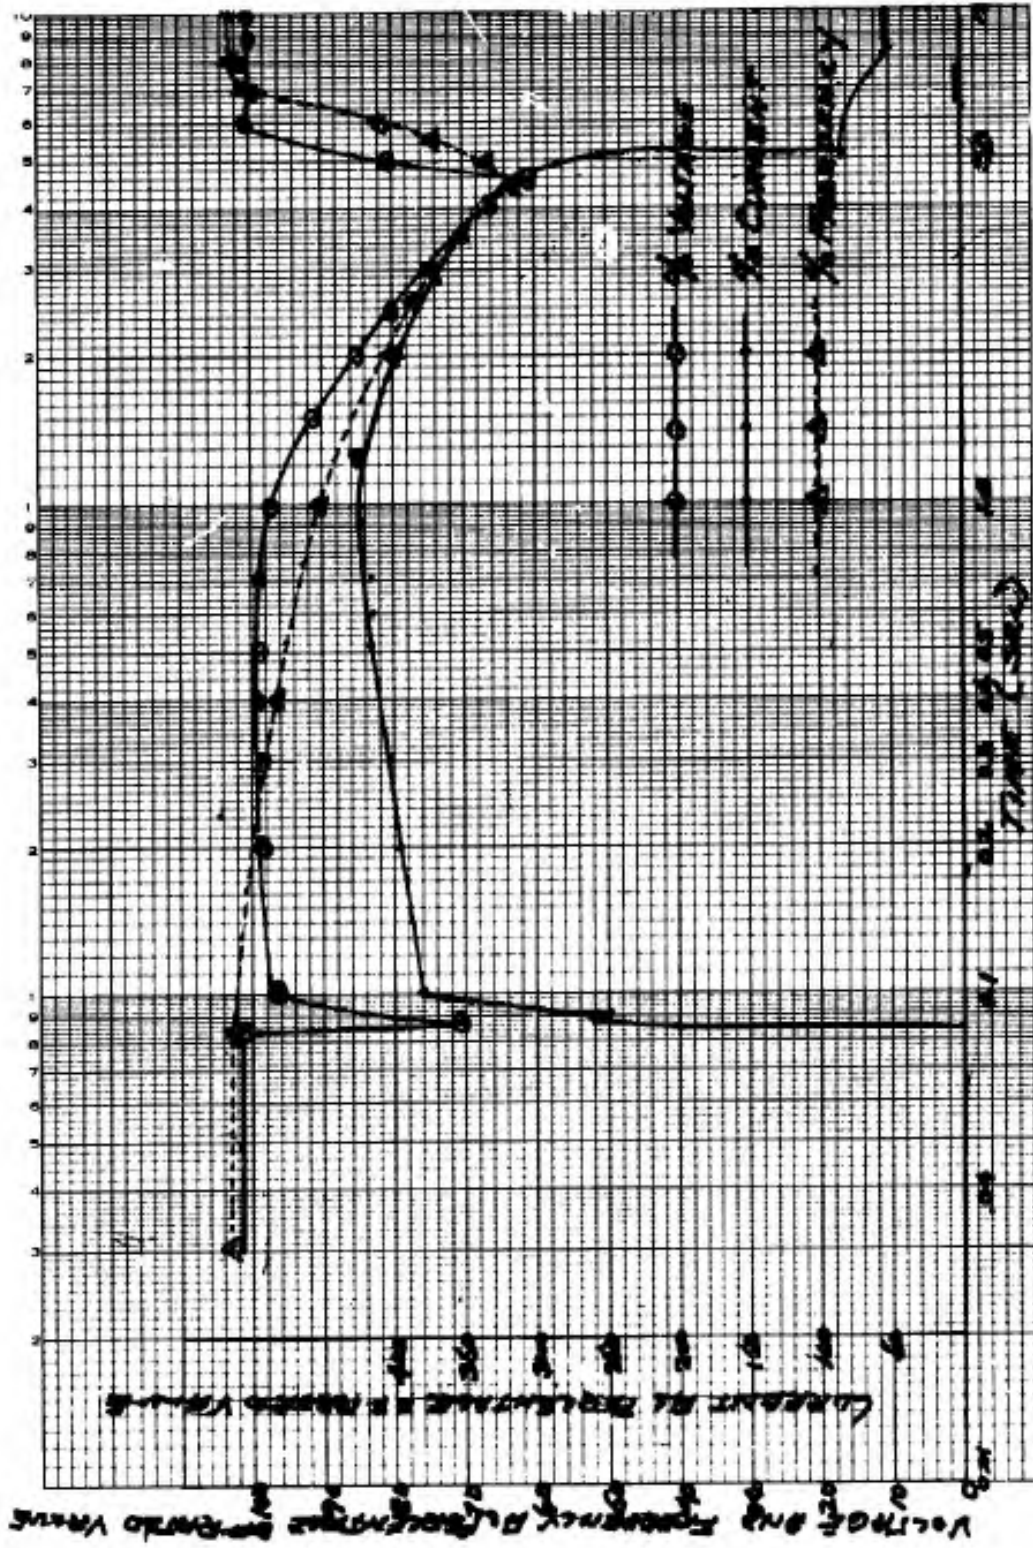
Fig. 8. Motor start test---inertia load equal to twice motor inertia.

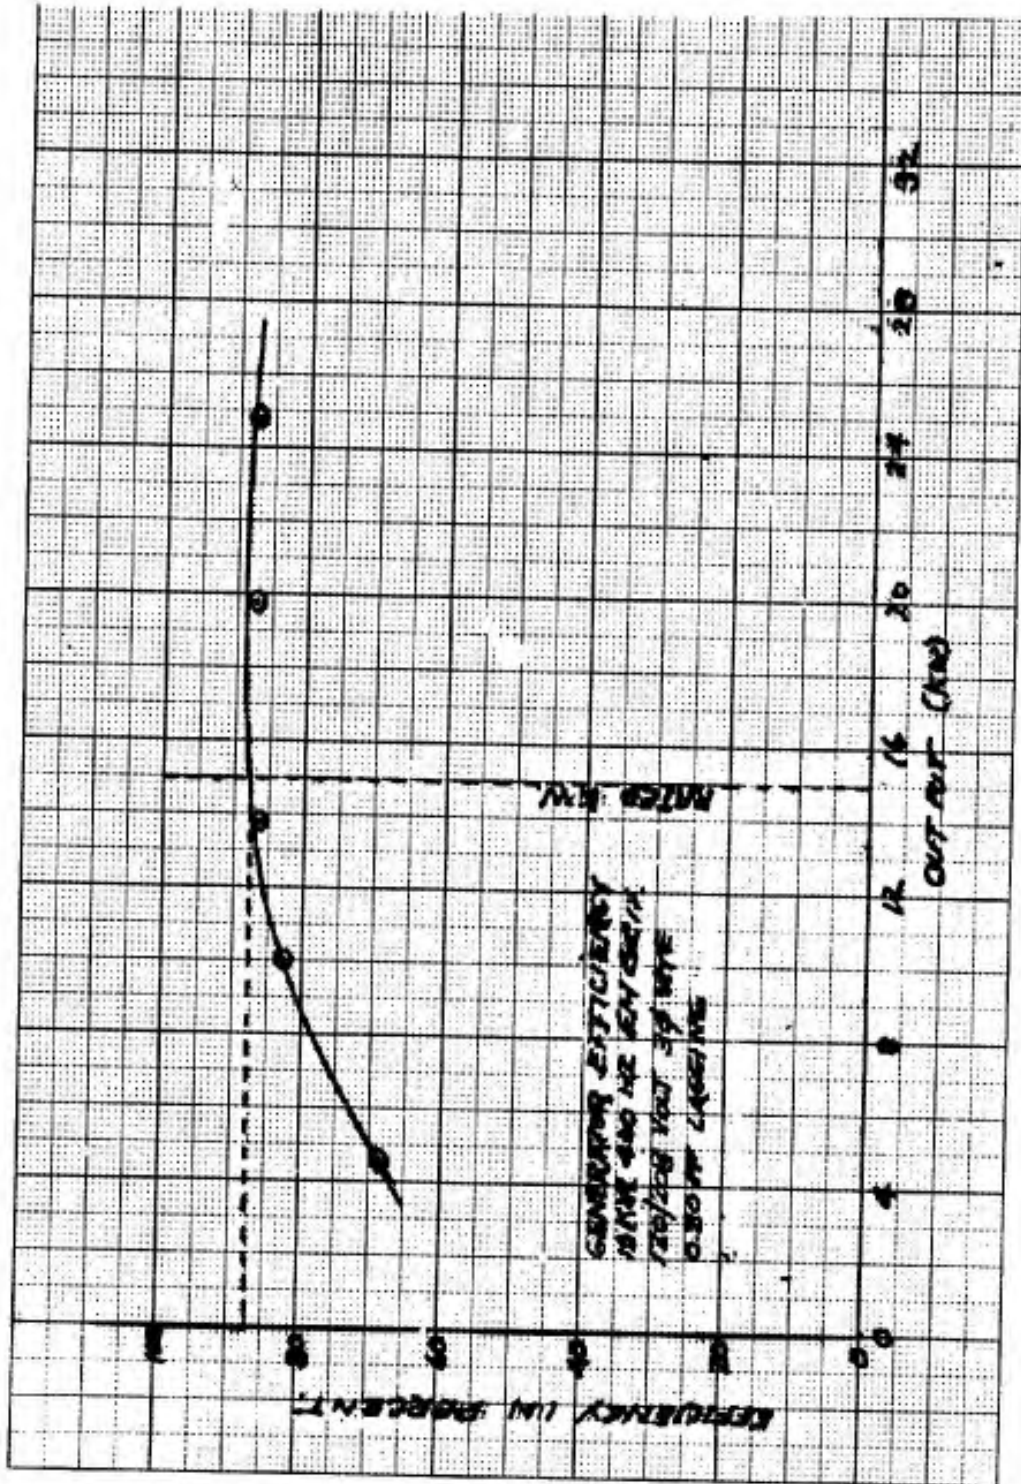
(1) Efficiency. The efficiency of the generator was determined at both the single-phase and 3-phase connections. The results of this test are shown in Figs. 9 and 10. During this test, separate excitations were used for the alternator field. The alternator was loaded at 0.80-pf and the output determined by wattmeter readings. The input was the sum of power measurements made for the rotating field (voltage and current) and the dynamometer indication (pounds pull and speed).

Fig. 9. Generator efficiency, three-phase.

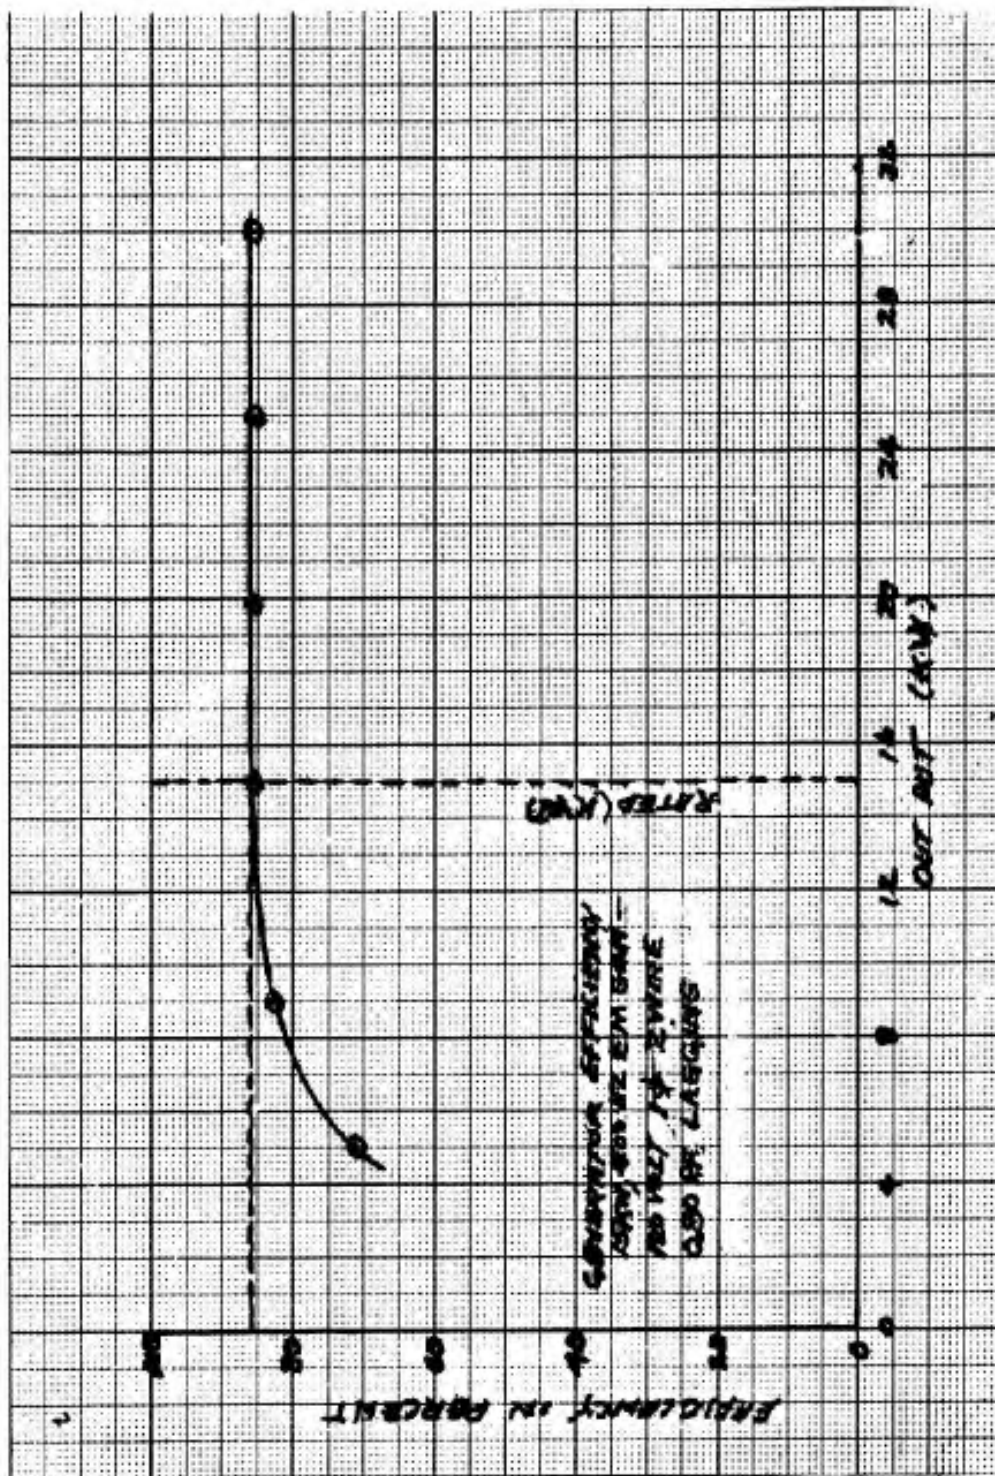
Fig. 10. Generator efficiency, single-phase.

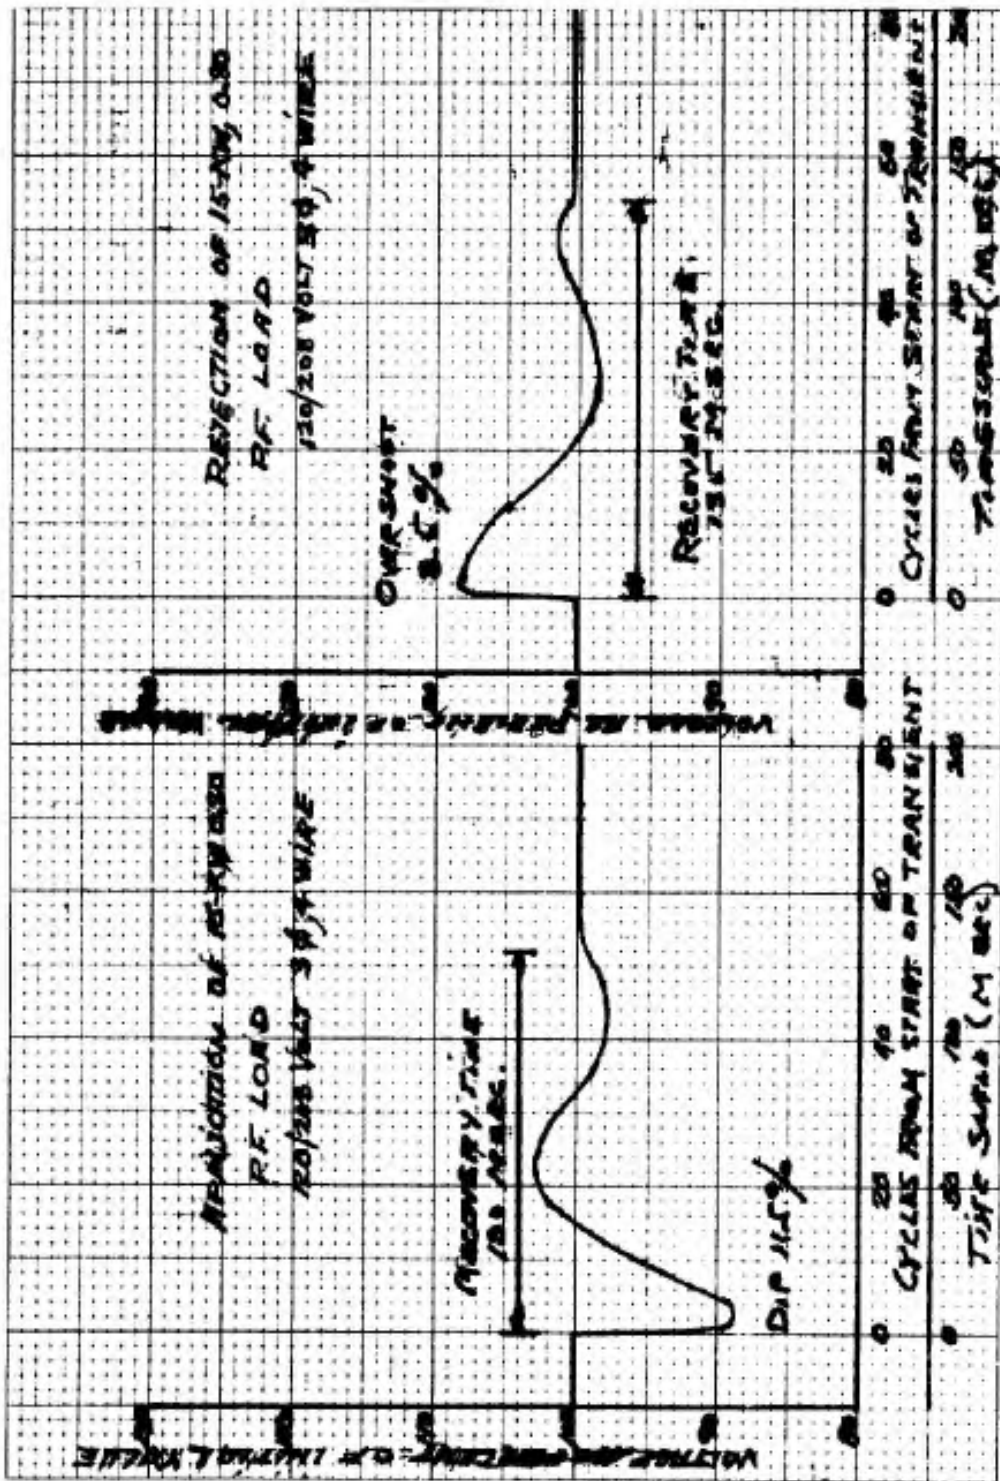
Fig. 11. Rated load, voltage stability, and transient response, three-phase---original CVT's.

(2) Regulator Stability and Transient Response. Results of these tests, on equipment as received at MERDC, are shown in Figs. 11 through 15. After this data was taken, it was learned (at MERDC and also at the contractor's plant) that the voltage-regulator control was excessive on most units being produced; this would not permit adjusting voltage to the specified minimum value. The generator excitation system was designed to operate with a nominal control current of 1.0 ampere. The first production sets had control current as high as 1.80 amperes. This value approaches the output limit of the voltage regulator and does not allow for proper operation. Investigation revealed that an interference occurred during manufacture of the exciter Current-Voltage Transformer (CVT) which introduced an air gap in the laminations. This gap necessitated a higher control current. A correction in manufacturing was made to eliminate the air gap in the CVT's; and regulator stability and transient response tests were repeated at MERDC using an exciter equipped with the new CVT's. Control current was 0.75 ampere for rated generator output voltage, and performance was improved in that the lower limit of the specified range of voltage adjustment could now be obtained; however, the stability after shock loading was relatively poor as denoted by the relatively large number of voltage oscillations which took place after the load was changed. Figures 16 and 17 illustrate this condition. By adjusting the stability resistor (R-11) in the voltage regulator, it was possible to improve stability to an acceptable value. Figures 18 and 19 show results obtained after this adjustment and are the basis of the data included in Table III. As a further check on the effectiveness of the change, two additional sets of the new CVT's were installed in the exciter in turn. Performance was satisfactory and not significantly different.

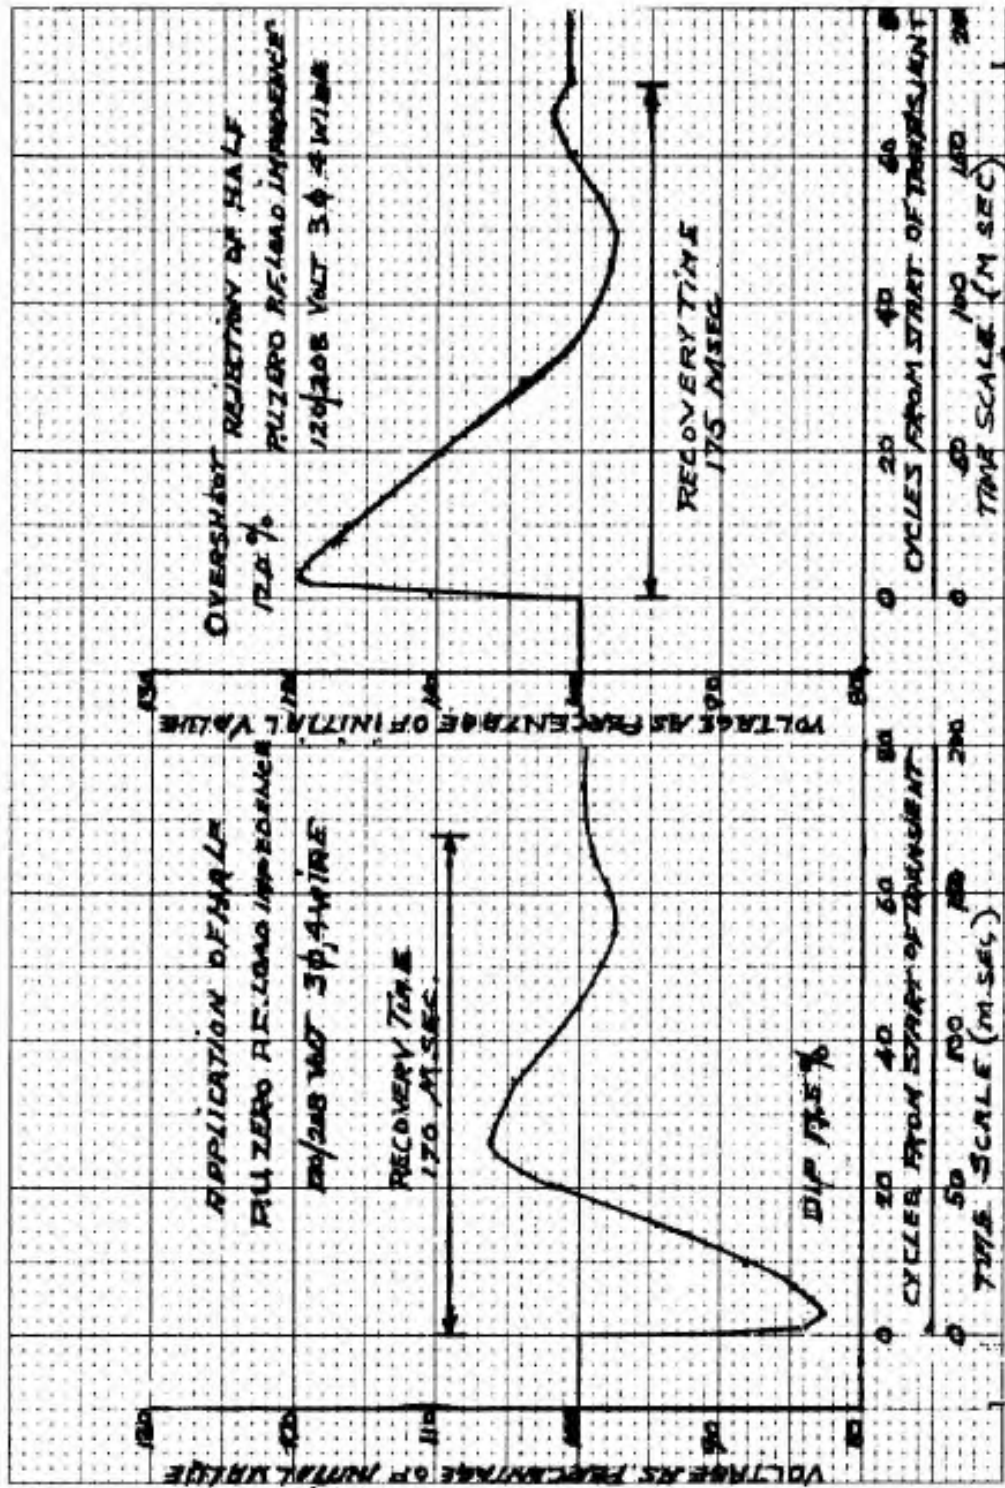
Fig. 12. Zero pf load, voltage stability and transient response, three-phase—original CVT's.

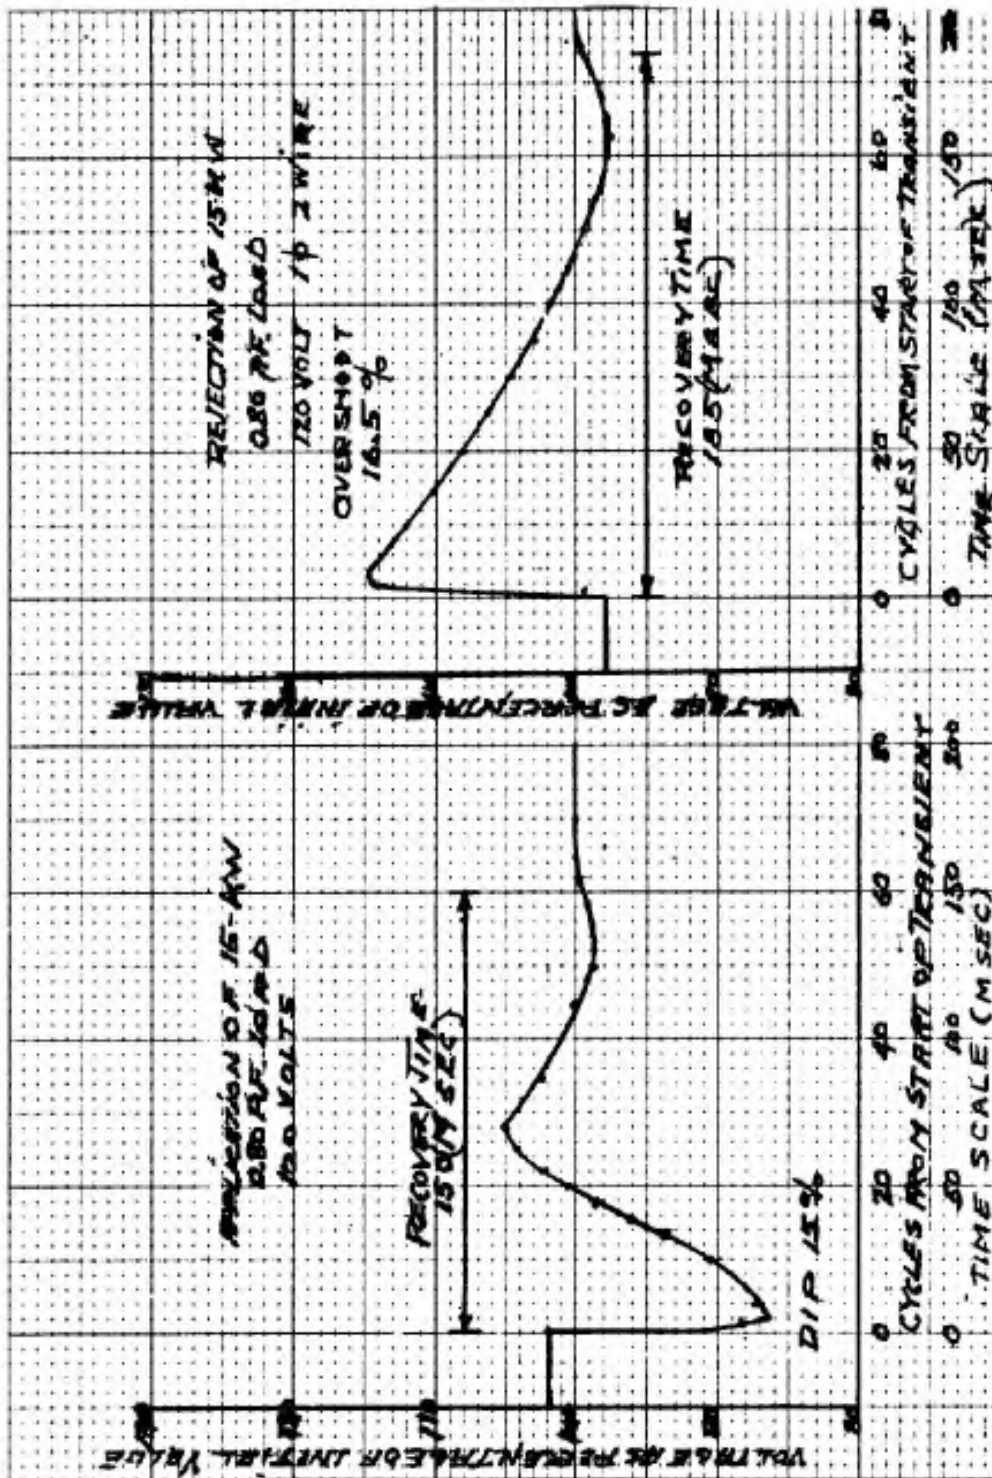
Fig. 13. Rated-load, voltage stability and transient response, single-phase—original CVT's.

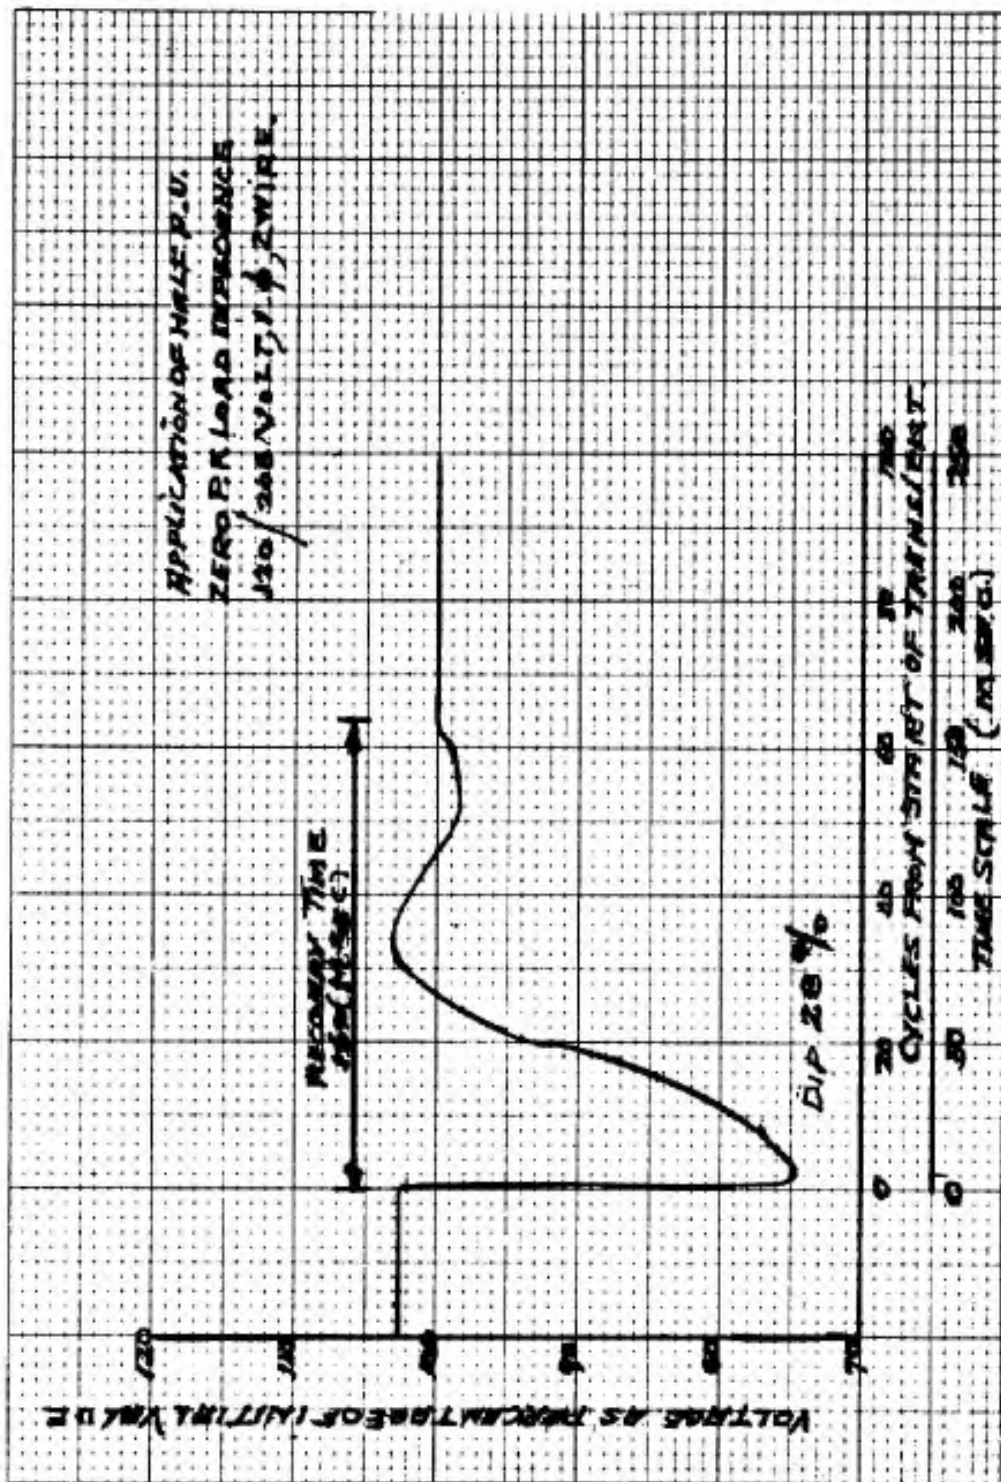
Fig. 14. Zero pf load, voltage stability and transient response, single-phase—original CVT's.

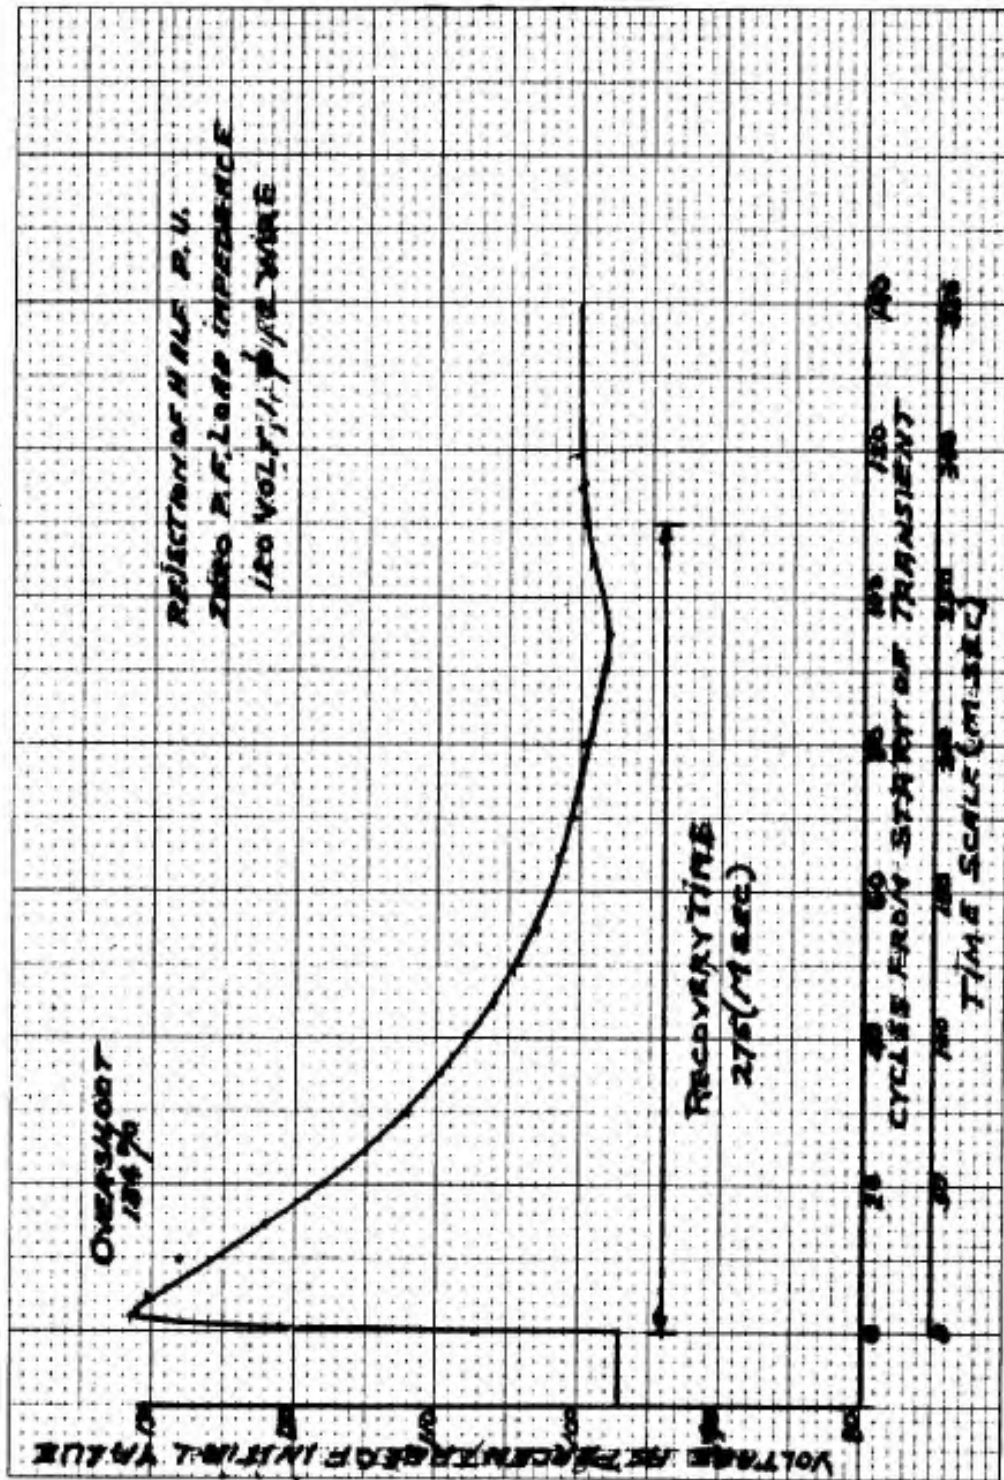
Fig. 15. Zero pf load, voltage stability and transient response, single-phase—original CVT's.

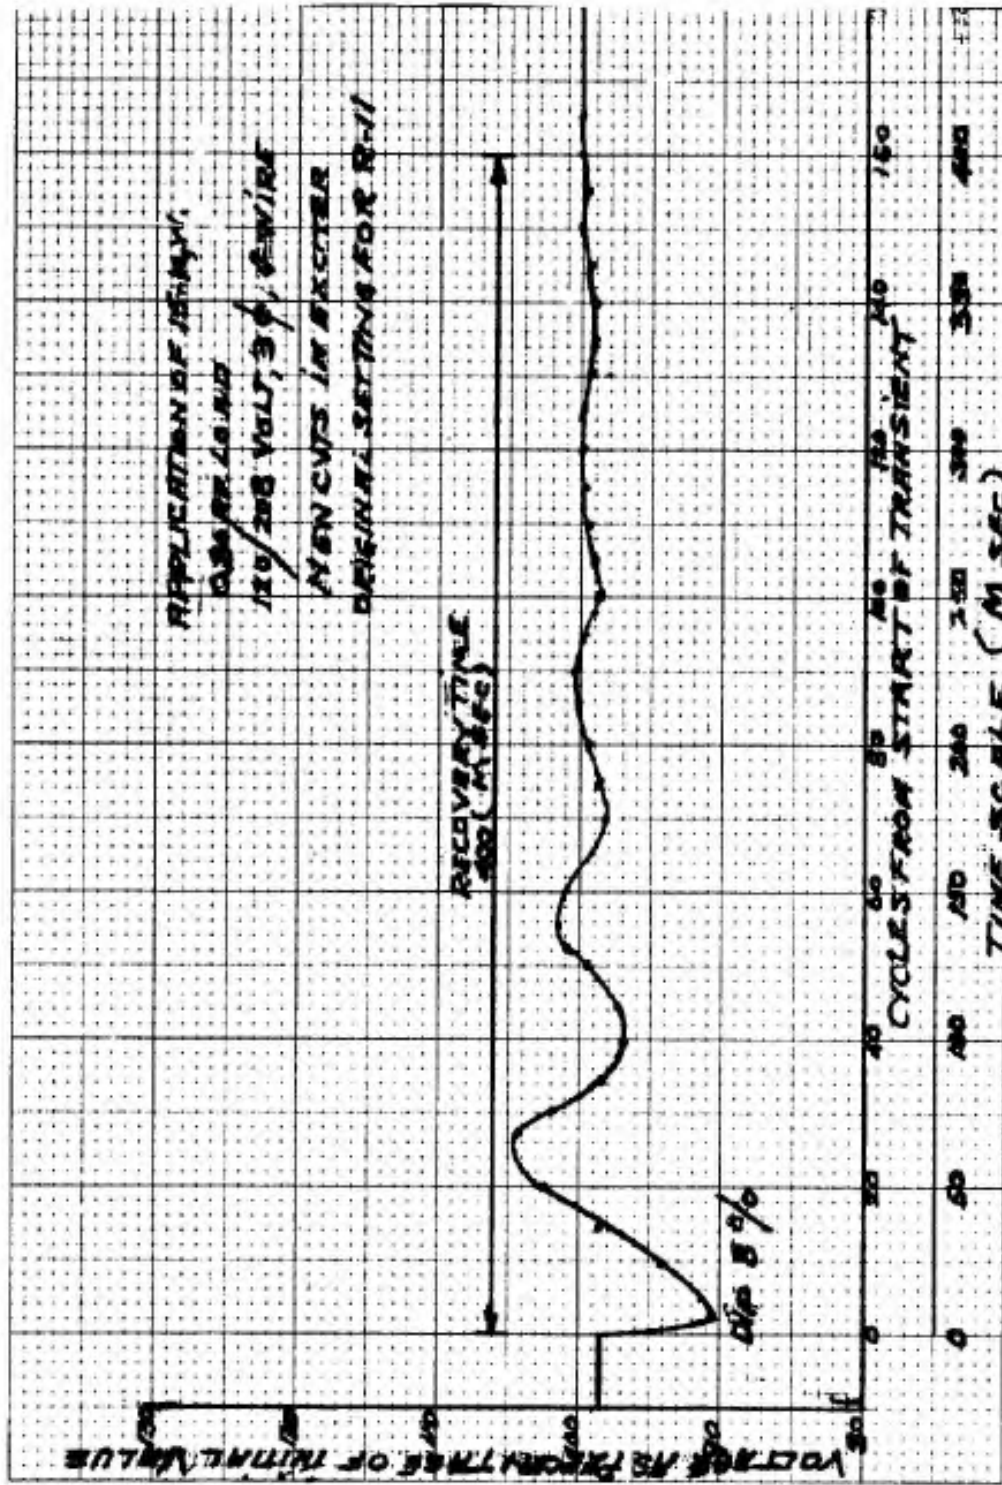
Fig. 16. Rated load, voltage stability and transient response, three-phase—new CVT's (R-11 not adjusted).

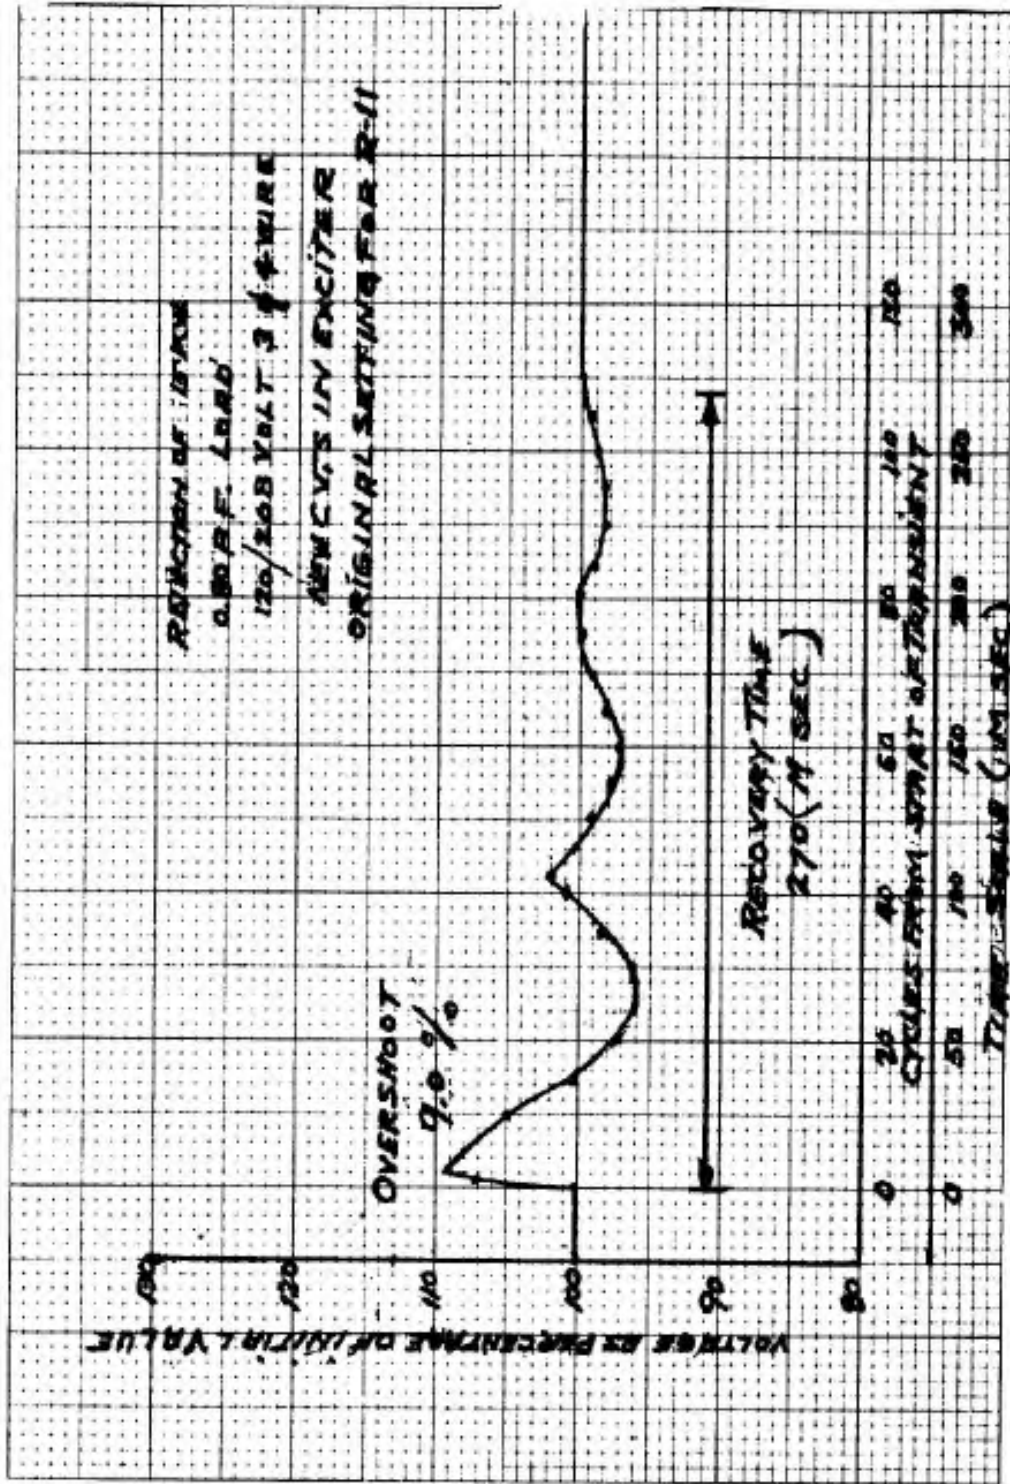
Fig. 17. Rated-load, voltage stability and transient response, three-phase---new CVT's (R-II not adjusted).

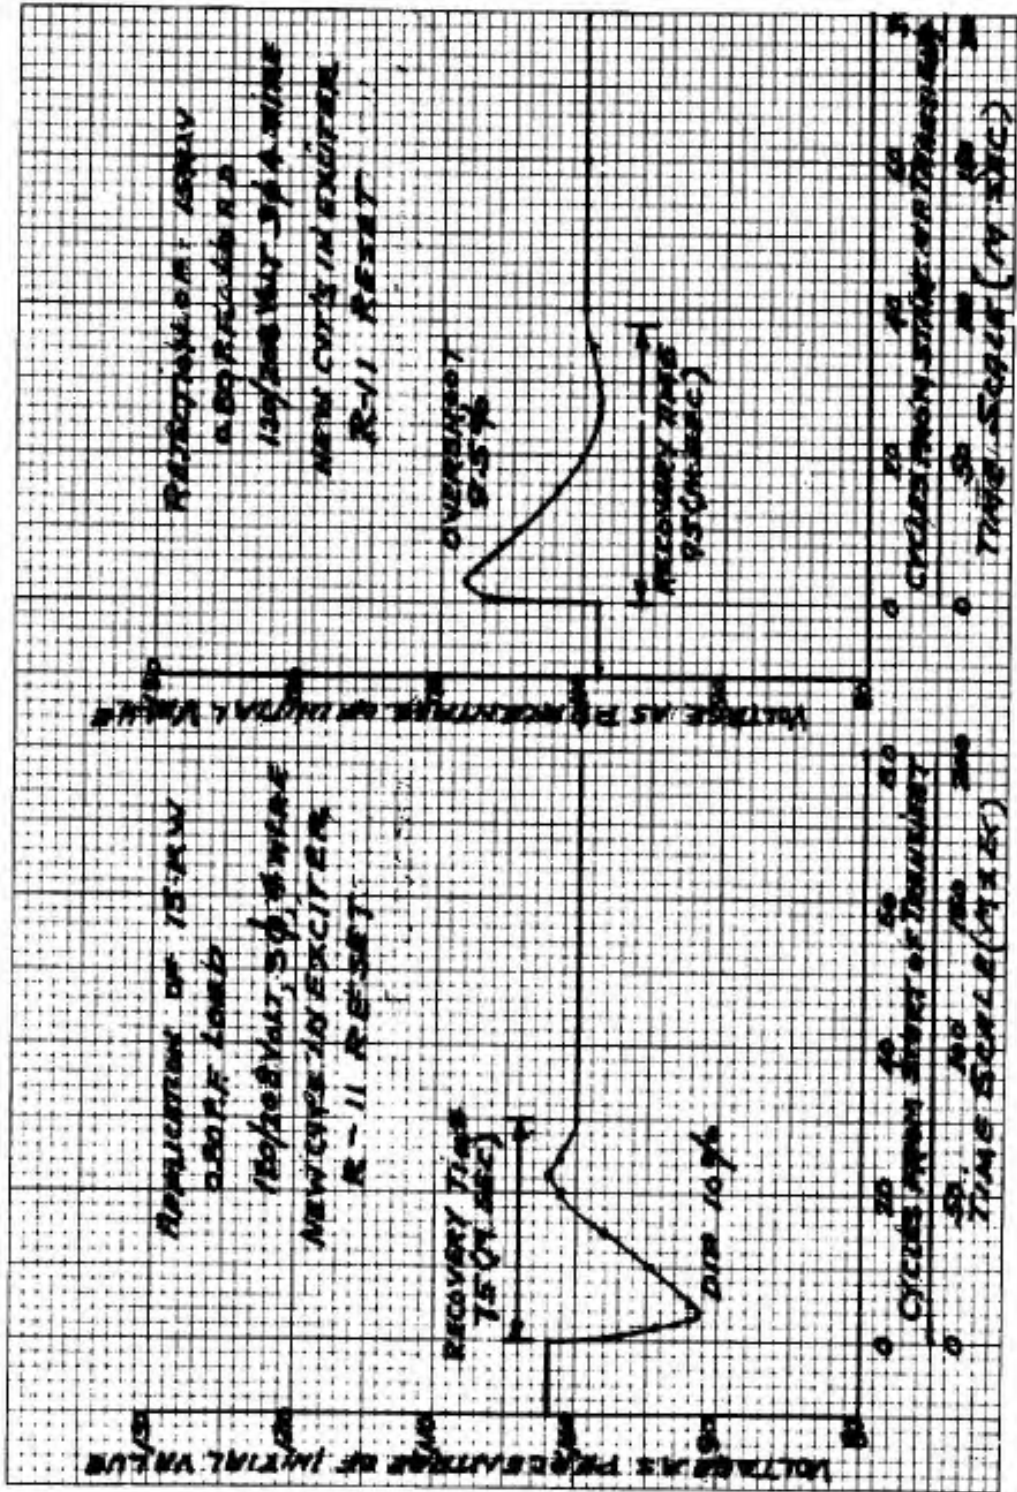
Fig. 18. Rated-load, voltage stability and transient response, three-phase---new CVT's (R-11 adjusted).
