HOL-GAR MODEL SP-HF-15, 15-KW,
400-HERTZ ENGINE GENERATOR SET

Army Mobility Equipment Research and
Development Center
Fort Belvoir, Virginia

May 1969

Report 1951

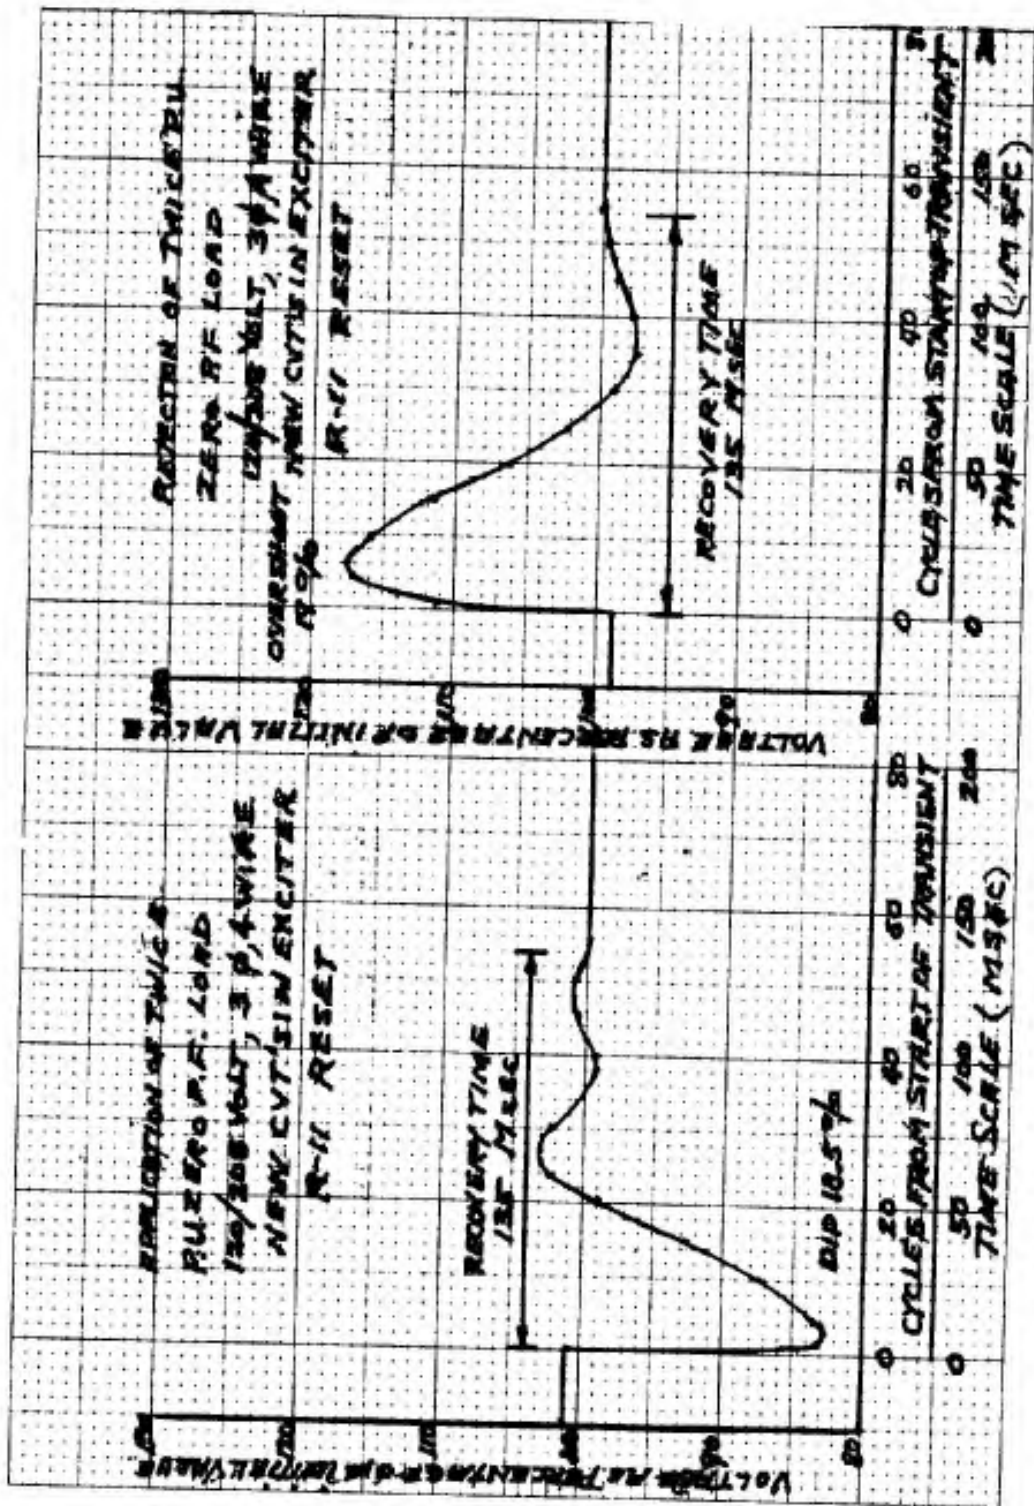
Fig. 19. Zero-pf load, stability and transient response, three-phase---new CVT's (R-11 readjusted).
