HLH/ATC ENGINE SHAFT SUPPORT BEARING  
DEVELOPMENT PROGRAM

Boeing Vertol Company

May 1974

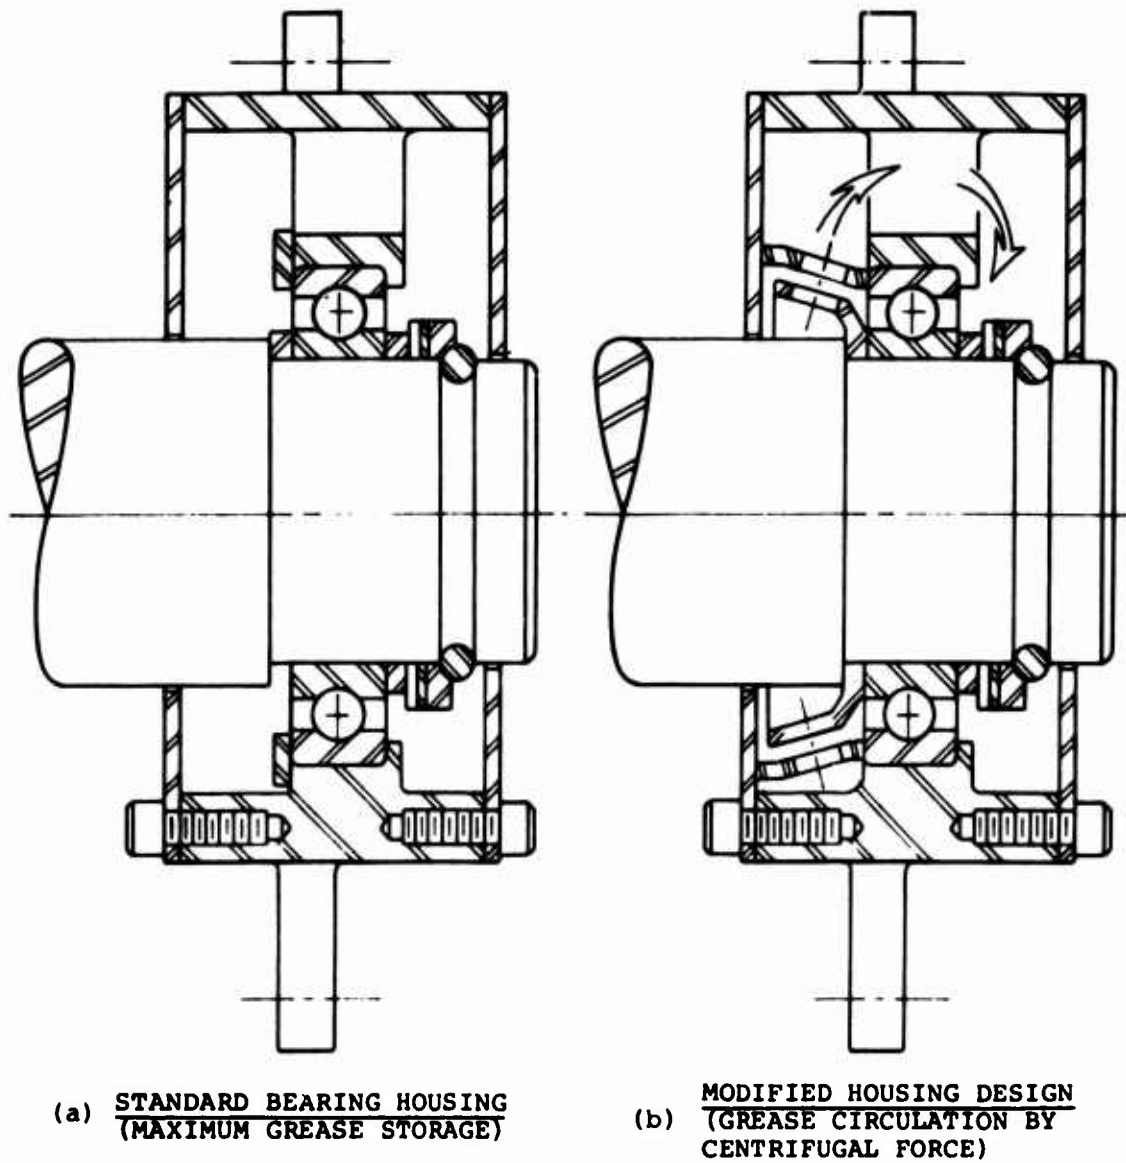
Figure 42. Standard and Modified Bearing Housing Design.

This test evaluated bearings S/N E9 and E2 with standard pressed steel cages and the grease circulating device in a housing (Figure 42a) versus a standard bearing housing (Figure 42b). Each housing was packed with 7 ounces of grease. After 71.7 hours, temperature of the drive-end bearing indicated inadequate lubrication. Six ounces of grease were added to the drive-end housing and 3 ounces to the outboard. At 171.7 hours, 6 more ounces of grease were added to the drive-end housing. The test was suspended as scheduled at 300 hours. Both bearings were serviceable, but bearing S/N E9, the drive-end bearing, indicated three overheated ball pockets. See Figures 43 and 44 for examples of the bearings with standard pressed steel cages after test. Figure 45 shows the inside of both housings after test. The housing with the grease circulating device appeared to retain the grease better than the standard housing.

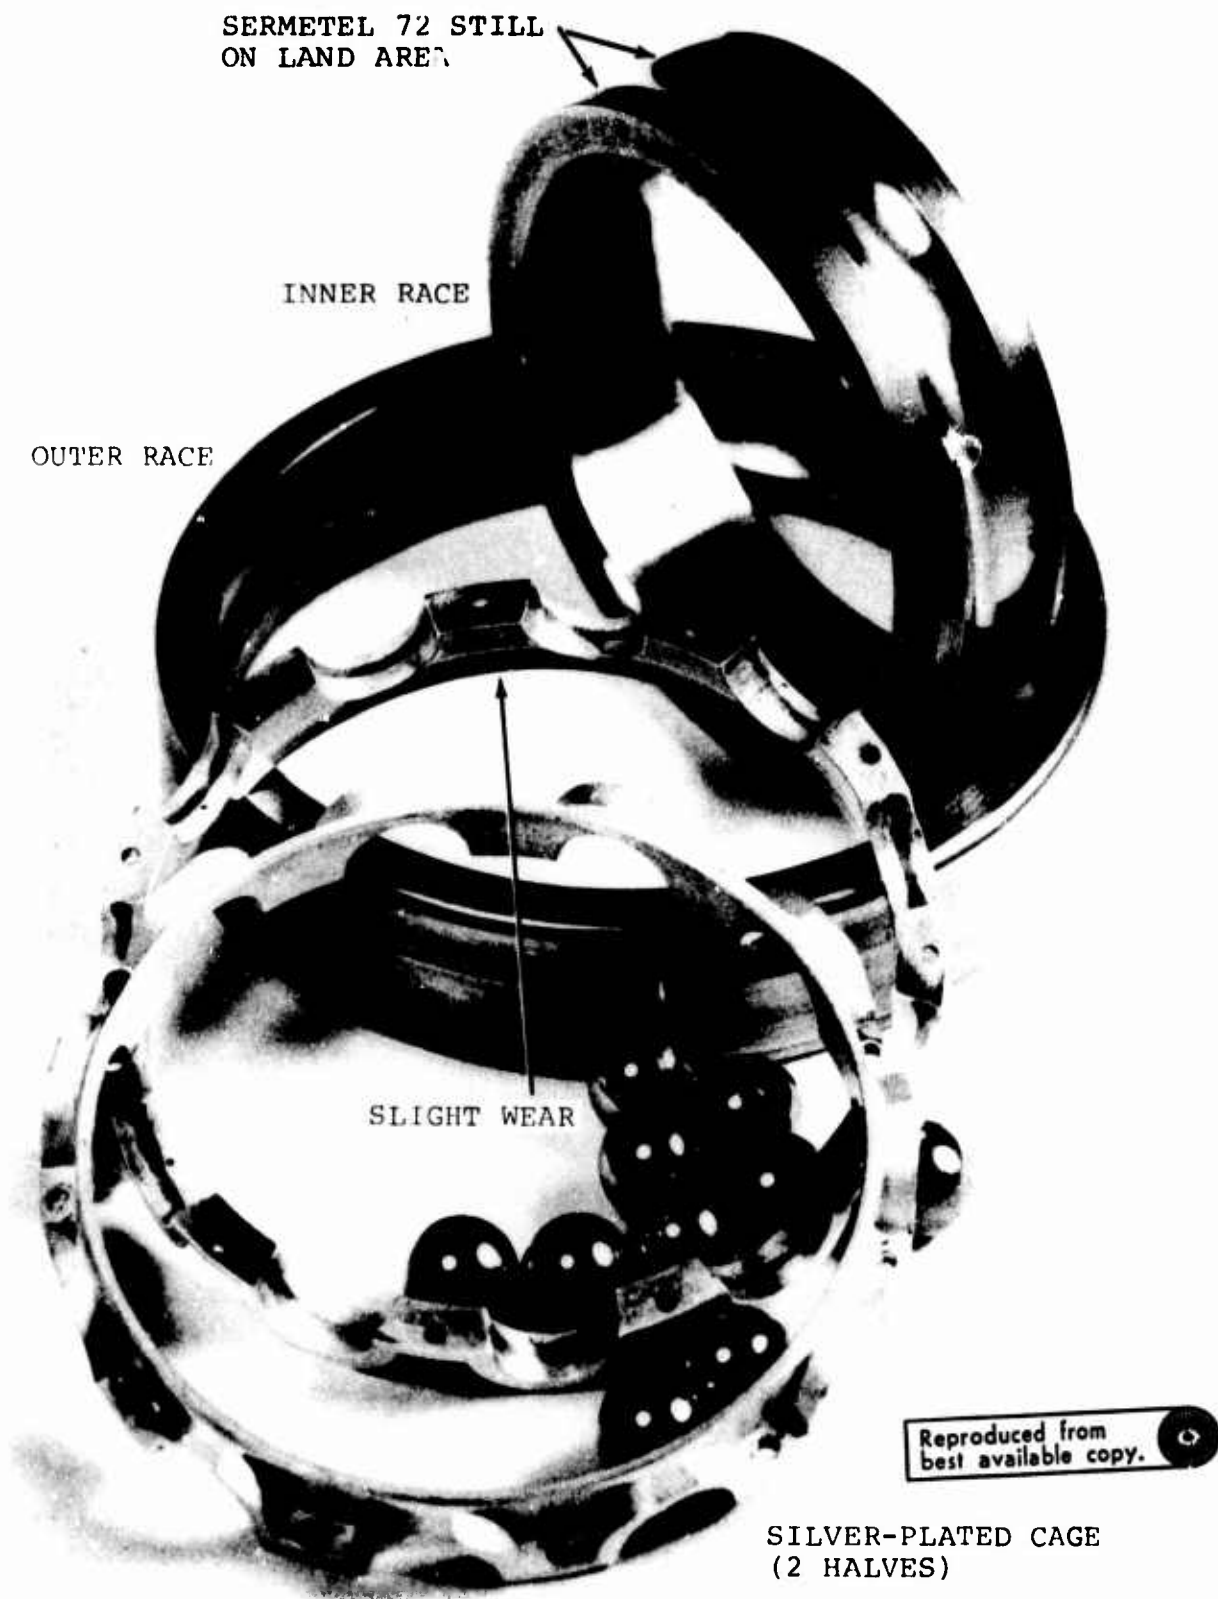
Figure 77. Drive-Shaft Support Bearing S/N 1, Outboard End After Test.

Outboard bearing races were in relatively good condition with well-defined ball paths. These paths presented a cloudy appearance and indicate ball migration under the combination load-misalignment conditions. The inner ring showed the Sermetel 72 still covering most of the land area (Figure 77).
