ELASTIC PITCH BEAM TAIL ROTOR OPERATIONAL  
SUITABILITY INVESTIGATION

Kaman Aerospace Corporation

Army Air Mobility Research and Development  
Laboratory

July 1974

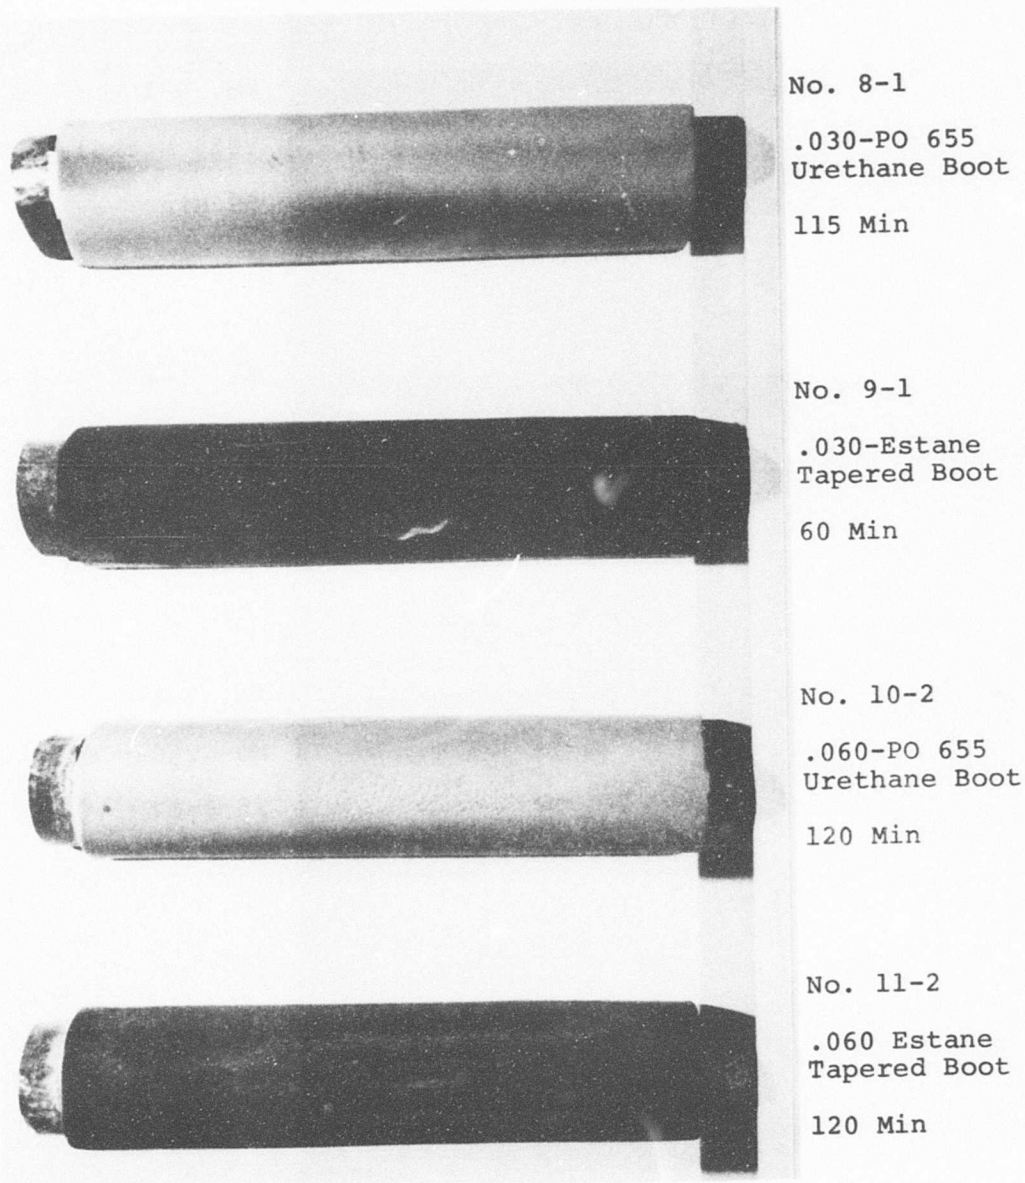
Figure 33. Urethane-Covered Test Specimens After Sand Erosion.

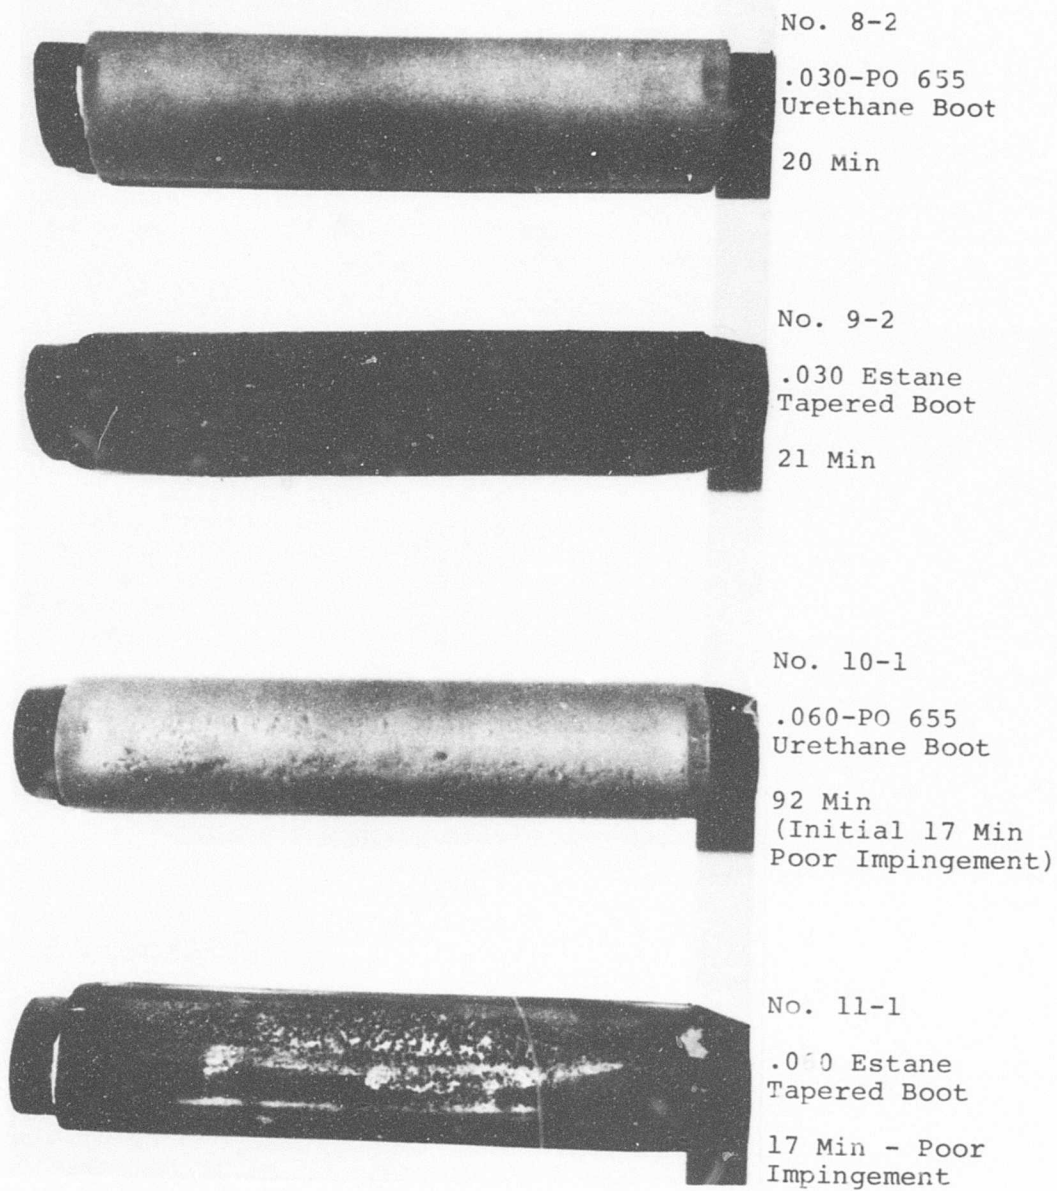
Figure 34. Urethane-Covered Test Specimens After Rain Erosion.

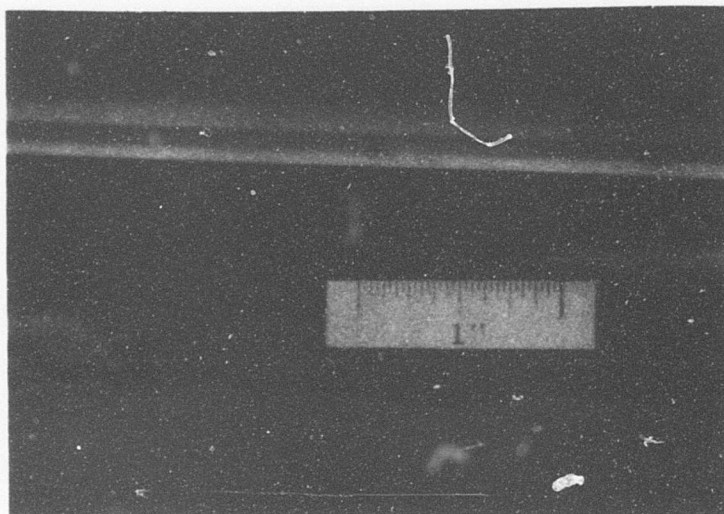
Figure 39. Condition of Erosion Guard on A-Blade From Gravel Impingement After Completion of Run 2.

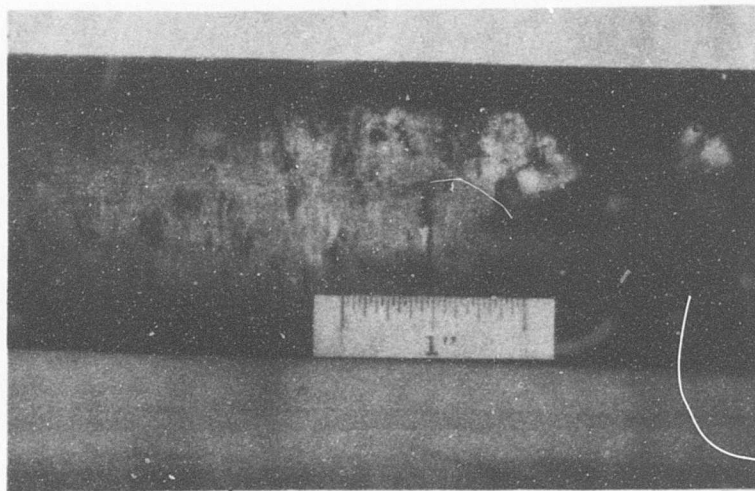
Figure 40. Side View of Erosion Guard on A-Blade, Showing Blisters Caused by Pulverizing of Gravel on Penetration Through the Erosion Guard.

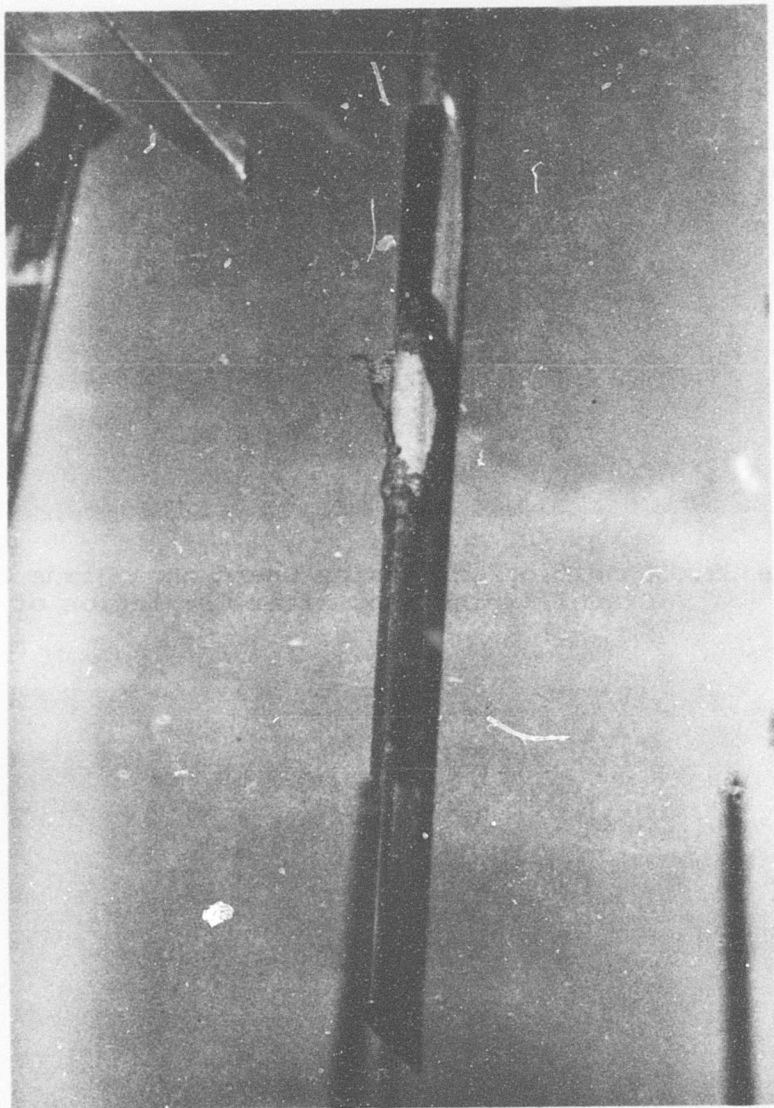
Figure 41. Condition of B-Blade From Gravel Impingement After Completion of Run 2.

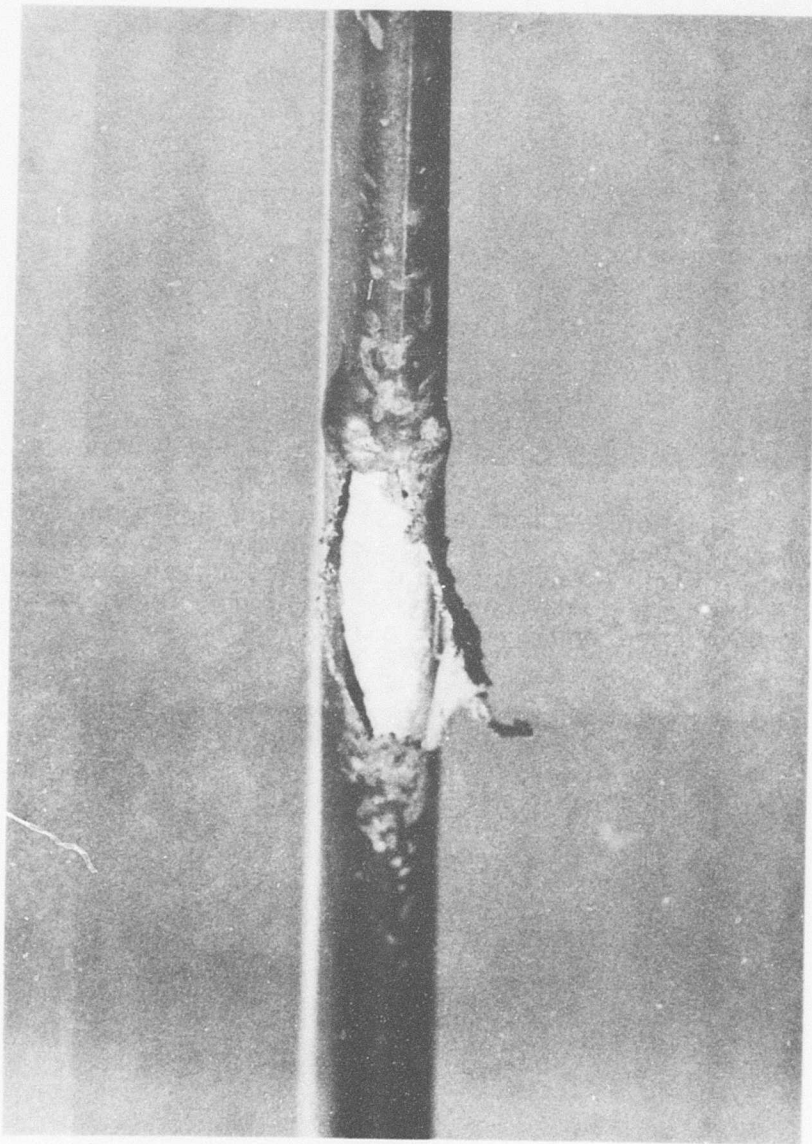
Figure 42. Close-Up View of Gravel Impingement Damage.  
(Same View as Figure 41.)

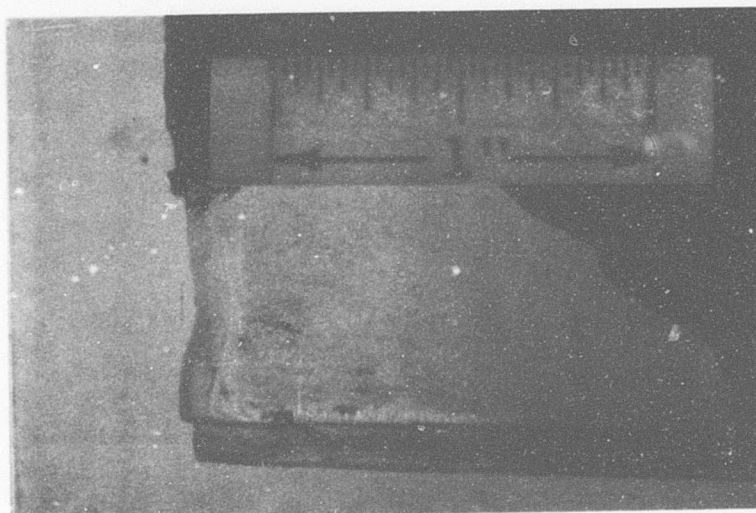
Figure 44. Side View of A-Blade After Severing 5/8-Inch Maple Dowel in Run 8.

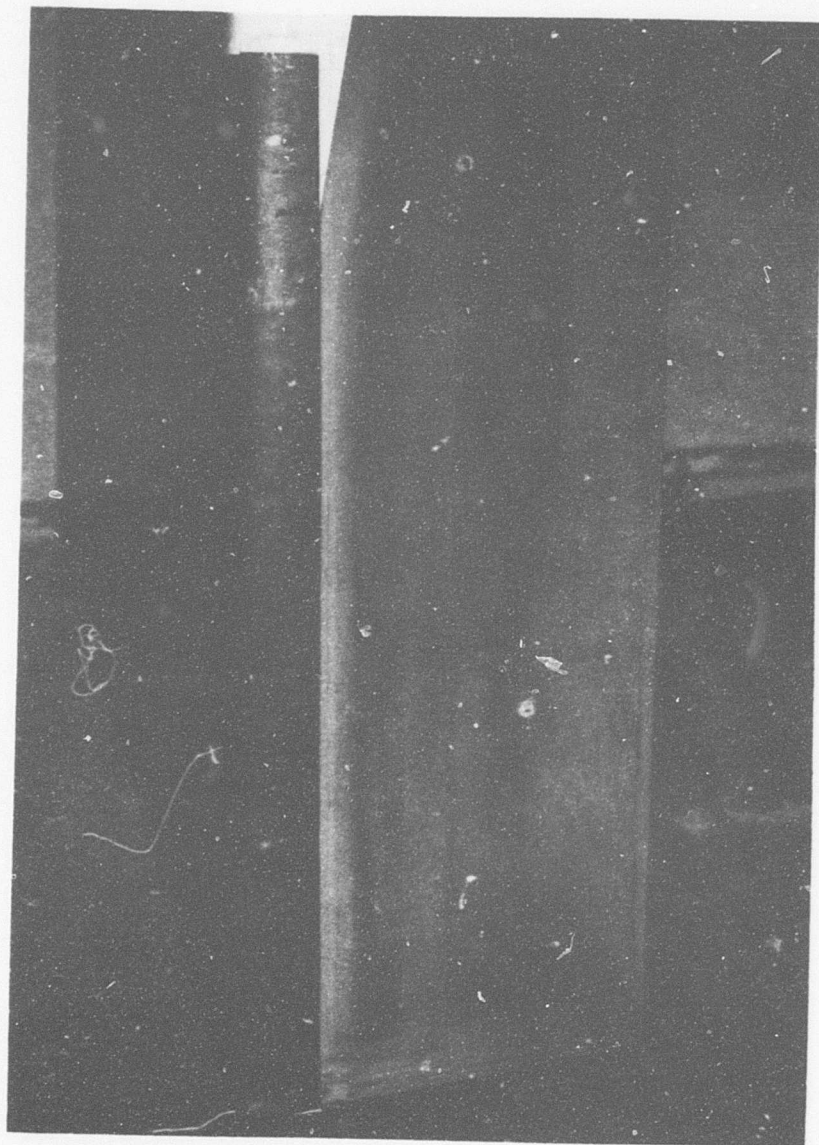
Figure 45. Ballistic Damage to A-Blade From 7.62mm Ball - Entry Side of Bullet. (Two outboard hits inflicted just prior to Run 9. Inboard hit made prior to Run 6. Shot through erosion guard and .050-inch aluminum leading edge caused localized boot unbonding. Shots through fiberglass skin to core created no damage other than hole.)

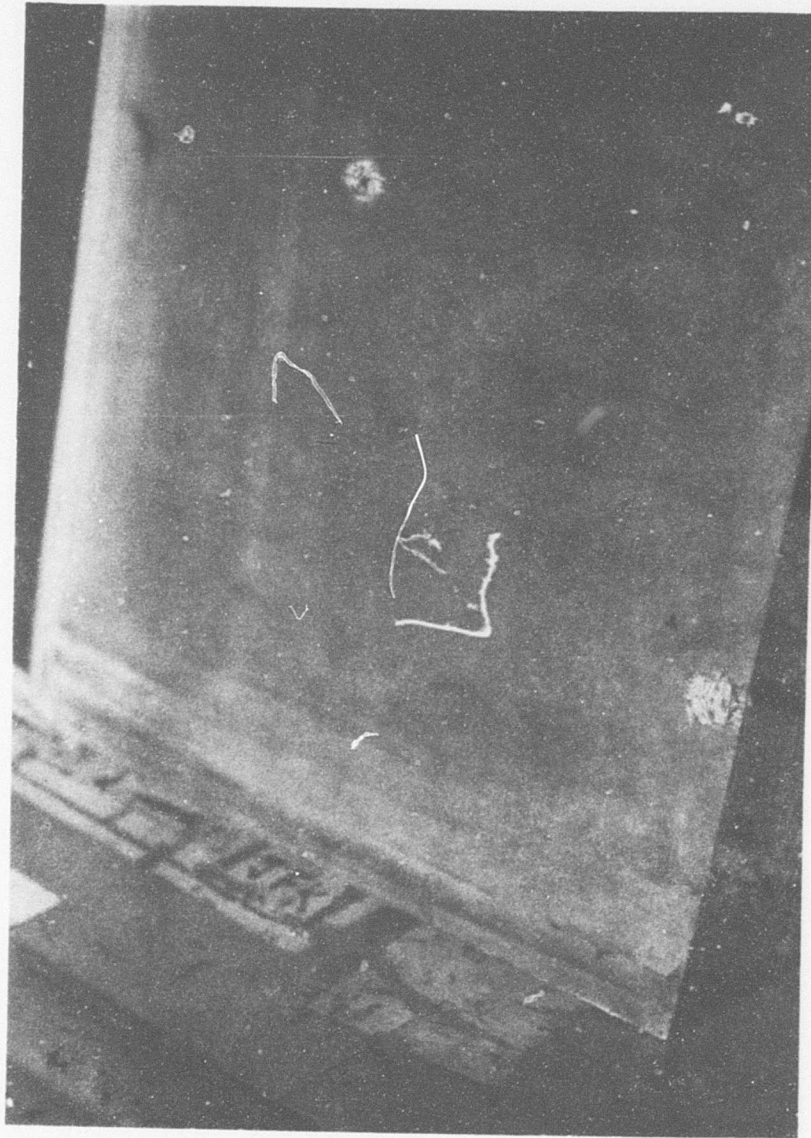
Figure 48. Ballistic Damage to B-Blade From 7.62mm Ball - Exit Side of Bullet. (Extent of damage other than hole was a 7/8-inch-diameter skin delamination around hole through spline as evident. Delamination opened to trailing edge for 5/8-inch length.)

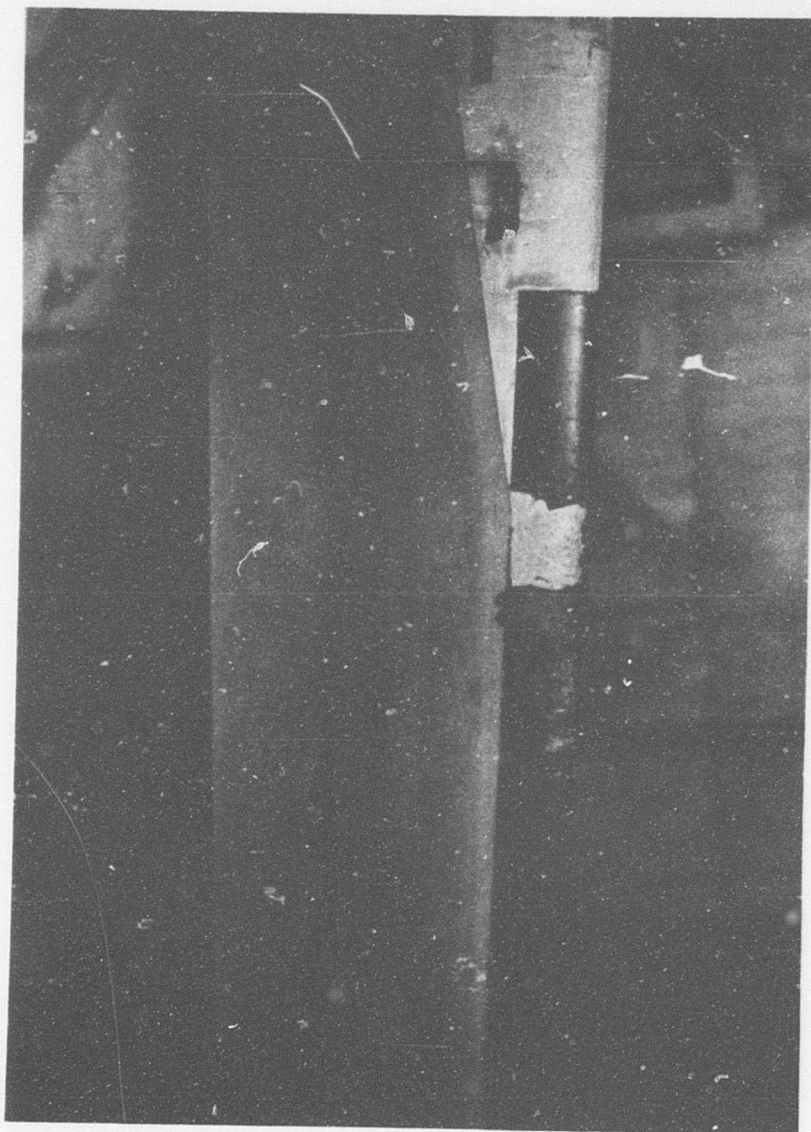
Figure 49. Condition of A-Blade From Crushed Stone Impingement After Termination of Run 11.

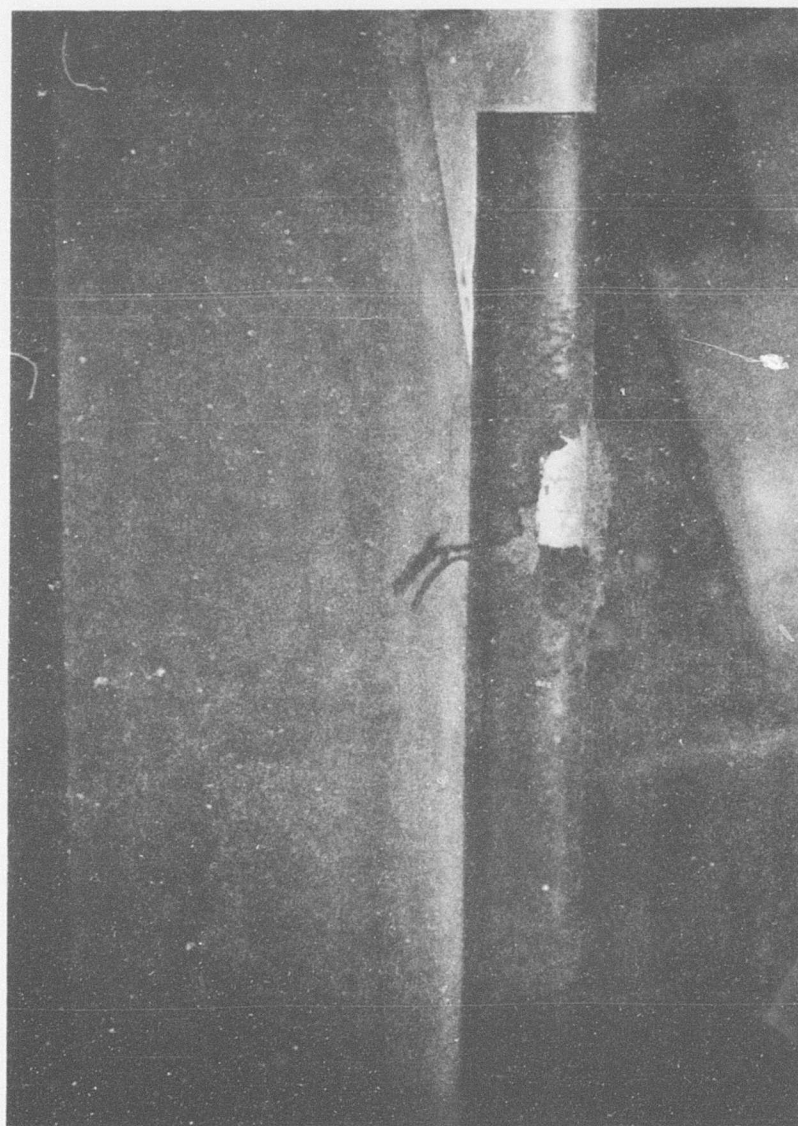
Figure 50. Condition of B-Blade From Crushed Stone Impingement After Termination of Run 11.

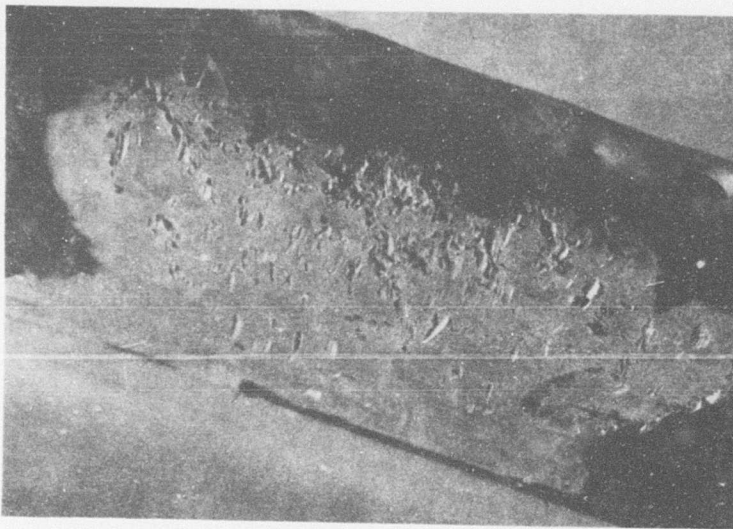
Figure 51. Damage to Aluminum Leading Edge of A-Blade  
Caused by Run 11.

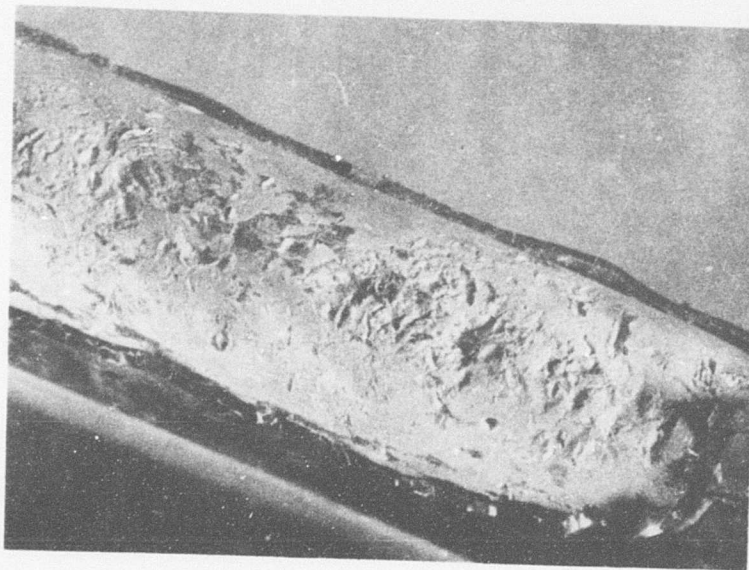
Figure 52. Damage to Aluminum Leading Edge of B-Blade  
After Run 11.

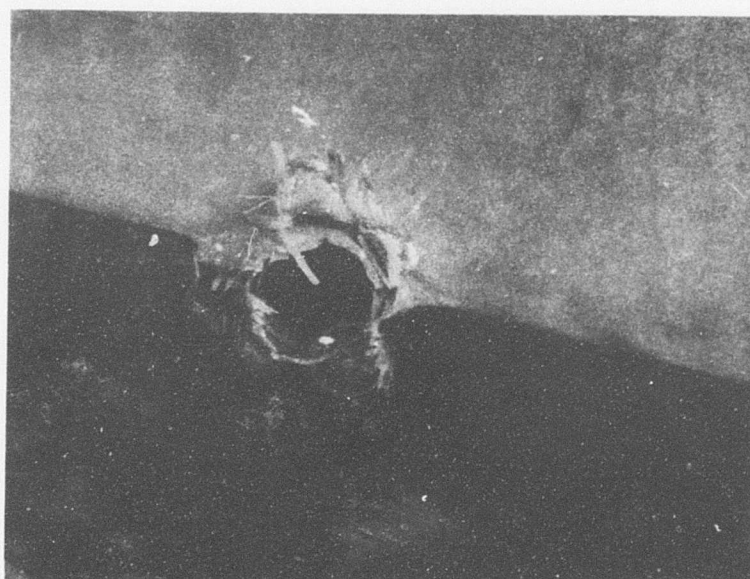
Figure 56. Ballistic Damage to B-Blade at Station 37.5 From 7.62mm AP Hit Through Forward Channel Section. (Bullet entered top surface as shown in upper view, penetrated through spar, and exited from bottom side as shown in lower view.)

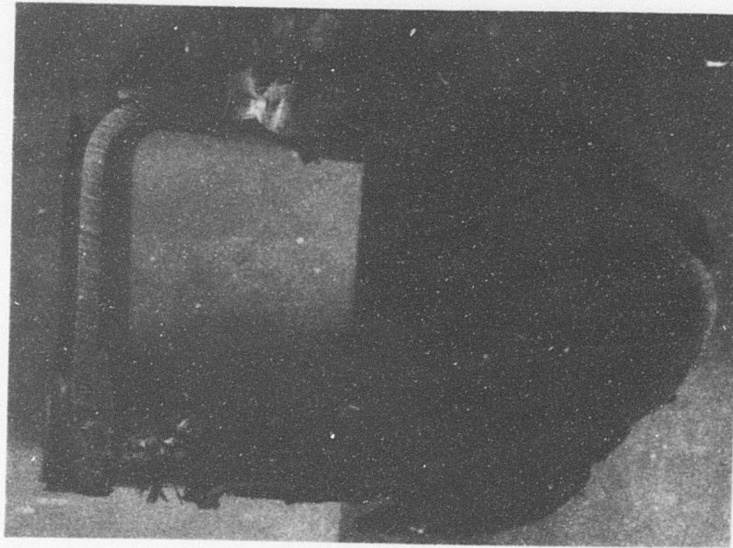
Figure 57. Sectioned View Through B-Blade at Station 37.5, Showing Forward Channel. (Same hit as shown in Figure 56. Bond delamination between channel to leading edge confined to immediate vicinity of hit. Delamination attributed to metal deformation rather than shock.)

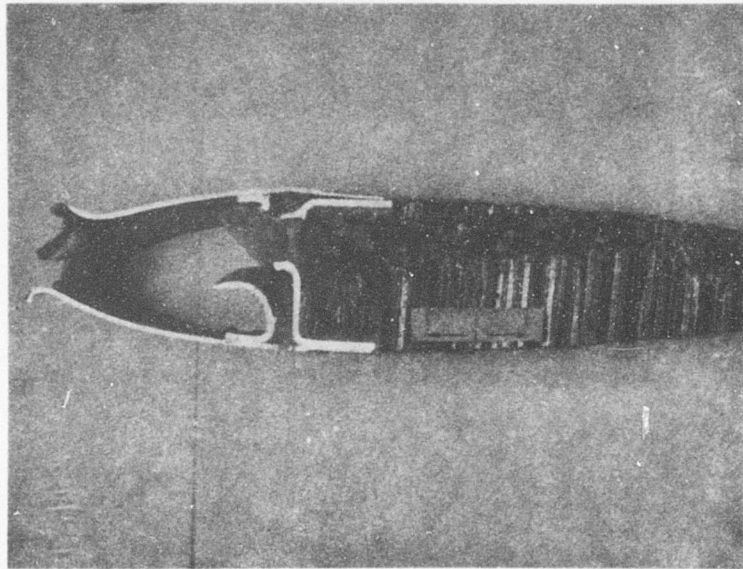
Figure 59. Sectioned View of Ballistic Damage to B-Blade at Station 27. (Same hit as shown in Figure 58. Station 27 is just inboard of the termination point for the GRP spar in the tapered section region. Delamination of bond is again localized to the damaged area and attributed to deformation rather than shock.)

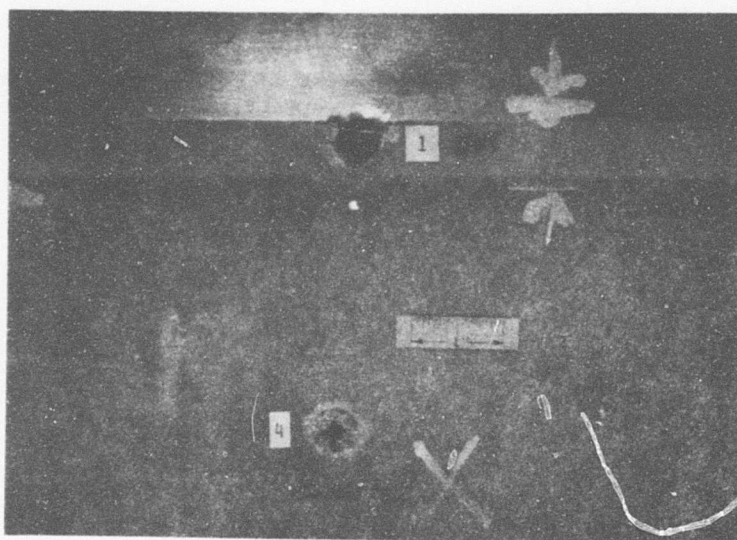
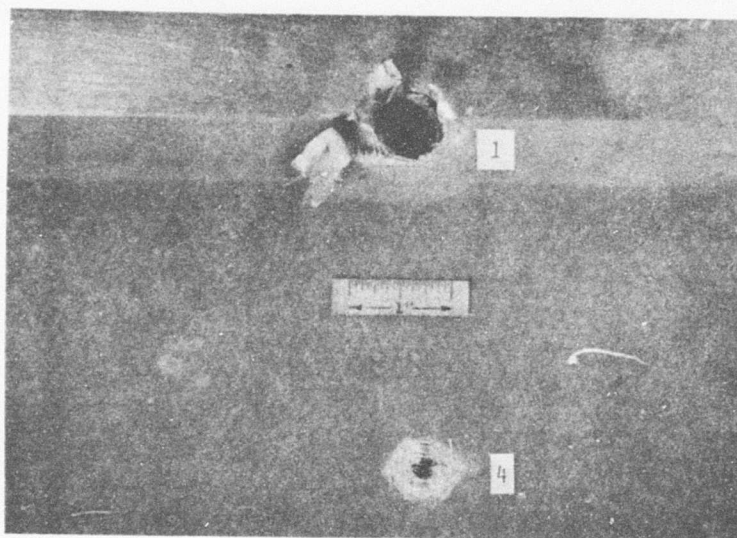
Figure 60. Ballistic Damage to Blade Section From 12.7mm AP Hits. Entry Side, Top View. Exit Side, Lower View. (Shot No. 1 is through forward channel - leading-edge section equivalent to Figure 56. Bond delamination confined to immediate vicinity of the hit and attributed to localized deformation rather than shock. Shot No. 4 through skin-core structure produced no significant damage.)
