| EVALUATION OF PNEUMATIC CHECK VALVES | | |
| LMSD-4064 | 3 MARCH 1958 | W3 117L |

LOCKHEED AIRCRAFT CORPORATION, MISSILE SYSTEMS DIVISION

## EVALUATION OF PNEUMATIC CHECK VALVES

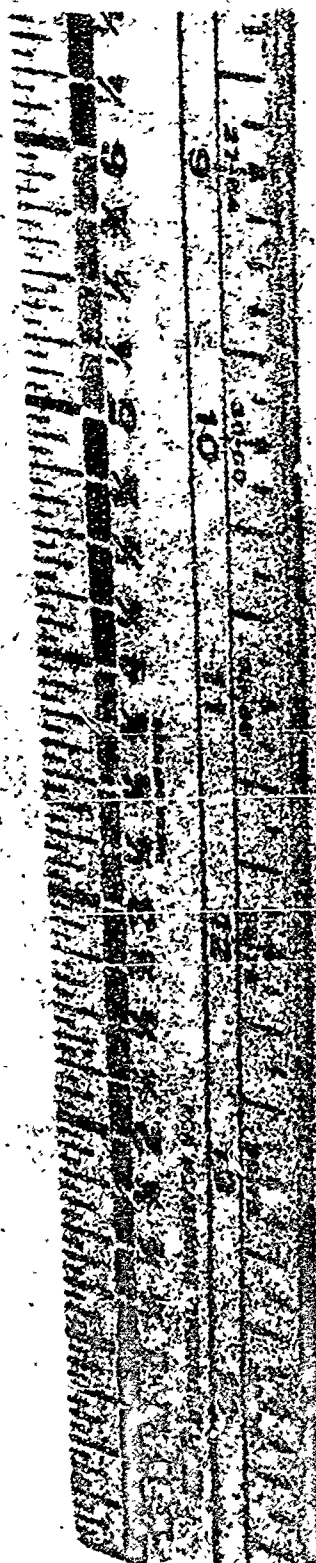
After disassembly, the interior of the valves showed no deleterious matter with one exception, the James-Pond-Clark 3/8-inch diameter (S/N 3) had Mercury globules on the threads and on the various internal surfaces (see Figure 11). This may account for the odd results obtained in the low temperature tests.

FIGURE 11. CHECK VALVE EXPLODED VIEW, CIRCLE SEAL .36 INCH DIA. (30/71) SHOWING MERCURY ON THREADS

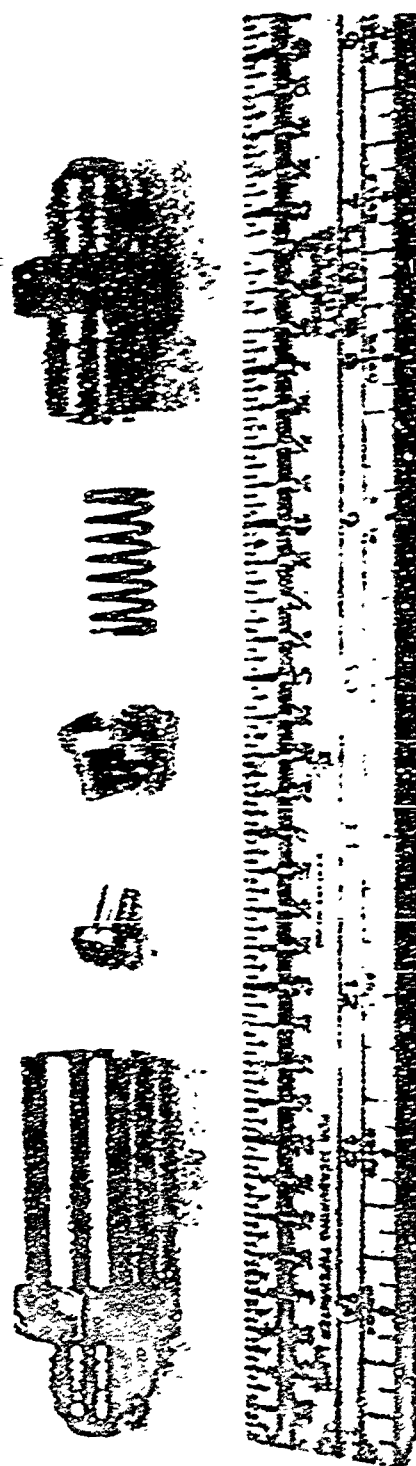
Contamination consisted of oil, water and dirt.  
 The Sealol valves exhibited poor workmanship, i.e., tool marks, rough threads, burrs, etc.

FIGURE 1A CHECK VALVE EXPLODED VIEW, SEAL O.D. 1/2 INCH DIA.
