NATF(SI) REPORT OF TEST RESULTS
NATF(SI) 13800/16 (3/67)

REPORT NO: NATF(SI)-R1
DATE: 24 April 1967

PROJECT TITLE
British-type wire supports; evaluation of

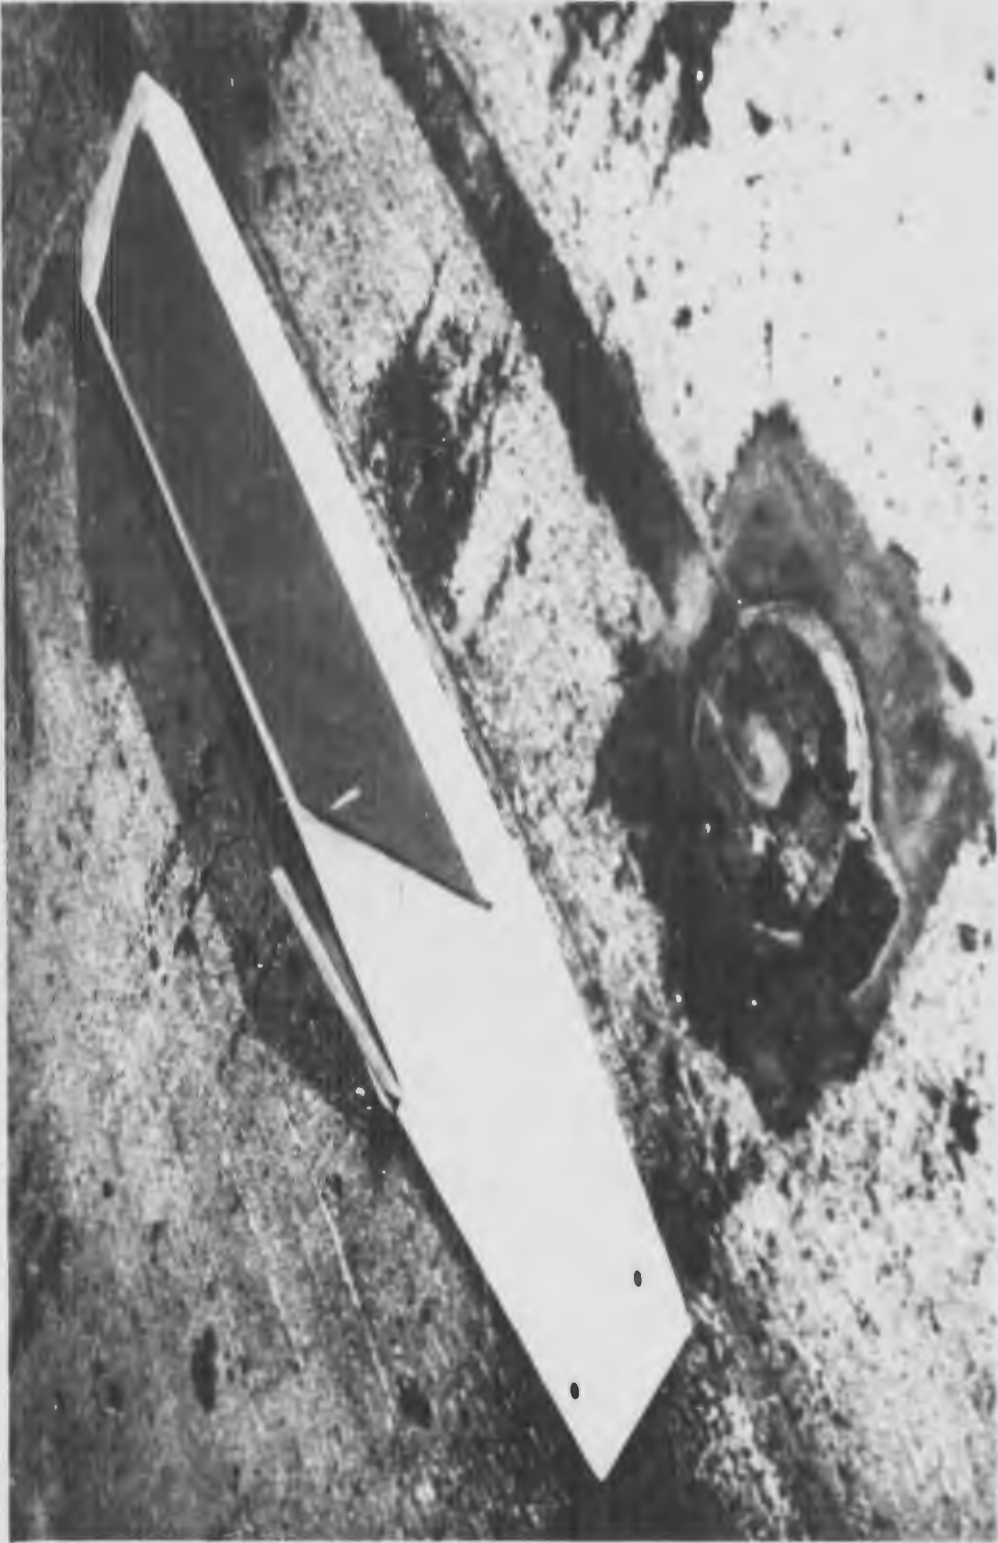
2. Three pairs of the wire supports, manufactured in accordance with British Drawing NA/D77948, were provided by NAEL(SI). Each assembly is comprised of a flat rectangular steel base and two inclined, trapezoidal shaped, polyurethane blades. The blades are mounted on the sides of the steel base as shown in enclosure (1). The steel base is not symmetrical, in that one end is steeply inclined and the other end is blunt. A separate wood ramp assembly is butted against

INCLOSURE (1) - BRITISH-177 WIRE SUPPORT TEST D IN CONJUNCTION WITH
MARK 3 MOD 3 ARRESTING-GEAR PROGRAMS

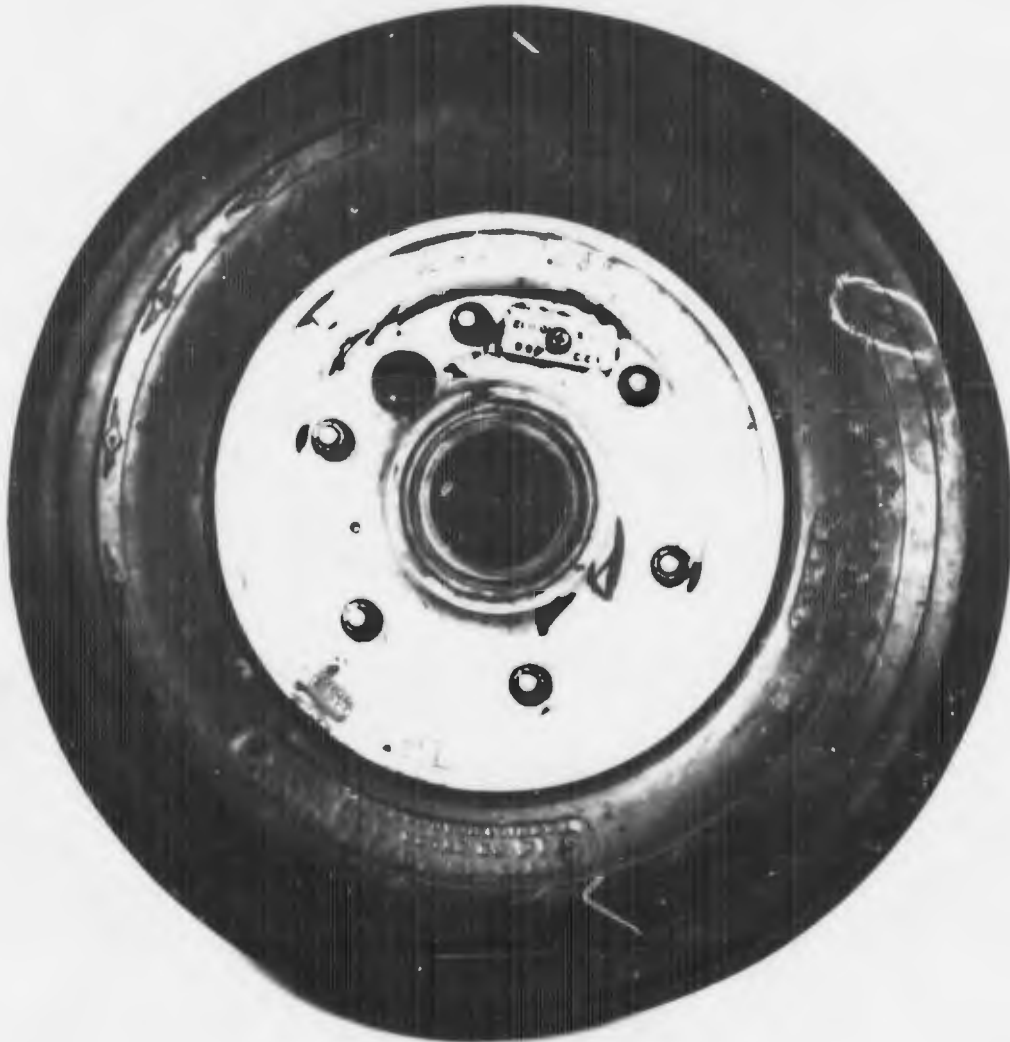
ENLARGED
VIEW OF
CUT

a. During the initial series of arrestments and taxi-overs, the supports were monitored for any immediately evident adverse wear characteristics. No adverse wear characteristics occurred as a result of the arrestments; however, A-3 and A-4 aircraft tire damage occurred after only a few roll-overs. The damage to the A-3 tires was restricted to gouging of the tread area, while one A-4 tire sidewall was severely cut, enclosure (2).

ENCLOSURE (2) - VIEWS OF A-4 AIRCRAFT TIRE CUT WHILE TAXIING OVER
BRITISH-TYPE WIRE SUPPORT

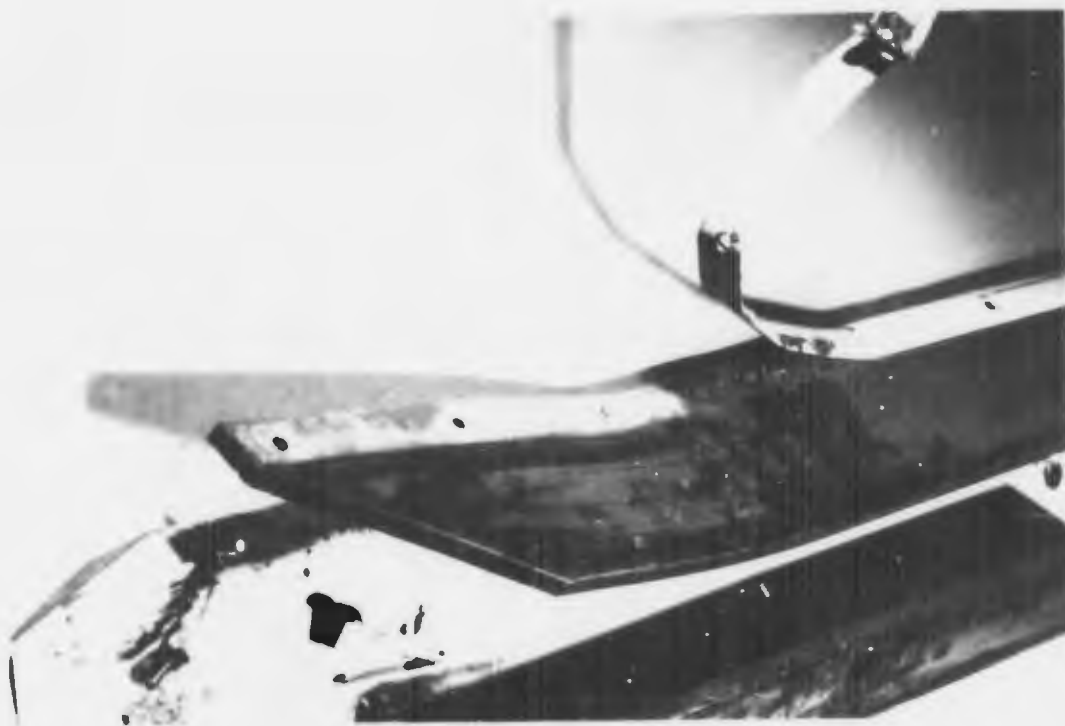
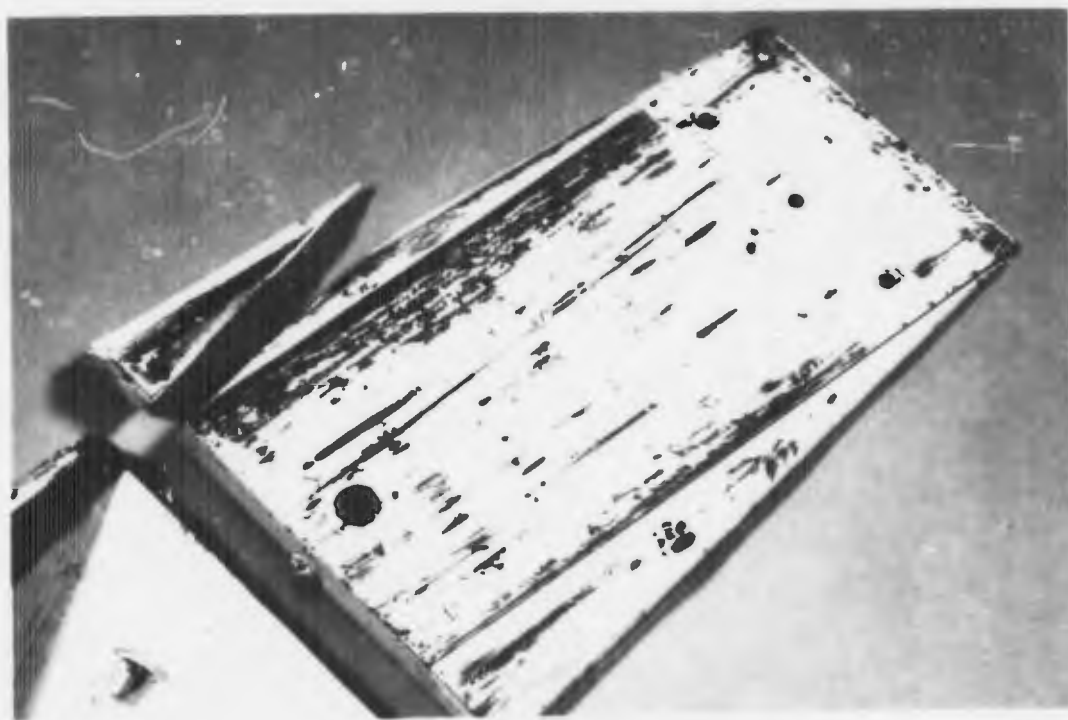
b. Several attempts were made to impact the pendant supports with the aircraft hook point. During the first of these attempts with an A-3 aircraft, the arresting hook impacted the steel base and tore the pendant support from the deck. (Damage to the pendant support is shown in enclosure (3).) The damaged pendant support was reconditioned and both supports were reinstalled (180° from the original installation) with the long tapered wooden ramp on the approach side. During a later attempt with the A-3 aircraft, a large section of one of the polyurethane side plates was torn off as shown in enclosure (4). The wire support, however, was still usable despite the missing section.

ENCLOSURE (3) - VIEWS OF BRITISH-TYPE WIRE SUPPORT DAMAGED BY
ARRESTING-HOOK IMPACT

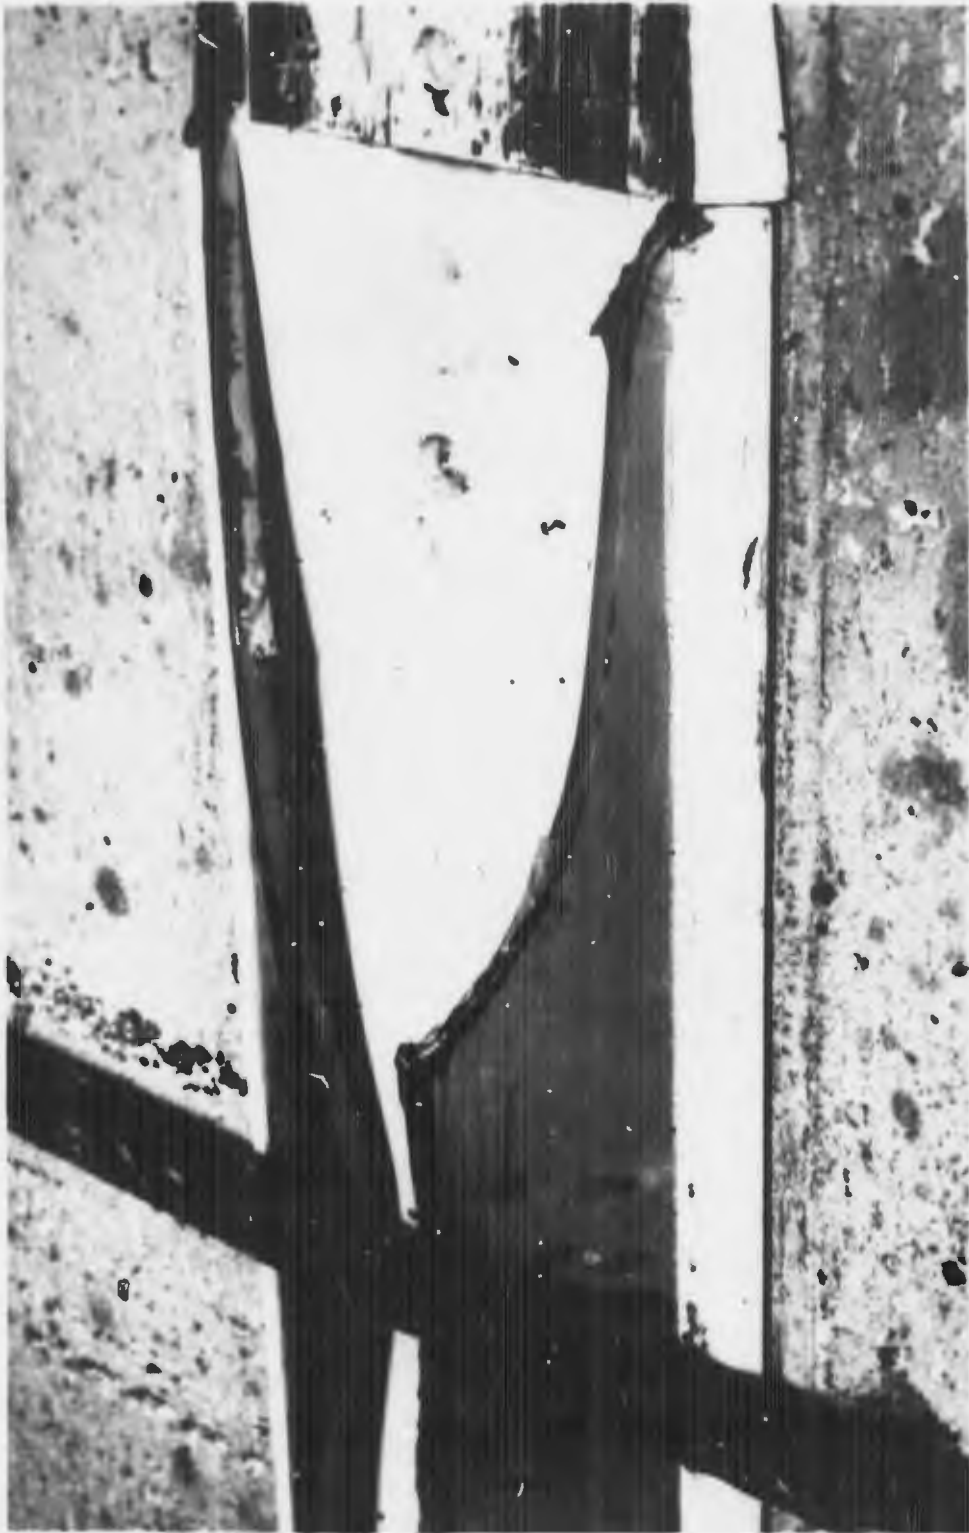
ENCLOSURE (4) - BRITISH-TYPE WIRE SUPPORT DAMAGED DURING "HOOK-DOWN"
ARRESTMENT OF A-3 AIRCRAFT
