EFFECT OF ENBRITTLED 110-18 WELD METAL  
on the  
FATIGUE LIFE OF HY-80 STEEL BUTT WELDMENTS  
Lab. Project 9300-1, Technical Memorandum 2  
SR 007-01-01, Task 0856

17 October 1963

MATERIAL SCIENCE DIVISION

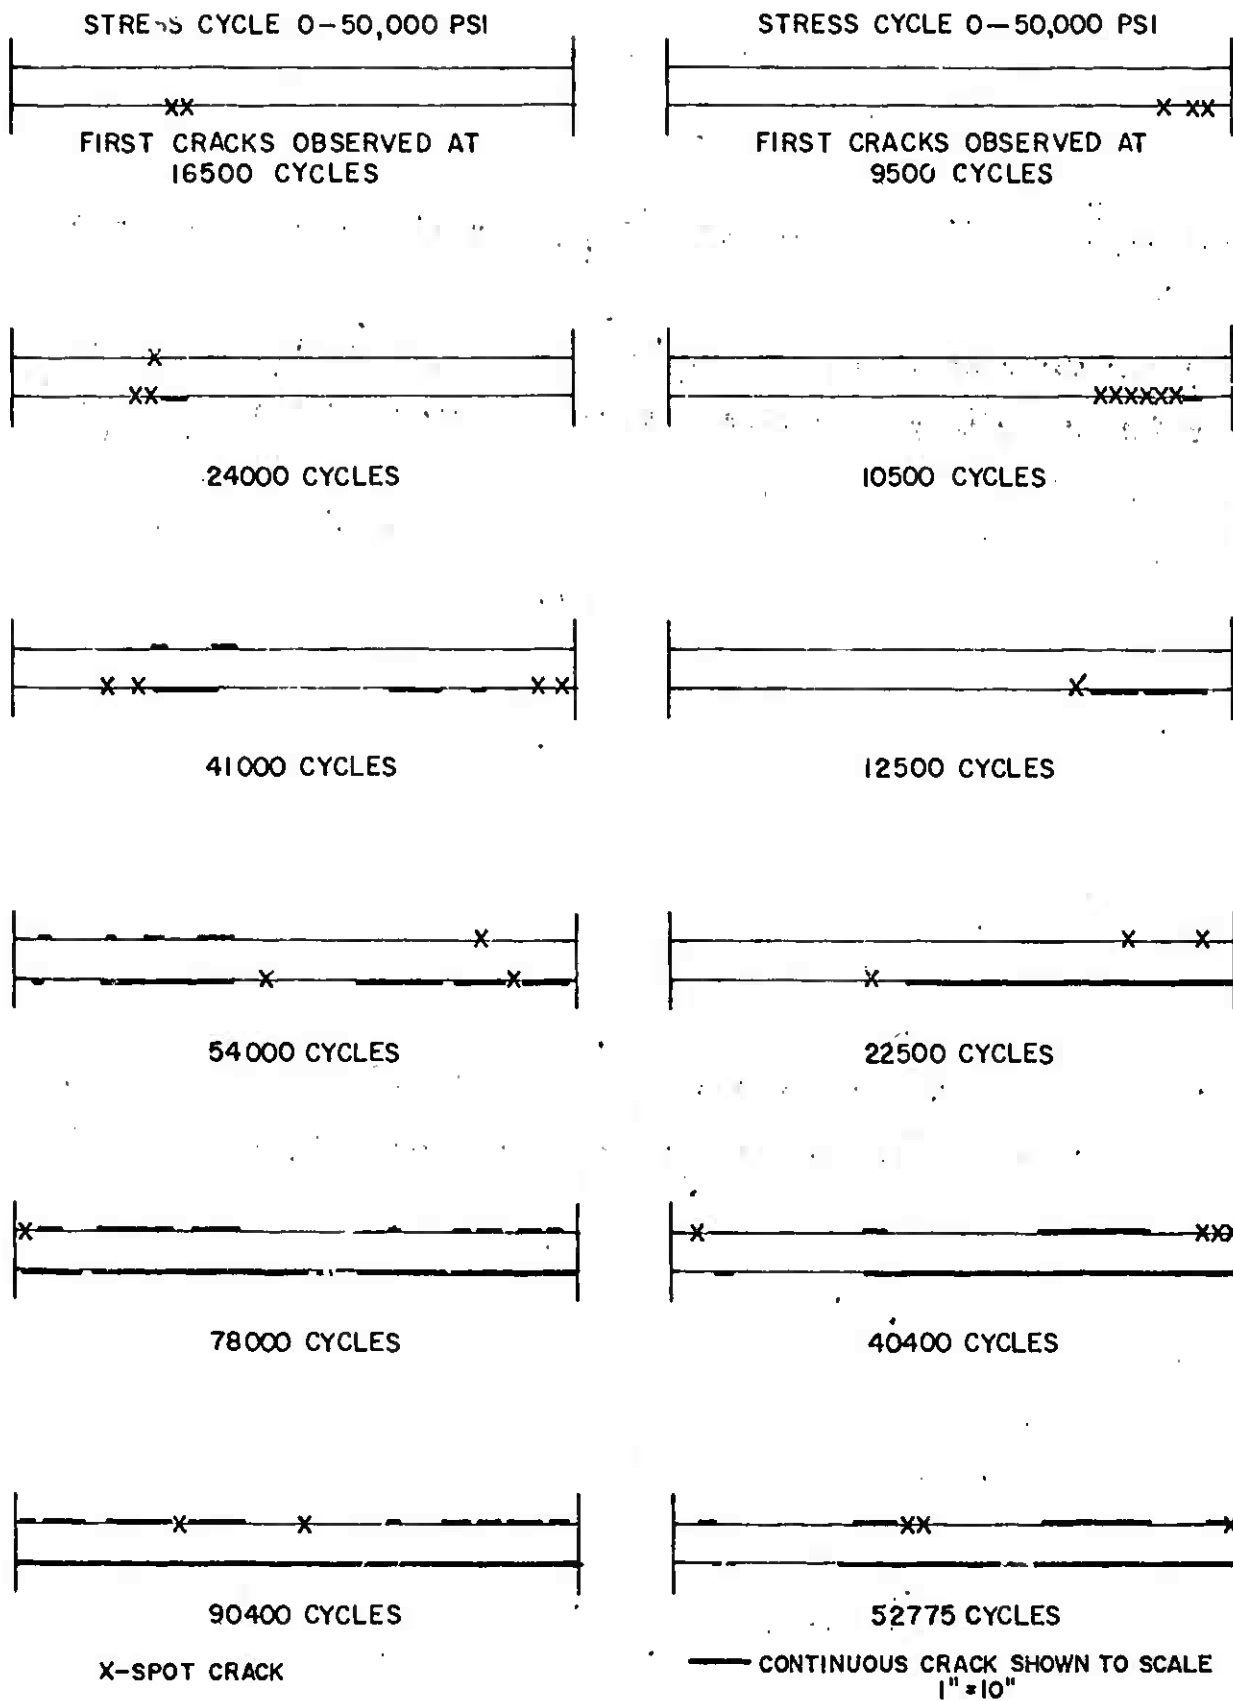
Fig. 2 -CRACK PROGRESS IN BUTT WELDED PLATE TYPE  
SPECIMENS L5PBC-2 AND L5PBC-3

8. Figure 2 shows the initiation and progression of surface crack lengths which formed in the course of fatigue testing.

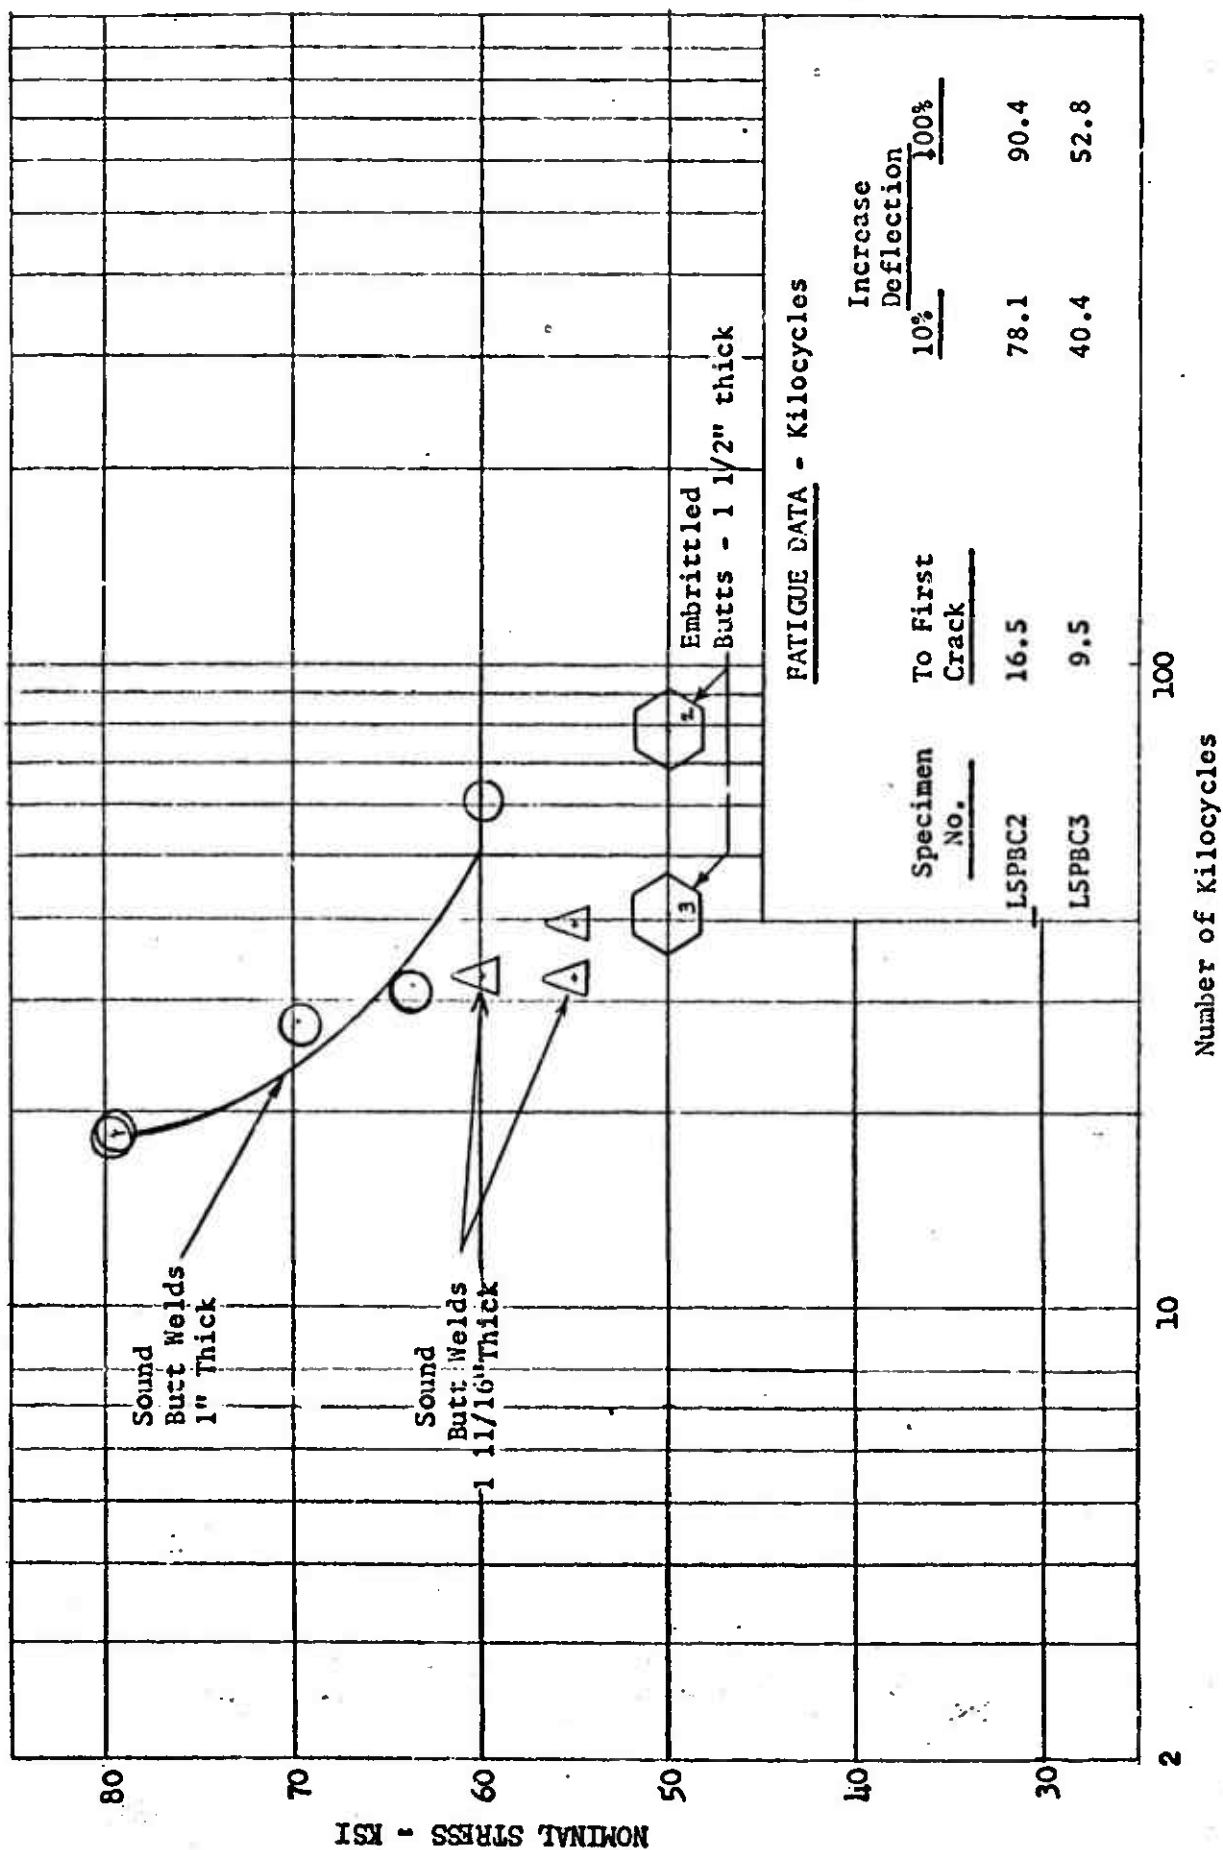
Fig. 3 - Fatigue Life of HY-80 Butt Weldments to 10% Increase in Deflection

A comparison of results on the embrittled weldments and sound weldments is shown graphically in Figure 3. As indicated therein, the fatigue lives of the two embrittled assemblies approximated those which would be expected for sound weldments on the basis of results reported in reference (b).
