CRASH INJURY REPORT

U. S. ARMY U-1A
De HAVILLAND OTTER ACCIDENT
Fort Carson, Colorado
16 June 1959

Aviation Crash Injury Research
of the **F**light **S**afety **F**oundation

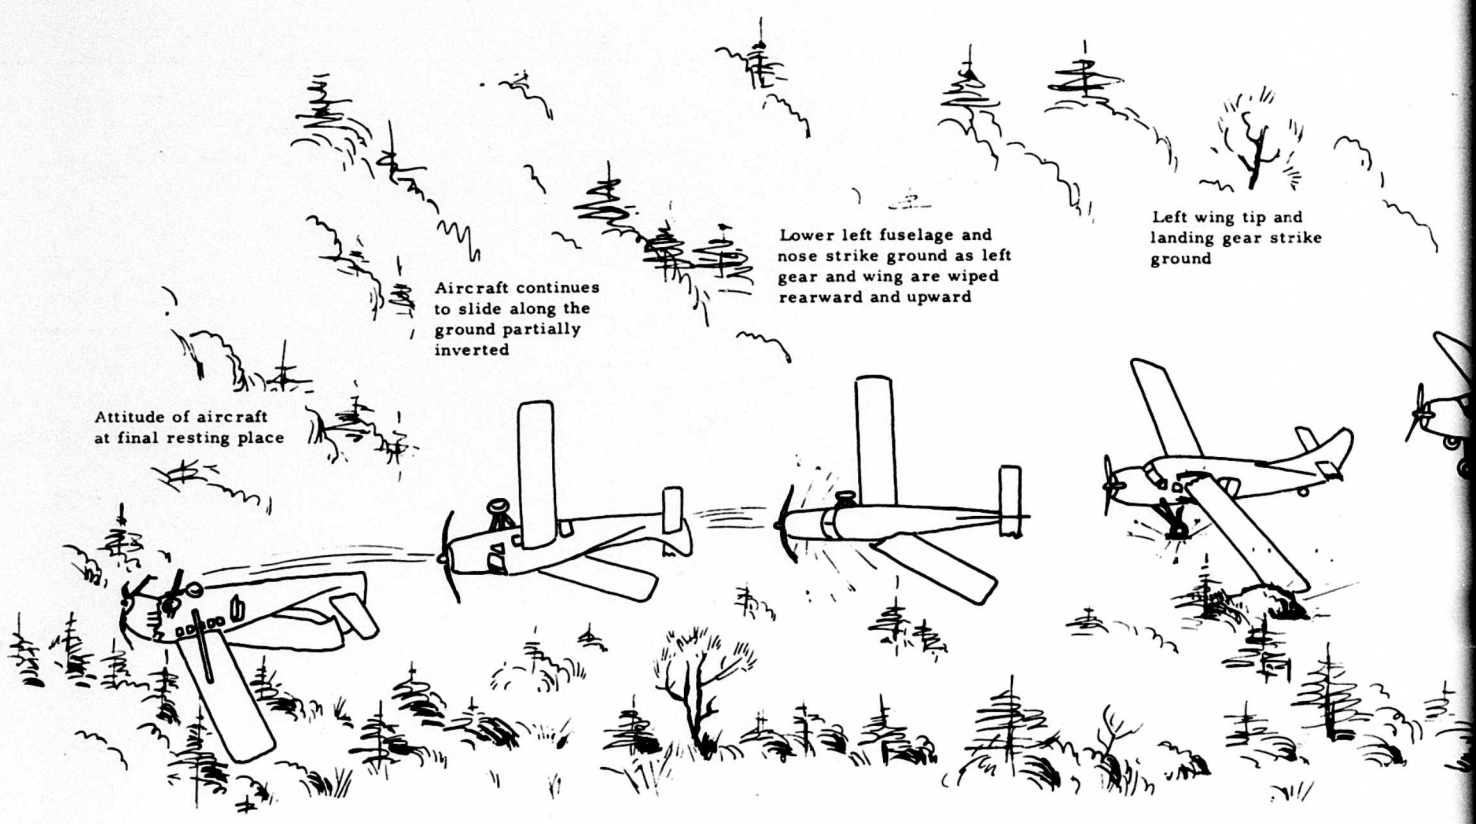
KINEMATICS DIAGRAM - U. S. Army U-1A De Havilland Otter Accident

As the aircraft descended into the canyon, the left horizontal stabilizer struck the trunk of a dead tree, shearing off part of the stabilizer and elevator. (See Kinematics Diagram, p. 9, and Fig. 12, p. 21.) At the time of this impact the aircraft was flying at minimum flying speed in a nose-high attitude with the left wing slightly down. The impact caused the aircraft to yaw approximately 10 degrees to the left and to begin rolling to the left while continuing to move forward and downward.

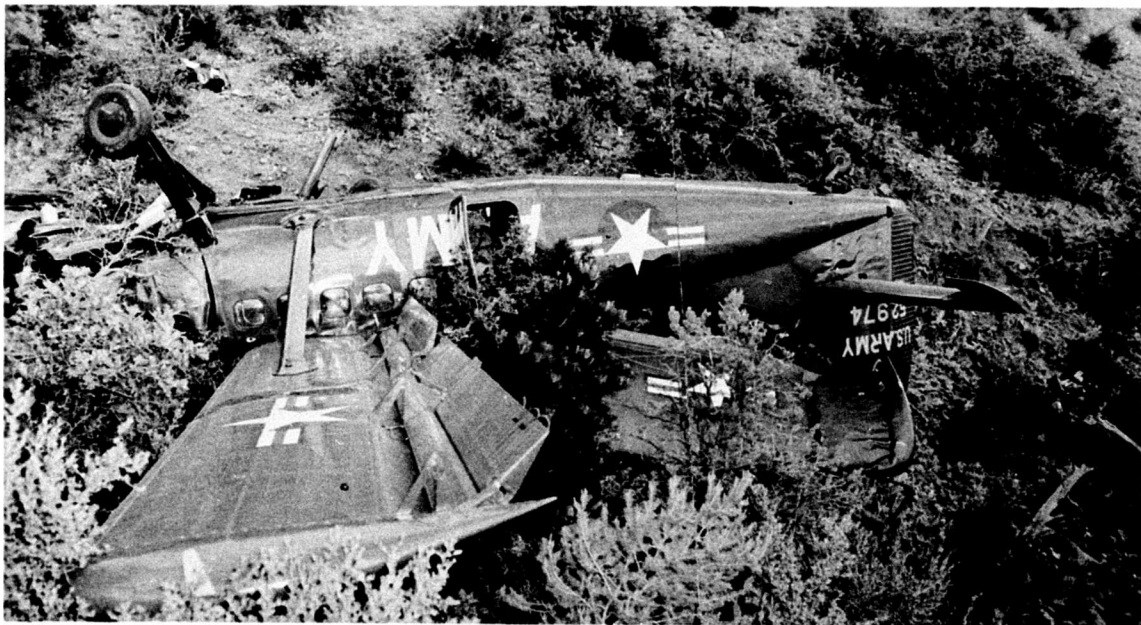
Fig. 2. Final position of wreckage after the crash (composite photo).

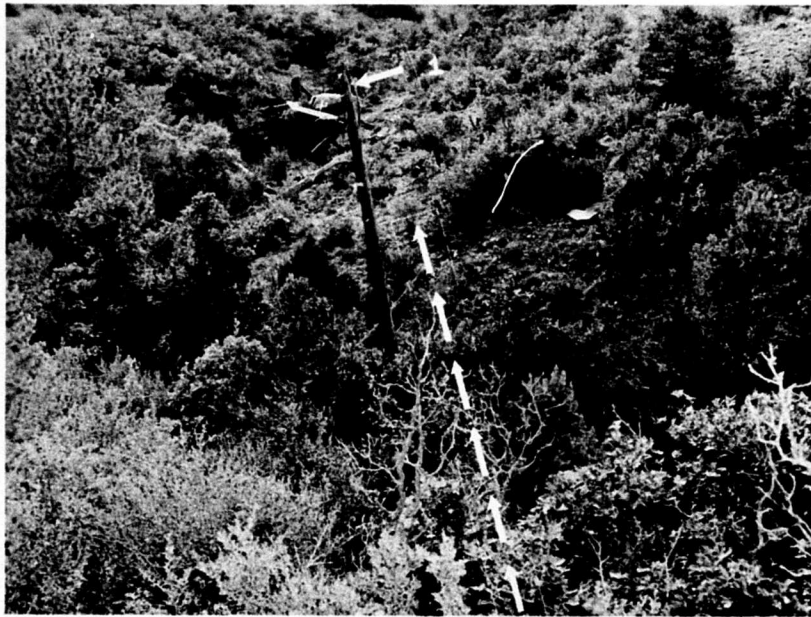
Fig. 3. View looking forward along flight path (indicated by line of arrows) showing final resting place of the aircraft. The dead tree (arrow 1) was struck by the leading edge and underside of the left horizontal stabilizer at a point approximately 6 feet above the present top of the tree trunk.

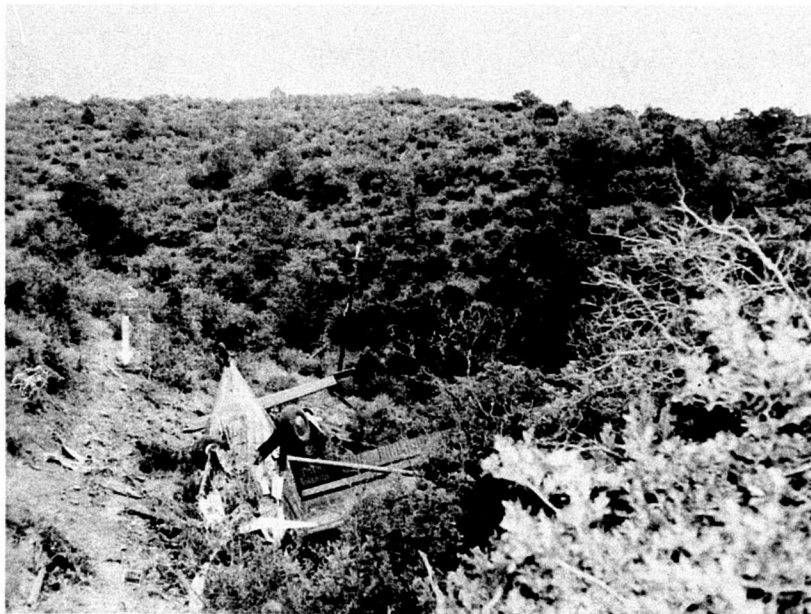
Fig. 4. View looking rearward along the crash path, showing the point of initial impact (arrow) of the aircraft in relationship to its final resting place. Shortly after coming to rest in a partially inverted attitude, the aircraft (after being evacuated) was rolled to a completely inverted attitude by strong winds.

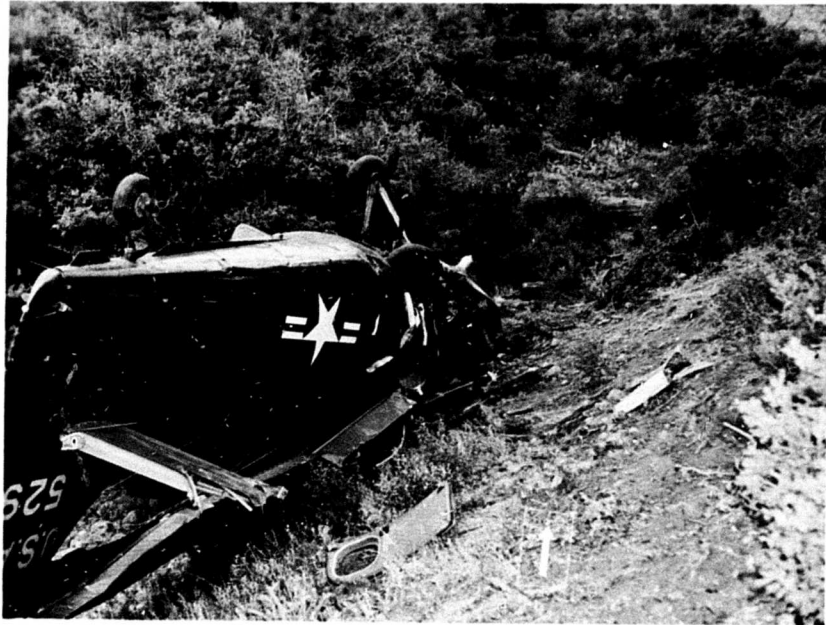
Fig. 5. View showing gouging (arrow) caused by the aircraft's decelerating along the ground following the principal impact. Note the relative intactness of the rear cabin and fuselage structure.

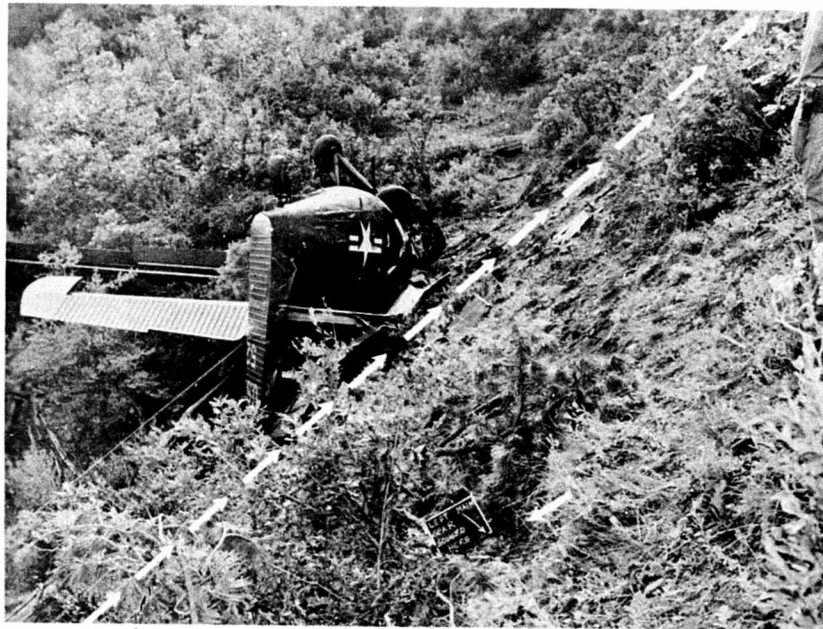
Fig. 6. The side slope of the terrain at the point of principal impact with the ground was approximately 40 degrees. Analysis indicates that the left wing of the aircraft was down about 60 degrees when the wing tip first struck the ground; this resulted in a 20-degree wing-down angle with relation to the terrain at the instant of impact. Note the gouge (arrow) caused by the left landing gear.

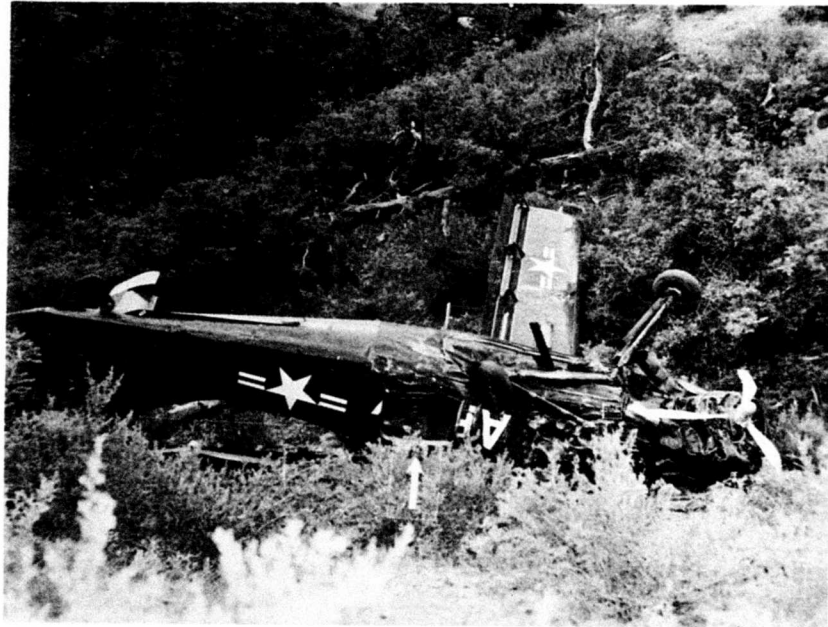
Fig. 7. View showing overall damage to the underside of the fuselage, landing gear, and nose structure. The main cabin door was torn free during the crash, and the open doorway (arrow) was subsequently utilized for evacuation by the cabin passengers.

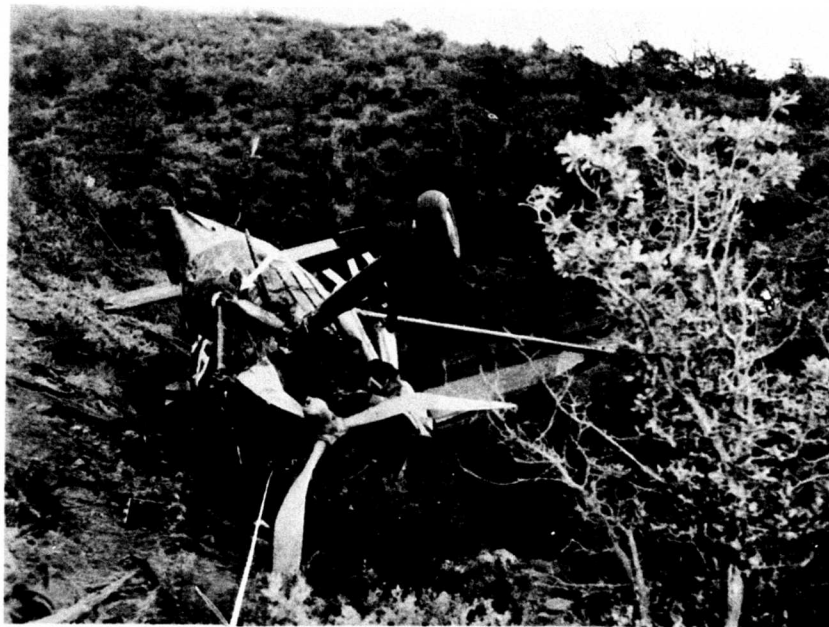
Fig. 8. View of the lower fuselage, showing the extent of rearward displacement of the left landing gear (arrow) and the damage sustained by the belly, engine, and nose areas. The collapse of structure in these areas absorbed an appreciable amount of crash energy and thus reduced the forces transmitted to the cockpit and cabin and to their occupants.

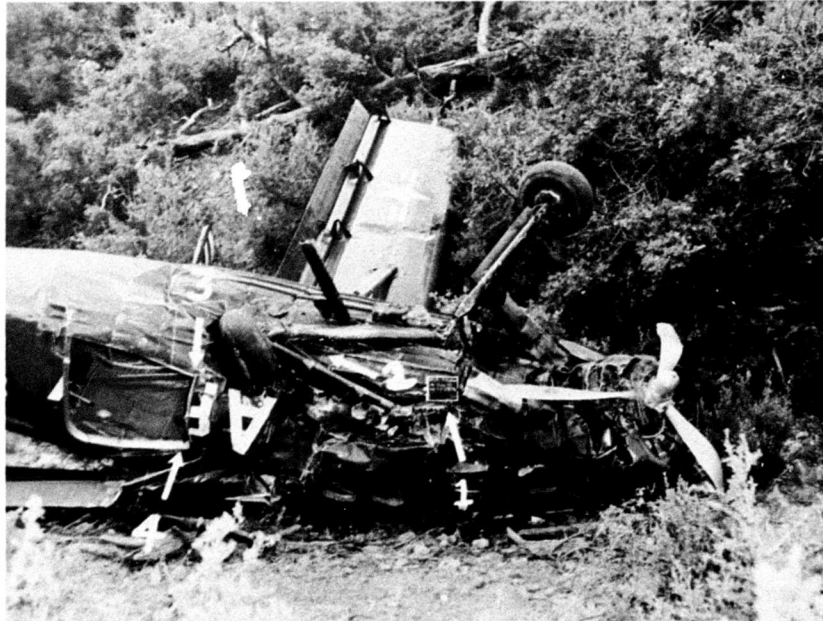
Fig. 9. The lower left fuselage section, slightly aft and below the cockpit (arrow 1), struck the ground immediately after the left landing gear collapsed. As the left gear was swept rearward and upward, fuel cells located in the belly of the aircraft were ruptured (arrow 2), and the lower main cabin door frame was distorted (arrow 3).

Simultaneously, the left wing, pivoting at its root, was forced rearward and upward as the aircraft continued to roll over on its left side. This resulted in an inward displacement of the left cabin wall and ceiling and in severe distortion of the upper main cabin door frame (arrow 4).

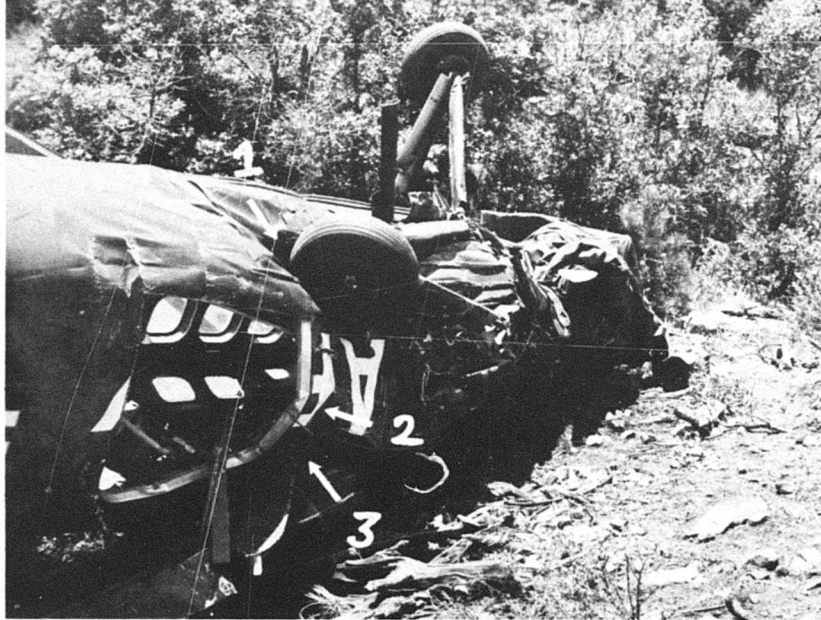
Fig. 10. View of damage to fuel cell area (arrow 1), main cabin door frame (arrow 2), and upper left cabin structure (arrow 3). Gasoline flowing downward into the cabin from the ruptured fuel cells drenched the occupants.

Although two occupants were seated adjacent to the structure that was severely damaged by the inward collapse of the wing root (arrow 3), both escaped serious injury. Upheaval of the cabin floor structure, caused by the left landing gear's collapsing upward into the fuselage area (arrow 1), occurred directly beneath the seat of one of these two occupants and resulted in partial failure of the seat anchorages.

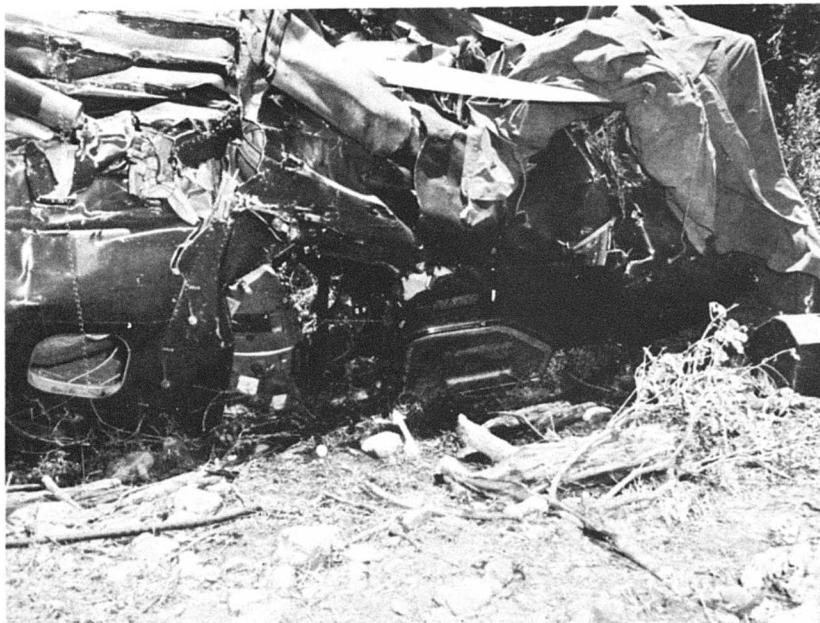
Fig. 11. The cockpit doorway (arrow), although "popped" open during the crash, was not available as an emergency exit because the aircraft was resting partially on its left side. The pilot and copilot escaped through the broken front windshield.

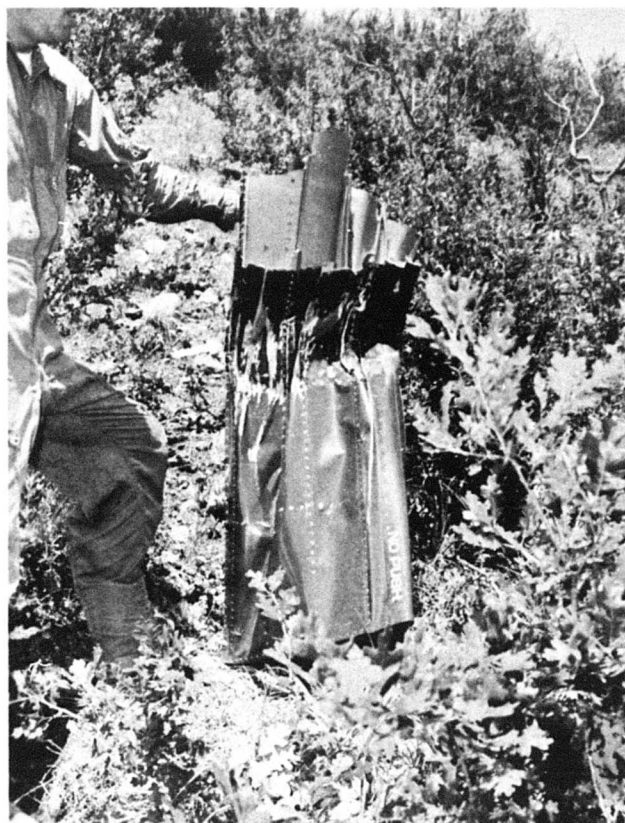
Fig. 12. Impact damage (arrow) to the leading edge and underside of the left horizontal stabilizer was caused by initial impact with a dead tree. This outer portion of the stabilizer along with the entire left elevator subsequently tore free prior to principal impact of the aircraft with the ground.

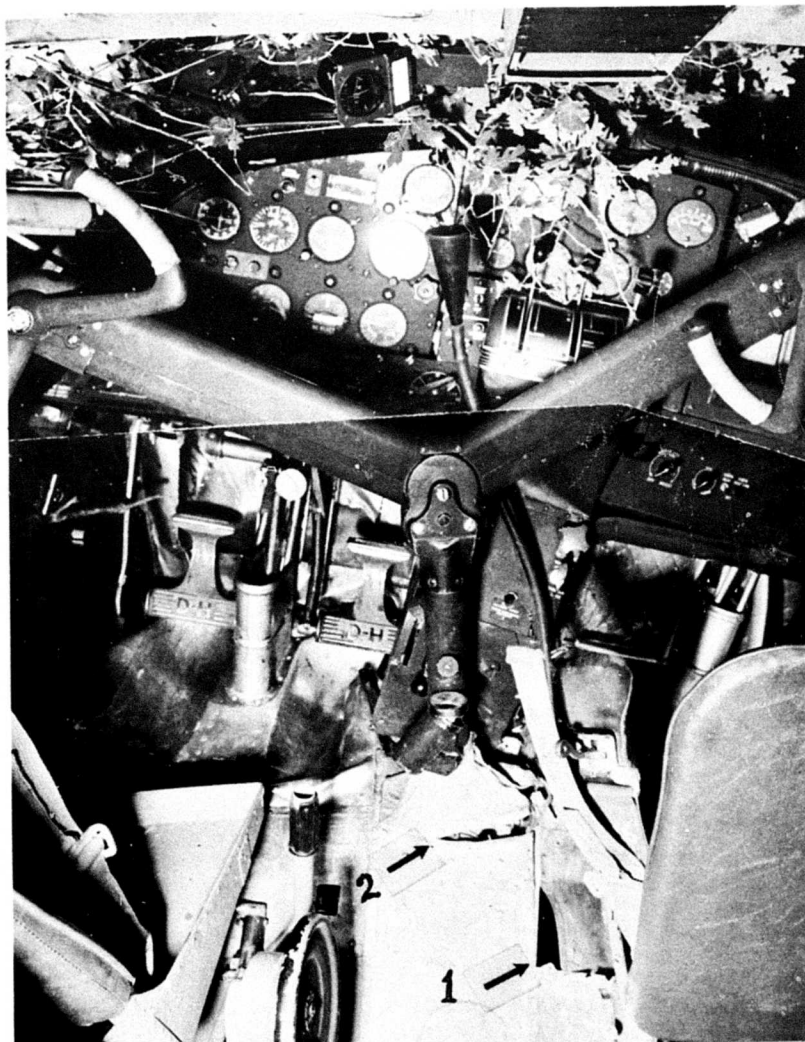
Fig. 17. Interior view (composite photo) of "intact" cockpit area. The upheaval and collapse of the floor structure (arrow 1) and the tearing free of the control column (arrow 2) probably occurred at the principal impact.

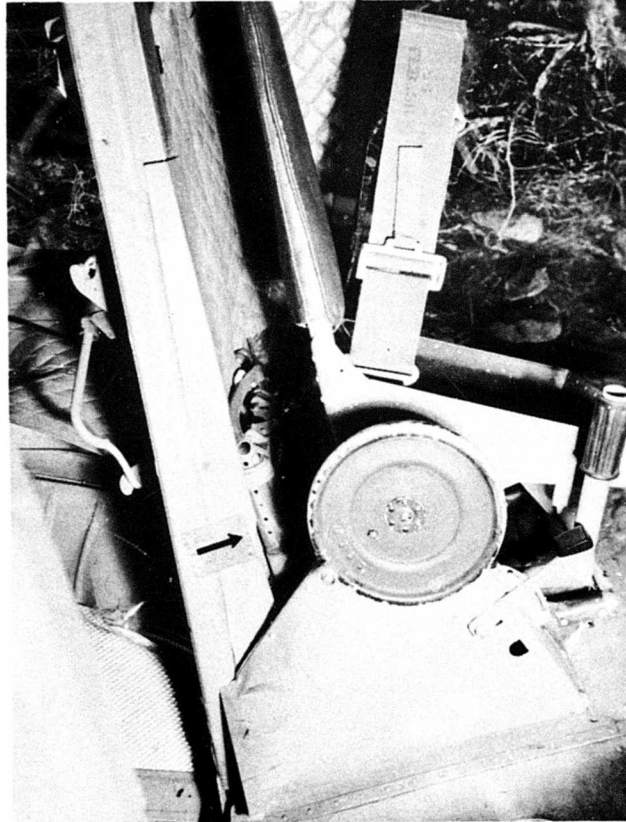
Pilot - The pilot, occupying the left front seat (Figs. 18, 30-35) received minor injuries which were sustained as he evacuated the aircraft through the broken windshield. At principal impact he was thrown forward, downward and to the left as the aircraft struck the ground. His shoulder harness, which was attached to the bulkhead separating the cockpit and cabin, functioned properly and prevented his body and head from being thrown against the control wheel and/or instrument panel.

Fig. 18. The pilot's seat was broken forward, downward, and to the left, tearing almost completely free (arrow) from its attachments to the rear tubular supporting members. The pilot, restrained by a shoulder harness and a safety belt, both of which functioned properly, sustained only minor injuries.

Analysis of the seat failure indicates that the restraint provided by the shoulder harness (anchored to the bulkhead separating the cockpit and cabin areas) prevented the seat from tearing completely free at impact.

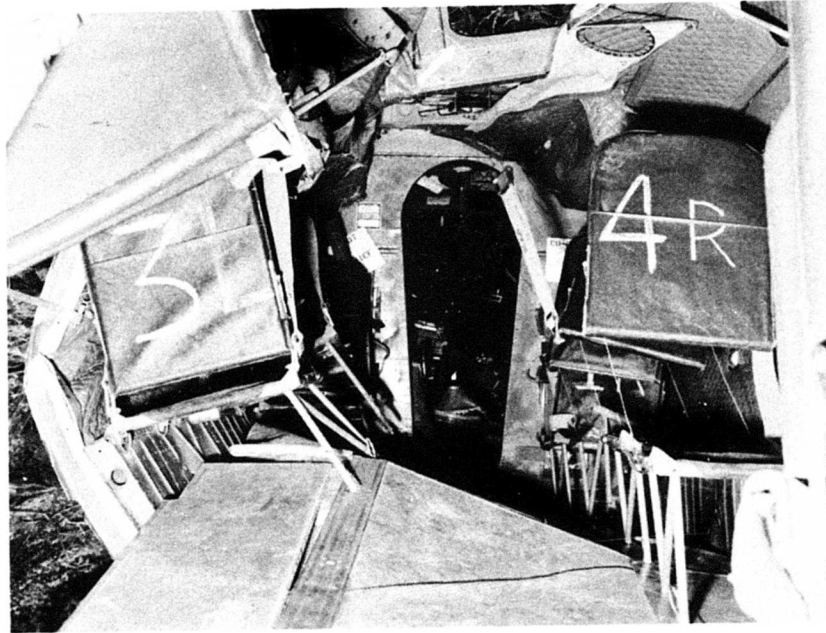
Fig. 19. View showing forward cabin area. Upheaval of the cabin floor structure was caused by the left landing gear's collapsing upward and rearward into the bottom fuselage area during the principal impact. The overhead emergency exit (arrow) popped out during the crash and was found underneath the wreckage.

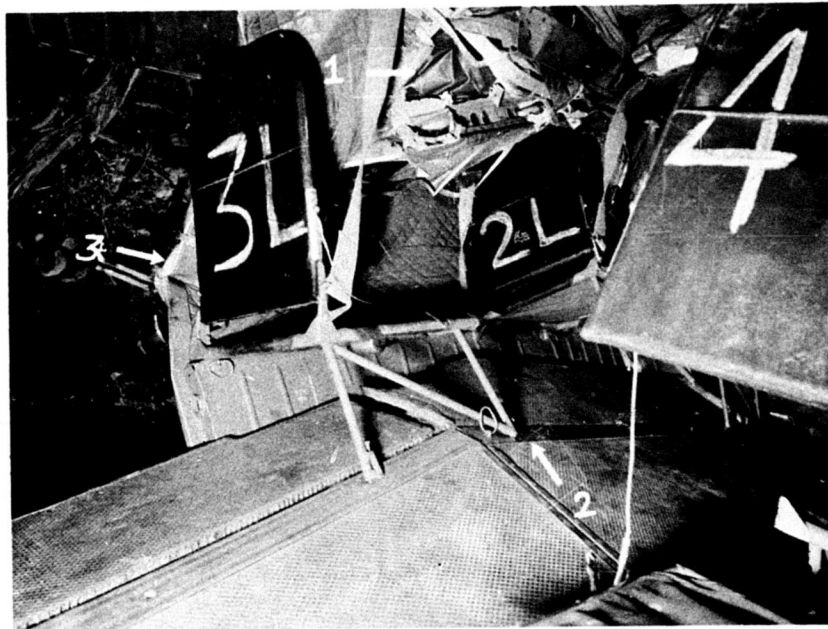
Fig. 20. Rearward hinging of the left wing root pushed the cabin wall and ceiling structure into the area (arrow 1) between seats 2L and 3L. The forward aisle attachment of seat 3L tore free from the floor (arrow 2) because of the upward displacement of the floor structure. Note the distortion of the main cabin door frame (arrow 3).

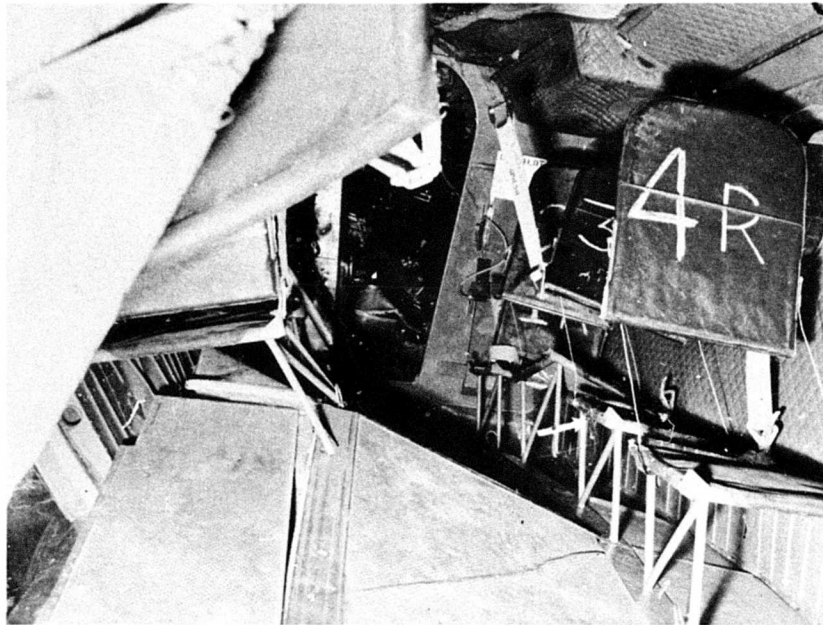
Fig. 21. View of the right side of the cabin (looking forward). The right-hand sidewall and ceiling structure sustained very little impact damage and remained completely intact. Seat 3R (arrow) was torn completely free during the crash. (It was replaced in its normal position prior to being photographed.)

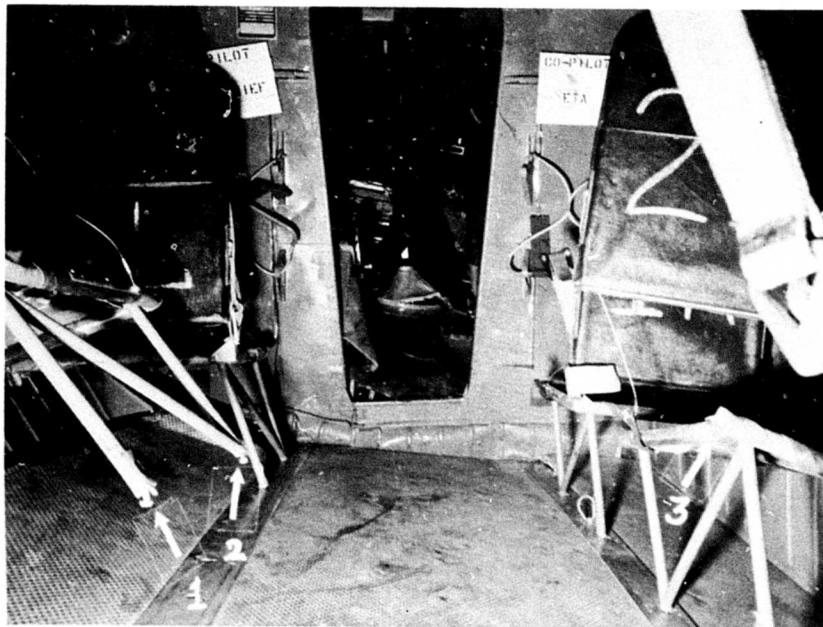
Fig. 22. View of forward cabin and cockpit areas. Failure of both aisle floor attachments on seat 2L (arrows 1 and 2) was apparently caused by the upward displacement of the cabin floor. The seatback on 2R was torn free from the seat pan (arrow 3); both rear anchorages of seat 2R failed.

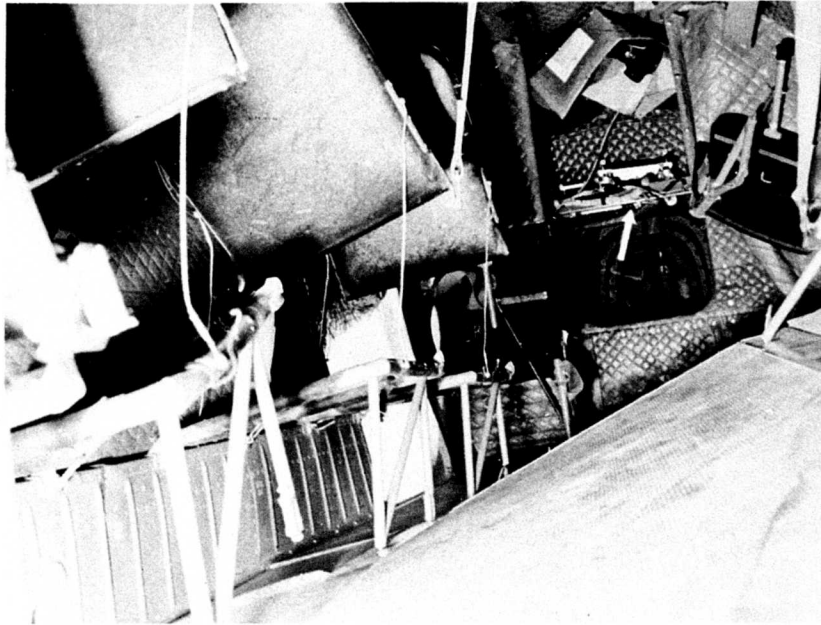
Fig. 23. View of cabin, showing the extent of upward displacement of the floor structure. The shelf utilized for installation of radio equipment (arrow) was not damaged in the crash. (Radio equipment was removed before this photograph was taken.)

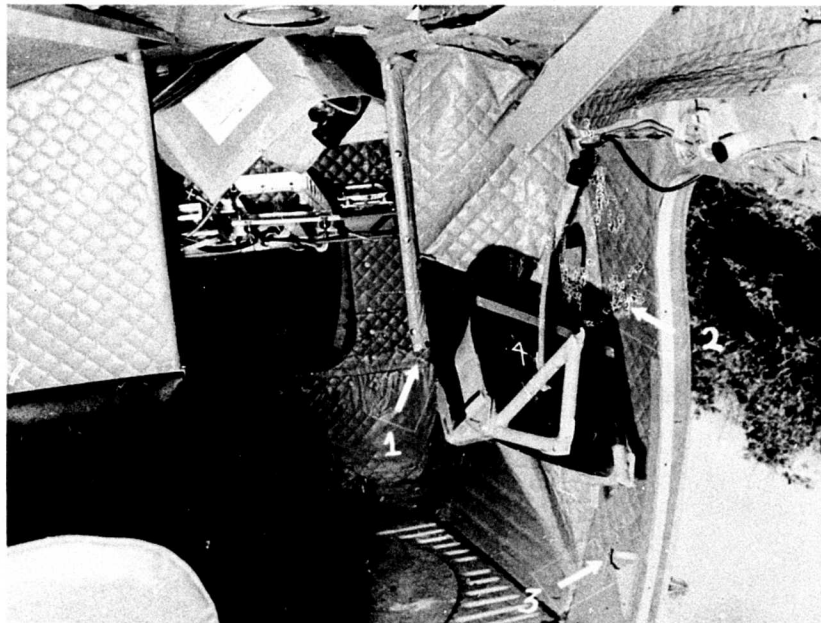
Seat 4L - The occupant of this seat (Figs. 42, 43, 47) sustained moderate injuries to his head and right knee. His injuries consisted of a 2-inch laceration on the top of his head, a 3-inch laceration on his right forehead and a torn ligament in the right knee. These injuries were caused by partial failure of his seat which allowed him to move forward, downward, and to the left, as the seat pivoted around the intact wall fitting (Fig. 24) allowing him to strike the cabin wall and rear door frame.

Fig. 24. View of after cabin showing failure of seat 4L and damage to luggage compartment. Seat 4L, normally attached to the luggage compartment post (arrow 1), to the upper and lower cabin wall (arrow 2 and 3), and to the cabin floor, tore partially free; the seat remained attached only by the upper wall fitting (arrow 2). The upper wall attachment, although intact, was badly distorted.

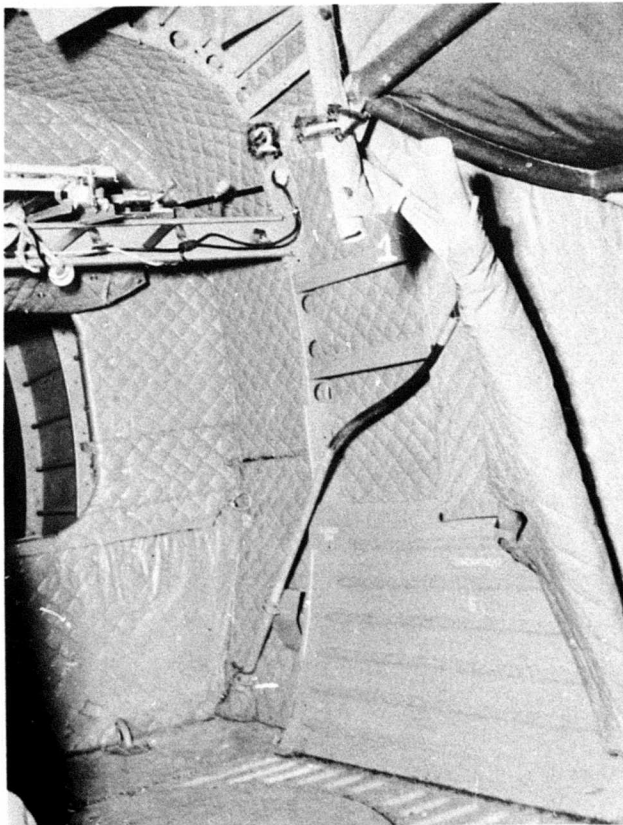
Fig. 25.
View showing failure of luggage compartment post (arrow 1) at the attachment point of seat 4L. The attachment bracket is indicated by arrow 2.

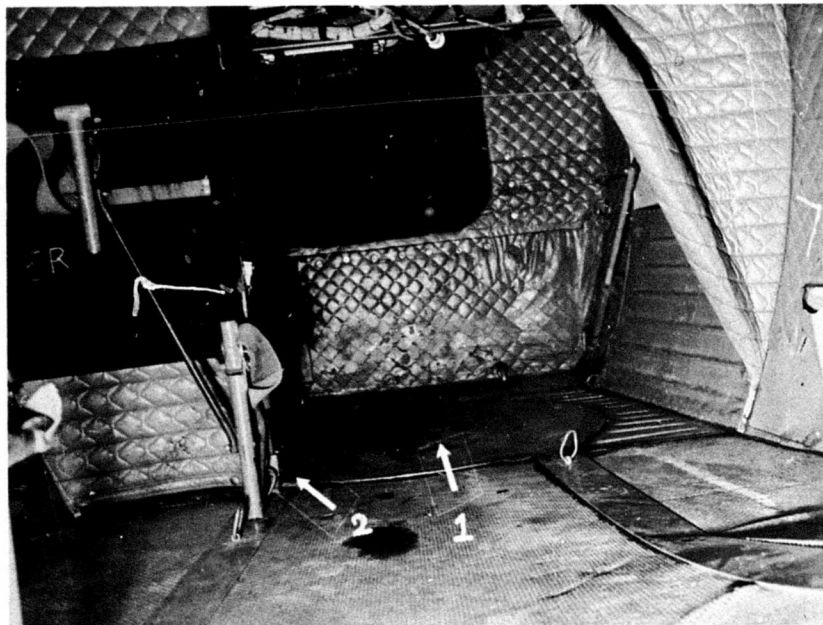
Fig. 26. View of the right-rear cabin area. A toolbox that was carried unsecured on the luggage compartment floor (arrow 1) was found rammed against the left vertical support of seat 5R (arrow 2), and impaled on two exposed bolt ends. It remained attached to them as the aircraft rolled to a partially inverted attitude during the crash sequence.

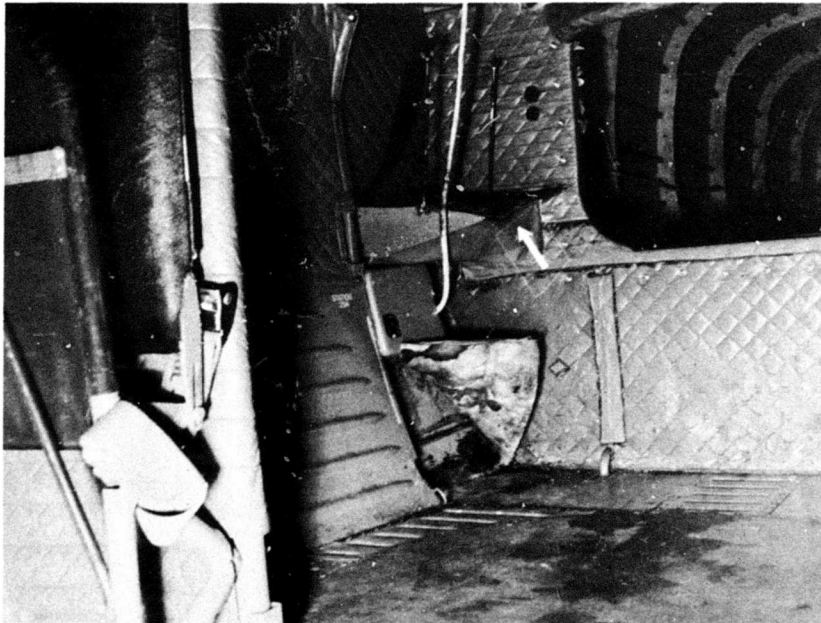
Fig. 27. View of luggage compartment showing downward distortion of the left forward portion of the battery rack (arrow).

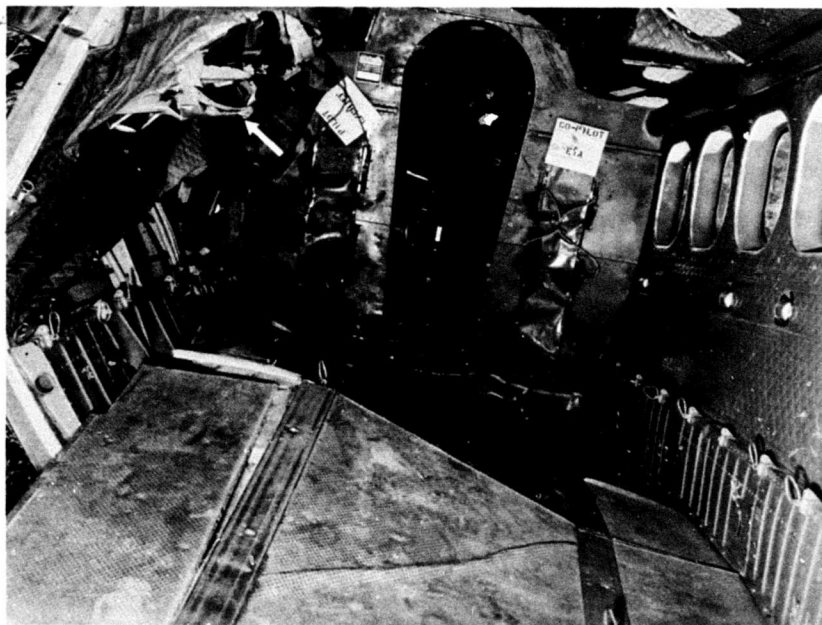
Fig. 28. Looking forward in the cabin after removal of the passenger seats. Note the upward displacement of the cabin floor and the inward displacement of the left cabin wall and ceiling structure in the vicinity of the wing root (arrow).

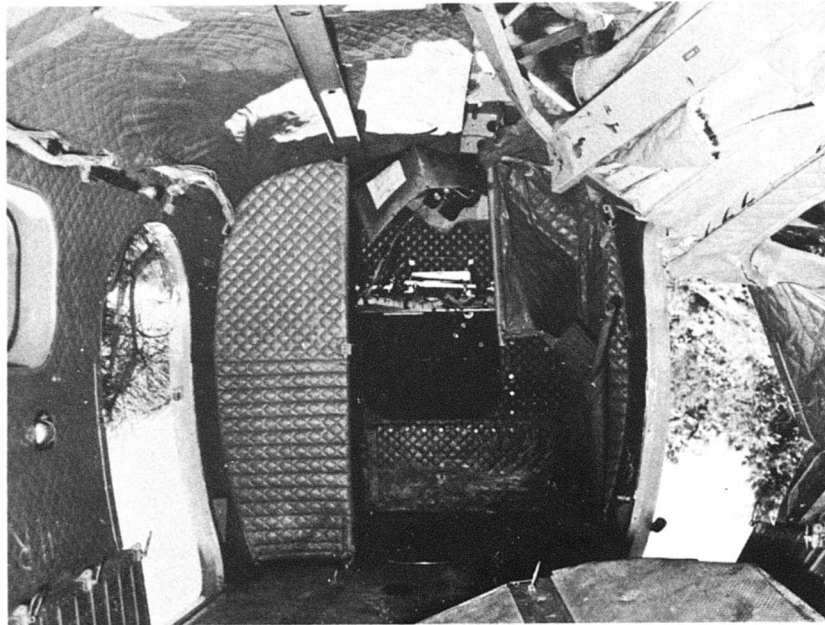
Fig. 29. Looking aft in the cabin following removal of the passenger seats. The upheaval of the cabin floor and the damage to the left cabin wall in the vicinity of the wing root are readily apparent.

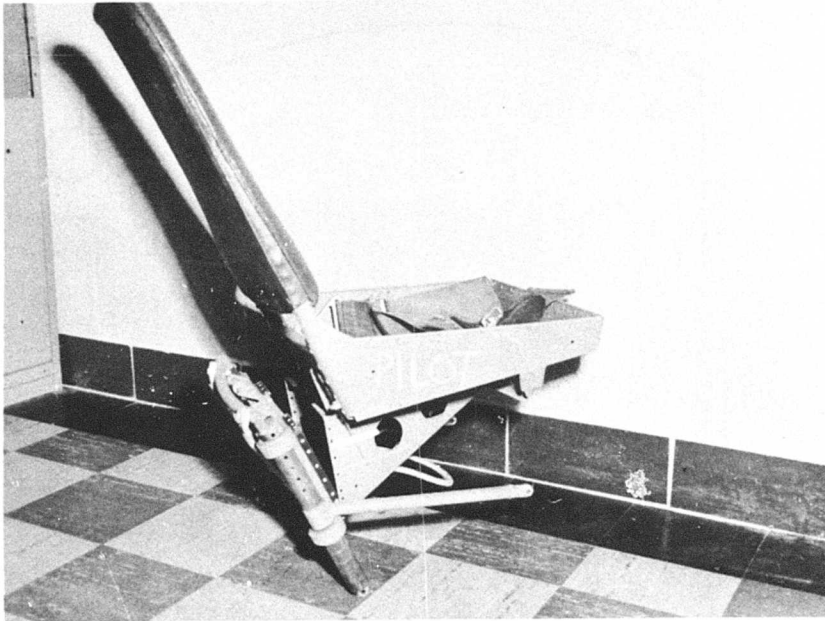
Fig. 30. Failure of the pilot's seat pan, due to shearing of the rivets which attach it to the primary support structure (arrow).

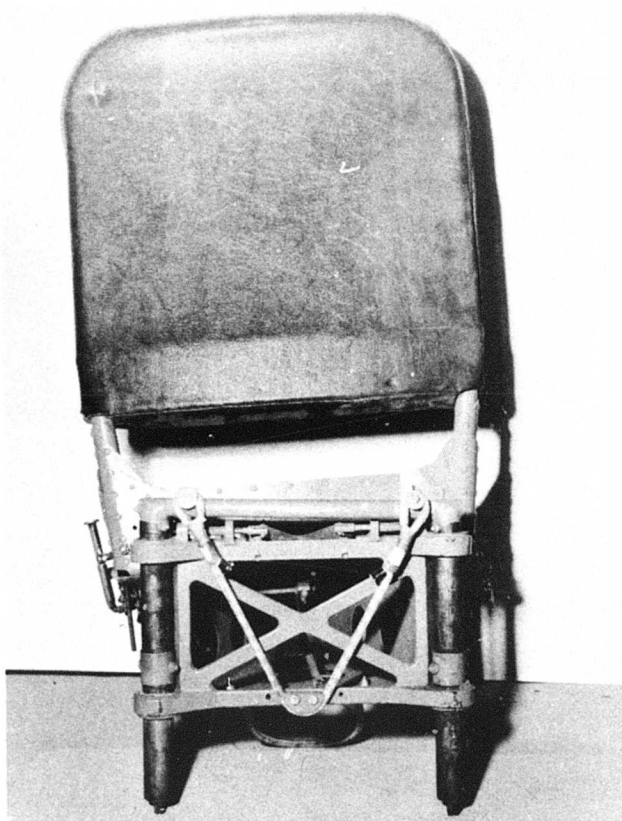
Fig. 31. Rear view of pilot's seat. Note the distortion of the seat pan and the seat back (downward and to the left).

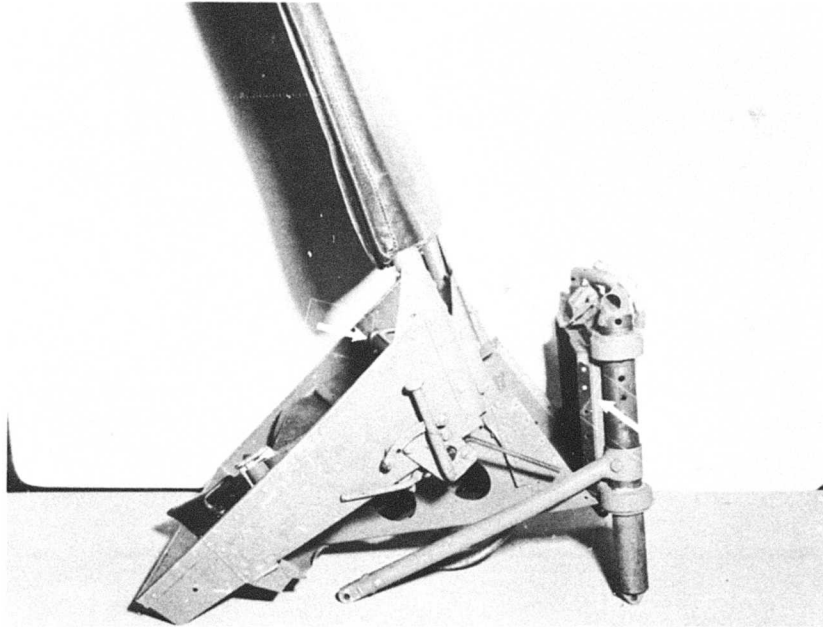
Fig. 32. View of the pilot's seat, showing failure of the seat pan at its left-hand attachment to the rear tubular supporting members (arrow 1). Analysis of the damage to the seat pan indicates that it failed downward and to the left, tearing almost completely free from the rear support assembly. The seat pan, which was free to move in a downward direction, bottomed on the left horizontal support member and/or the cockpit floor structure.

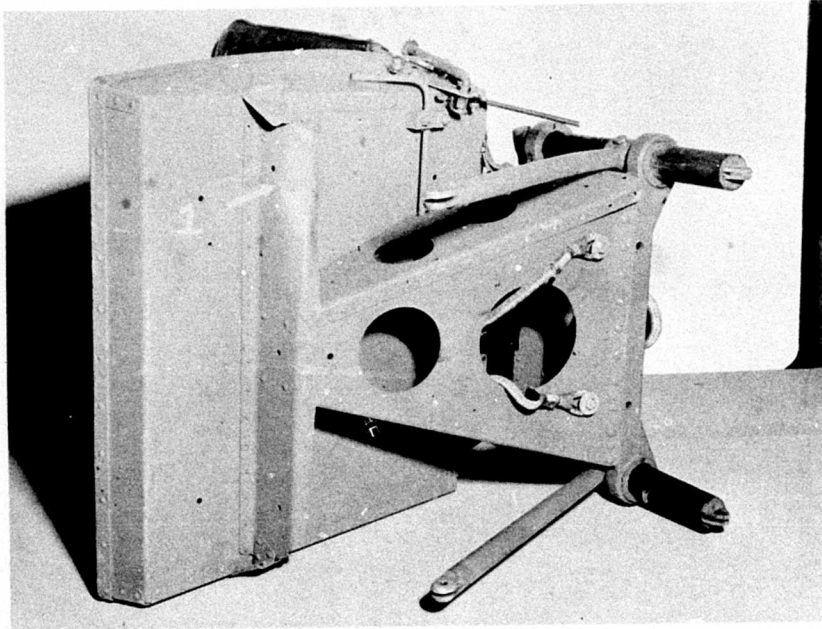
Fig. 33. Close-up view of the underside of the pilot's seat pan, showing bending and distortion of the support bracket (arrow 1) due to bottoming of the seat pan on the horizontal seat-supporting assembly and/or cockpit floor.

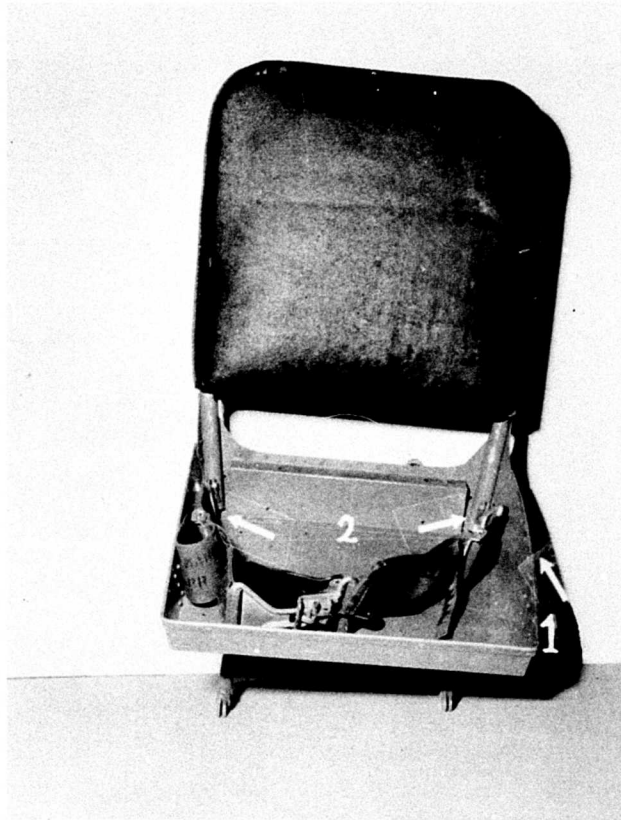
Fig. 34. The outward distortion of the left side of the pilot's seat pan (arrow 1) was due to the pilot's being thrown forward, downward, and to the left during the principal impact.

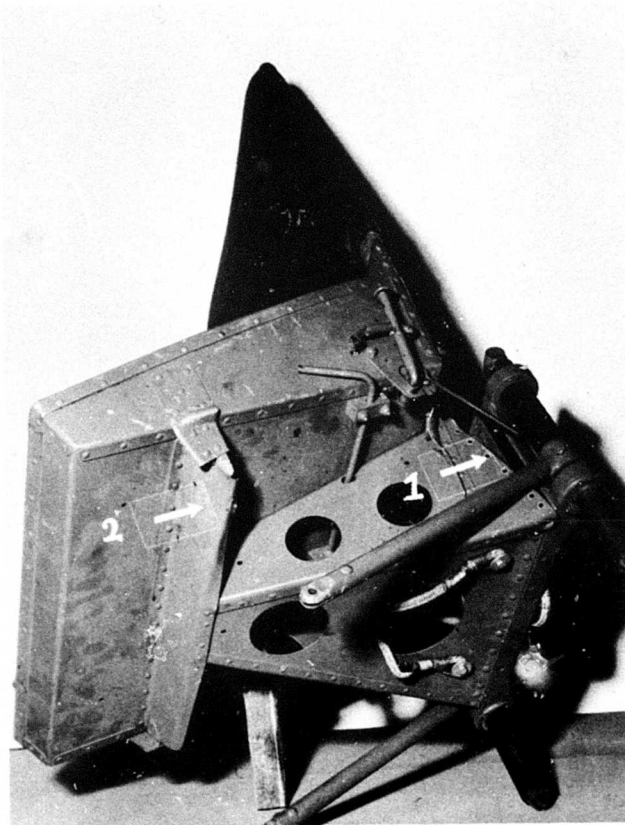
Fig. 35. View of the damage sustained by the pilot's seat, caused by the seat pan's tearing almost completely free from the rear supporting member (arrow 1) and bottoming against the lower horizontal supporting assembly (not shown) and/or cockpit floor. Note bending of the seat pan supporting bracket (arrow 2). Analysis of the damage to the support bracket (arrow 2) indicates that the force with which the seat pan bottomed was relatively low.

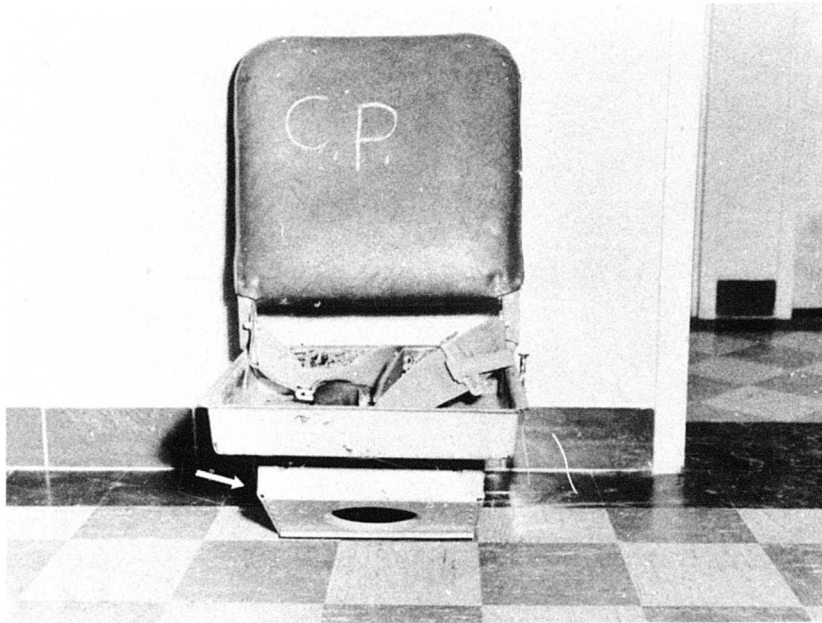
Copilot - The combat scout leader occupying this seat (Figs. 36-37) received minor injuries during his evacuation from the aircraft through the broken windshield. As in the case of the pilot, his restraint system functioned properly, preventing him from striking cockpit structures and components during the crash.

Fig. 36. The copilot's seat was intact and showed no evidence of any damage. Both the occupant's shoulder harness (attached to the bulkhead) and seat belt (attached to a bracket joining the inner rear corners of the seat pan and the vertical seat-back support members) functioned properly during the crash.

The person occupying this seat received only minor injuries, which were apparently sustained during his evacuation from the aircraft through the broken windshield.

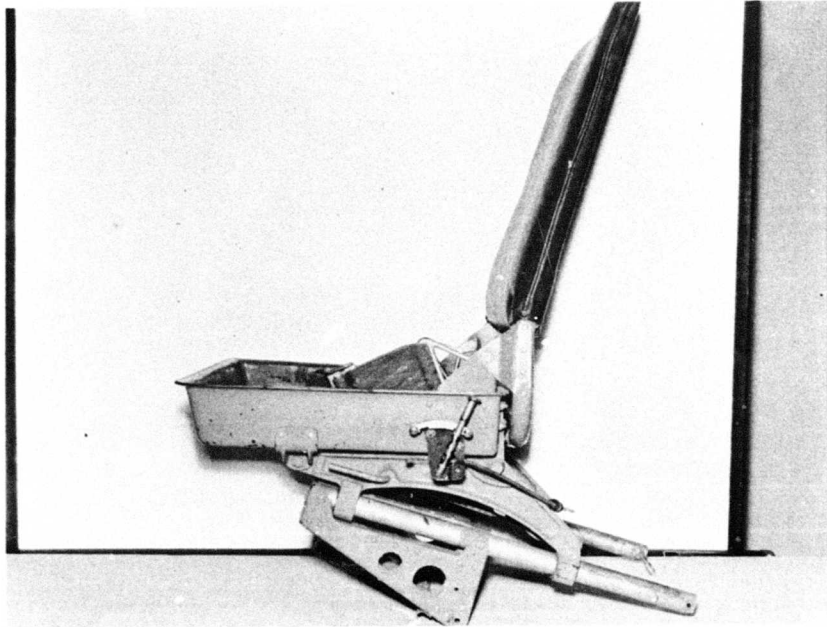
Fig. 37. The copilot's seat, designed to withstand 9g horizontally and a load equal to 6g vertically (upward) when occupied by a person weighing 190 pounds, did not fail, although the calculated crash force apparently exceeded the seat's design limits.

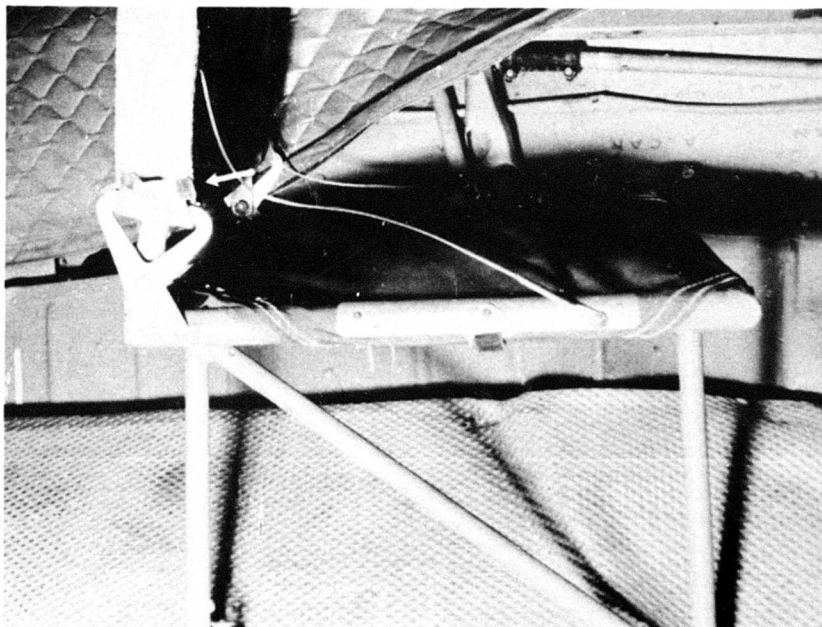
Fig. 38. Seat 1L, which is shown in its normal position in the cabin, remained completely intact during the crash. However, inspection of the safety belt revealed evidence of the beginning of webbing failure near the belt's attachment to the seat (arrow).

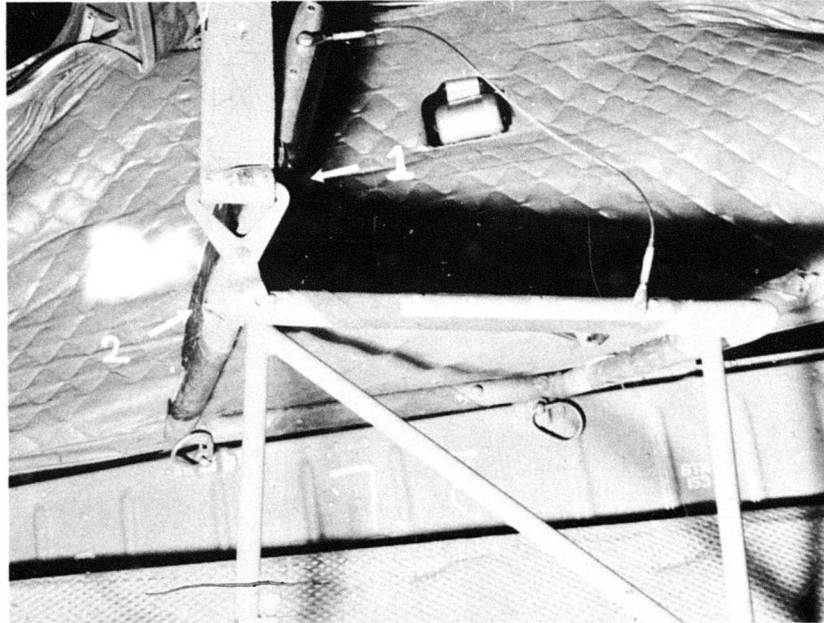
Seat 2L - The occupant of this seat (Figs. 39, 40, 45) sustained minor injuries consisting of lacerations of the left side of his chin and contusions of the lower lip. These injuries were caused by striking the muzzle of the rifle which he was holding upright between his knees.

Fig. 39. Seat 2L in its normal position in the cabin. Both aisle anchorage buttons (attachments) were torn free, apparently because of the deceleration and upheaval of the cabin floor during the principal impact. The seat belt showed evidence of incipient webbing failure at its attachment to the seat (arrow). Both the left and the right brackets joining the seat pan and seat back were badly distorted and started to fail. (Arrow 2 indicates the right bracket; the left bracket is not shown.)
