CRASH INJURY REPORT

U. S. ARMY U-1A
De HAVILLAND OTTER ACCIDENT
Fort Carson, Colorado
16 June 1959

Aviation Crash Injury Research
of the **F**light **S**afety **F**oundation

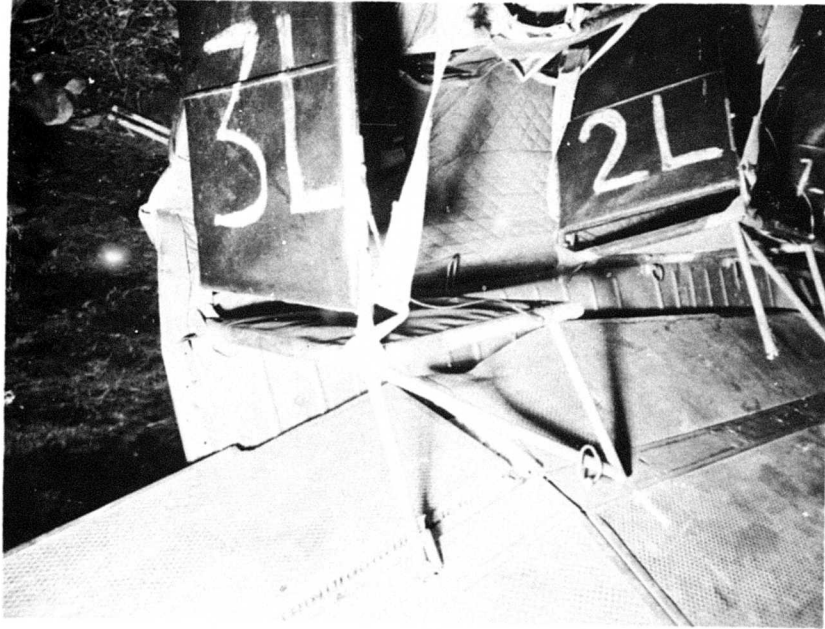
Seat 3L - The occupant of this seat (Figs. 40, 41, 46) received moderate injuries, although seated in the area of the cabin where the ceiling, wall and floor structure was badly buckled and collapsed (Fig. 40). Lacerations above the right eye, bridge of the nose, and upper lip were caused by striking the muzzle of the rifle which he was holding upright between his knees; abrasions of the left temple and front of the left ear were caused by striking adjacent cabin wall structure and/or seat structure in front of him.

Fig. 40. Seat 3L remained intact except for the forward aisle attachment, which was torn free (arrow). The upheaval and separation of the cabin floor between the forward and rear aisle attachments were in the area where the left wheel collapsed upward into the fuselage during the principal impact.

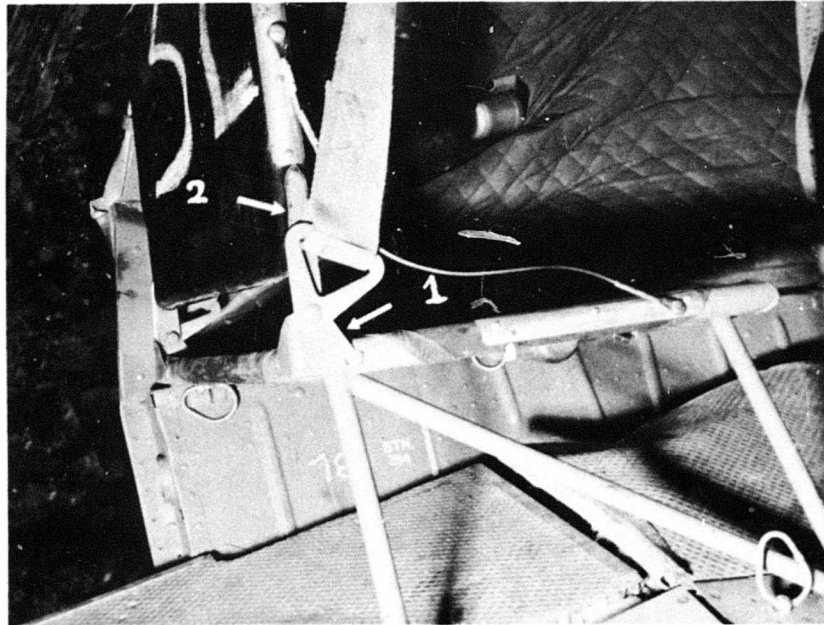
Fig. 41. The safety belt is anchored to the bracket attaching the seat back to the seat pan (arrow 1). The metal strap (arrow 2) attaching and hinging the seat back to the seat-pan bracket showed evidence of beginning to separate from the vertical seat-back support to which it was welded. Complete failure of the metal strap would have allowed the seat back to tear free from the seat pan.

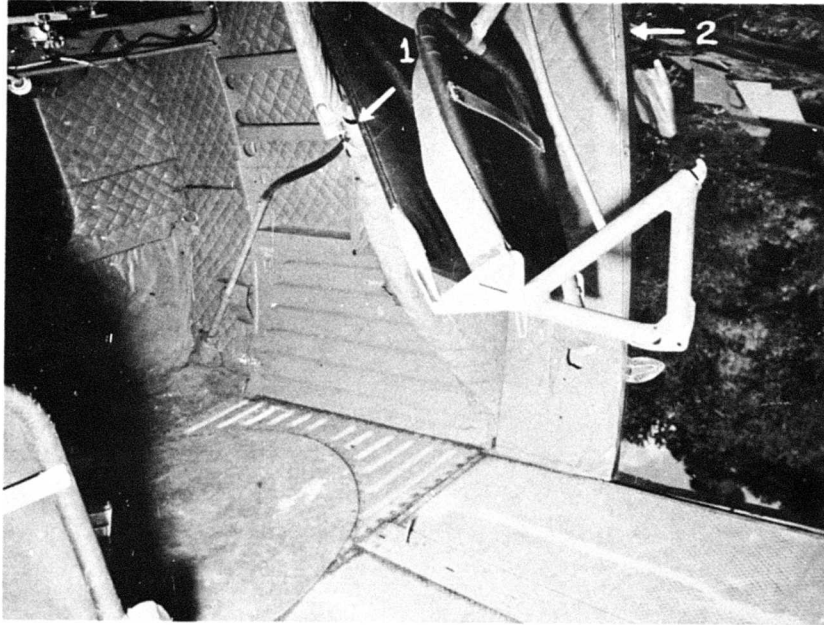
Fig. 42. Seat 4L was torn partially free, remaining attached only to the upper wall fitting. The vertical luggage compartment post, which was utilized as one of the seat attachments, failed completely (arrow 1). Simultaneously, the floor and lower wall attachments tore free and allowed the seat and the belted occupant to move forward, downward, and to the left while pivoting around the intact upper wall fitting. The occupant apparently struck the cabin wall and rear door frame (arrow 2); he sustained moderate injuries.

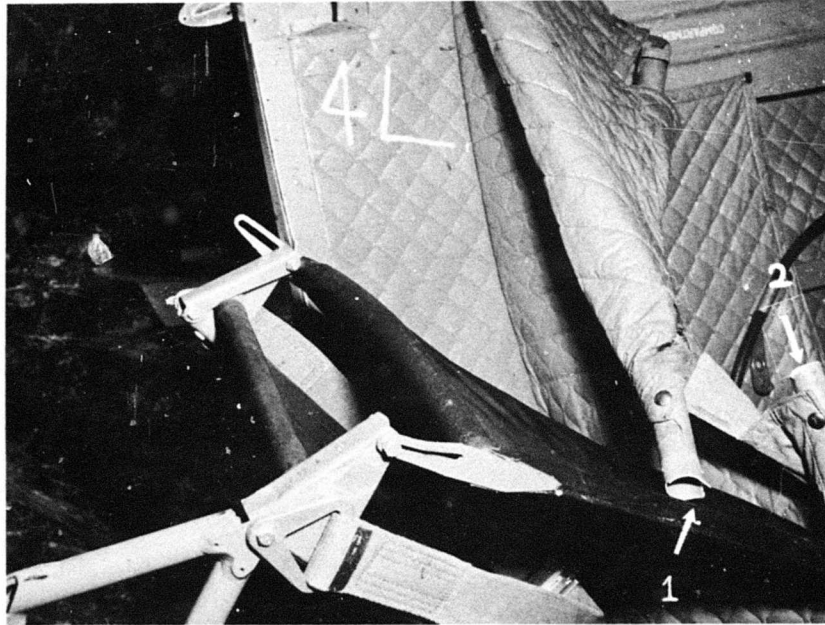
Fig. 43. Failure of the luggage compartment post utilized as one of the seat attachments is shown by arrows 1 and 2.

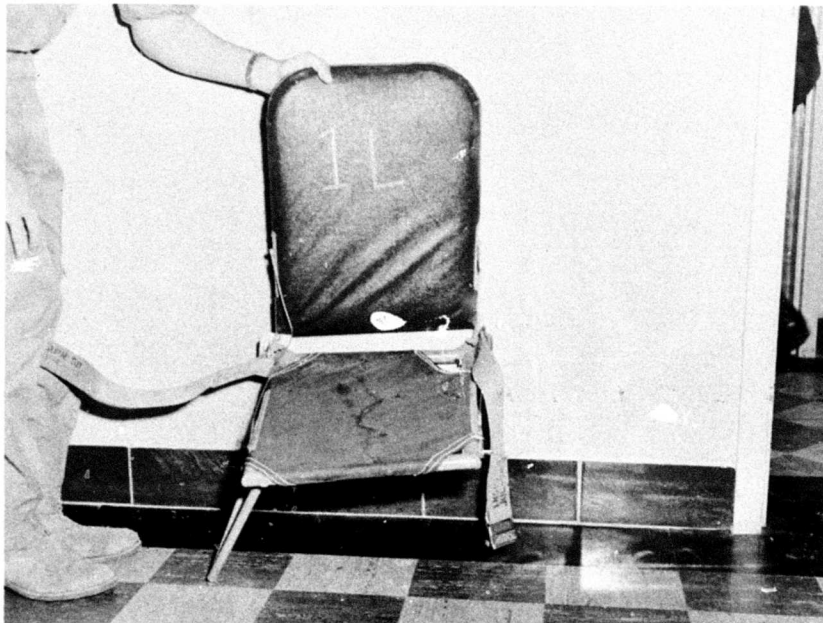
Fig. 44. Seat 1L remained completely intact and in its normal position in the cabin during the crash. However, both aisle floor attachments were distorted, and the safety belt revealed evidence of incipient failure at its anchorages to the seat pan.

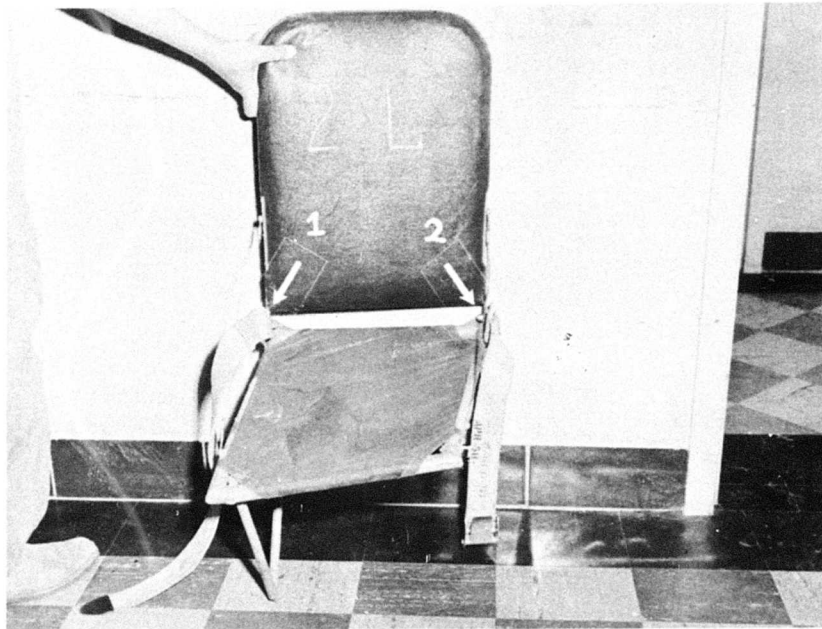
Fig. 45. Both aisle floor attachments of seat 2L tore completely free. The seat was forced in a forward direction, partially "hinging" at its two wall attachments, which were badly distorted. The safety belt showed evidence of incipient failure near its attachment, and both the left and the right brackets joining the seat pan and the seat back were badly distorted (arrows 1 and 2).

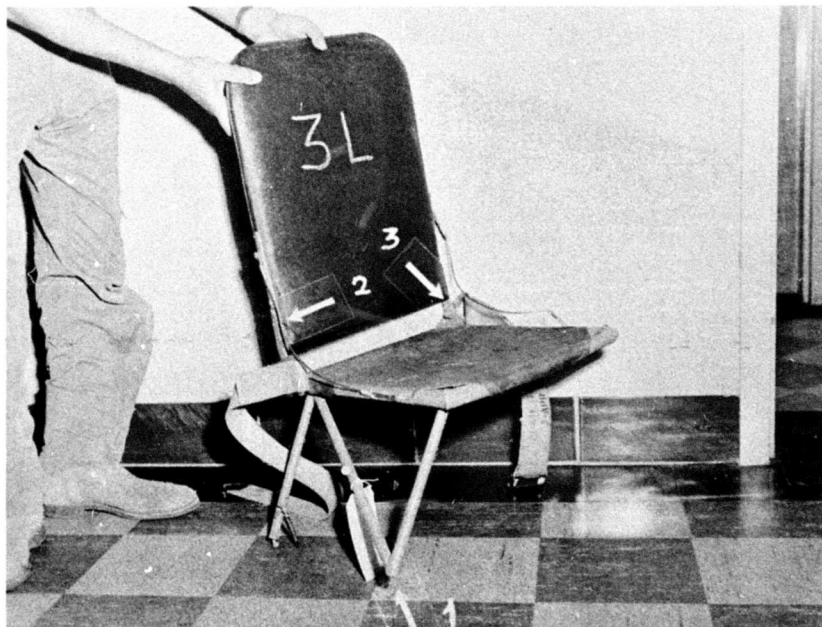
Fig. 46. The forward aisle attachment of seat 3L tore free (arrow 1); the other aisle and both wall attachments were badly distorted. The metal strap (arrows 2 and 3) attaching and hinging the seat back to the seat pan showed evidence of incipient failure. Both safety belt attachments were intact but distorted.

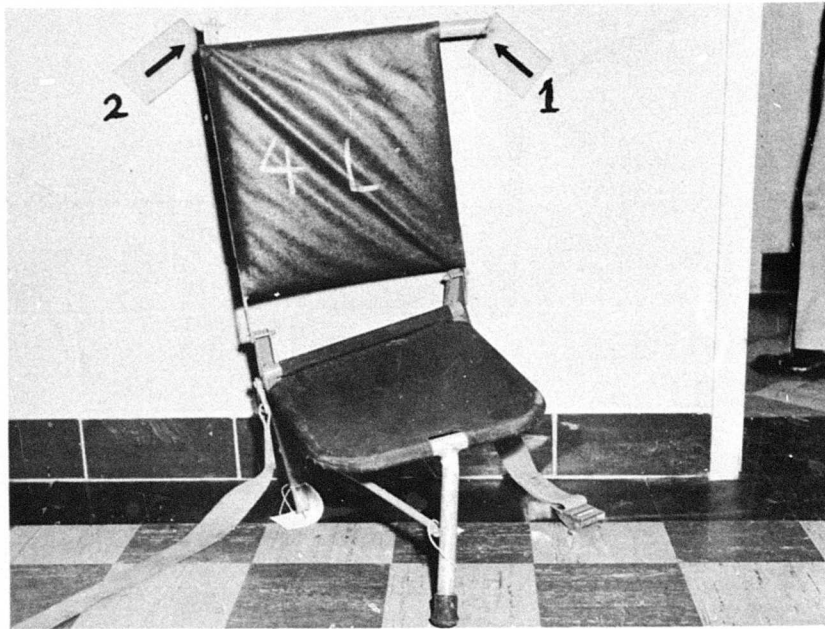
Fig. 47. Seat 4L was torn partially free, remaining attached by only the upper left wall fitting (arrow 1). The seat pan was distorted. Failure of the luggage compartment post allowed the upper right seat attachment (arrow 2) to tear free.

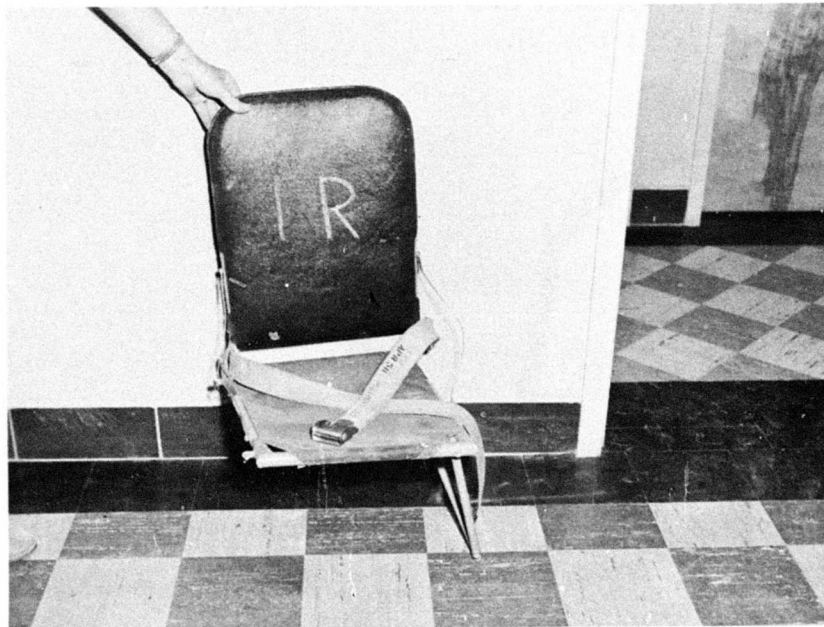
Seat 1R - The occupant of this seat (Fig. 48) received moderate injuries. His injuries consisted of a 4-inch laceration on the top of his head and an abrasion of the left flank. These injuries were caused by striking his head and upper torso against the forward bulkhead, even though he was restrained by his seat belt.

Fig. 48. Seat 1R was the only seat in which the safety belt, seat pan, seat back, and all seat anchorages remained completely intact. The occupant of this seat, who was restrained by his seat belt, received moderate injuries that were apparently caused by his striking his head and upper torso against the bulkhead separating the cockpit and the cabin.

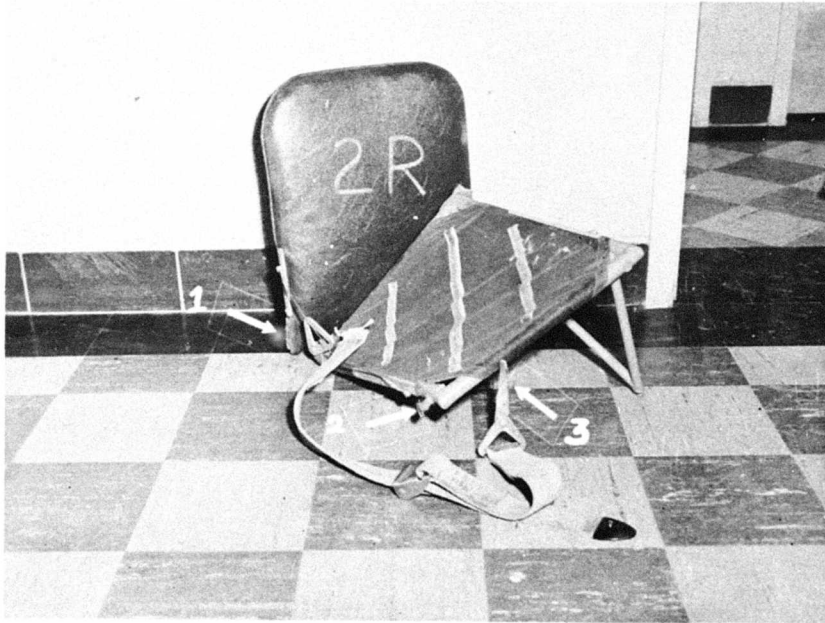
Seat 2R - The occupant of this seat (Fig. 49) was thrown free in the cabin when both his seat and seat belt failed completely. He received moderate injuries which consisted of lacerations on top of his head and above the left eye; abrasions of the shoulder, left hand and right shin. His injuries resulted from (1) being thrown completely free in

Fig. 49. Seat 2R was severely damaged during the crash. The seat back was torn free from the seat pan because both of the metal straps joining and hinging the back to the pan (arrow 1) failed. Both aisle floor anchorages and the rear wall anchorage tore completely free; the forward wall fitting was badly distorted (arrow 2).

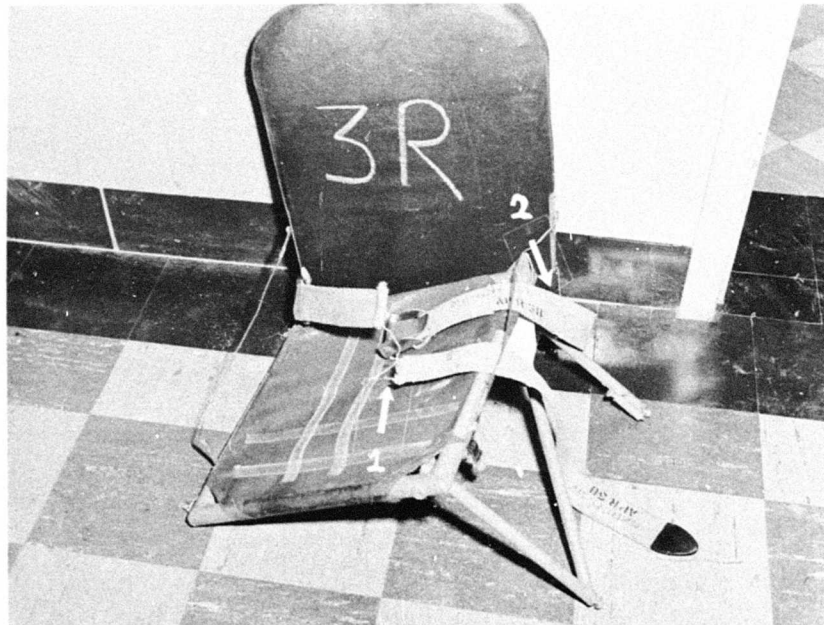
Seat 3R - The occupant of this seat (Fig. 50, 52) received severe injuries and required assistance in evacuating the wreckage. His injuries consisted of a dislocation of the hip and moderate abrasions. The simultaneous failure of his seat anchorages and safety belt allowed him to be hurled through the cabin striking interior structures and components.

Fig. 50. Seat 3R tore completely free because of failure of the wall and aisle floor anchorages. Failure of the metal straps that joined and hinged the seat back to the seat pan allowed the seat back to tear free from the seat pan. The safety belt failed in two places: (a) in the webbing (arrow 1) because of the cutting action of the serrations of the buckle cam, and (b) in the anchorage (arrow 2), which allowed the left-hand portion of the belt to tear free from the seat.

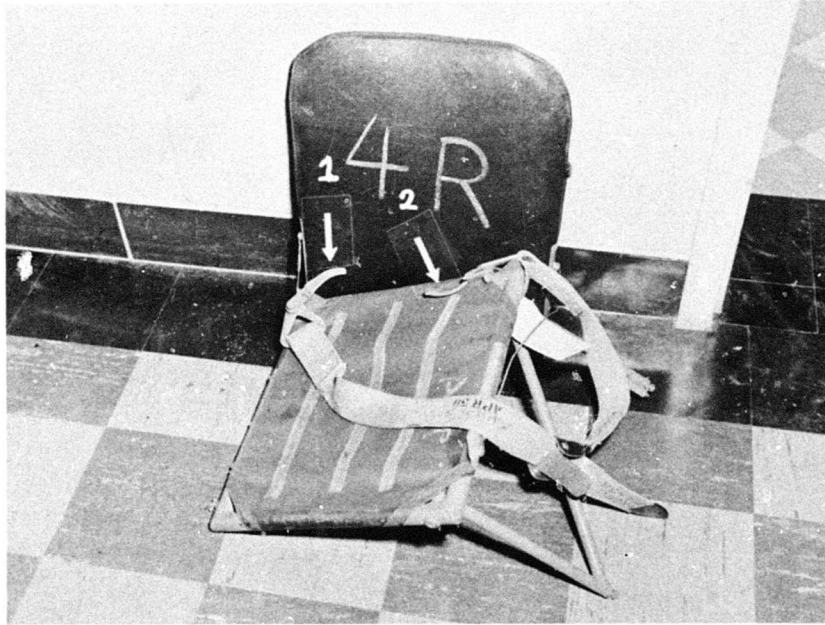
Seat 4R - The occupant of this seat (Figs. 51, 52) sustained minor injuries although the failure of his safety belt resulted in his being thrown forward and to the left across the aircraft cabin. His injuries consisted of abrasions of the left forehead, cheek, and chin and loss of two teeth. It is believed that these injuries were caused by a combination of striking the muzzle of the rifle which he was holding upright between his knees and/or striking interior cabin structures and components.

Fig. 51. Both the wall and the aisle floor anchorages of seat 4R remained intact although badly distorted. The seat back and both safety belt anchorages (arrows 1 and 2) tore completely free because of (a) failure of the metal straps hinging and joining the seat back and seat pan and (b) failures of the brackets attaching the seat belt anchorages to the seat pan.

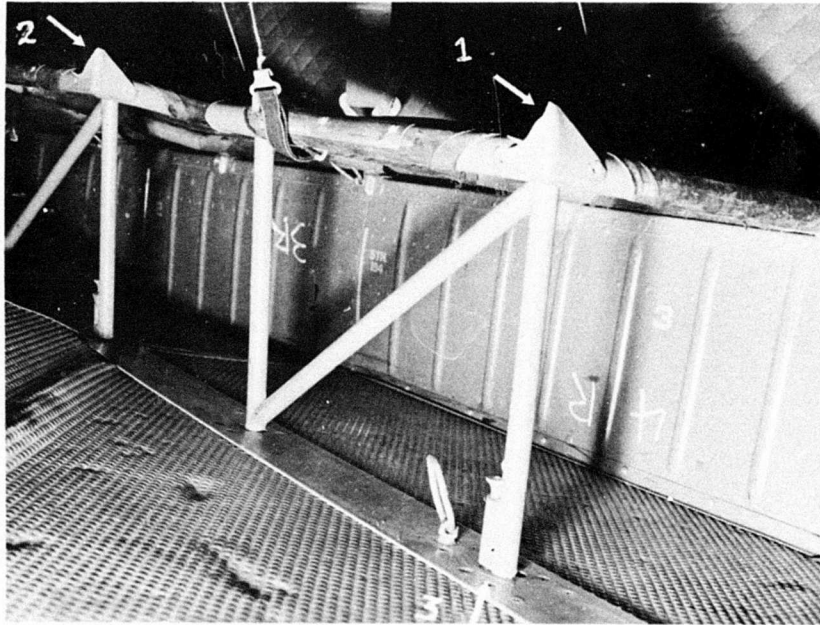
Fig. 52. Although torn completely free during the crash, seat 3R was placed in its normal position in the aircraft for this photograph.
