**CRASH INJURY INVESTIGATION**

**HU-1A BELL IROQUOIS HELICOPTER ACCIDENT**

**East St. Louis, Illinois**

**21 October 1959**

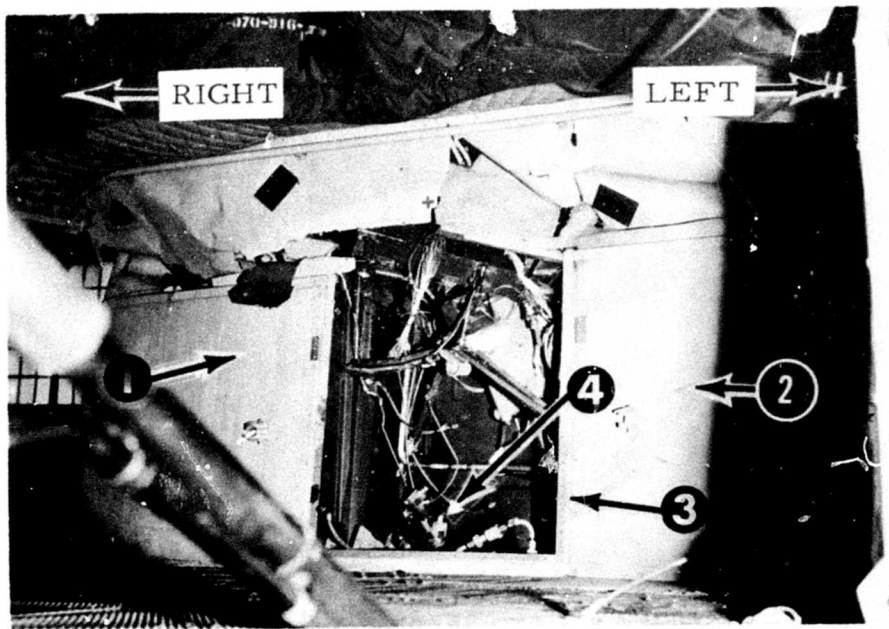
Fig. 30. Aft cabin bulkhead, showing fuel cell area, right (arrow 1) and left (arrow 2). Hoist well (arrow 3) and hoist coupling (arrow 4) are located between fuel cells. Seats and floor covering are removed to reveal intact floor, without the slightest distortion.

The two 67-1/2 gallon fuel tanks located to the left and to the right of the hoist mechanism, just below the transmission deck of the aircraft, appear to have held up very well during the crash sequence. (See intactness of tank area in Fig. 30, p. 21). No fuel spillage was noted. The tanks did not rupture, although the outer tank walls sustained some damage.

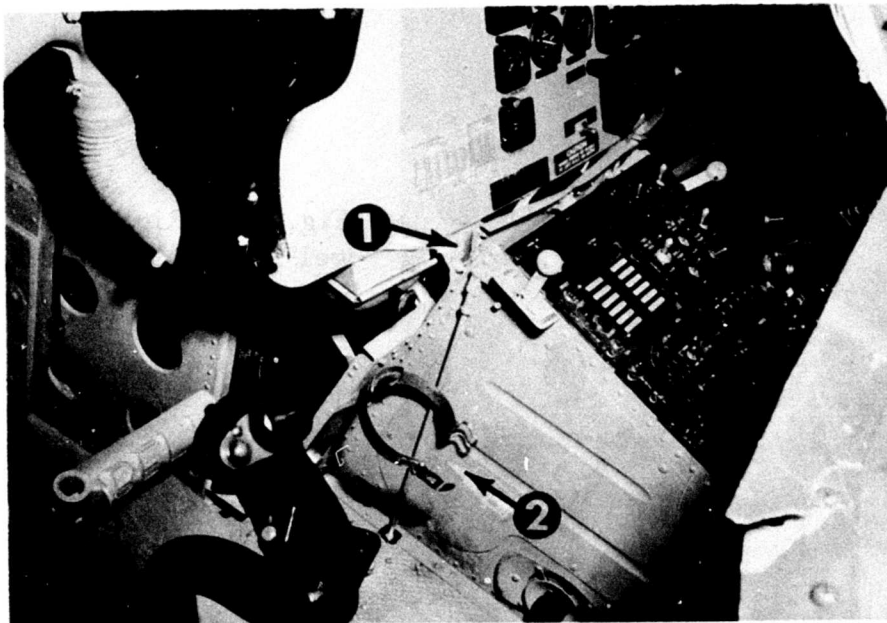
Fig. 31. Instrument panel and control console on copilot's side (left). Note that instrument panel is broken forward, away from occupant (arrow 1). Arrow 2 indicates the fire extinguisher mount.

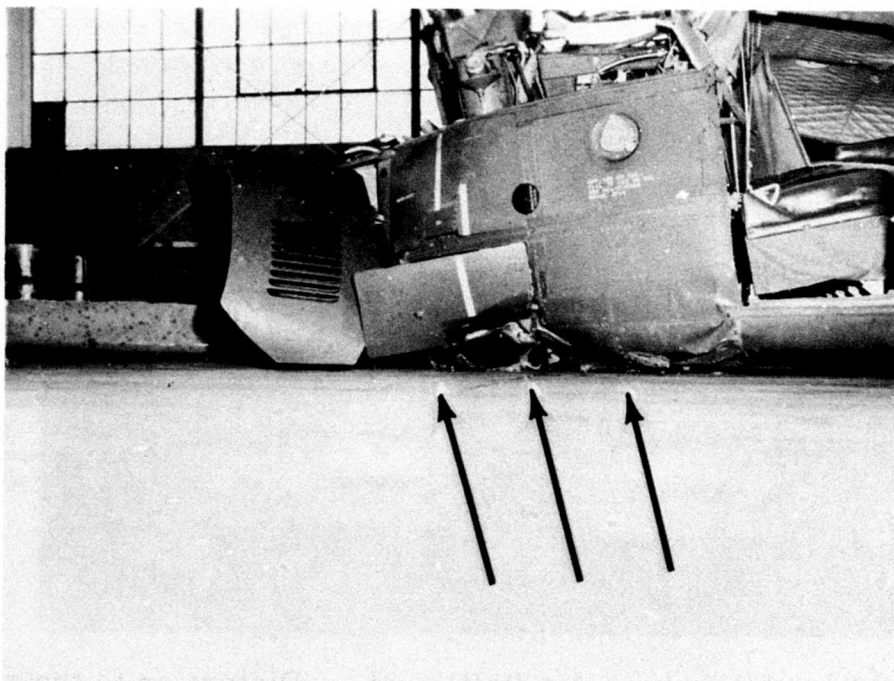
Fig. 40. Aft right fuselage. Arrows indicate fuselage belly area (believed to have been damaged at initial impact).

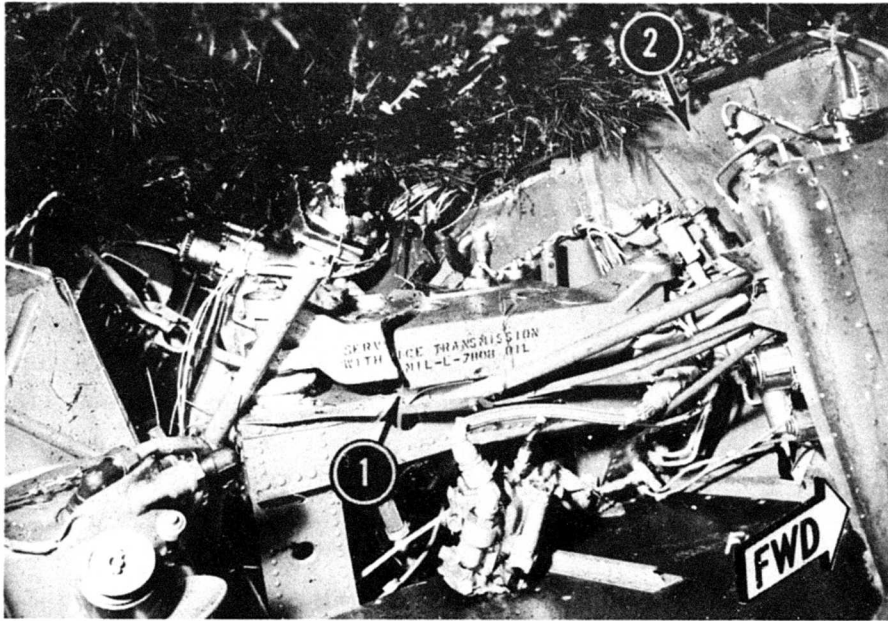
Fig. 48. Transmission mount (arrow 1) was cracked; transmission, rotor mast, rotor head and blades broke off completely to the left. Forward firewall bulkhead (arrow 2) is pointed out for orientation.

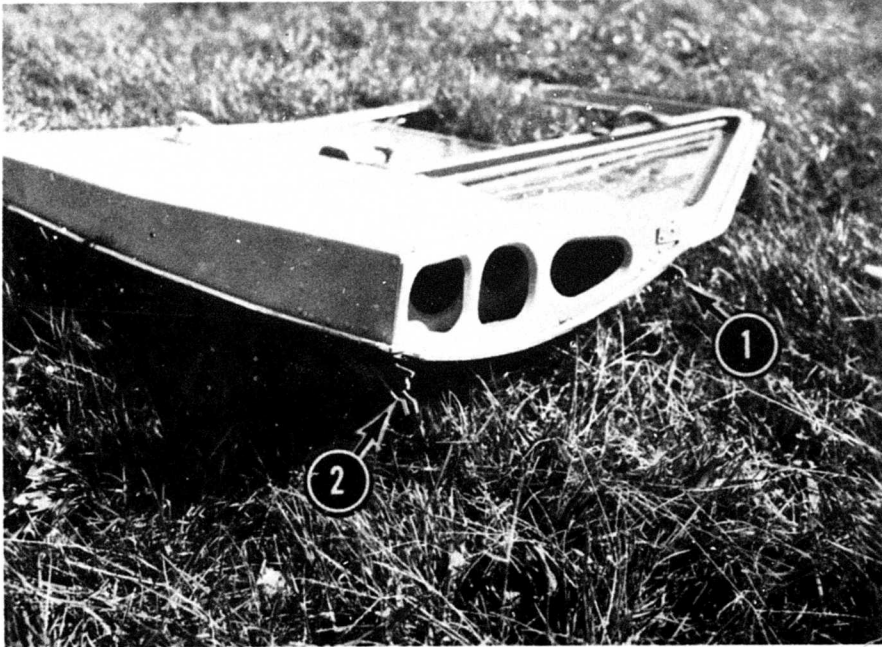
Fig. 50. Left front (copilot's) door, which was also torn partially free at initial impact, was found approximately 175 feet along the crash path. Both the upper (arrow 1) and the lower (arrow 2) hinges were torn free.

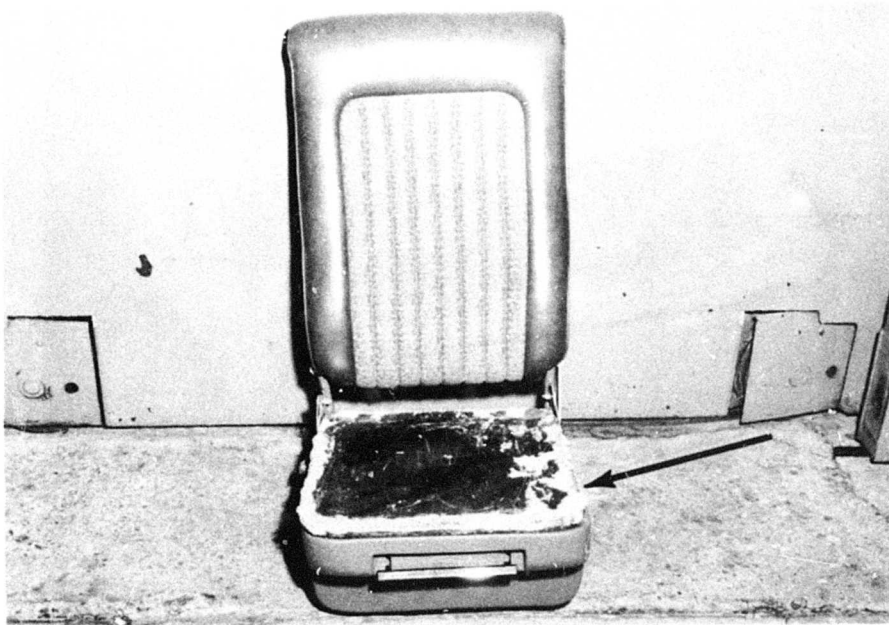
Fig. 61. Polyurathane cushion, cemented to the neoprene-impregnated nylon seat pan, is removed. The seat pan does not appear to have any degree of yield or stretch.

2. Deficiency in crashworthiness exists in the following respects:
  - a. The seat cushions used are too soft to provide an effective stopping distance for impact alleviation.

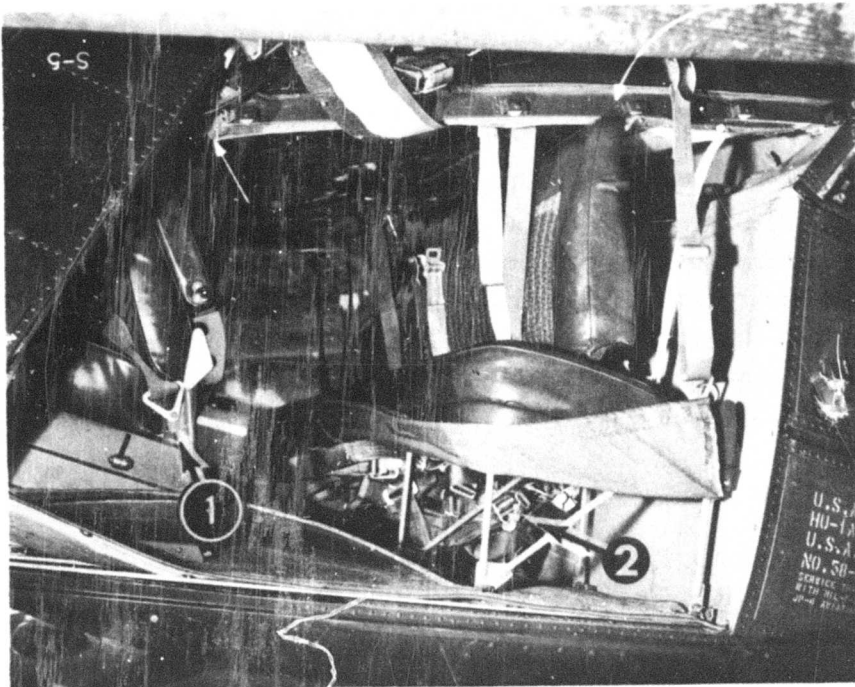
Fig. 64. Safety belt anchorages on single seats are designed to be flexible for force application in one plane only; they pivot on their attaching bolts (arrow 1). Note parachutes and harness stored beneath rear passenger seat (arrow 2).

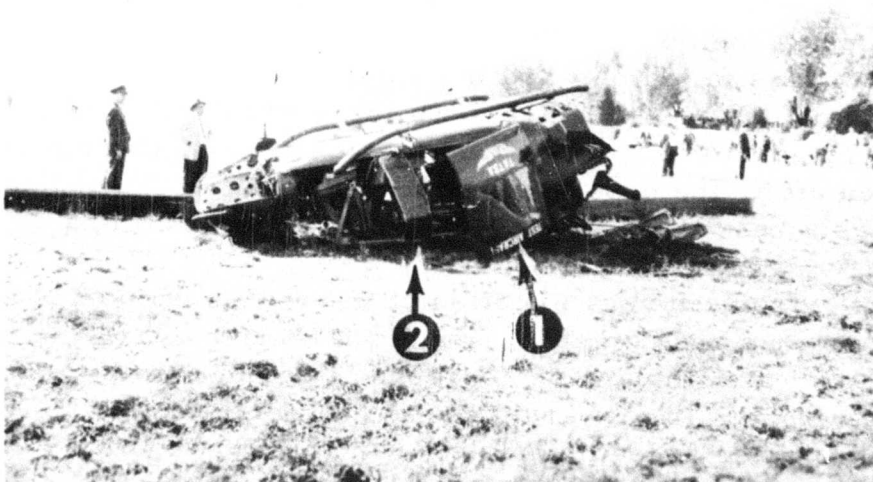
Fig. 65. Right side of helicopter. Cargo door (arrow 1) was out of its track, but still attached to the fuselage. Note inward deformation of "roof" structure and buckling of vertical support member (arrow 2).

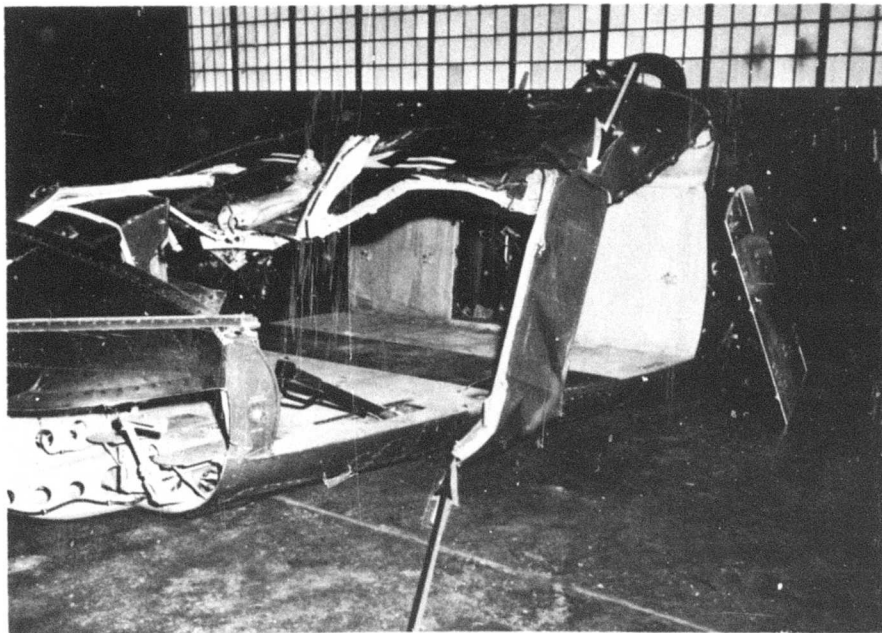
Fig. 66. Left side of fuselage (seats removed). Vertical overhead support (arrows) failed. (See Fig. 67).

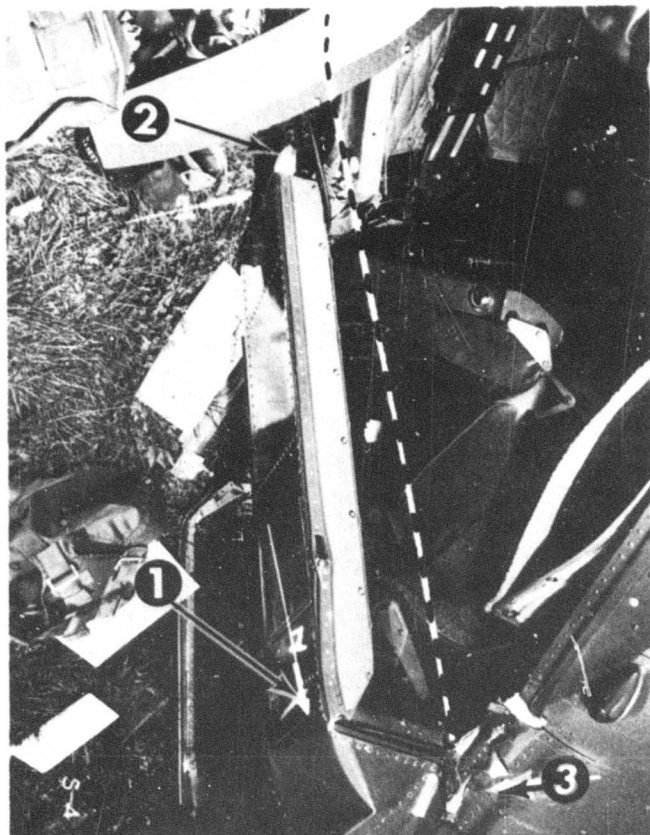
Fig. 68. Left support member, aft edge (looking forward). Note compression buckling (arrow 1). Dotted line indicates normal position. Failure of this member occurred both at the top (arrow 2) and bottom (arrow 3) attachments.

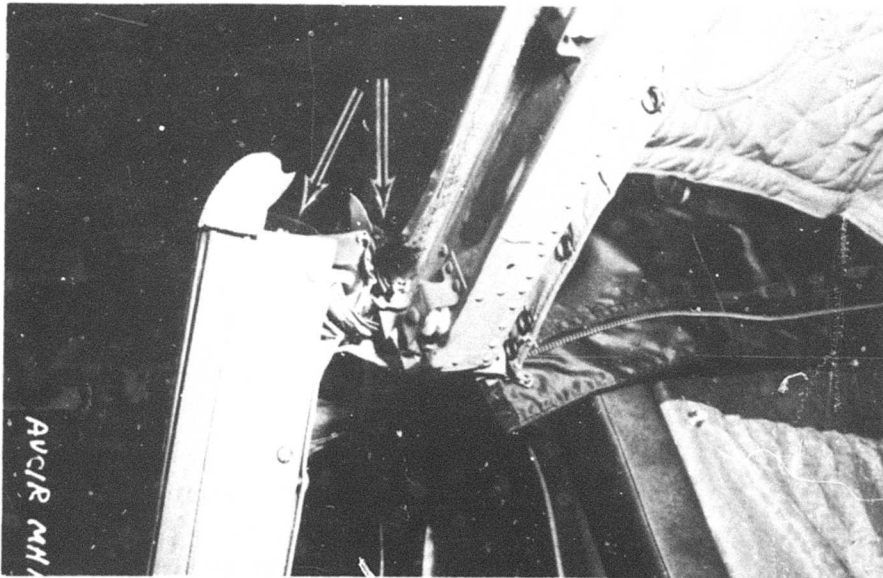
Fig. 69. Left support member, aft edge, top (looking forward). Failure (arrows) is believed to have occurred during final rolling of the fuselage onto its back. Failure of this structure outward, as it occurred, is more desirable than failure inward would be.

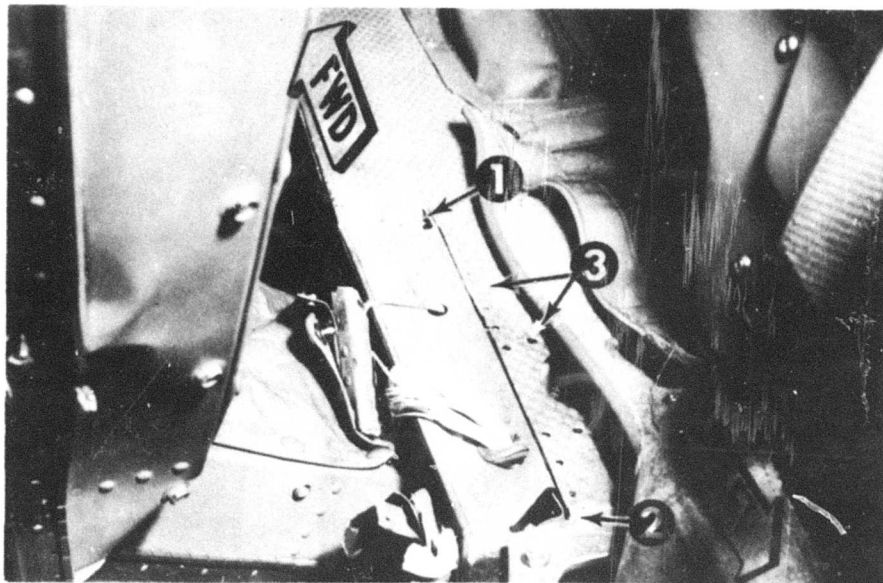
Fig. 70. Left support member, lower attachment points. The triangular cutouts (arrows 1 and 2) allow "L" stringers to pass through vertically. The "L" stringers and the inner and outer skin of the support member attach the member to the fuselage. The line of rivet holes (arrow 3) indicate where the skin attaches to the floor.

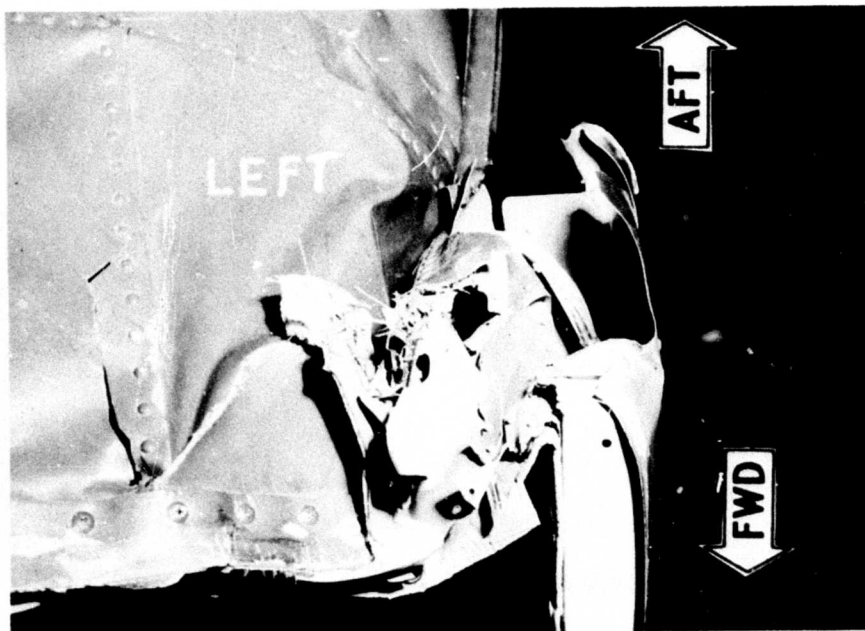
Fig. 72. Left vertical support member, upper attachment point. It does not appear that the "L" stringers extend up to the top of this member for attachment. Inner and outer skin appears to be largely relied upon, in addition to other structural attachment methods, to provide integrity.

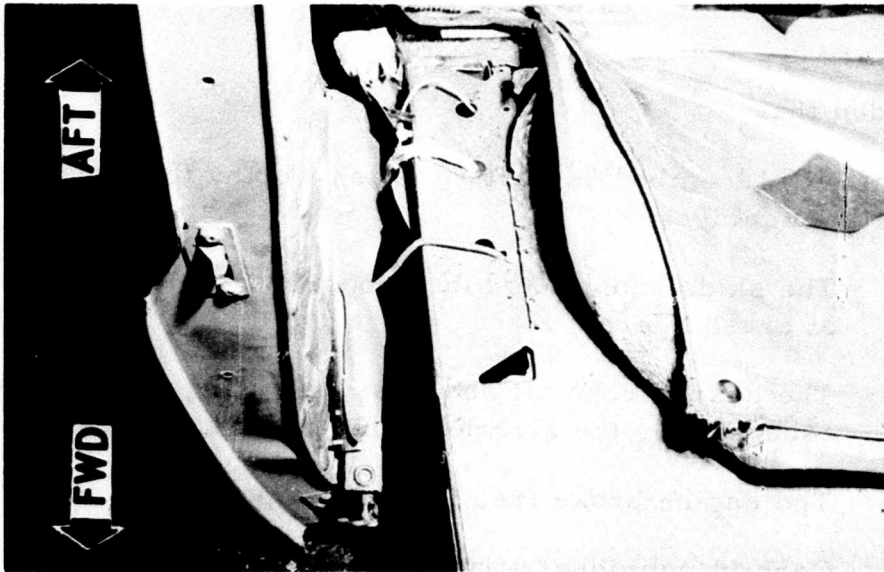
Fig. 73. Right vertical support member, lower attachment point. Failure of this area is essentially the same as the left. Forward and aft "L" stringers and outer skin and inner skin attachments all failed, a condition that allowed the support member to tear free.

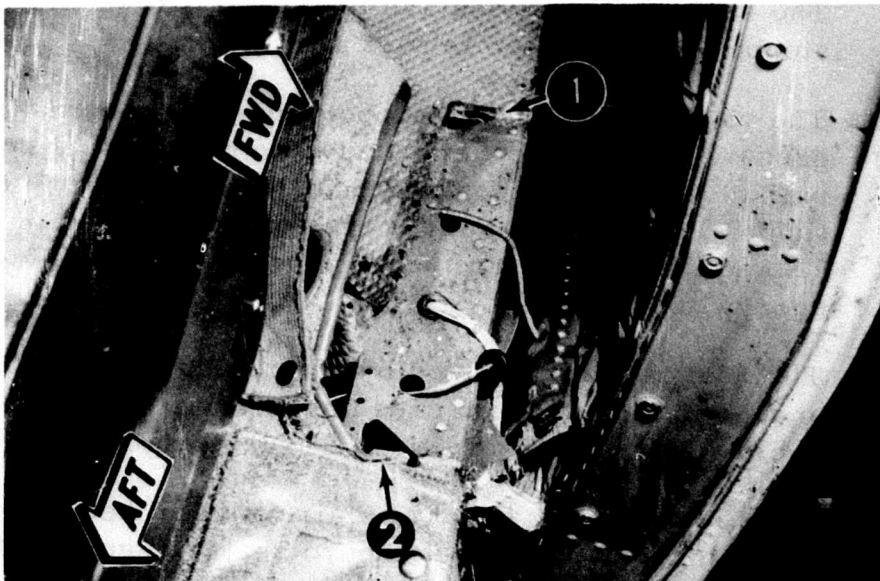
Fig. 74. Right vertical support member, lower attachment point. Depth and type of failure of forward "L" stringer is shown by arrow 1 (as compared to that of aft "L" stringer). Arrow 2 indicates some application of force against the upper area of the member in an aft direction during its failure.
