# CRASH INJURY INVESTIGATION

U. S. ARMY H-21C

SHAWNEE HELICOPTER ACCIDENT

2 December 1959

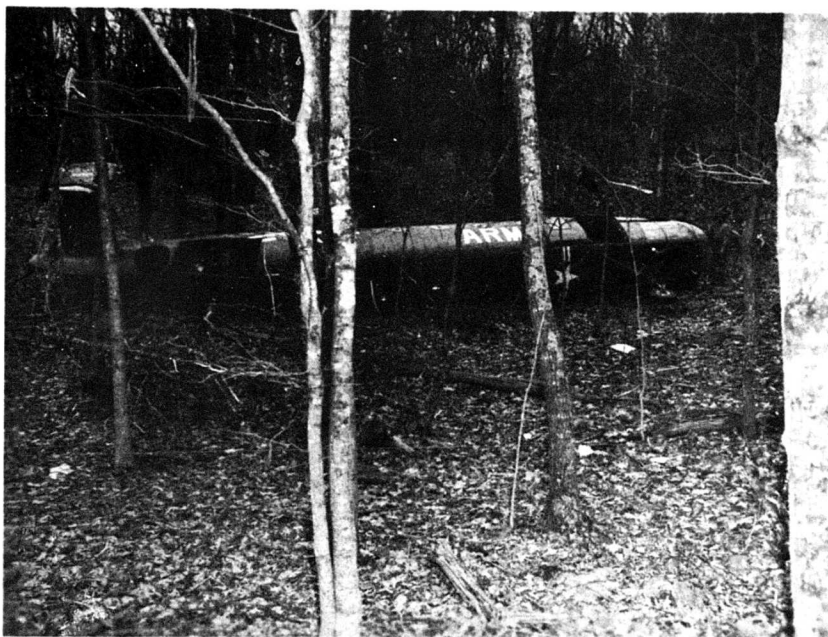
During the crash sequence, the aircraft rolled approximately 90 degrees to the left, scraping down the sides of trees approximately 40 feet in height. The aircraft impacted on its left side. Initial ground contact occurred on the left side of the pilot's compartment, forward of the copilot's seat, with the aircraft in a 3-5° nose-down attitude in relation to the ground. After initial impact, the rear section of the aircraft settled with the tail cone wedged between several trees. The kinematic behaviour of the aircraft during the crash is shown in Figure 4. Figures 5, 6, and 7 show the aircraft in its final position.

Figure 5. A side view of subject aircraft as it came to rest on its left side. The engine covers were removed after the accident.

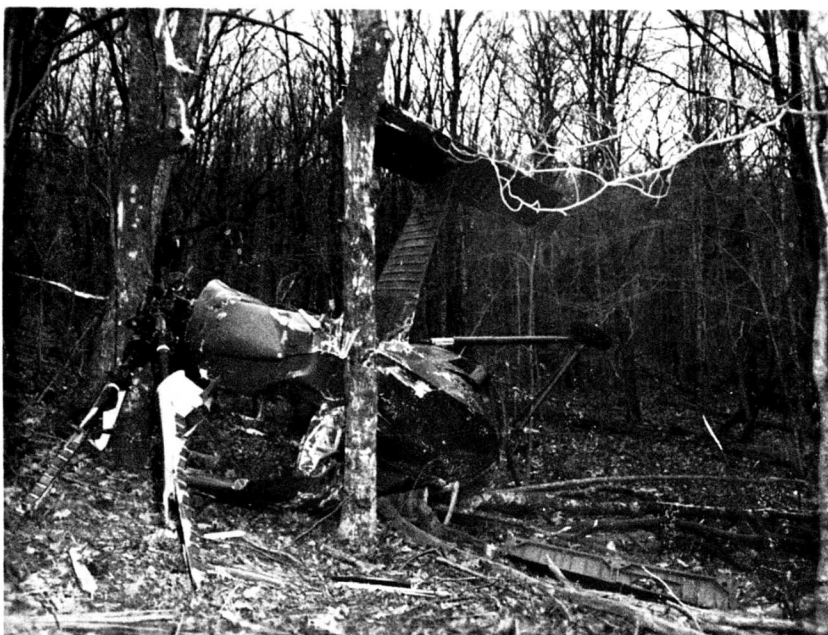
Figure 6. The nose-down attitude was caused by the aft end of the aircraft being wedged between several large trees as shown in the above photograph.

In addition, the left cabin door was torn free, the left rear landing gear was bent and the drag strut broken and pushed into the engine area. Some distortion occurred on the left side of the engine area and fire wall. The fuselage skin aft of the forward rotor along the left side was wrinkled as the nose struck the ground (Figure 9). The tail assembly was damaged by sliding down the 40 foot trees (Figure 6).

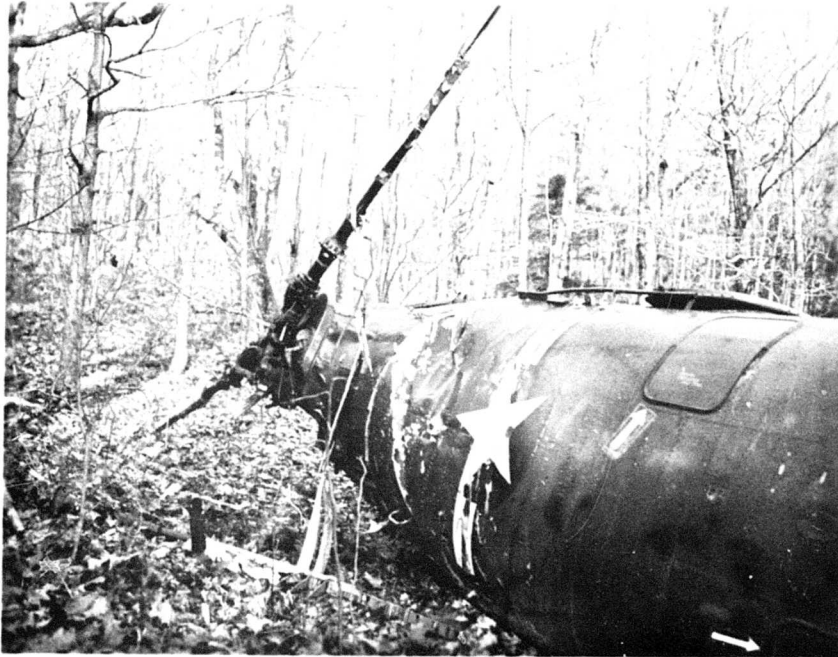
Although adequate emergency exits are provided in this aircraft, they were not utilized. Figures 9 and 10 show the location of two ceiling exits, which were operable but were not utilized, probably as a result of inadequate emergency evacuation briefing prior to the flight or the incapacitation of the crew chief.

↑ Figure 9. A view of the aircraft looking toward the forward rotor. The arrows indicate the operable, but unused, ceiling emergency exits.

The time required to evacuate all personnel from the aircraft including those requiring assistance indicates that more emphasis should be placed on briefing occupants of military aircraft on evacuation procedures and the location and use of emergency exits prior to the flight.

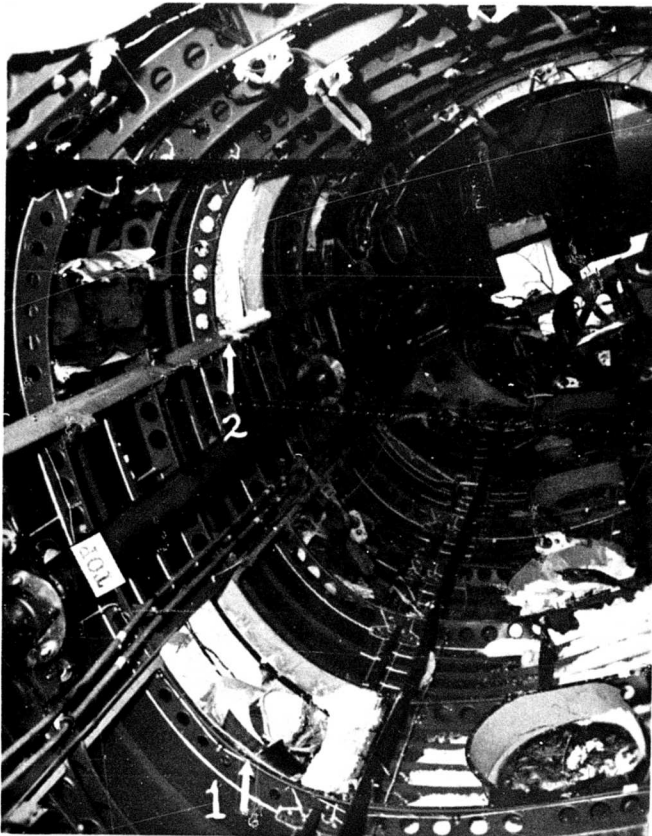
← Figure 10. Interior view of the operable but unused ceiling emergency exits (arrows 1 and 2). Both exits were opened by the accident investigators.

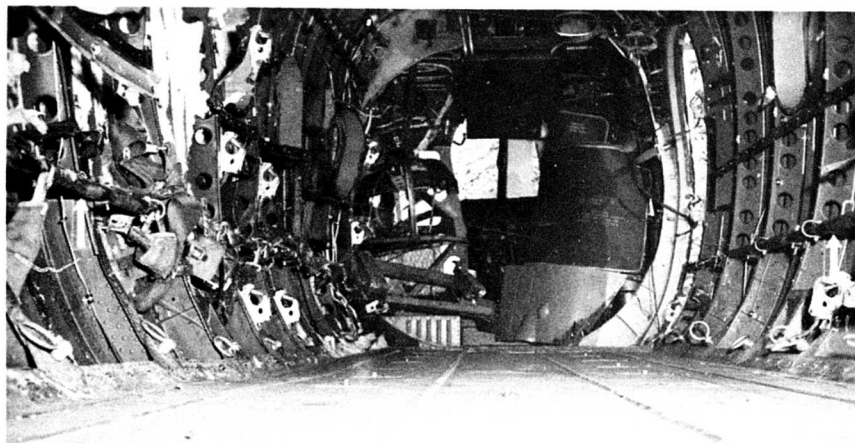
Figure 11. View looking forward to show intactness of the helicopter. The floor showed no distortion. Arrows denote the rear-seat supporting structure.

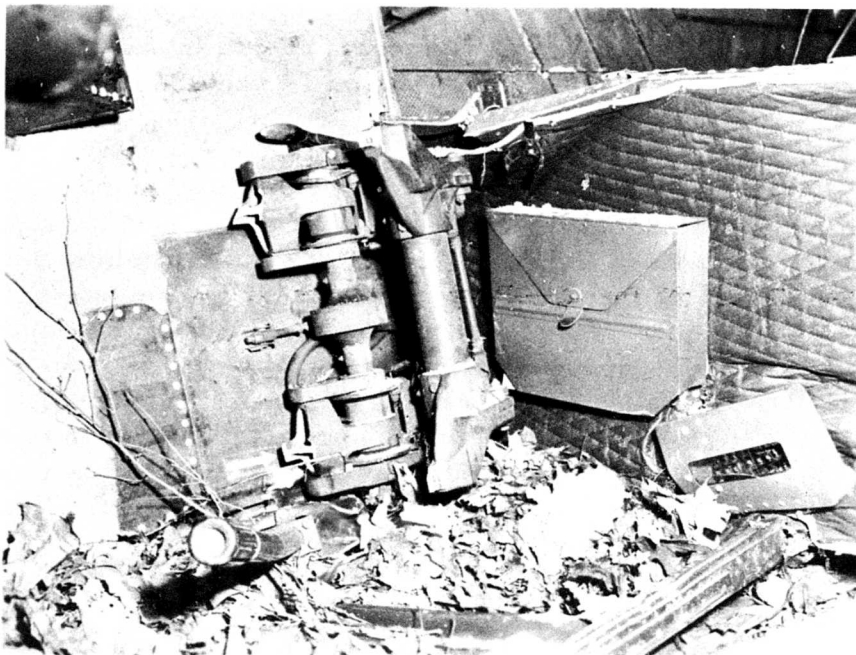
The most significant damage in the entire cockpit area was the failure of both pilot and copilot's seats during the lateral deceleration. Both seat supporting structures failed, permitting the pilot and the copilot to be thrown violently to the left. This movement caused the copilot to strike the left vertical support member, as shown in posed photograph (Figure 12). Figures 13 and 14 show the seat supporting structures and the failure points.

Figure 13. The four seat support members (arrows) of the copilot's seat failed due to side load.

1. The seat supporting structure of the pilot and copilot seats in the H-21 be re-designed to prevent failures due to lateral forces under survivable conditions. A more ductile material, which will absorb energy through progressive collapse, is suggested.

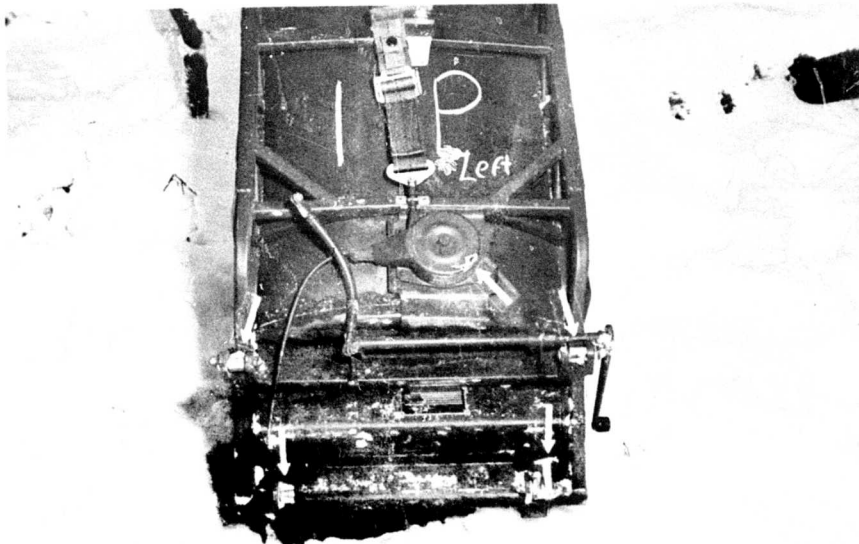
The complete failure of the seats from their supporting assemblies rendered the shoulder harnesses and the seat belts of both the pilot and the copilot ineffective. Figures 15 and 16 show the inertia reels, which are of the impact type, mounted on the seat backs. The copilot's inertia reel did not lock during this crash, apparently as a result of predominant side loads. Had the inertia reels been anchored to primary structures of the aircraft, the occupants would have been partially restrained by the shoulder harnesses even though the seats failed. An additional item of interest is the excessive width of the shoulder harness guide at the top of the seat (Fig. 17). Under seat load conditions as experienced in this accident, the occupant is permitted to move laterally several inches before the harness becomes effective.

Figure 15. A rear view of the copilot's seat. Arrows depict points of failure of the support members. Location of inertia reel mounted on the seat back is also indicated.

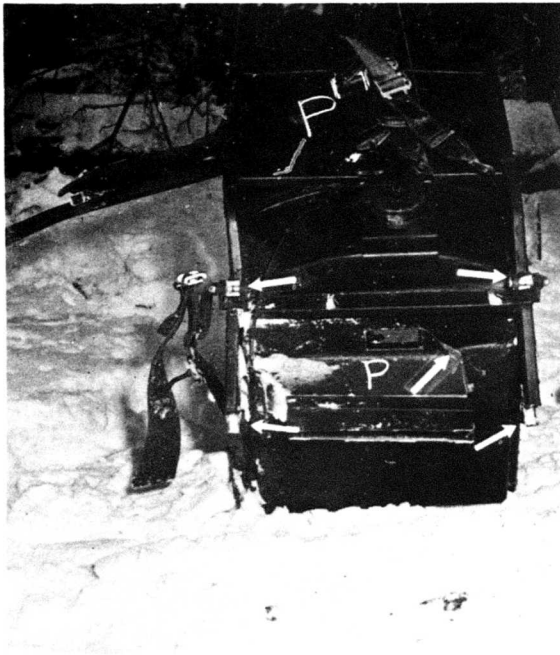
Figure 16. The failures of the seat-support members are depicted by the arrows. The inertia reel locked but due to the seat failure the shoulder harness was ineffective. There are indications that the seat structure offered the pilot some protection when he struck the console.

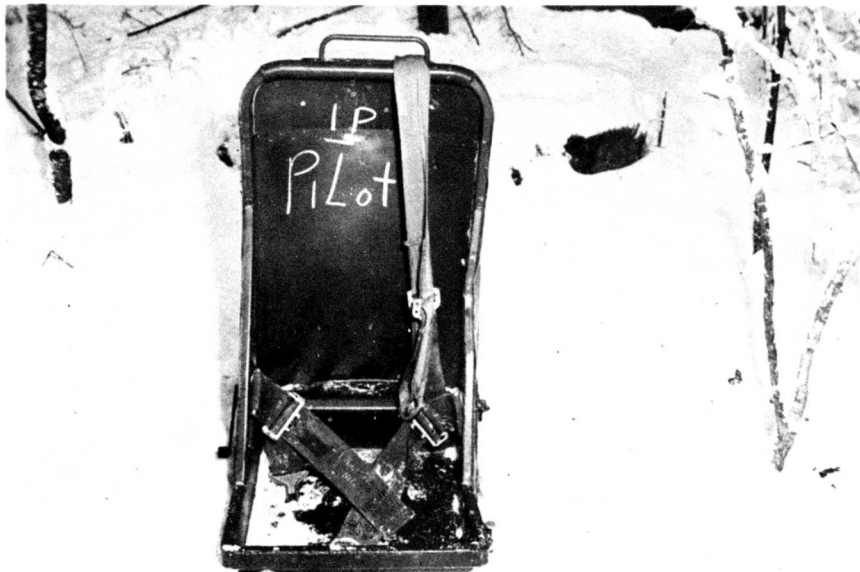
Figure 17. The wide shoulder harness guide at the top of the seat permits considerable lateral movement under side load conditions.

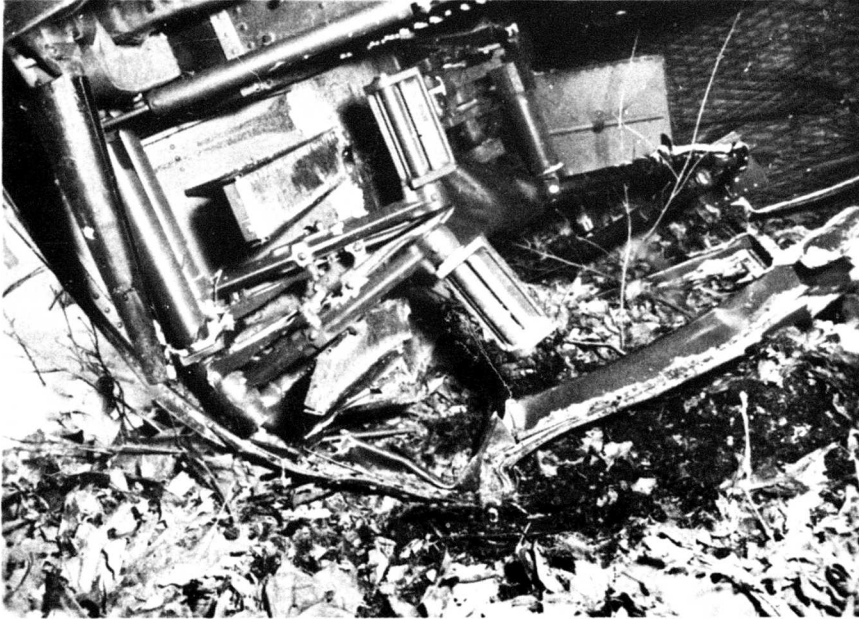
In addition to the seat failures, the instructor's left pedal was pushed inward and rearward; the right pedal was distorted; the copilot's cyclic control stick was broken; his collective pitch control was bent inward against the stick, and the pilot's collective pitch control was broken to the left (Figures 18 and 19).

Figure 18. Front view of the left cockpit area after removal of the copilot's seat.

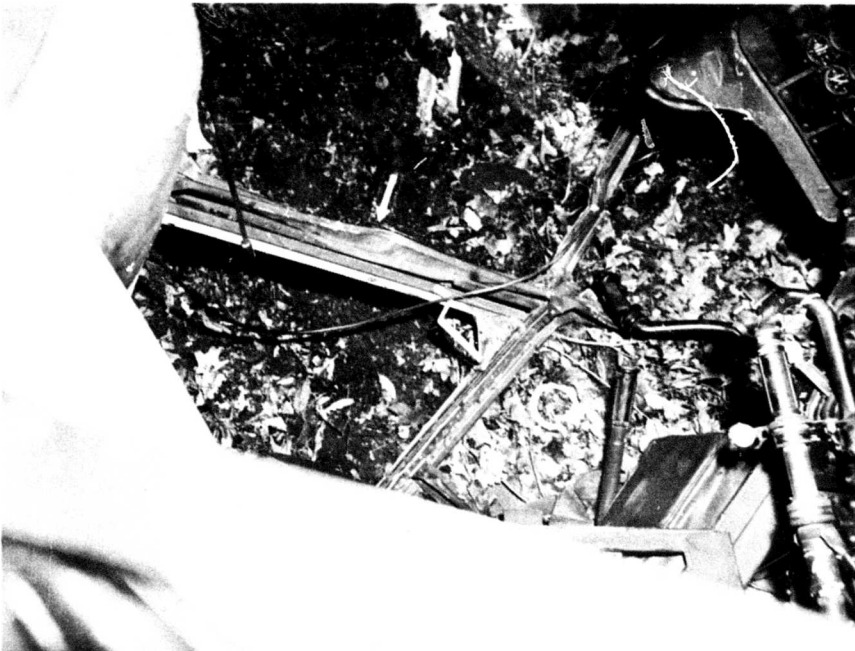
Figure 19. The arrow denotes the point where the copilot's helmet contacted the support member. The copilot's seat is visible in the lower right.

4. Cockpit support members within striking range of either the pilot or copilot be padded with high energy absorption material, such as ensolite.
5. The three-man troop seat used in this aircraft be re-designed or a new design be developed which will prevent structural failures under survivable conditions.

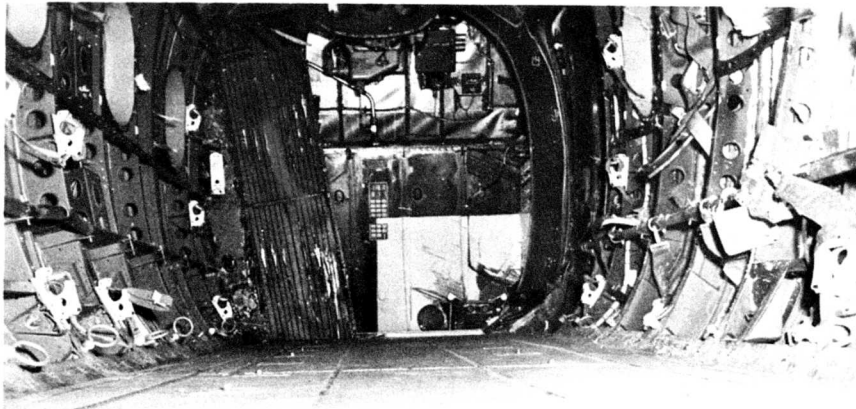
2. MAIN CABIN—The basic structure in the main cabin area remained completely intact, as illustrated in Figure 20. In spite of the intact condition of this basic structure (indicating moderate crash forces), a number of the seats and seat belts failed, resulting in numerous injuries to the occupants of the main cabin. Figure 21 is a chart showing the seating arrangement of all occupants at the time of the accident, seat and seat belt damage, and a summary of the injuries sustained by each occupant.

Figure 20. View looking aft at floor level. Note the tie-down rings (floor level) designed for cargo. Each ring is tied into primary structure and stressed for 2,000 lb. Similar tie-downs for the safety belts would prevent some of the failures that occurred in this accident.

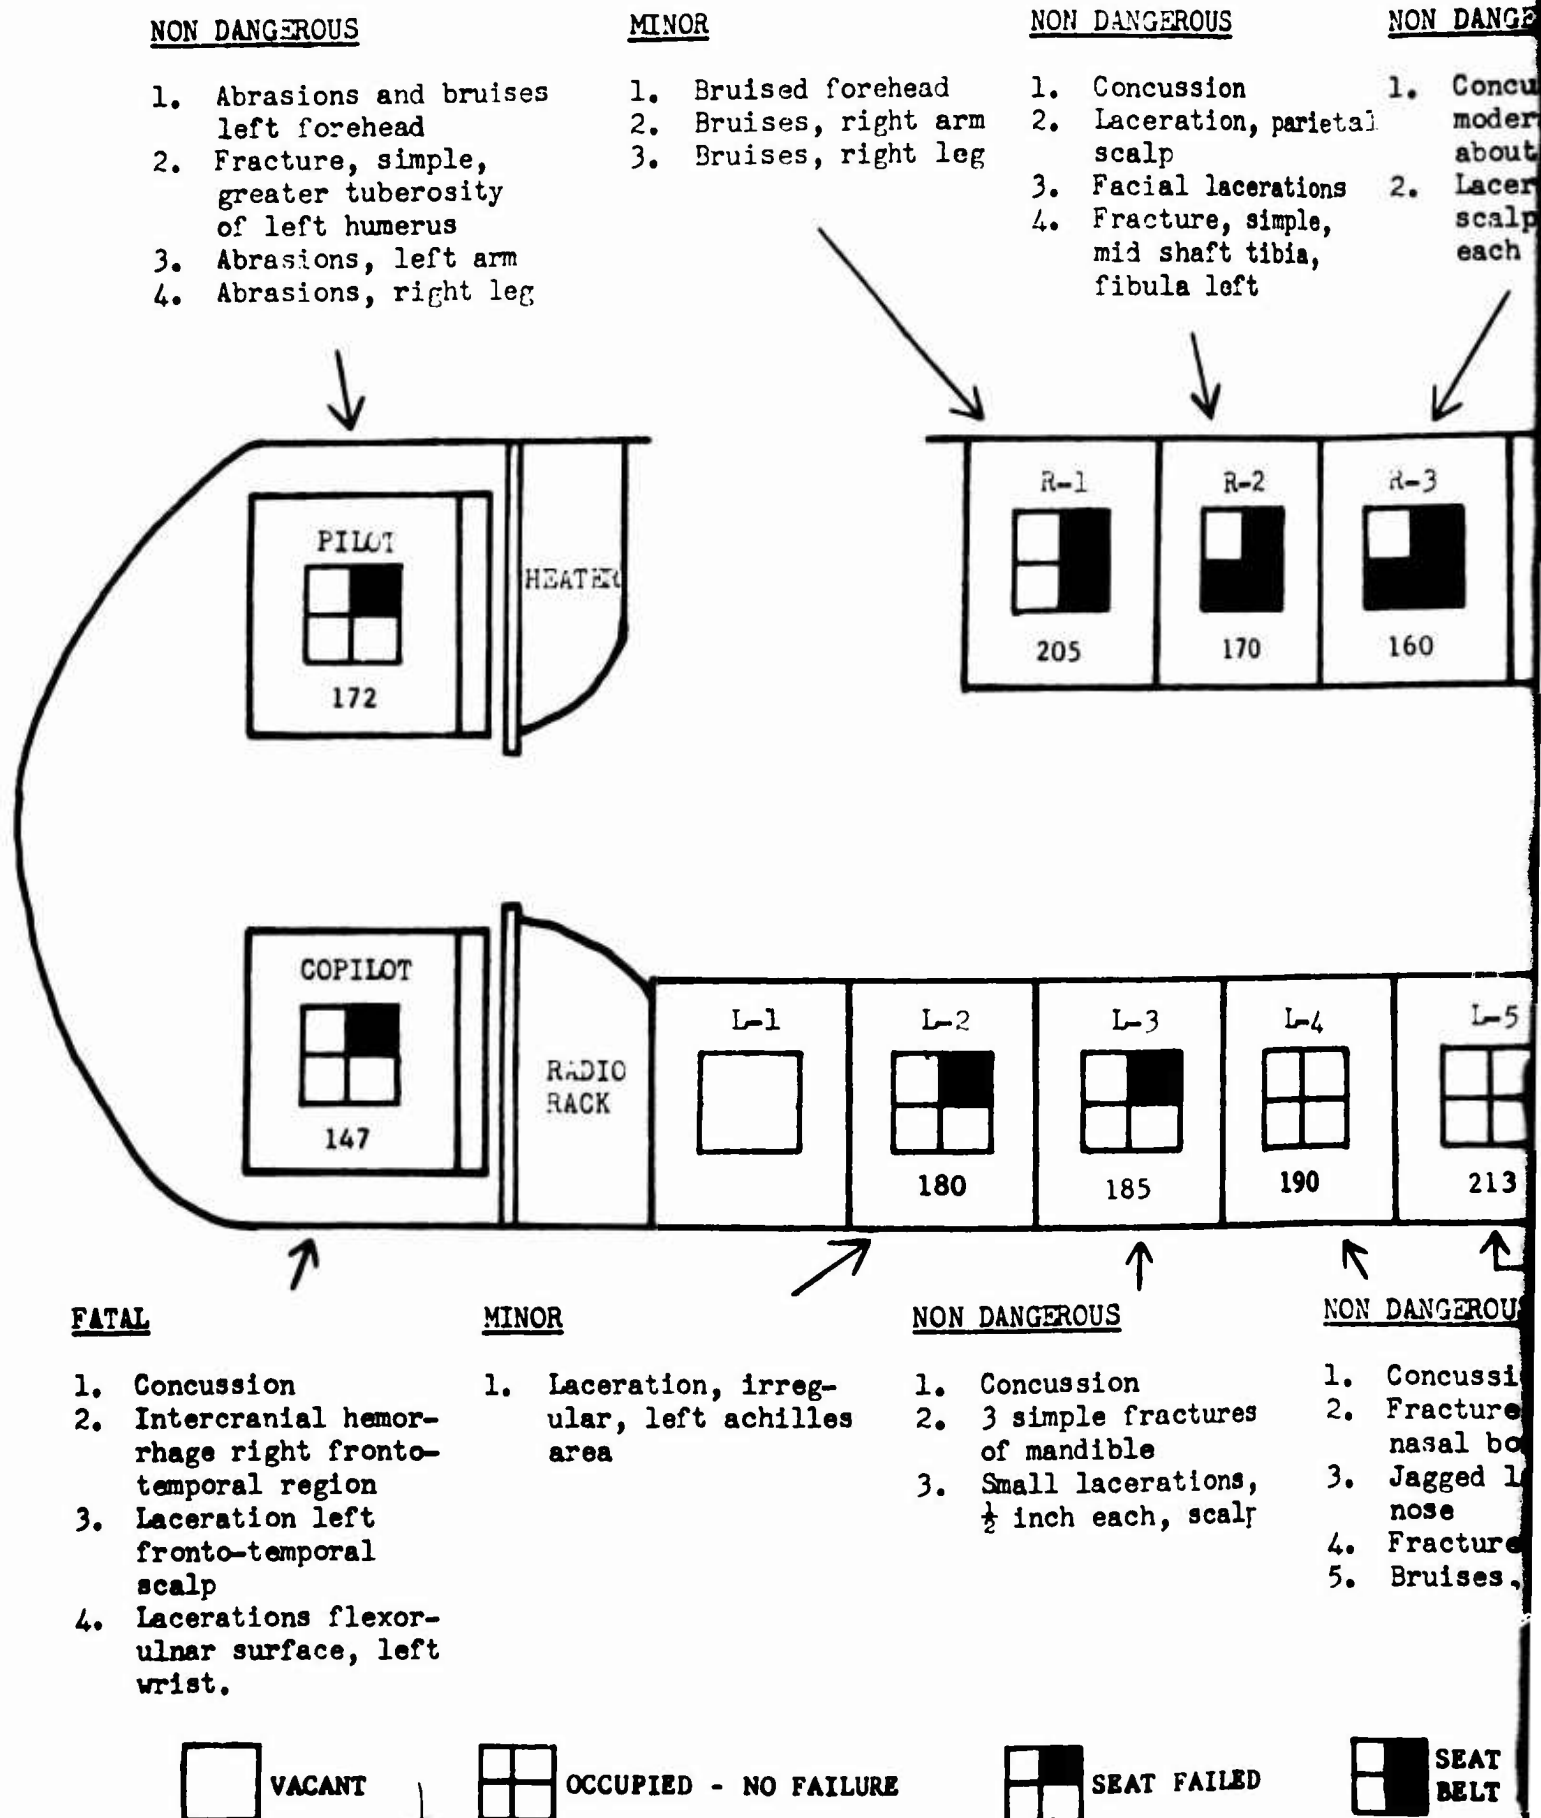
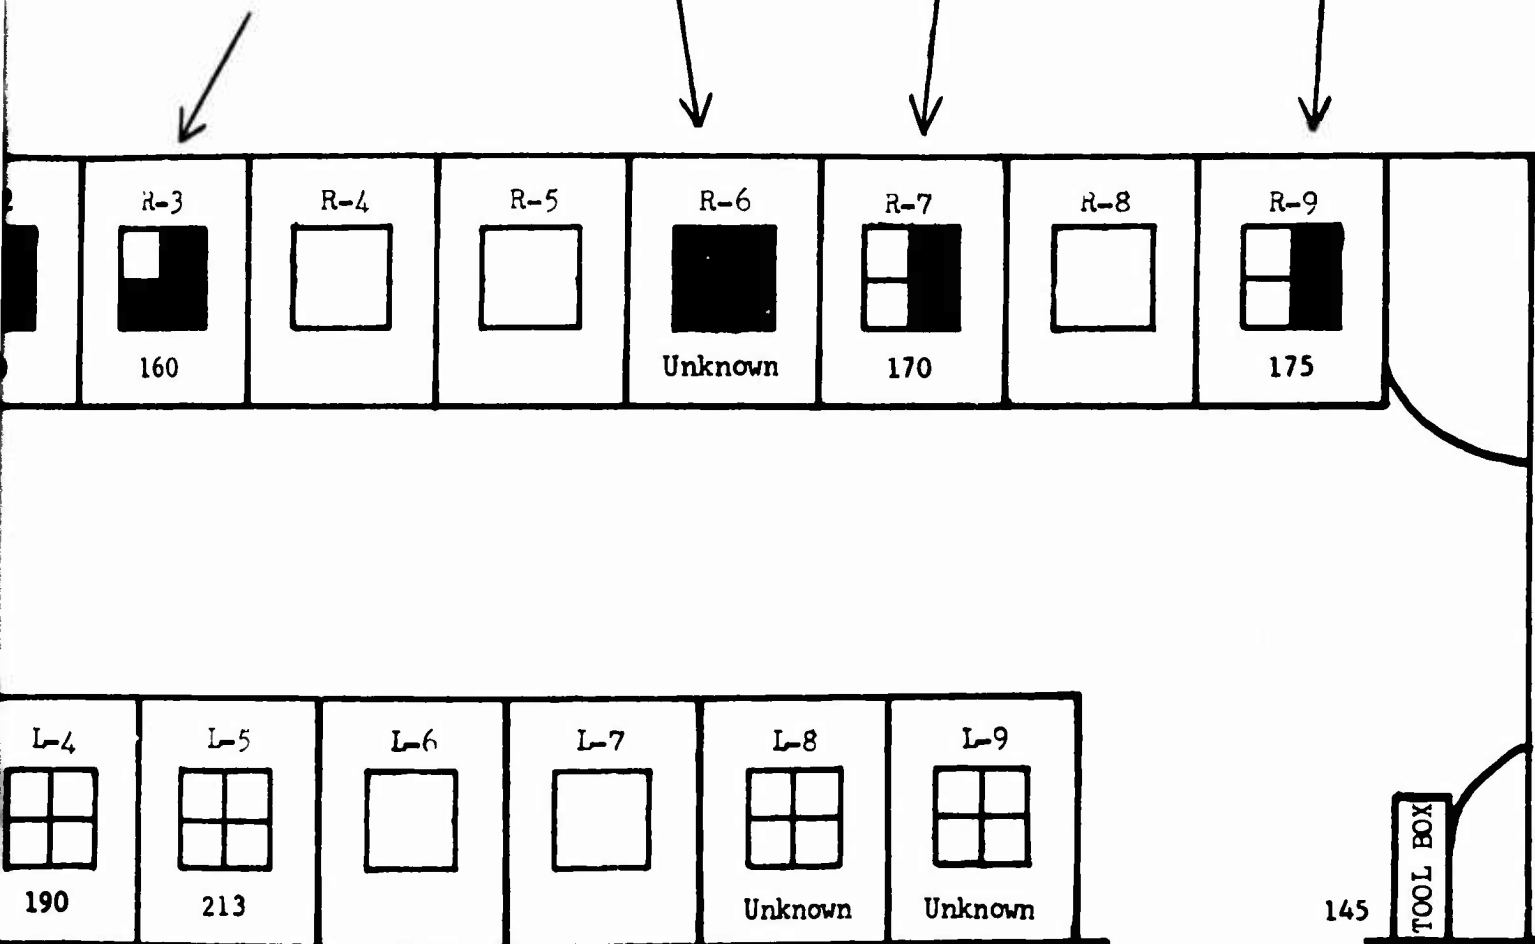
FIGURE 21.

An examination of the chart reveals that six seats failed, two on the left, or low side, of the aircraft and four on the right, or high side. The two failures on the left side of the cabin consisted of failure of the vertical seat supports. These failures probably occurred when the occupants from the right side were thrown against them. The four seat failures on the right side resulted mainly from a number of breaks in the rear seat supporting structure. These failures occurred at the points where the seat supporting structure is drilled to accommodate either a seat belt

Further examination of Figure 21 also reveals six seat belt anchorage failures on the right, or high side, of the cabin. These failures also resulted from failure of the rear seat supporting member. The safety belts are attached to this rear seat supporting member in the following manner: A D-ring is attached to the rear seat support member through one of the drill holes cited above. The safety belts are then snapped to this D-ring. Two safety belts are frequently attached on one D-ring; that is, the left safety belt of one occupant and the right safety belt for another occupant are both attached to the same ring. This is illustrated by Arrow 5 in Figure 27. A single failure, under such conditions, permits two occupants to be thrown free in the cabin area. Attachment of the seat belts in this manner, combined with the forces generated by the occupant in the seat, contributed to the numerous failures of the rear seat supporting structure in the accident.

Figure 21 also reveals that two seat belt webbing failures occurred during the accident (Seats R-2 and R-3.) These failures are illustrated in Figures 28 and 29. The failures were probably caused by the occupants wearing the seat belts loosely fastened, resulting in amplification of the impact forces or jolt loads on the belts.

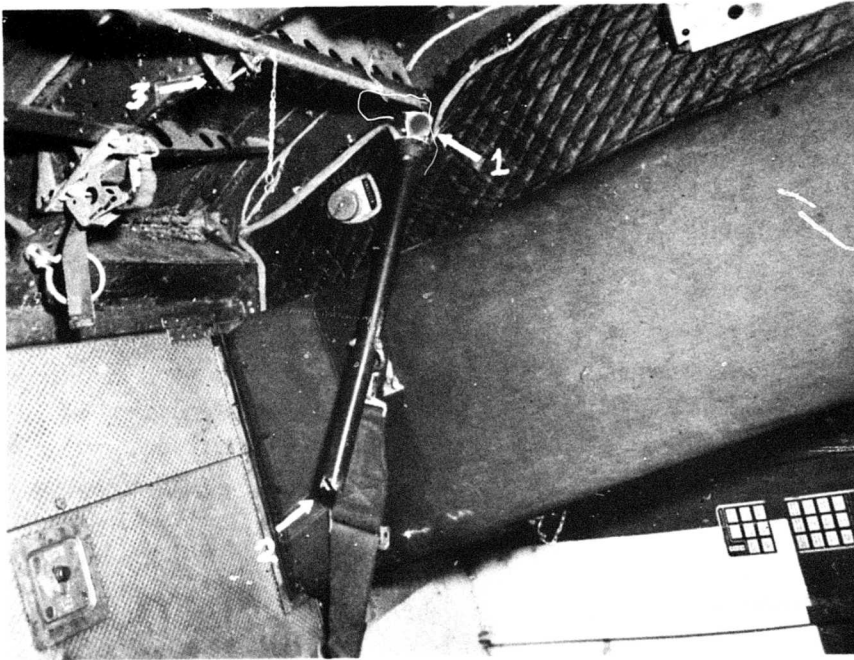
Figure 22. The rear support member, in addition to failing, was nearly torn free from the rear bulkhead (arrow 1). Arrow 2 shows a failure in the rear support member which is normally attached at arrow 3.

attachment (D-ring) or a wall anchorage. The drill holes are located approximately every 18 inches along the length of the support member. In addition to the rear seat support member failures, there were also numerous vertical and diagonal support member failures of the seats on the right, or high side. Illustrations of seat failures are contained in Figures 22 through 27.

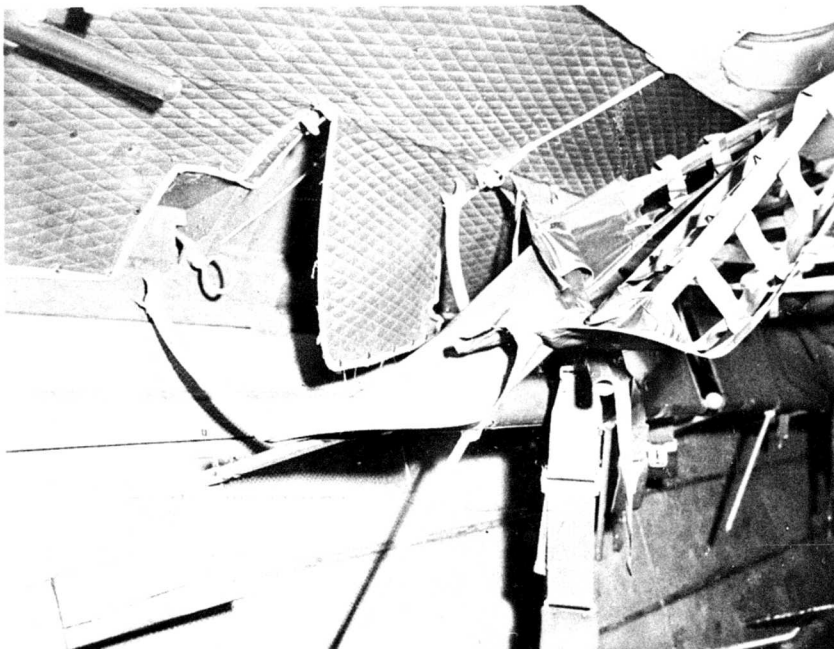
Figure 23. The first group of seats (forward) on the right or "high" side. The rear support failure plus belt and tie-down failures allowed the occupants to become projectiles.

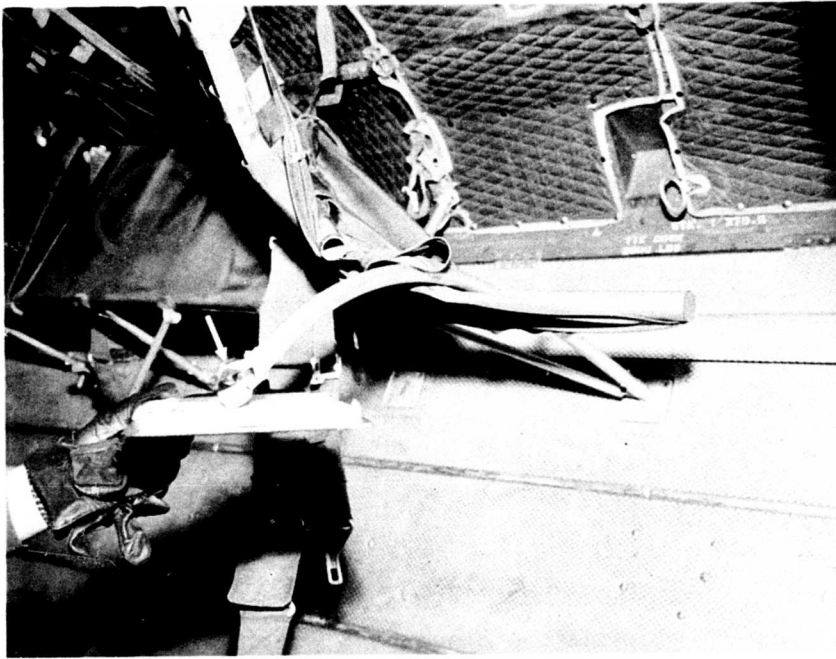
Figure 24. The seat spreader (arrow) was torn from the rear support member.

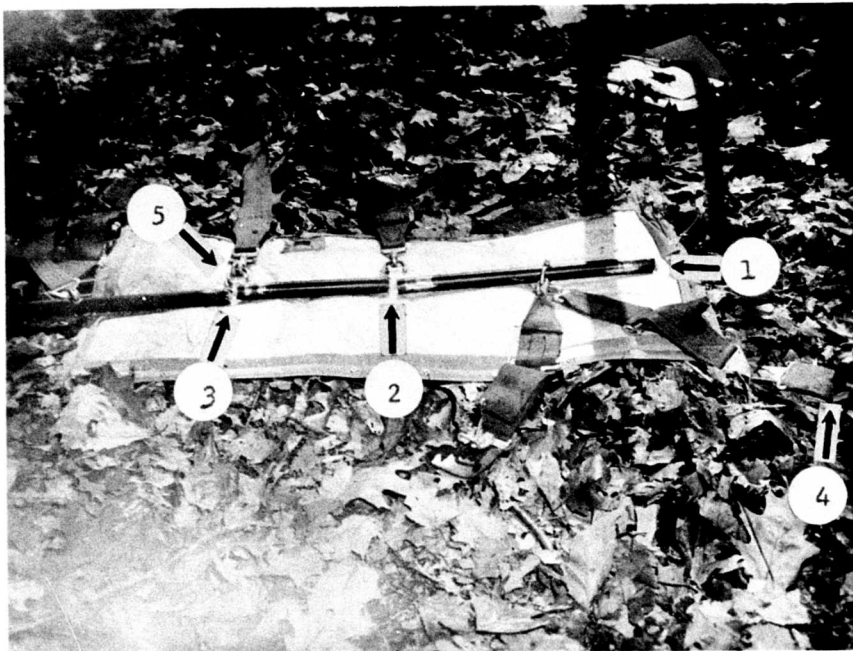
Figure 27. View showing the failures of the rear-seat supporting structure (arrows 1, 2 and 3) due to the seat belt anchorages' tearing free. Notice the failure of the seat belt webbing (arrow 4). Arrow 5 indicates the manner in which two belts are anchored to the same "D" ring.

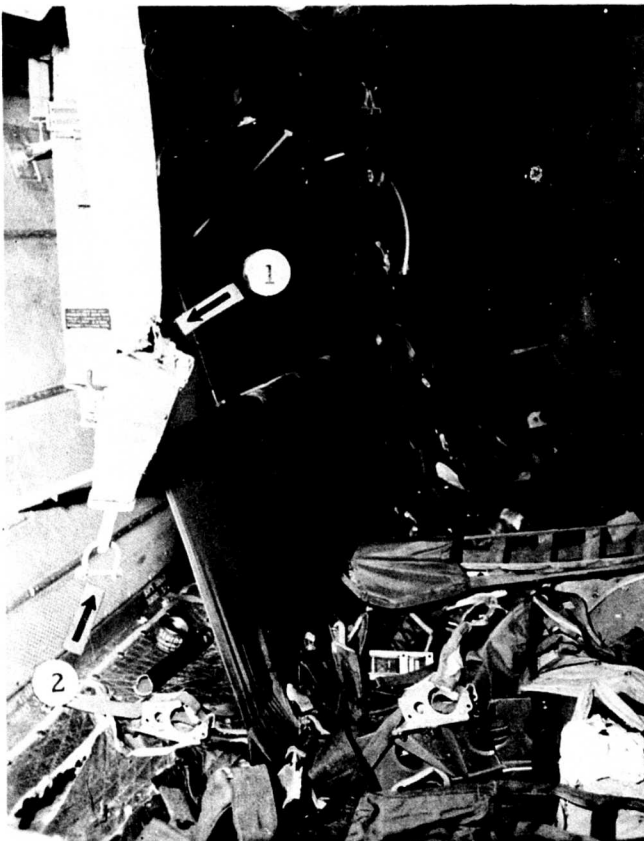
Figure 29. Particular attention should be paid to arrows 1 and 2. Arrow 1 indicates webbing failures. Arrow 2 shows the "D" ring that was pulled out of the rear-seat support structure. This was actually a double failure at a single restraint attachment point.

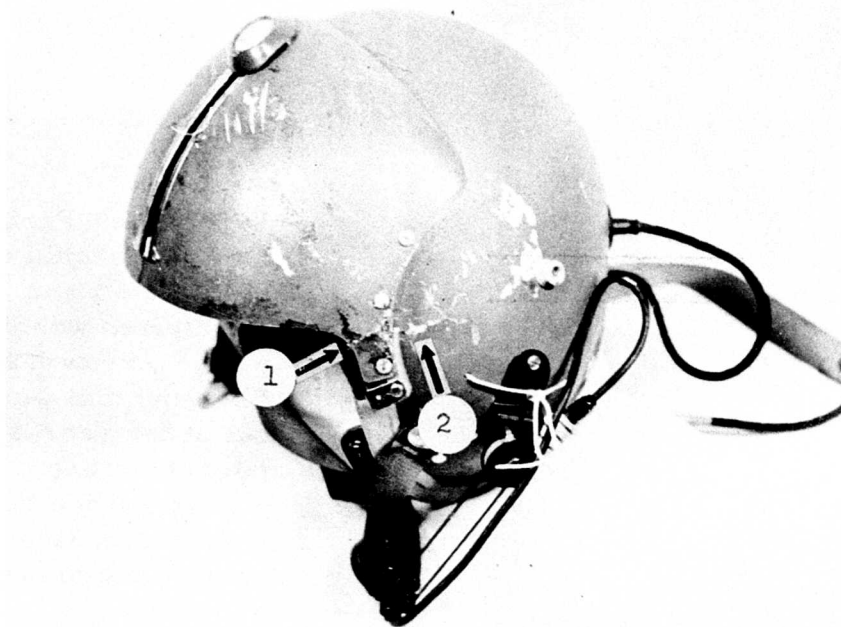
Figure 30. Impact marks were found on the left temple area and also on the visor housing. The arrows point out the area of impact.

1. COPILOT—At impact, both cockpit seats failed and permitted the seats and their occupants to be thrown violently to the left. The copilot, who occupied the left cockpit seat, nearest the point of impact, struck the left vertical cockpit support member with the left side of his helmet, just above the keeper on the eye shield housing. The impact marks on the helmet are indicated in Figures 30 and 31. A detailed examination of the helmet revealed that the blow was absorbed by the shield housing at the point indicated by Arrow 1 in Figure 30. The shield housing broke at this point, permitting inward bending of the outer shell, resulting in a fracture approximately one inch in length at the point indicated by Arrow 2. Removal and examination of the inner liner revealed that the total force was absorbed over an area of approximately 2 to 3 square inches.

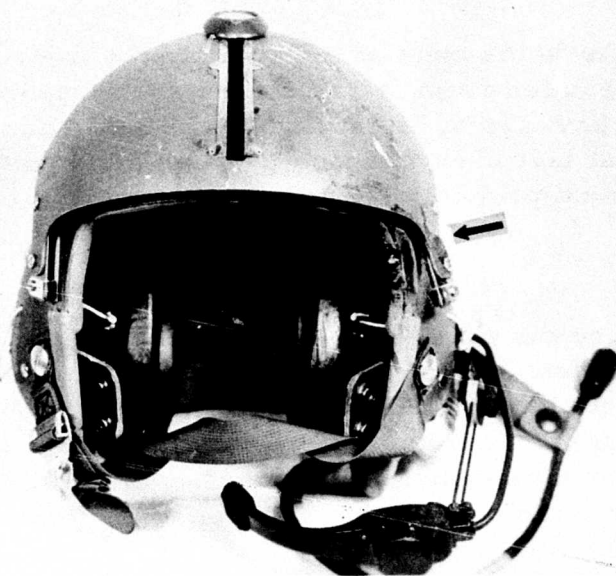
Figure 31. Front view of the copilot's helmet. The arrow denotes the impact area.

lesion (an inter-cerebral hematoma in the right fronto-temporal region). This brain injury was of the contrecoup type, the result of transmission of impact force from the point of impact to the opposite side of the brain. The copilot was hospitalized, underwent neuro-surgery, suffered a cardiac arrest and died about 20 hours after the accident. In addition to the brain injury, the copilot also sustained a laceration to the left wrist, apparently as his wrist struck the window handles.

The fatal injury suffered by the copilot resulted from a combination of the following factors: (1) failure of the seat-supporting structure; (2) attachment of his restraint system (seat belt and shoulder harness) to the seat itself, rendering them ineffective when the seat failed; (3) exposed vertical support member within striking range of his head; (4) concentration of the force of the blow in a very small area of the crash helmet. It is believed that elimination of any one of the above factors would have reduced the severity of the injury and, probably, prevented the fatality.
