HEADQUARTERS  
70TH ENGINEER BATTALION (COMBAT)(ARMY)  
APO 96294

SUBJECT: Operational Report-Lessons Learned (RCS CSFOR-65), for Quarterly Period Ending 31 Oct 66.

SUBJECT: After Action Report - Golf Course Airstrip

SUBJECT: After Action Report - Golf Course Airstrip Repair

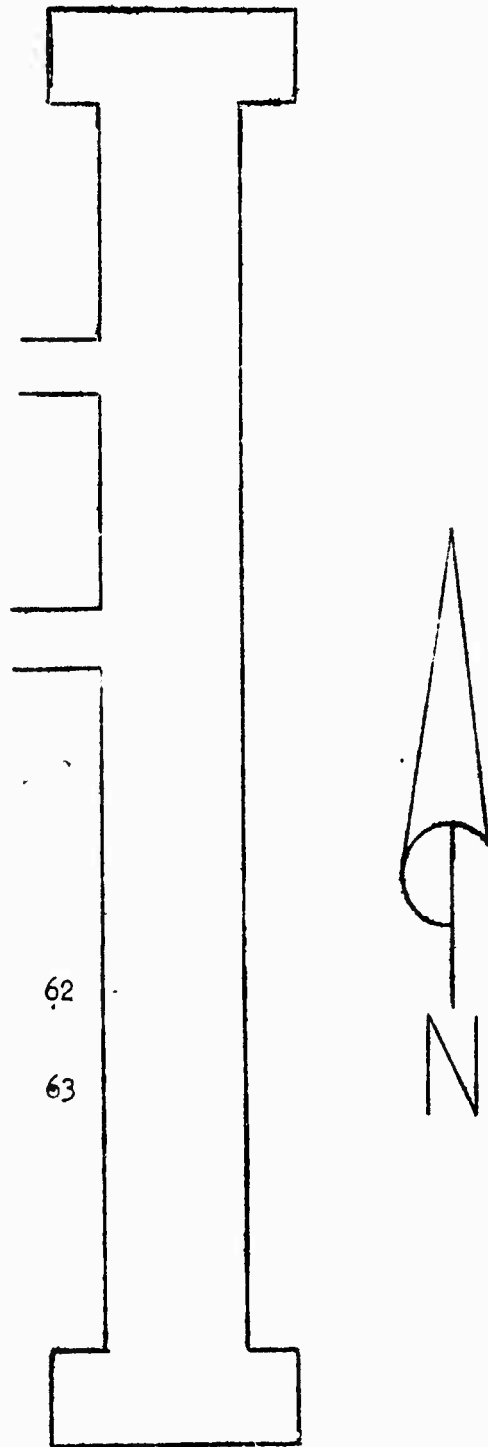
GOLF COURSE AIRSTRIP

1. General: On 19 Sep 66 a pumping action was observed at station #62, (see inclosed map) on the Golf Course Airstrip. This action at this particular time was confined to mud being forced up through the joints in the AM-2 matting. In as much as this was an isolated case and the AM-2 matting did not appear to be undergoing any damage it was decided to have this section monitored closely and keep the airfield open. On 30 Sep 66, personnel observing this area noted that the AM-2 matting was becoming deformed. The area undergoing a deformation process encompassed 1000 sq ft and had deflected approximately 2" vertically. The battalion continued to monitor the strip very closely since it could not be closed due to operation Thayer. At 1245 on 7 Oct 66, a hair line crack (sketch A) was observed in the joint of the end panel of the depression. Landing and taxiing of C-130 aircraft over the section where a depression had formed actually caused the AM-2 panels to become disengaged in two separate places. After removing the AM-2 matting and inspecting the sub-grade conditions the disengaging of the panels was attributed to the failure in the sub-grade, which when taxied upon by C-130 Aircraft effected a rippling action in the AM-2. The strip was officially closed as of 1800 hours 7 Oct 66.

(4) The T-17 membrane had a tear 75' long in the area of the depression and had rolled back 15-20' in several places. This tear in the membrane allowed water to penetrate the subgrade. Thus saturating the two inches of capping material, which turned into a slurry and was pumped up through the joints of the AM-2 when aircraft landed or taxied over it. All of the T-17 membrane was removed and due to its having sustained numerous small rips in addition to the large tears could not be reused. At station #63 a factory seam had separated for a length of 20-25'. The condition of the subgrade was as described above.

- a. 300' of AM-2 matting was removed and salvaged.
- b. 300' of T-17 membrane was removed.
- c. The areas in the subgrade which had failed were refilled, using a sand-cement and soil-cement mix, and compacted.
- d. T-17 membrane and AM-2 matting was replaced.

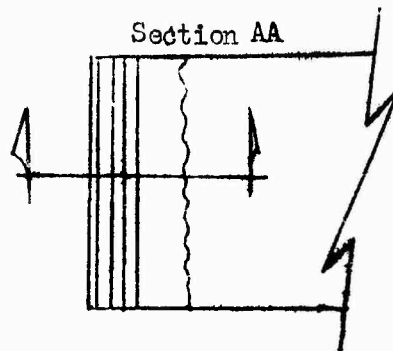
SKETCH A

Location of Hairline Crack

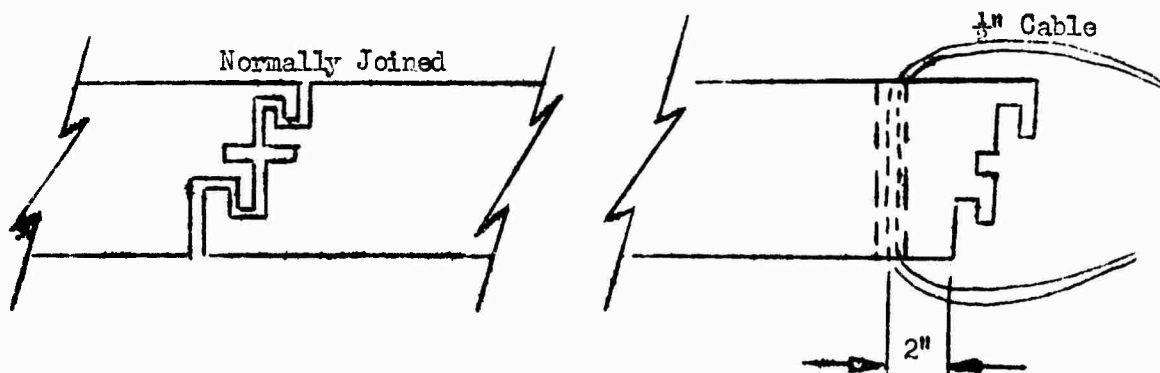
SKETCH B

Modified Panel

(2) A modified short panel (sketch B) with an attached cable for towing was then connected to the one end of the panel and an HD-16 was used to pull the entire section out. This operation was repeated at 5 different locations in order to determine the extent of the area to be repaired and also to facilitate removal of the AM-2.

c. Modified panels should be used in removing a row of AM-2 panels. These panels provide an expedient extraction system. Any removal of AM-2 using the modified panel or insertion of a closing strip using the modified panel should be accomplished by pulling the "run" with a HD-16 dozer. Pushing is undesirable because of possible buckling and destruction of the AM-2 panel.
