**SUBJECT:** Operational Report - Lessons Learned, Headquarters, 1st  
Battalion, 63d Armor, Period Ending 31 October 1967

DEPARTMENT OF THE ARMY  
 HEADQUARTERS, 1ST BATTALION 63D ARMOR  
 Fort Riley, Kansas 66442

SUBJECT: Operational Report - Lessons Learned RCS CSFOR-65

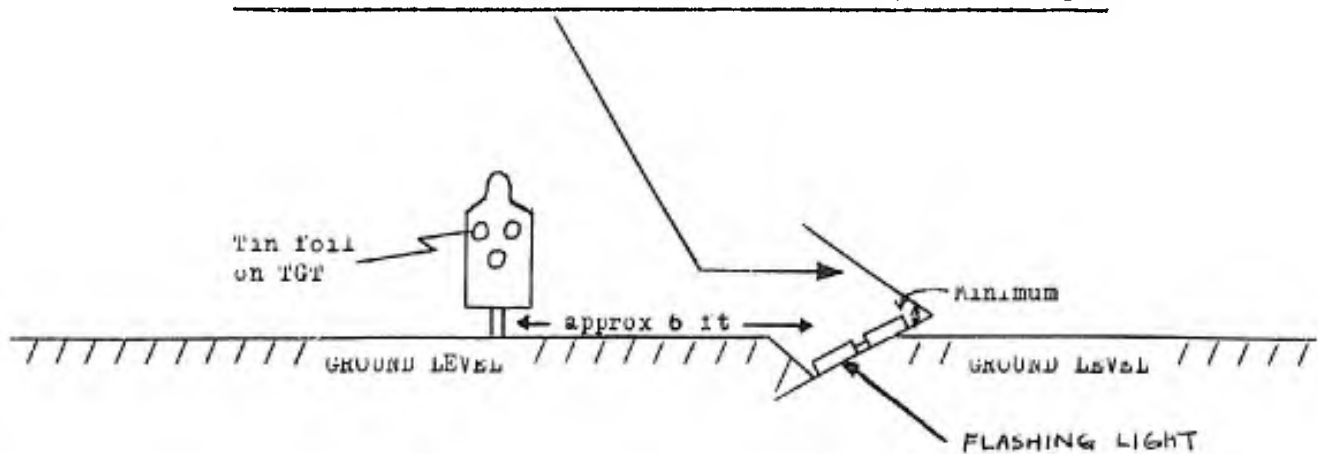
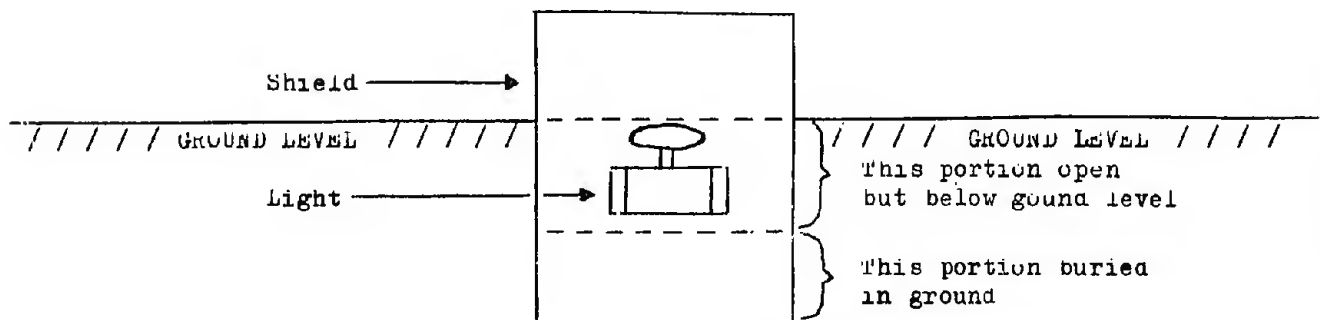
## IMPROVED PROTECTIVE DIAGRAM FOR TARGET NITE LITE DEVICE FOR SUBCALIBER RANGES

d. This unit plans to improve the protective measures for the lights. See Appendix 2 to Annex B for schematic drawing of new protective device.

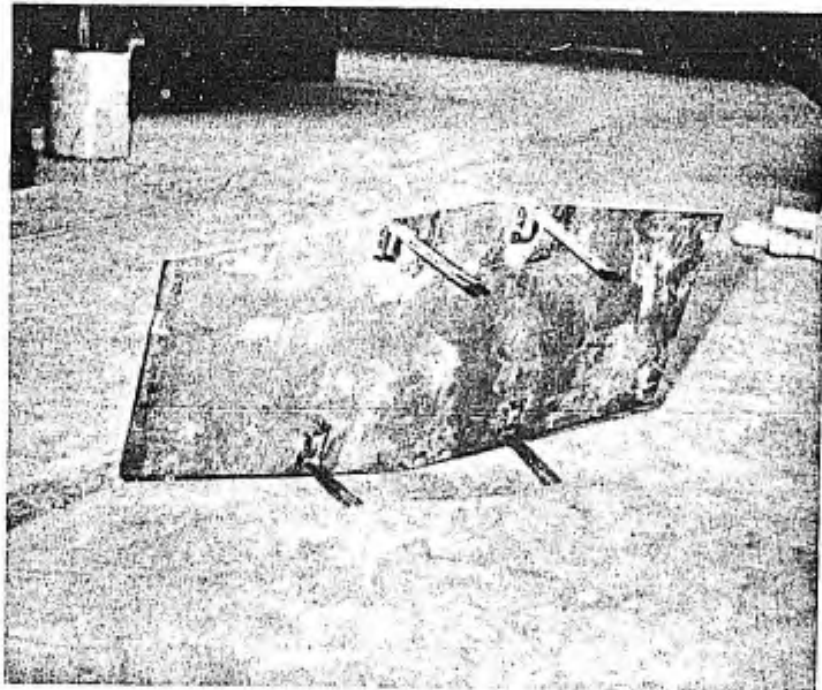
PICTURE OF UNIT-MADE SECURITY SHIELD

4. Intelligence and Security: When it becomes necessary to remove the gun tube and mantle, the tank is no longer a classified container. The unit has fabricated a metal shield bolted from the inside to alleviate this problem. A picture of the shield is included as Annex D.

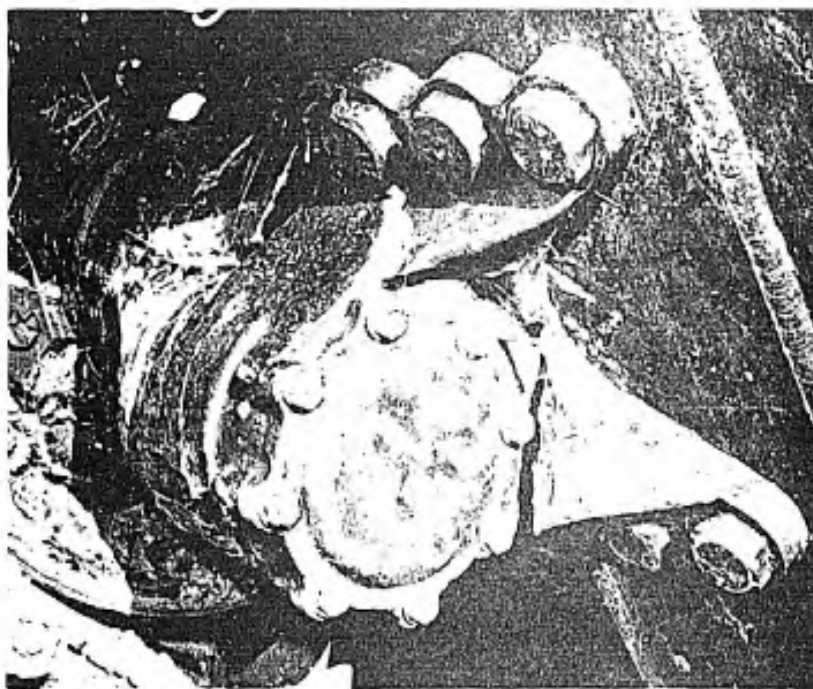
ANNEX E  
SUBJECT: BROKEN IDLER ASSEMBLY

(b) Idler Assembly: See Annex E.

(1) Broken Idler Assembly - Section I, paragraph 6b(2)(b) of  
basic report and Annex E.

The first instance of a broken idler assembly occurred on 11 October 1967. At the time for the damage, the vehicle was traveling at approximately five (5) miles per hour, under conditions of darkness when the right track struck a stump.

In addition to the damage illustrated below there was a slight dent in the right side of the hull immediately to the rear of the Idler assembly. The corner of the hull under the assembly was also dented.

The broken Idler arm assembly was sent to the factory for analysis.
