SUBJECT: Operational Report - Lessons Learned, Headquarters, 577th  
Engineer Battalion (Const), Period Ending 31 January 1968 (U)

DEPARTMENT OF THE ARMY  
HEADQUARTERS, 577TH ENGINEER BATTALION (CONSTRUCTION)  
APO US Forces 96316

SUBJECT: Operational Report - Lessons Learned (RCS CSFOR-65), for  
Quarterly Period Ending 31 January 1968

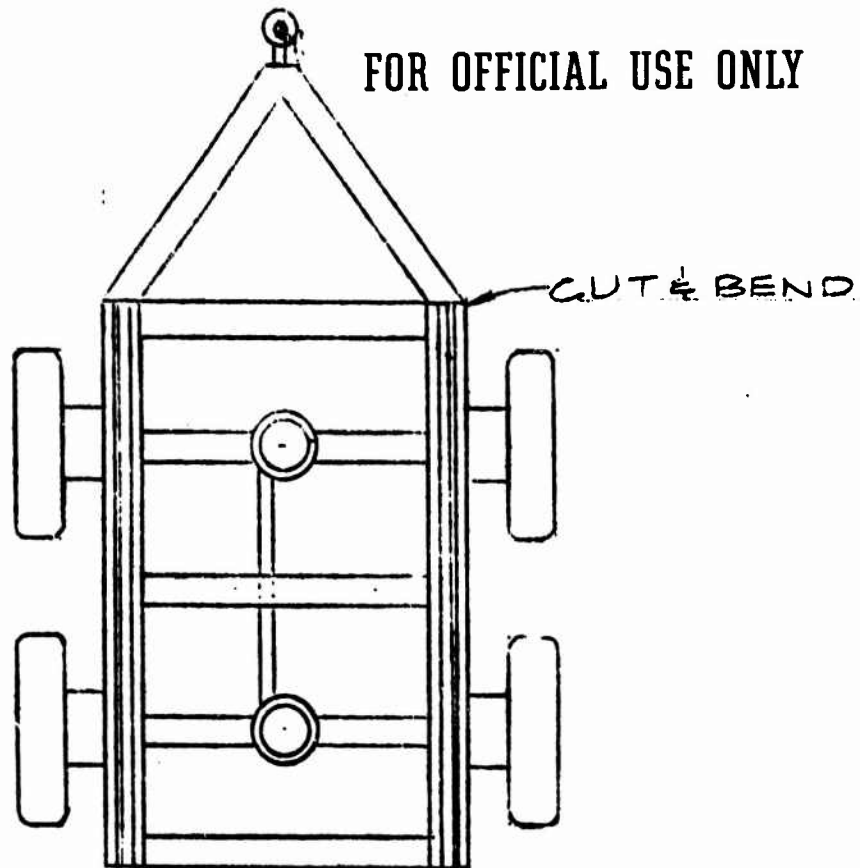
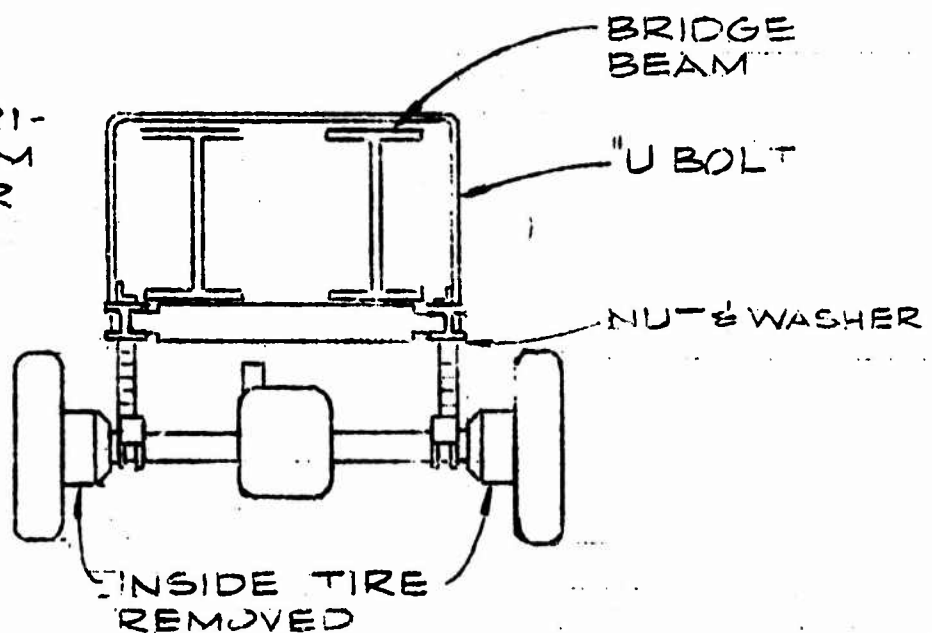
DOLLY TRAILER

Discussion: For bridge construction, long heavy beams and girders must often be transported over narrow winding roads where operation of 25 ton tractor-trailers is difficult and hazardous due to the overhang of the beams. A dolly-trailer was constructed from a salvaged M61 water distributor chassis and the goose-neck of a 25-T trailer (see sketch, Incl 3). The tractor chassis was cut off behind the cab, and the rear section was modified by eliminating the inside duals, providing a wider wheel base. Angle iron was used for bracing to prevent sliding of the beams. Four-foot long U-bolts were fabricated to secure the beams and a pintle hook was attached to pull the dolly when not hauling beams. The gooseneck of a 25-T trailer was modified by using angle iron as bracing to prevent sliding of the beams and again four-foot long U-bolts were used to secure the beams (see sketch, Incl 3).

Observation: Transportation of long length beams can be made easier through the use of a dolly-trailer.

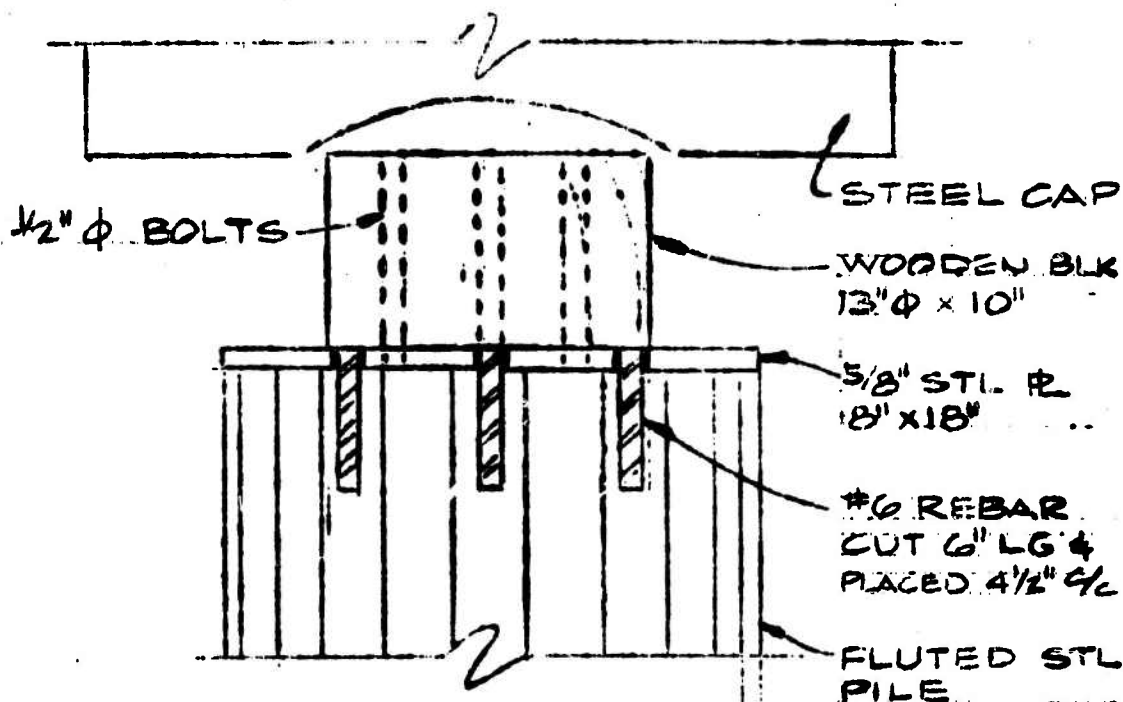
FLUTED STL PILE CAP ADAPTOR

Discussion: To drive an 18-inch diameter fluted steel pile, a cap must be prefabricated since the pile cap normally found with the 3,000-pound hammer is too small. A 5/8 inch thick steel plate was cut 18 inches square, with three 6-inch pieces of #6 rebar welded at 4 1/2 inch intervals on both sides of the plate. (See Incl 4).

Observation: A pile cap adaptor can be fabricated from locally available materials which will provide adequate control for driving fluted steel piles.

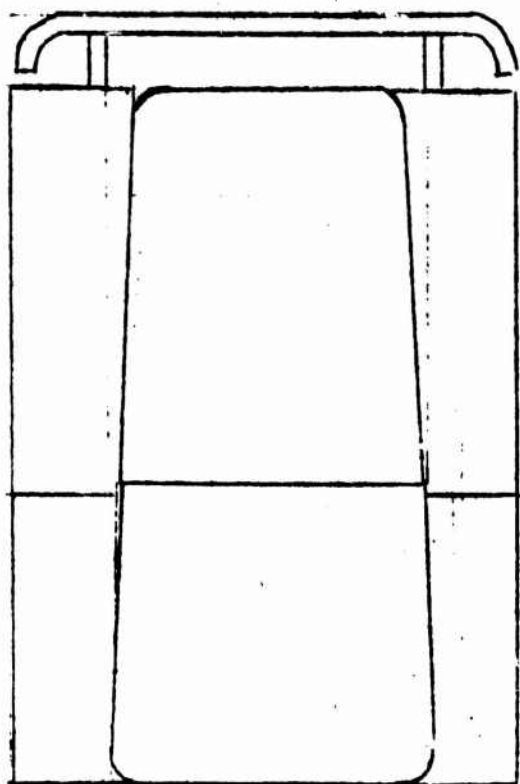
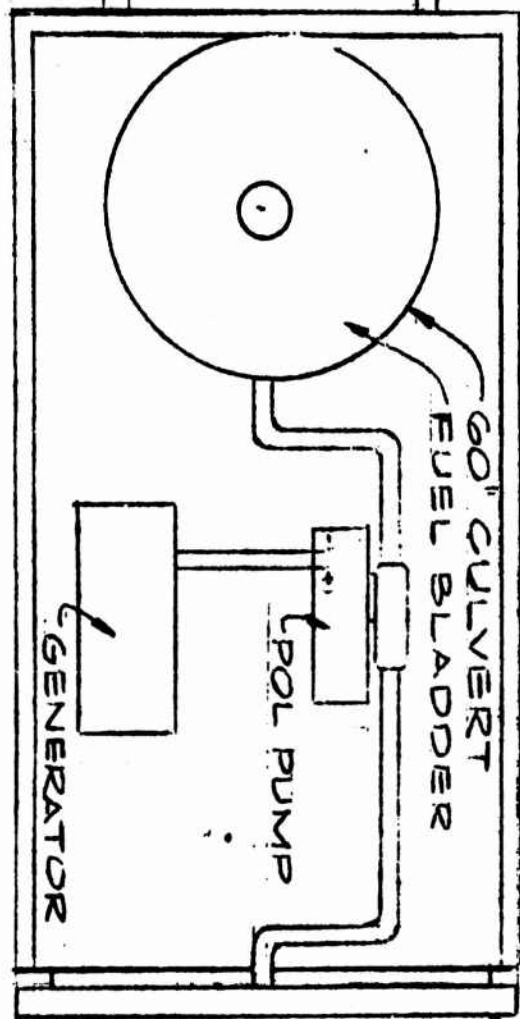
EXPEDIENT ASPHALT DISTRIBUTOR

Discussion: Asphalt distributors were in short supply and in great demand. The nonavailability of a distributor prompted the improvisation of an expedient distributor. The distributor was constructed using a 2 1/2 ton truck, a

section of 60" culvert, a generator, an electric pump, a POL bladder, and a pipe. When assembled, the unit has the capability to distribute cutback or emulsified asphalt for use as a dust palliative. (See Incl 5).

Observation: From materials and equipment normally available, an expedient asphalt distributor can be constructed and used for application of asphalt cutback.

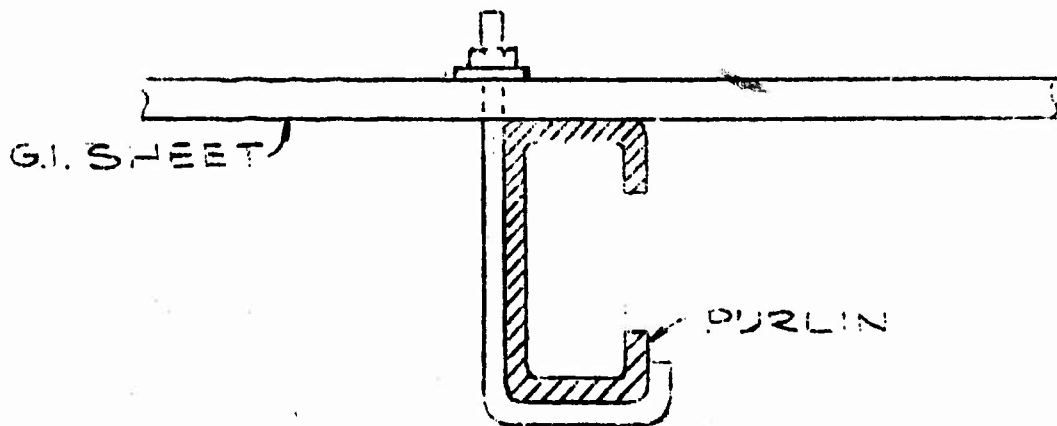
A. J-BOLT INSTALLED

Discussion: During Typhoon Freida the roof of the Nichimen 75' x 202' steel maintenance hangar at the Phu Hiep Army Airfield was subjected to a high dynamic wind loading and was blown off. The roof was constructed of heavy gage corrugated metal sheeting fastened to the roof purlins by use of 3/16-inch diameter J-bolts. It was observed that the bolts failed by bending (straightening out) and became disengaged from the purlins. No additional bolts were on hand to replace the damaged ones and experiments were conducted using a self-tapping screw driven thru the sheet metal into the purlin. This screw provided adequate holding power and had the advantage of easy and rapid installation. (See Incl 6).

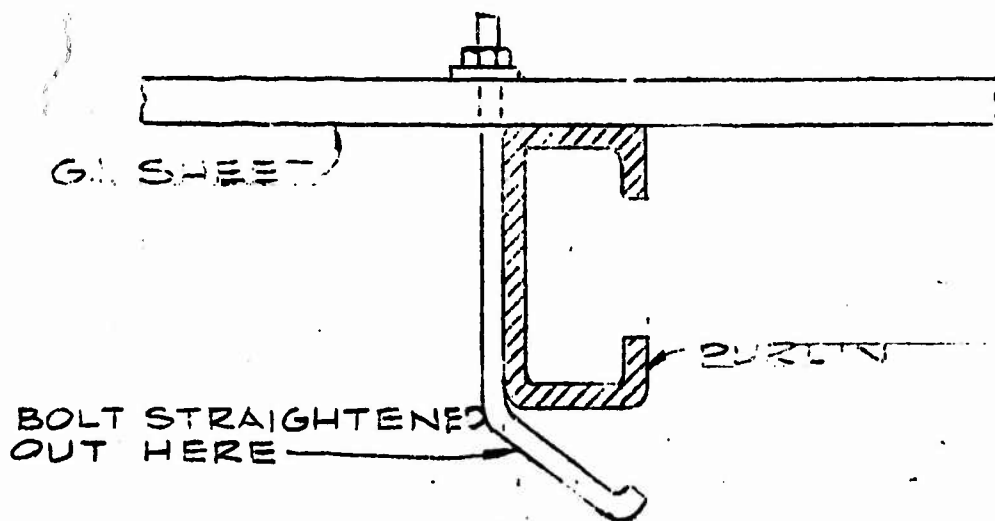
B. FAILURE OF J-BOLT

Observation: The large J-bolts supplied with the Nichimen 75' x 202' maintenance hangar are inadequate. A self-tapping screw which is adequate and easier to install can be substituted.

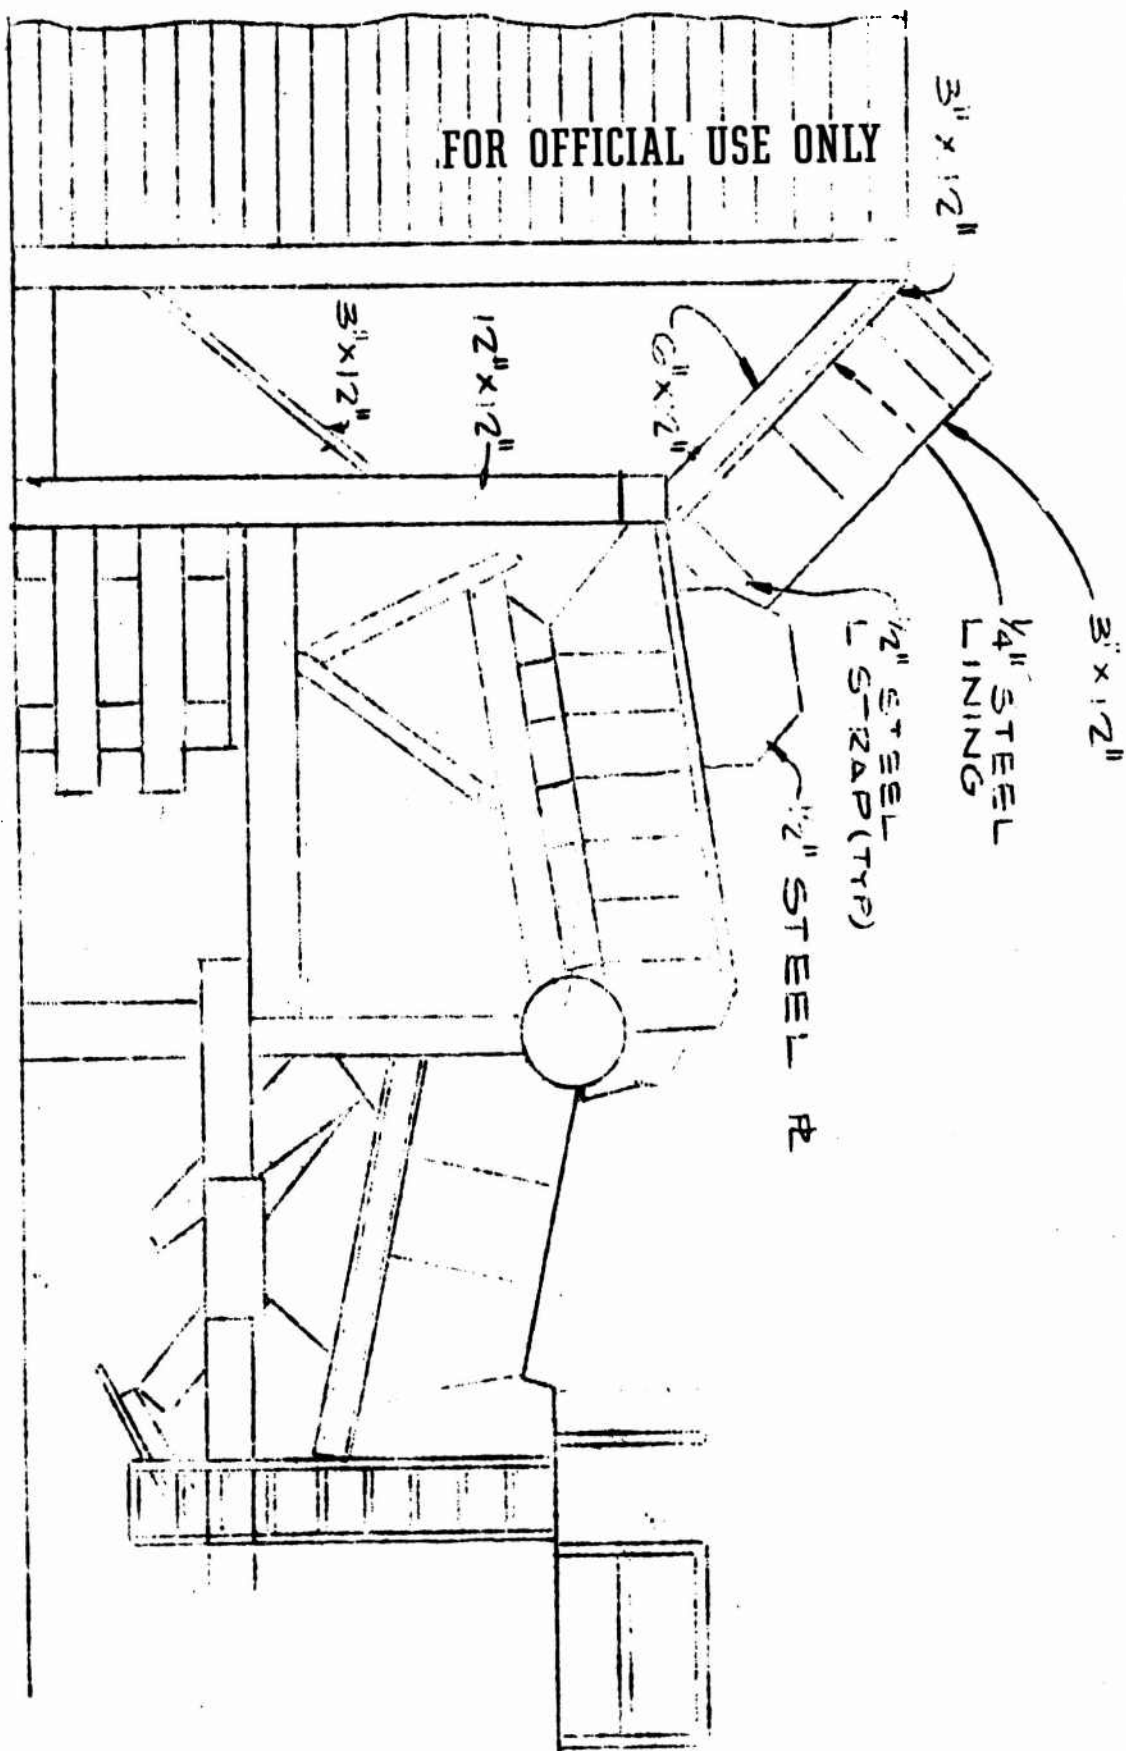
DUMPING CHUTE FOR 75-TPH PRIMARY CRUSHER

Discussion: When loading a 75TPH Eagle primary crusher by a 5 ton dump truck, considerable wear resulted on the drive system for the hopper and
