SUBJECT: Operational Report - Lessons Learned, Headquarters, 93d  
Engineer Battalion (Const), Period Ending 31 January 1968 (U)

SUBJECT: Operational Report - Lessons Learned  
for Quarterly Period Ending 31 January 1968

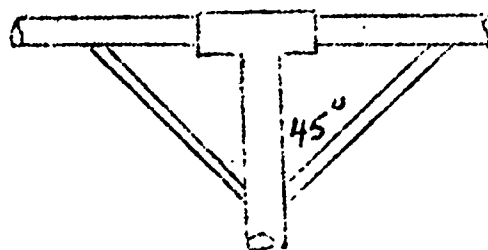
Discussion: The horizontal pipe on fill stands has been found to receive an undue amount of abuse by personnel using the fill stand. In several instances, the problem was solved by welding a pipe as a 45° brace between the vertical pipe and the horizontal pipe.
