AN ANALYSIS OF THE  
INTERNAL LEAKAGE CHARACTERISTICS  
OF CERTAIN MAROTTA VALVES

Report GDC-BRW65-008

1 December 1965

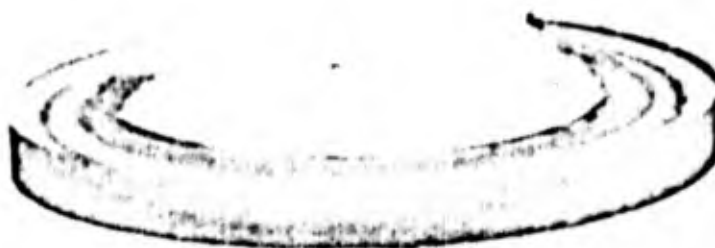
Figure 1. Overall View of Marotta Valve Seat from Problem Report A0255CP

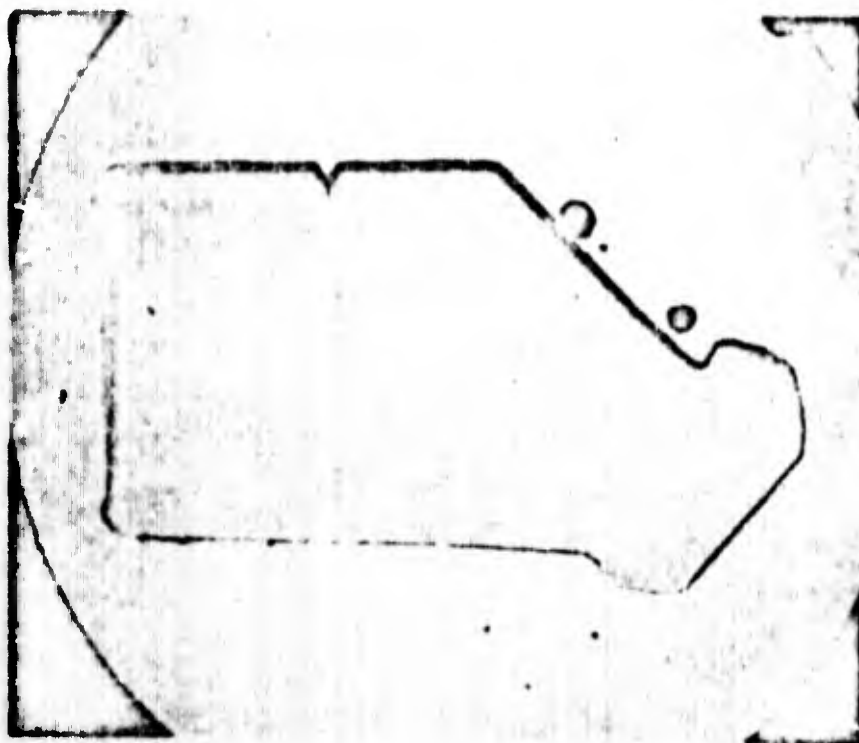
Figure 3. Cross Section of Marotta Valve Seat  
from Problem Report S0161CP

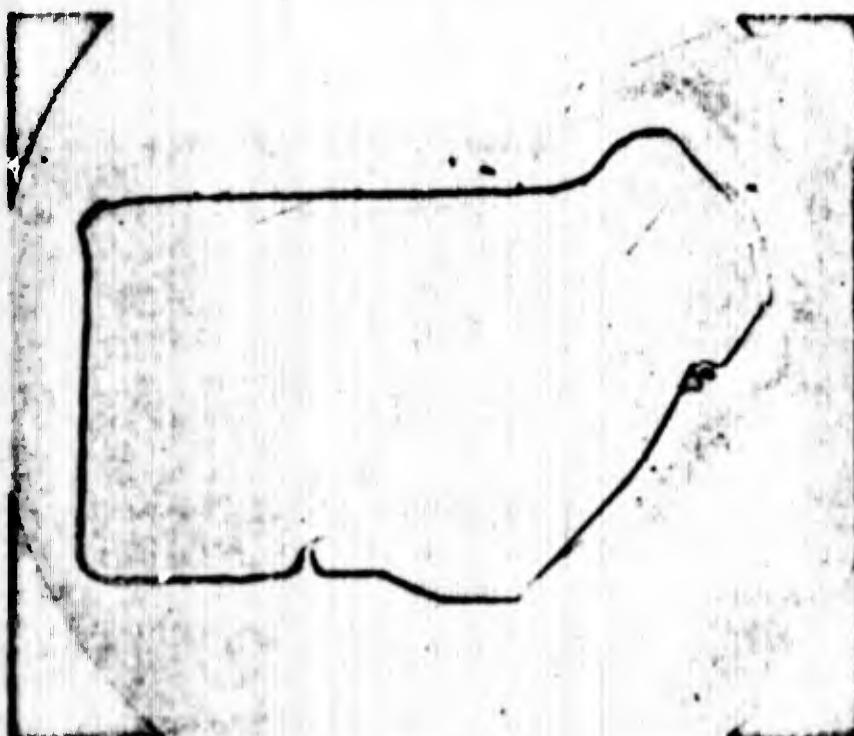
Figure 4. Cross Section of Marotta Valve Seat  
from Problem Report F1651CP

**Two of three redesigned units failed qualification testing. Failure analysis of these units revealed very low torque on the valve assembly nut and distorted seats. (Figure 4 shows a seat from one of these units.) The failures and analyses of the qualification test units demonstrated that the design changes had not eliminated the leakage or the distorted seats.**

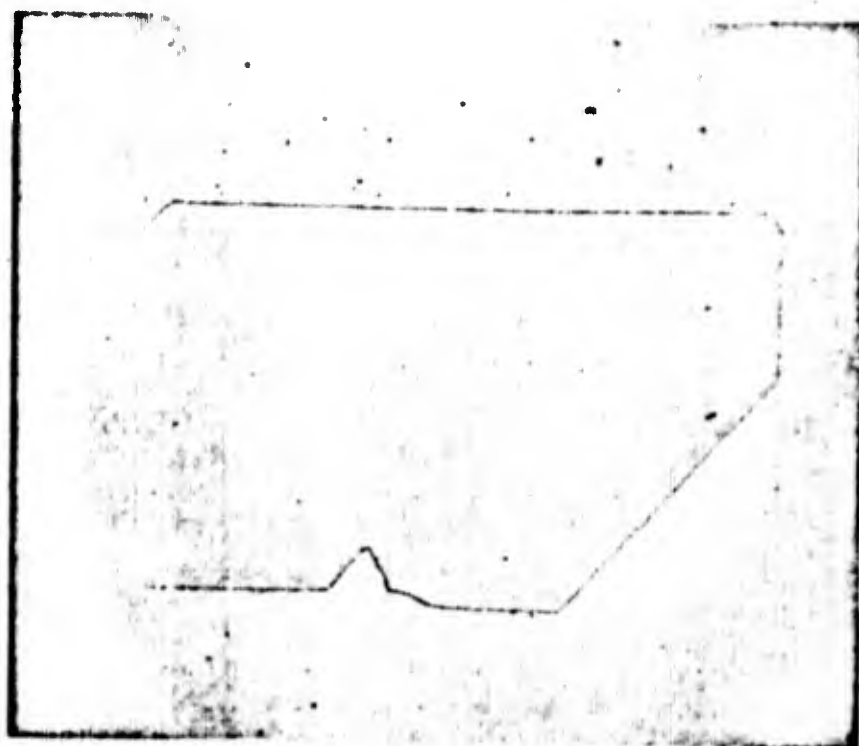
Failure analysis of MV544 units which failed in 1962, 1963, and 1964 ascribed failures to contamination and maladjustment resulting from unauthorized field adjustment. (Unauthorized field adjustment was suspected when low torque values were found on the main valve assembly nuts of many of the analyzed units.) However, in 1964 disassembly of one failed unit disclosed that the cross-section of the seat was distorted into a bulbous protrusion of the seating edge; and drawings specify that the configuration of this cross-section should show a near-sharp corner (see Figures 1 and 2). Subsequent analysis of failed units revealed that distorted seats were common in valves having appreciable service (see Figures 3 and 4). Disassembly of a valve known to have only Marotta acceptance test time disclosed no distortion (see Figure 5).

**Figure 5. Cross Section of Marotta Valve Seat  
from Problem Report F1647CP**

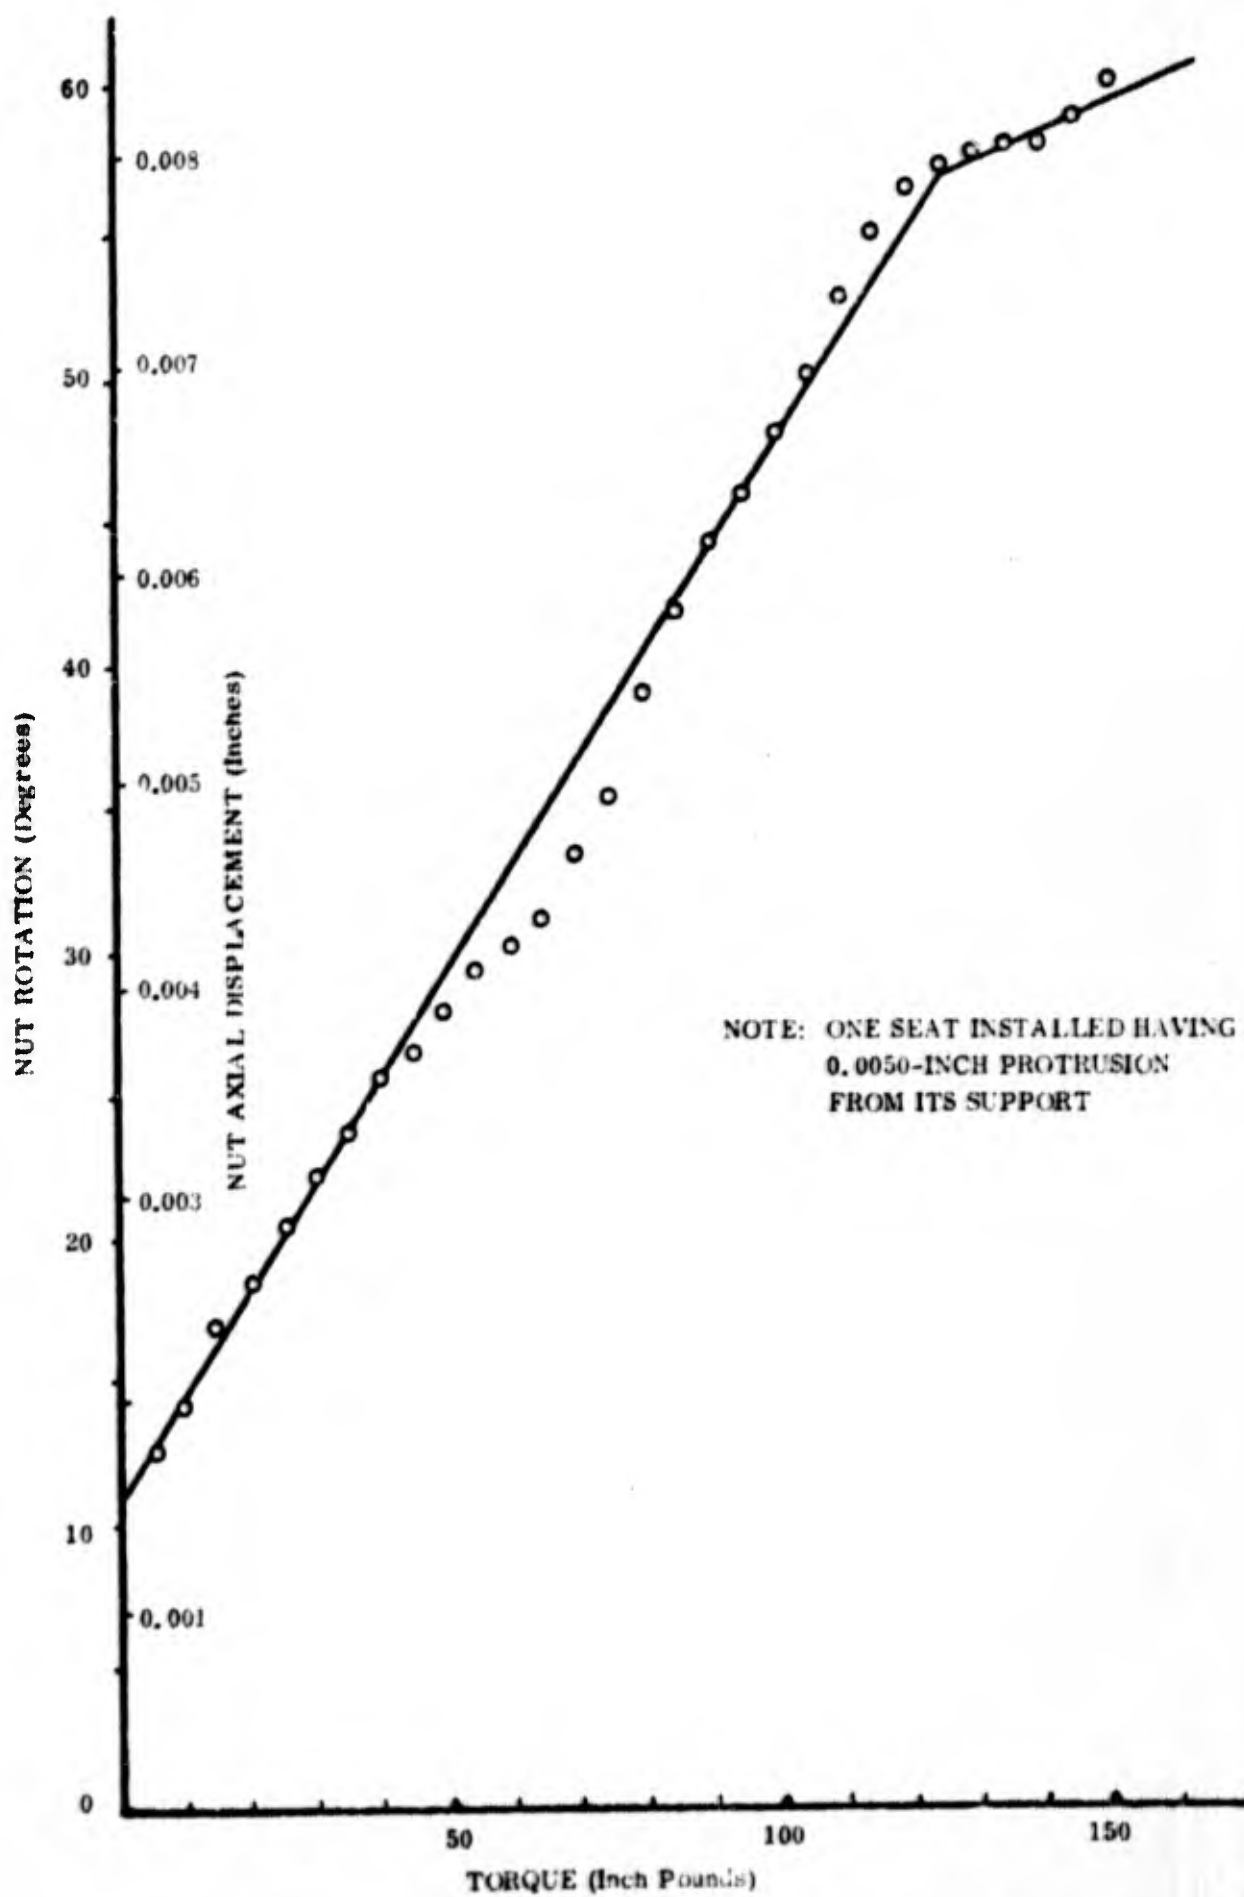
**2.1.1 Valve Assembly Characteristics.** The torque versus rotation characteristics of the valve assembly (stackup) nut were measured. To do this a valve was assembled and the nut screwed finger tight. Then the torque on the nut was increased in increments and the nut angular position recorded for each increment. The results, plotted in Figures 6 and 7, showed a linear relationship between torque and rotation with one sharp change in slope. The change in slope is interpreted as resulting from metal-to-metal contact being achieved when the seat was fully squeezed into its support (groove). The torque values required to achieve this condition were estimated by GD/C to be higher than on normally assembled valves although the vendor has declined to prescribe a torque value for the stacking nut.

The conclusion is that in a normally assembled valve, the seats prevent metal-to-metal stackup of the internal parts.

Figure 6. Marotta Three-way Solenoid Valve Stackup Nut,  
Torque vs. Displacement

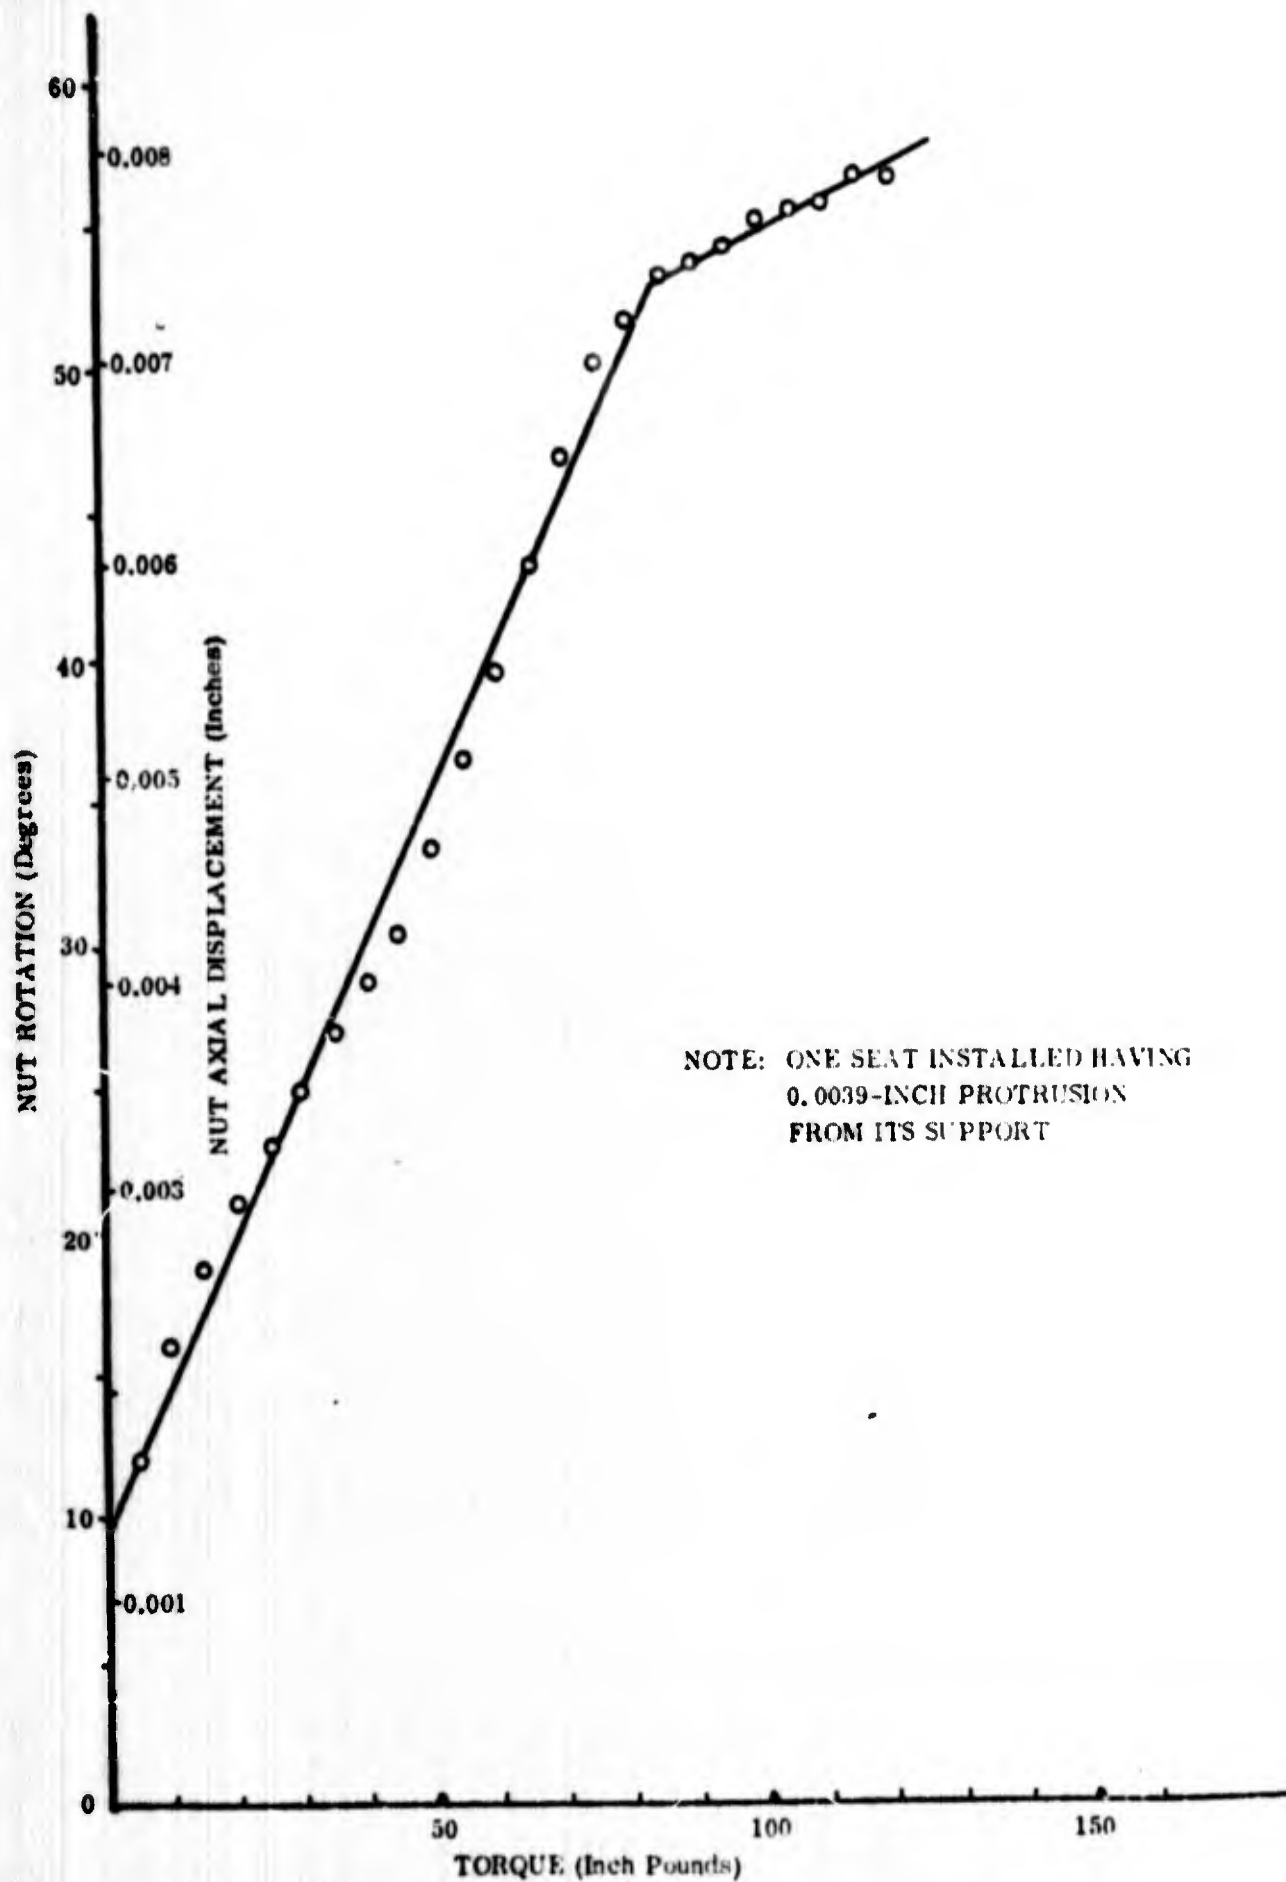
Figure 7. Marotta Three-way Solenoid Valve Stackup Nut, Torque vs. Displacement

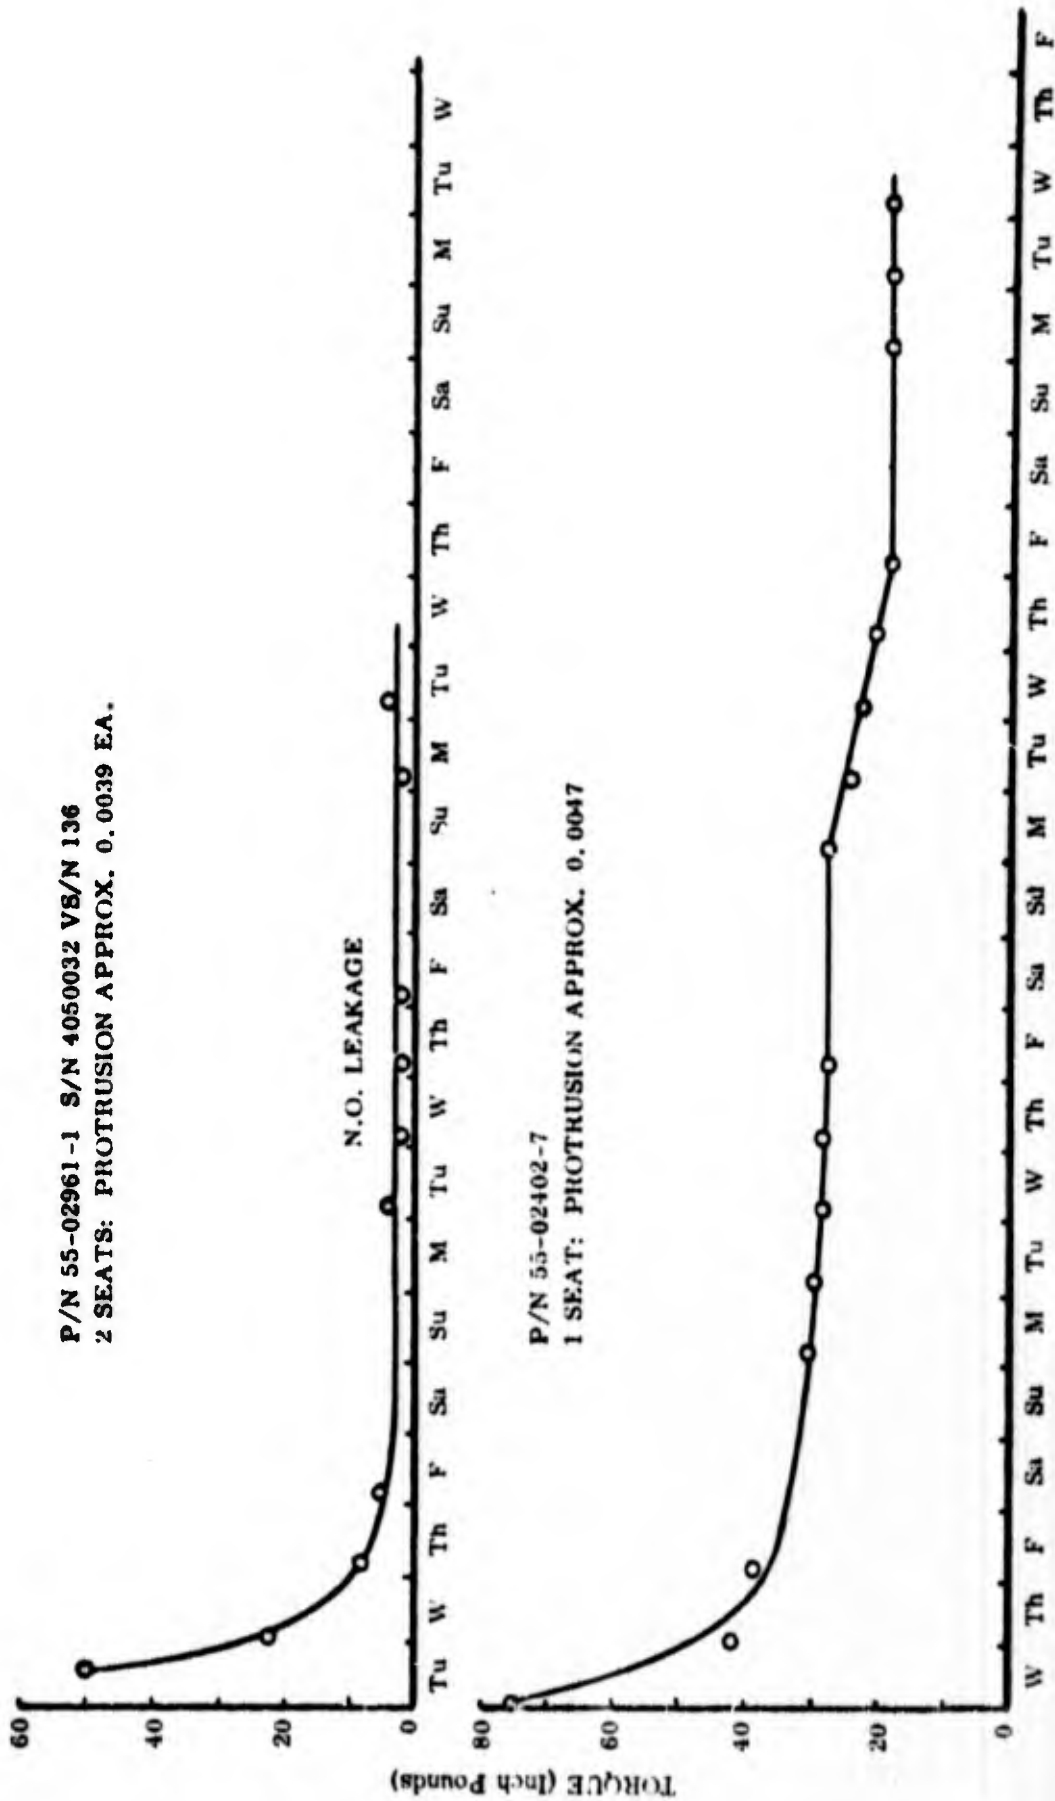
**2.1.2 Assembly Force Decay During Valve Operation.** Two additional valves were assembled and the stackup nuts were torqued to prescribed values as shown in Figure 8. The valves were then operated and the torque on the stackup nut was monitored morning and evening. The values recorded were those required to cause movement in the tightening direction and the nut was reset to its initial position after each torquing. The curves illustrate that the torques decreased rapidly at first and later appeared to stabilize. The torque values presented on the graphs are those taken in the morning before the unit had been operated. Torques measured in the evening, with the valve hot from operation, were four to eight inch pounds higher.

In the lower curve of Figure 8, the second torque drop-off resulted from a change in the operating cycle used for test. During the first week and a half, the valve was energized 5-seconds-on/5-seconds-off, eight hours per day. Subsequently, the valve was continuously energized for eight hours per day, thereby getting hotter. This valve was not leak-checked as only one seat was installed to conserve the seats available for testing.

The valve used to develop the upper curve of Figure 8 was energized continuously for eight hours per day. It developed a severe leak at the normally open seat after just four days of operation, but the leak was present only with the valve at ambient temperature. With the solenoid energized for as little as five minutes, with no gas flowing through the valve, the leak stopped, presumably from thermal expansion of the plastic seats.

Figure 8. Stackup Nut Torque Decay

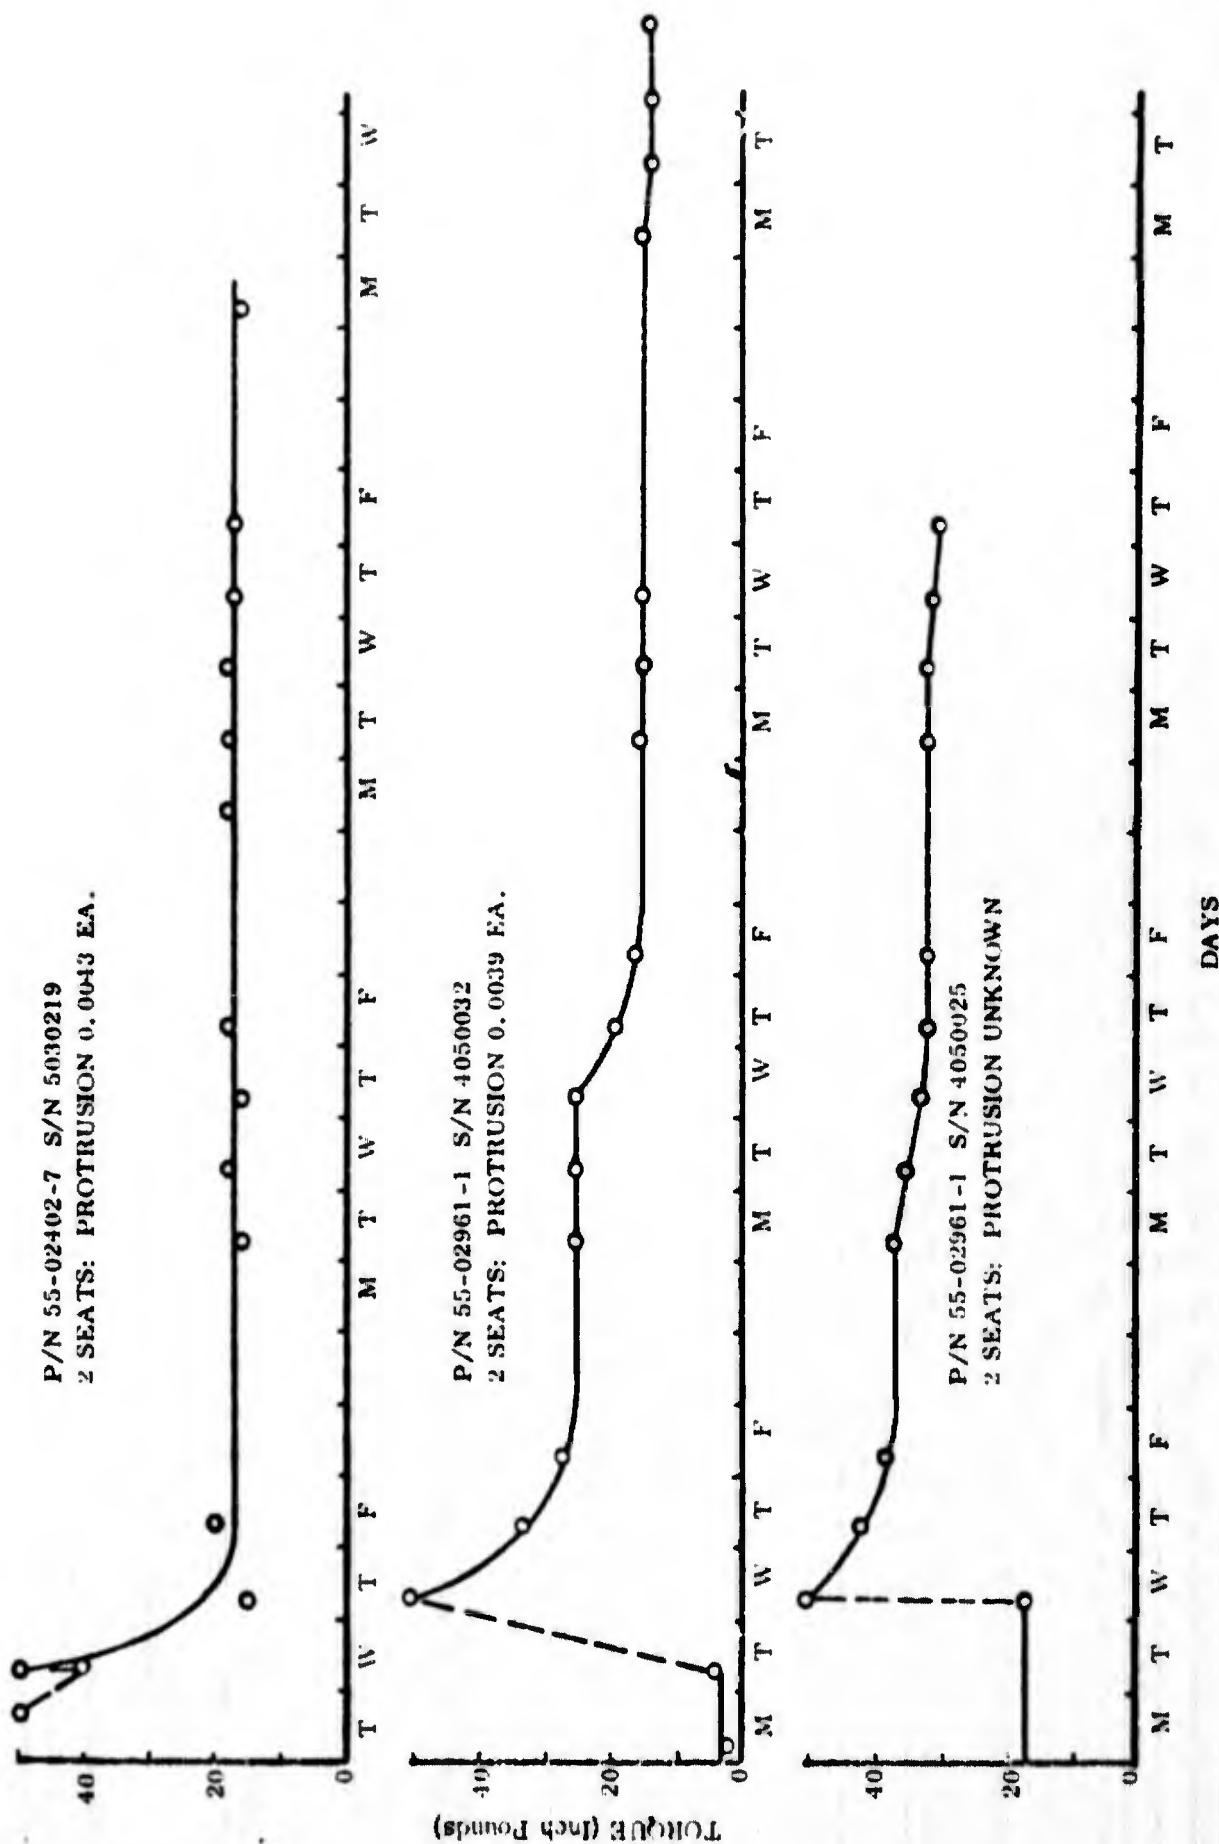
Retorquing a valve which was leaking as a result of testing did stop leakage, but relaxation continued although seemingly more slowly (see Figure 9).

Figure 9. Results of Retorque
