Technical Note N-986

AIRFIELD PAVEMENT EVALUATION, ROYAL THAI NAVY STATION,  
BAN U-TAPAO AIRFIELD, THAILAND

D. J. Lambiotte and R. B. Brownie

August 1968

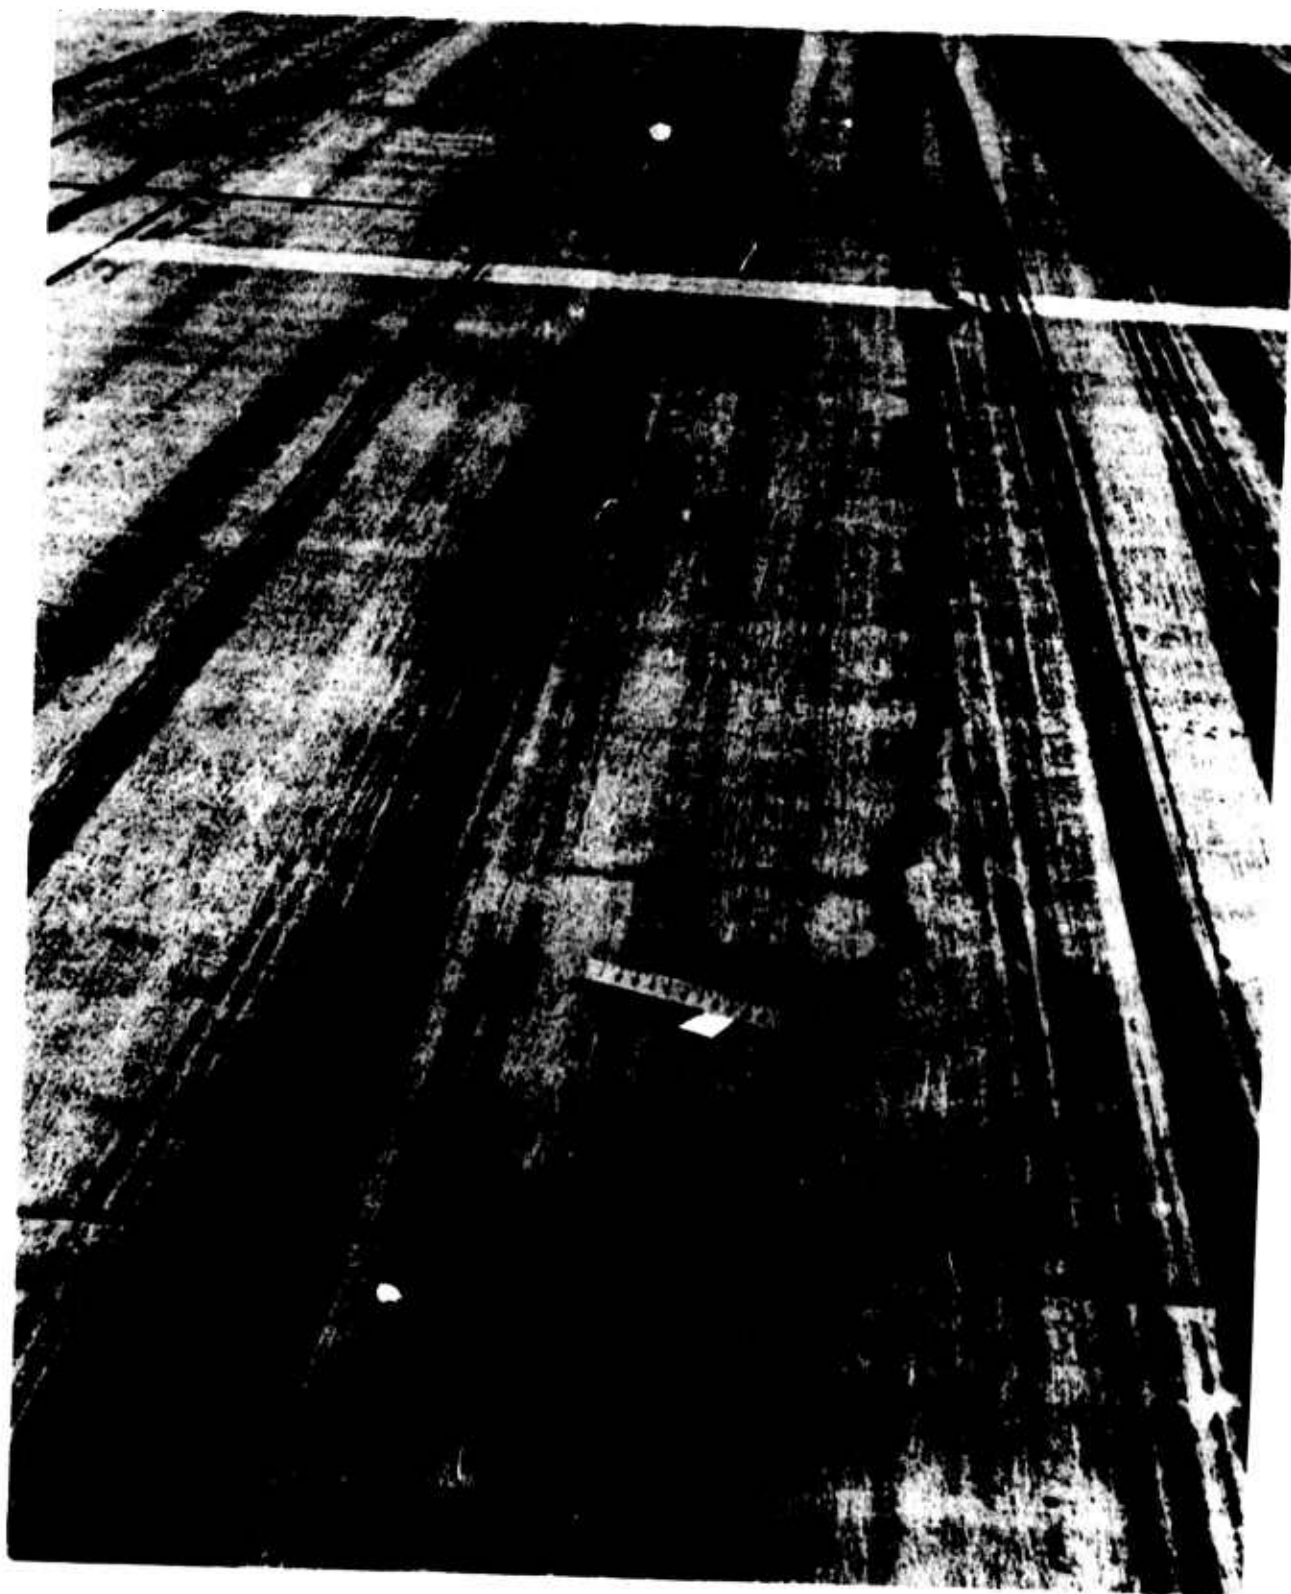
The cracked slabs appeared to follow a random pattern, except for two localized areas where more severe cracking (in terms of number of slabs) was evident. The most severe of these areas occurred at the intersection of the runway with Access Taxiway 2 and Cross Taxiway 2. At this spot, the three rows of runway slabs corresponding to the width of the taxiways on either side contained 11 cracked slabs out of a total of 24 (46 percent). (See Figures A-1, A-2 and A-3). Rated by itself, this small area could only be rated as poor. Designed as a runway interior, (Type C traffic), the area is being used as a taxiway (channelized traffic, type A) by heavy bombers entering and leaving the hardstand area by way of Access Taxiway 2.

Figure A-1. Longitudinal crack and corner break, Runway 18-36 at Cross Taxiway 2, Ban U-Tapao Airfield.

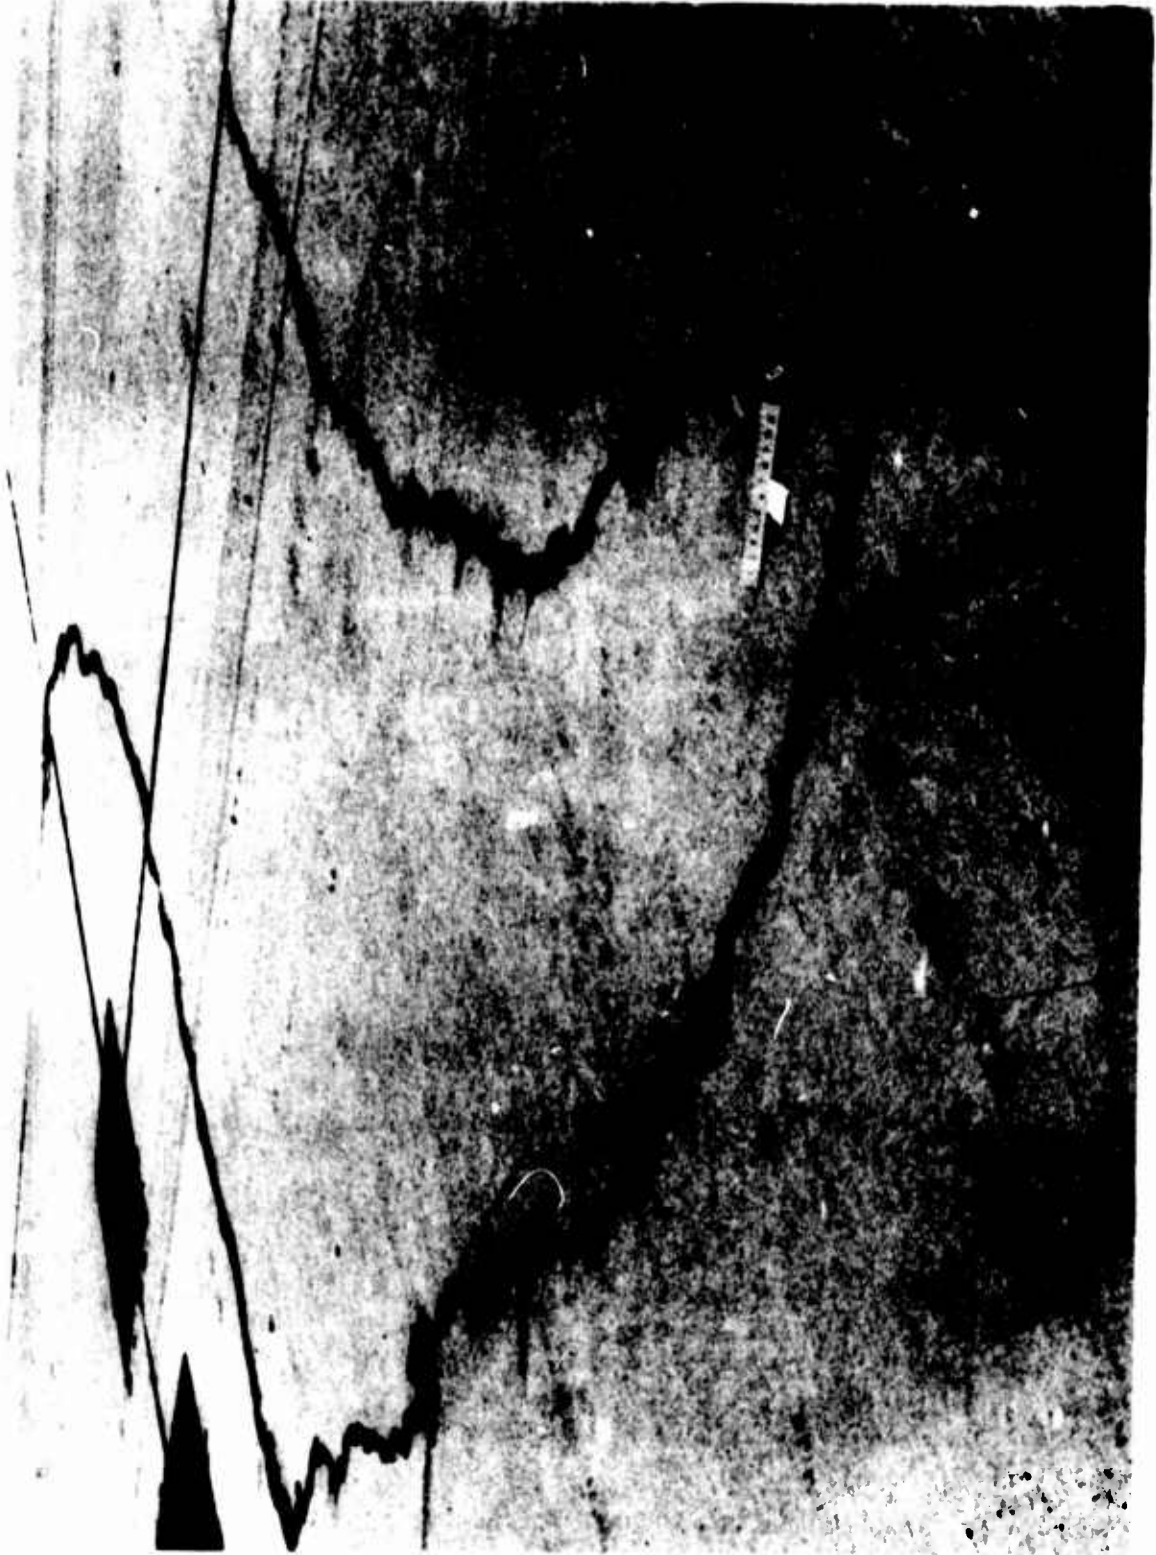
Figure A-2. Cracking in Runway 18-36 at Cross Taxiway 2,  
Ban U-Tapao Airfield.

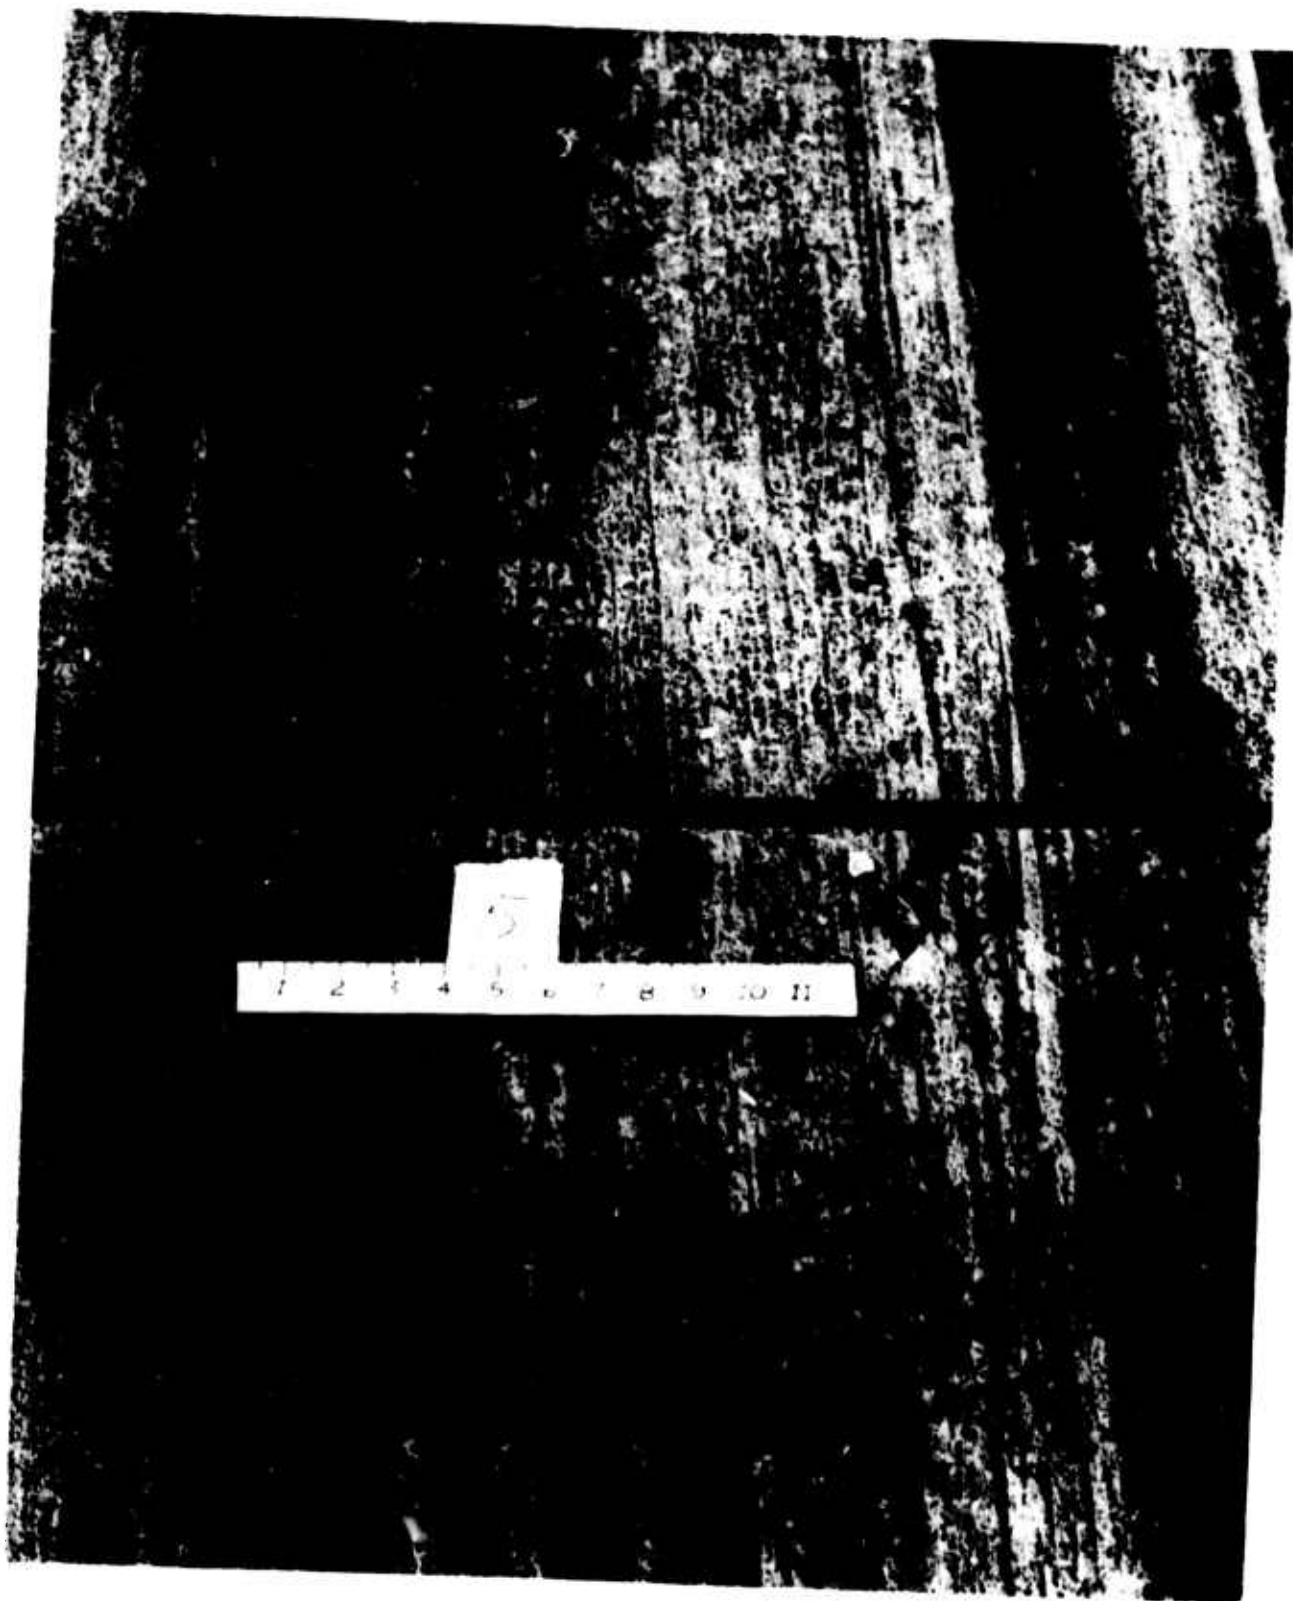
The second pavement area where localized distress has occurred is in the region of Station 55 + 250, about 900 feet from the south end of the runway. (See Figures A-4 and A-5). At this location, cracks have occurred in a group of 12 slabs, with some cracks occurring in lanes outside the center two. No evidence of lower-strength concrete could be found in this area. Contour maps, however, indicate that the site lies within a few feet of the course of an old klong (stream) over which 3 to 4 meters of fill was necessary during construction. It is thus possible that slight settlement and subsequent partial loss of subgrade support has occurred at this point. A majority of all cracks were unrepaired, unsealed, and showed evidence of incipient spalling.

Figure A-5. Longitudinal cracks with spalls in suspected klong area (Sta 55 + 250) of Runway 18-36, Ban U-Tapao Airfield.

It was noted that most pavement defects on the runway had not received maintenance. It is thus recommended, in light of the accelerated traffic rate, that all cracks be routed and sealed, and all spalls and similar pavement breaks be patched to prevent further deterioration of these defects into FOD problems.

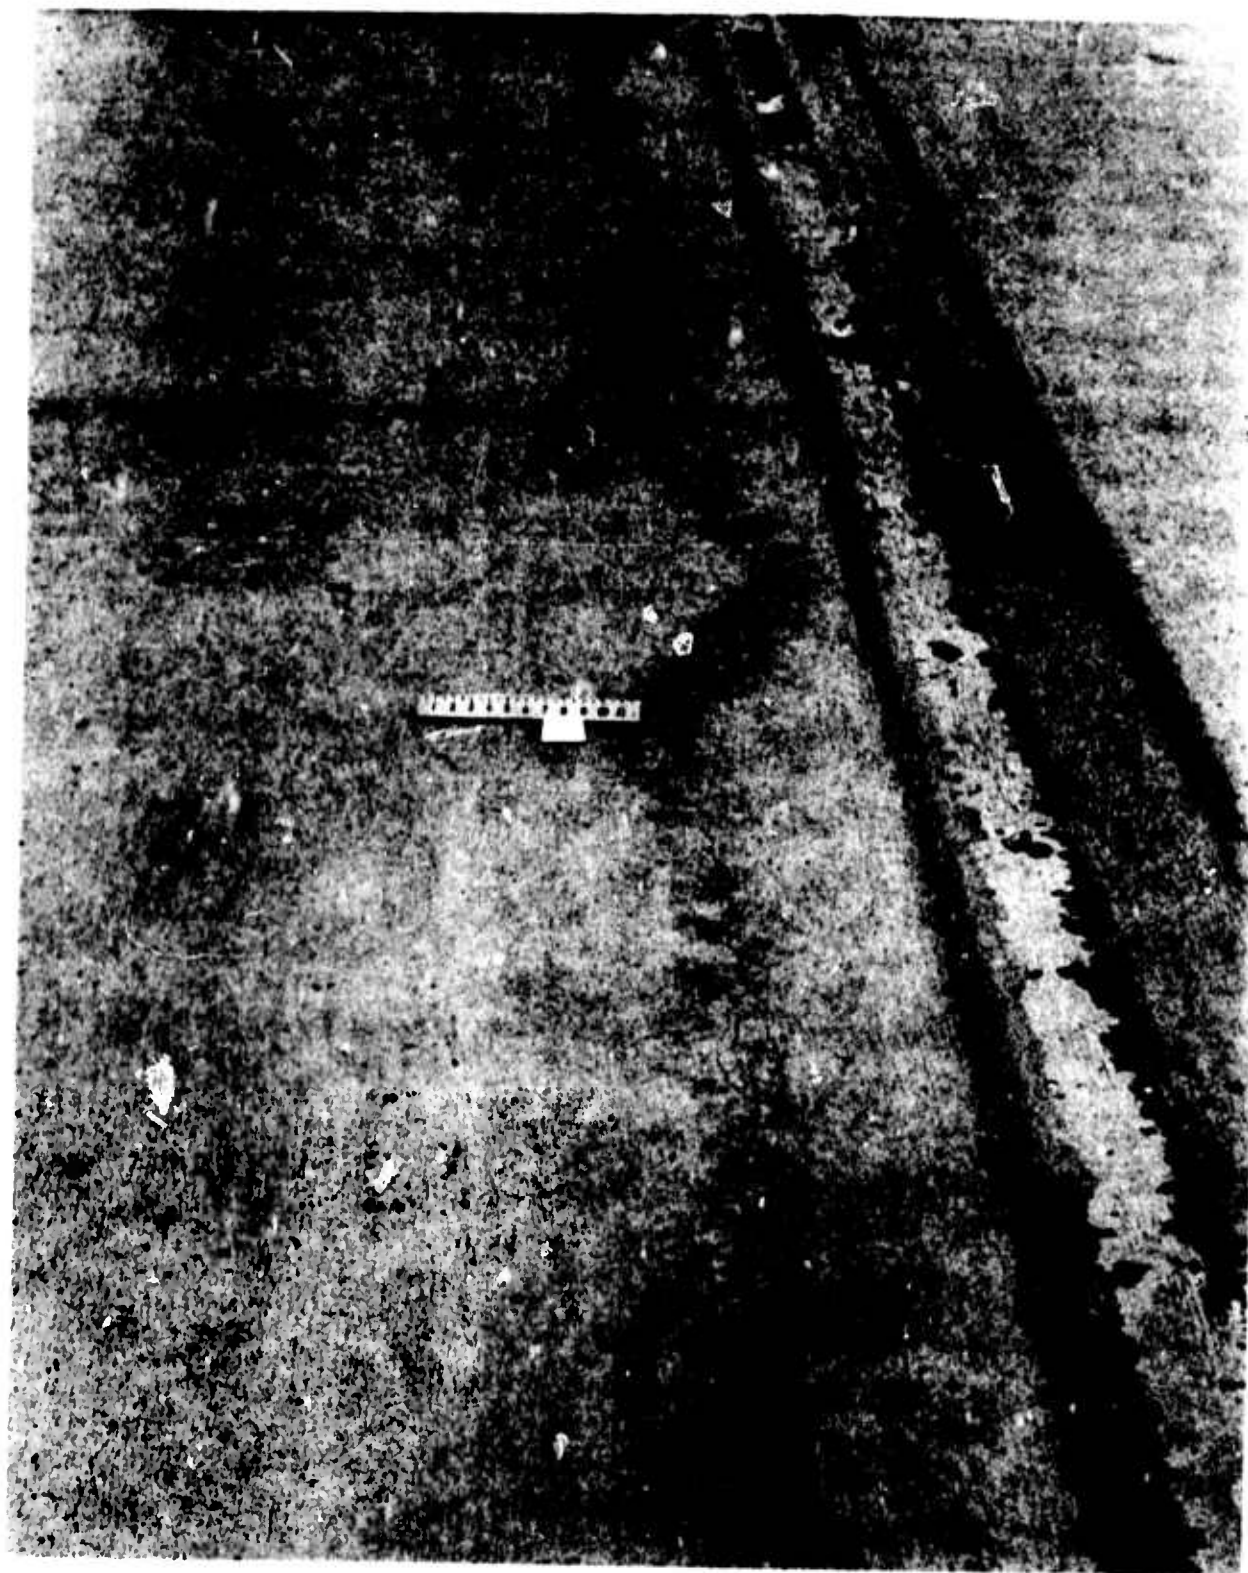
One hundred eighteen of 1,274 total slabs (9.3 percent of all slabs) contained defects which must be classified as "major", according to the foregoing Corps of Engineers criteria. However, 100 of these defects were longitudinal cracks directly down the centerline of the center slabs. This is a common occurrence on channelized primary taxiways at heavy load airfields and occurred here soon after initial traffic began. When the cracking became apparent, a centerline joint was sawed in all remaining uncracked slabs (about 75 percent of all center slabs). This, in effect, stabilized further occurrences of uncontrolled cracking. These centerline longitudinal cracks act essentially as joints where none were placed and as such present no structural deficiency. (See Figure A-6).

Figure A-6. Typical centerline longitudinal crack in Primary Taxiway, Ban U-Tapao Airfield.

Maintenance on the taxiway had been performed to a greater extent than on the runway. No cracks had been repaired, however, and again it is recommended that these cracks be routed and sealed before further deterioration and subsequent FOD problems are encountered.

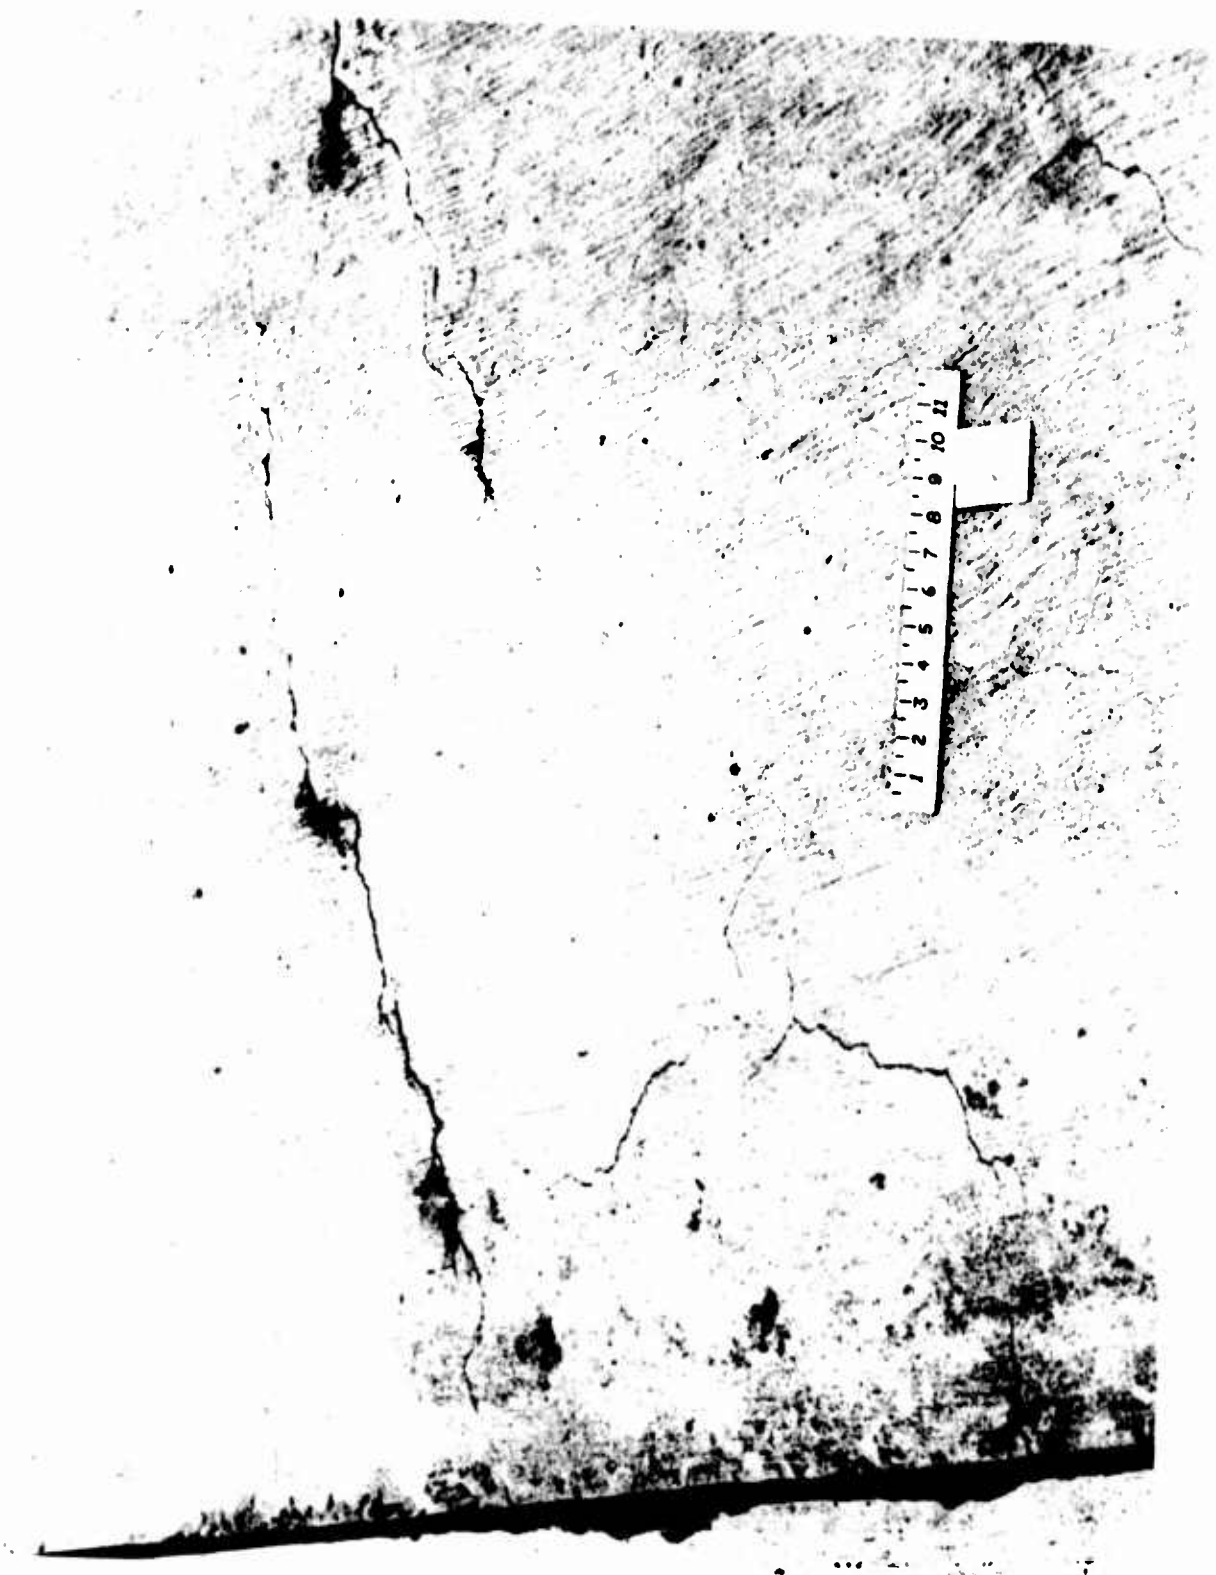
One group of seven adjoining slabs in the center lane were found to have severe surface map cracking indicative of poor concrete. (See Figure A-7).

Figure A-7. Typical map cracked slab in Primary Taxiway, Ban U-Tapac Airfield.

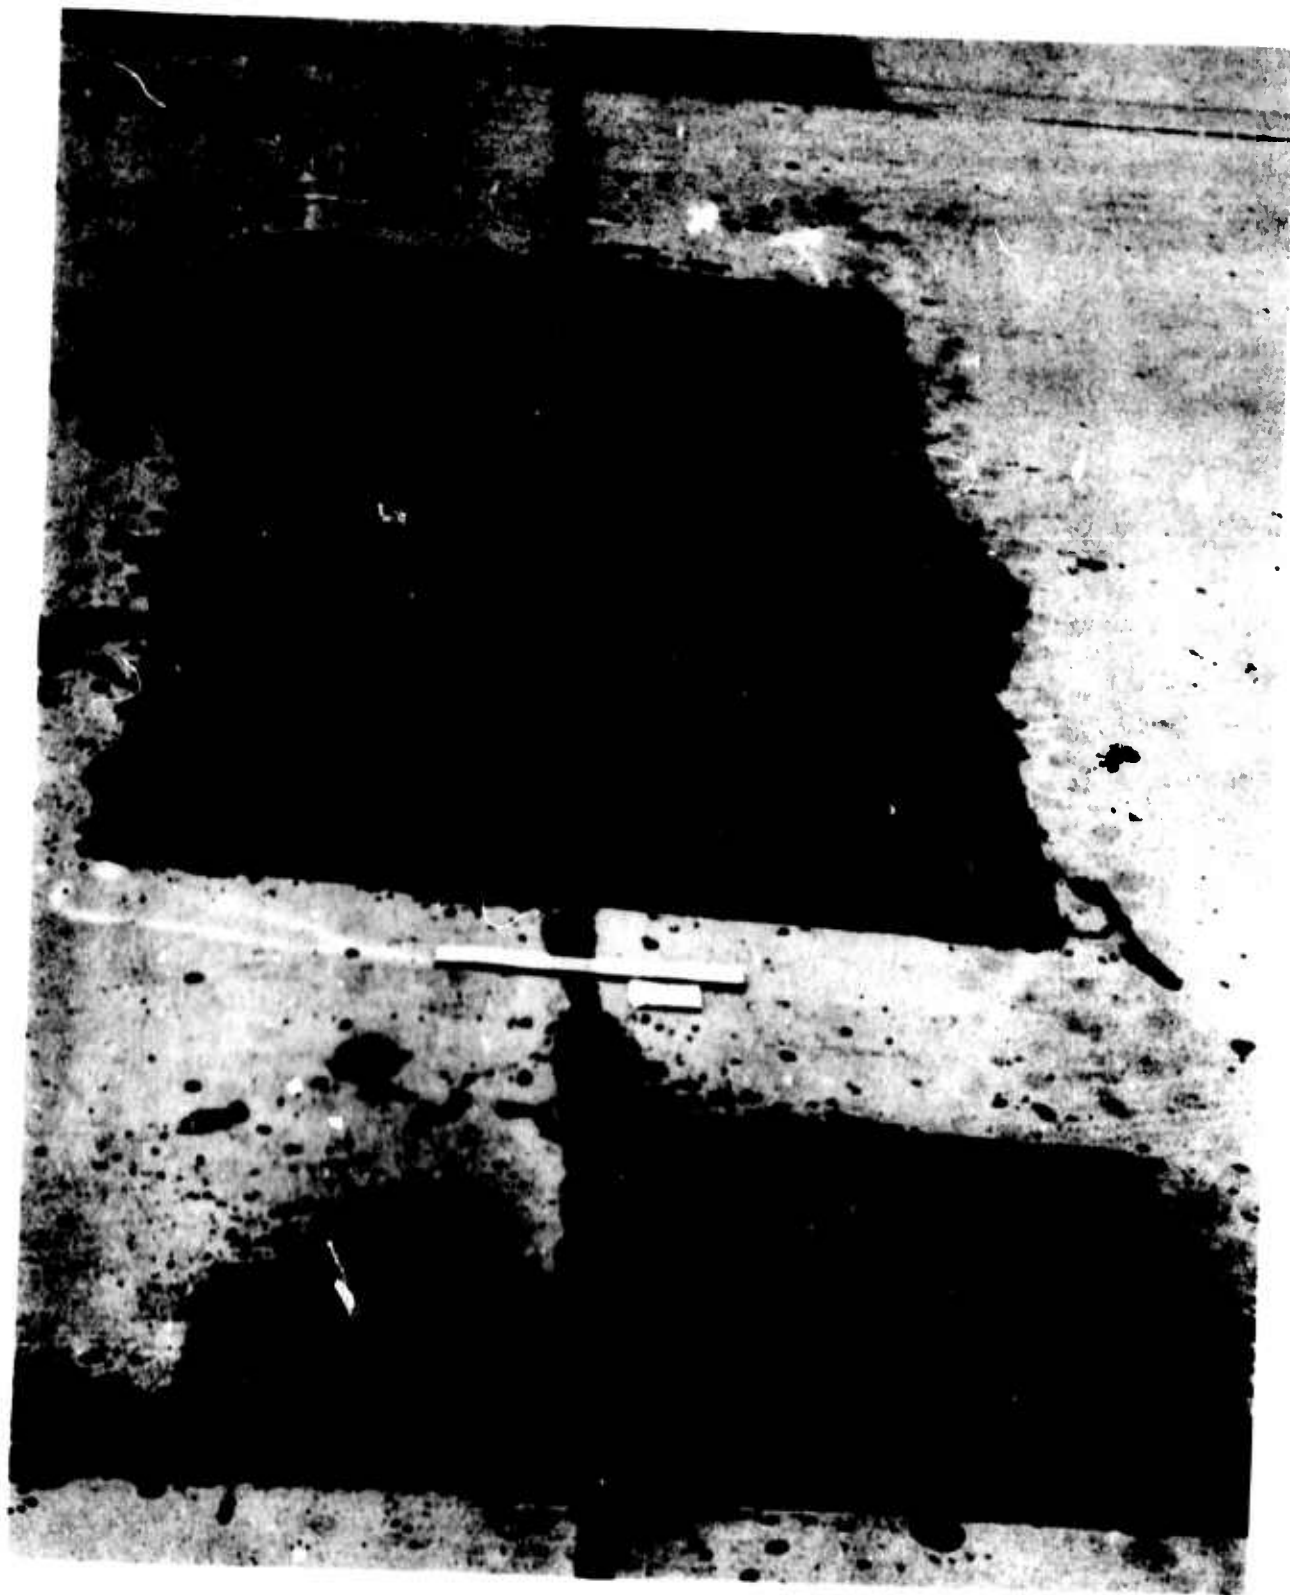
Figure A-9. Typical hot mix AC and epoxy concrete patches, Primary Taxiway, Ban U-Tapao Airfield.

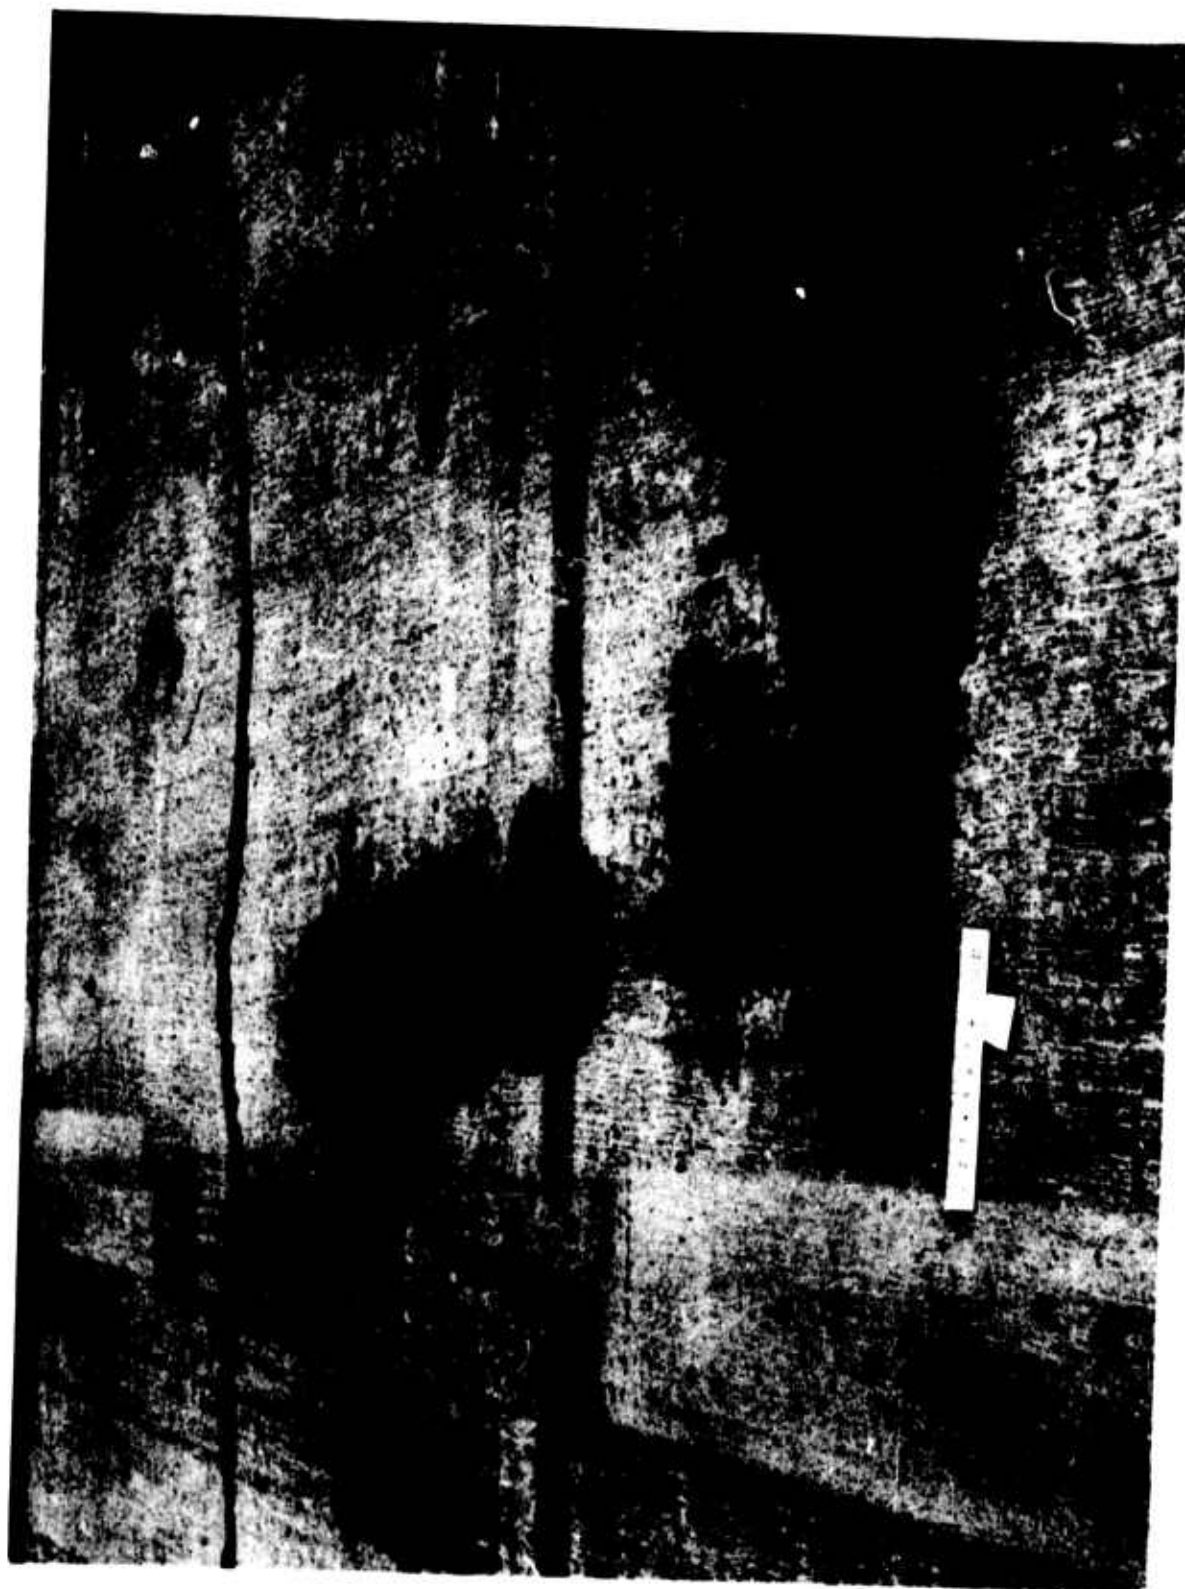
Twenty five of 60 center lane slabs (41.6 percent) contained major pavement defects. Most of these defects were transverse cracks with the appearance of having occurred under load. Seven other cracked slabs were observed in outer lanes. Some of these appeared to be shrinkage cracks. Slight dishing or settlement of at least two center lane slabs was noted, with standing water very evident on one of these. (See Figures A-11 through A-14). All cracks but one were sealed. Minor defects occurred in only 3.5 percent of all slabs. Joint seals were in excellent condition, as were the asphalt shoulders.

Figure A-11. Evidence of standing water and sealed transverse crack in Access Taxiway 2, Ban U-Tapao Airfield.

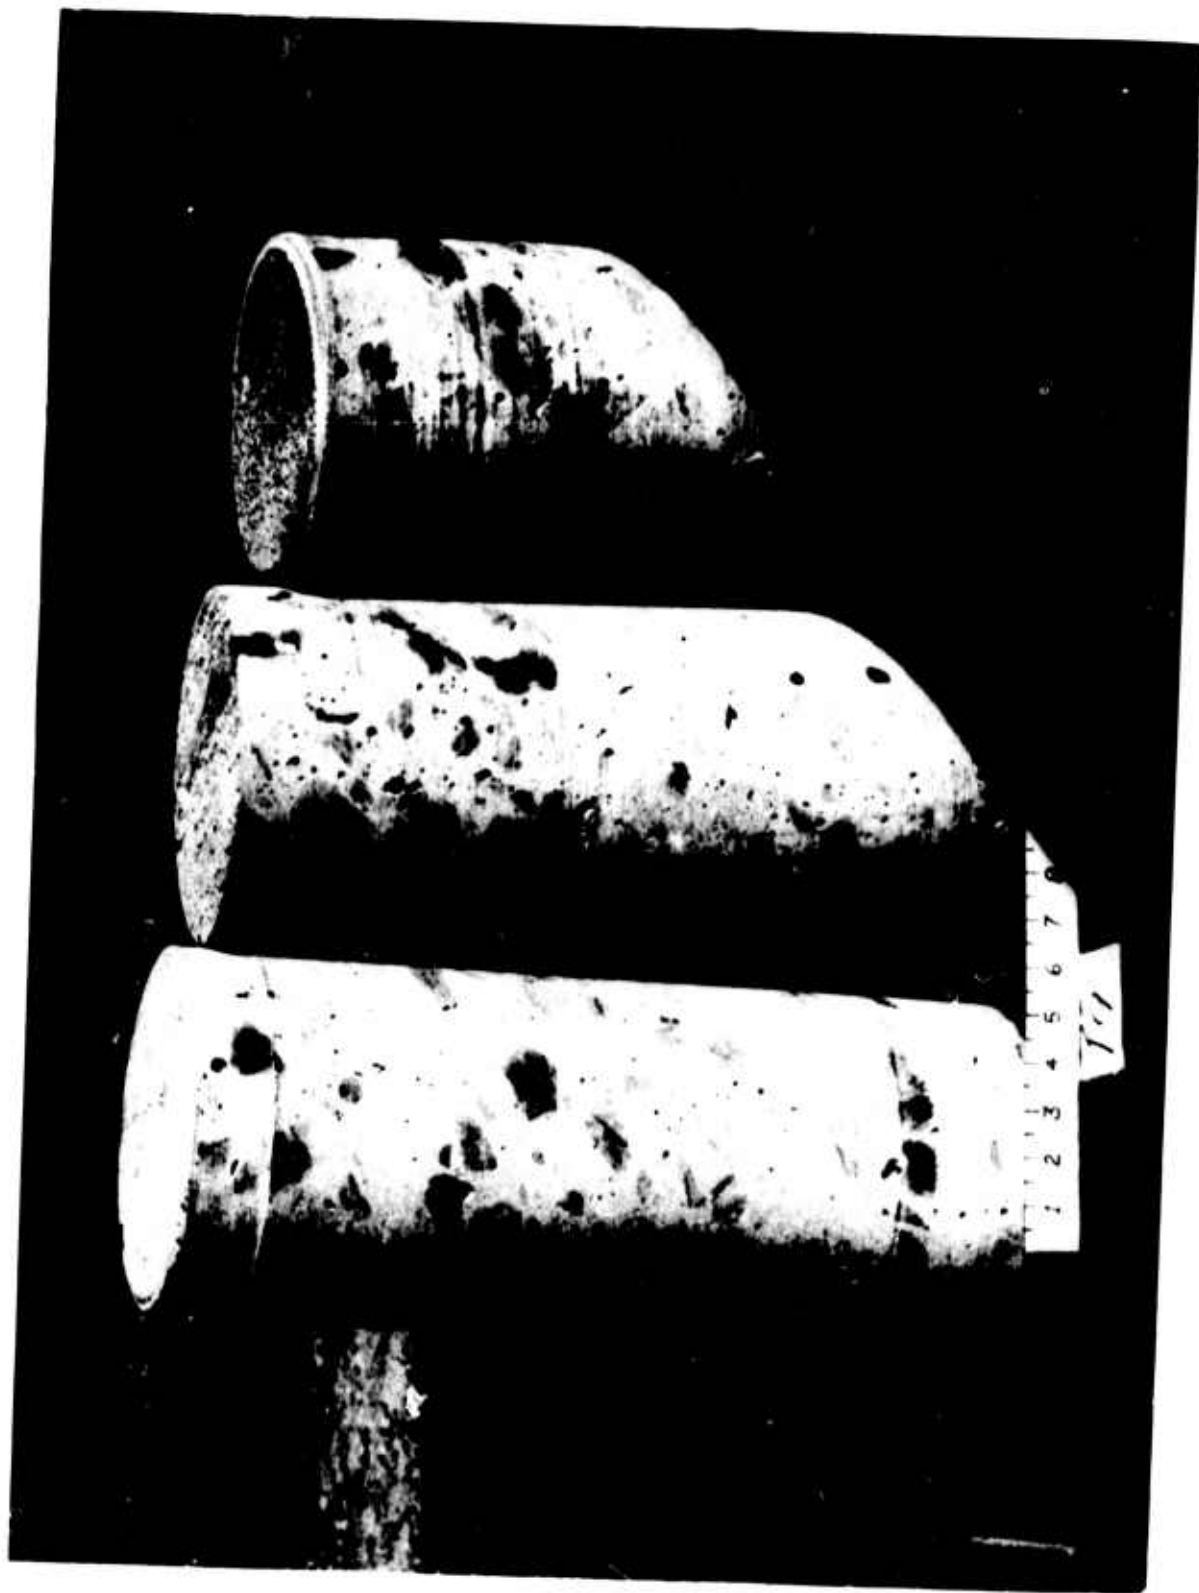
Figure A-17. Eight-inch diameter cores taken from Hardstand Taxiway 4,  
Ban U-Tapao Airfield.
