HIGH TEMPERATURE ELASTOMERIC INTEGRAL FUEL TANK SEALANT EVALUATIONS

TECHNICAL DOCUMENTARY REPORT NO. ML-TDR-64-207

September 1964

(Prepared under Contract AF33(657)-10962, by The Boeing Company, Airplane Division, Wichita Branch, Wichita, Kansas; Lyle G. Middleton, author)

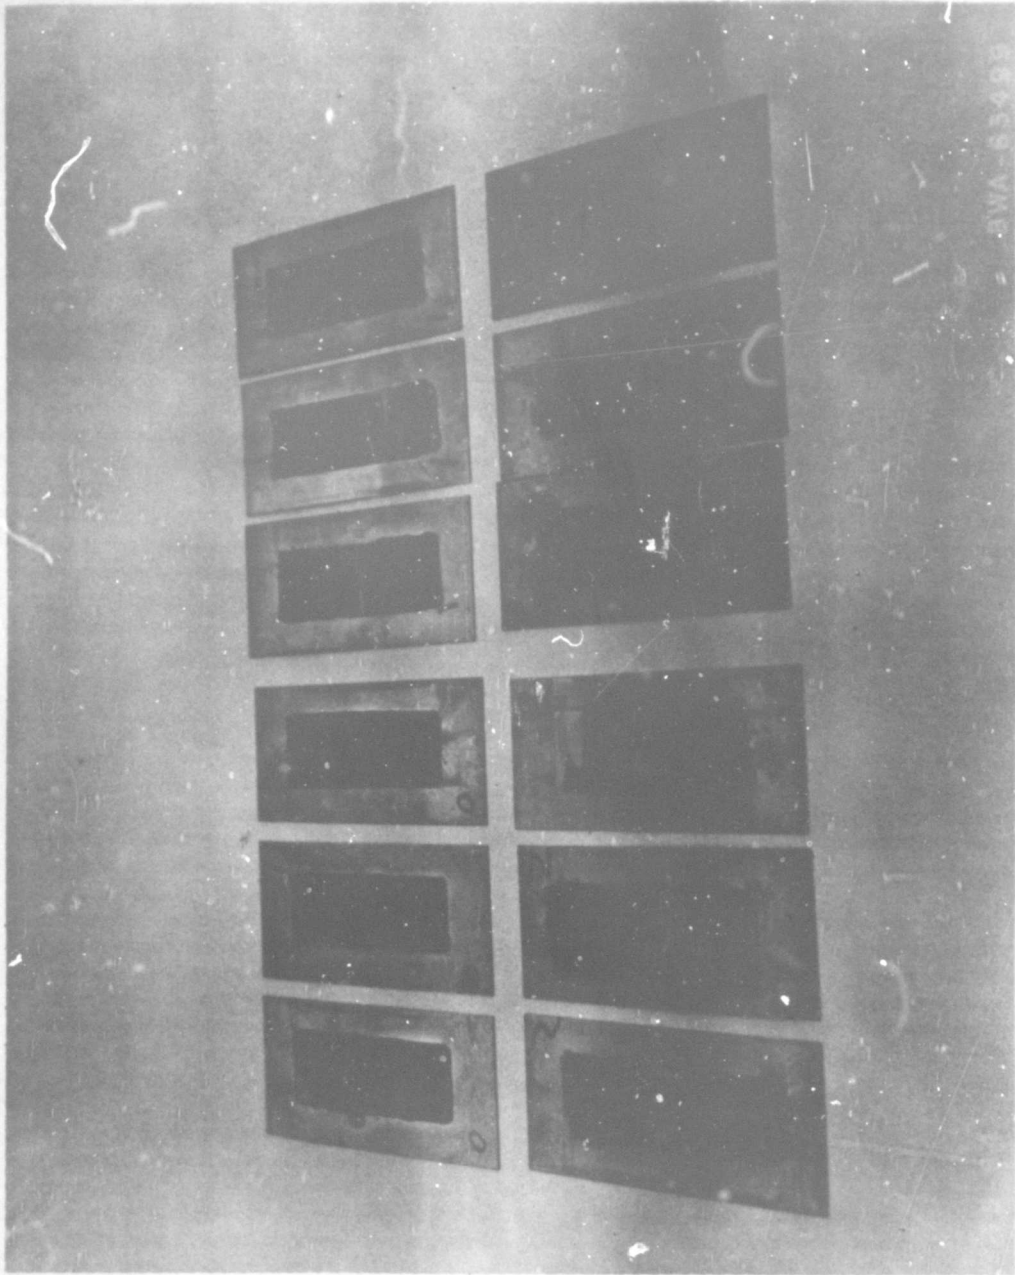
FIGURE 4
LOW TEMPERATURE FLEXIBILITY SPECIMENS -
AFML FLUOROCARBON SEALANT

Q95-500: Condition 1 (1 specimen)
 Conditions 5 and 9 (2 specimens each)
- c. AFML fluorocarbon sealant was exposed to the conditions specified in Table 4.
- d. All specimens were subjected to 130 cycles on the MIL-S-8802C Low Temperature Flexure Tester. All specimens were tested at -65°F, except the AFML fluorocarbon sealant which was tested as specified in Table 4.
- e. All EC-2288 and Q95-500 specimens passed with no specimens cracking or losing adhesion. The AFML fluorocarbon sealant specimens failed as shown in Table 4 and Figure 4.

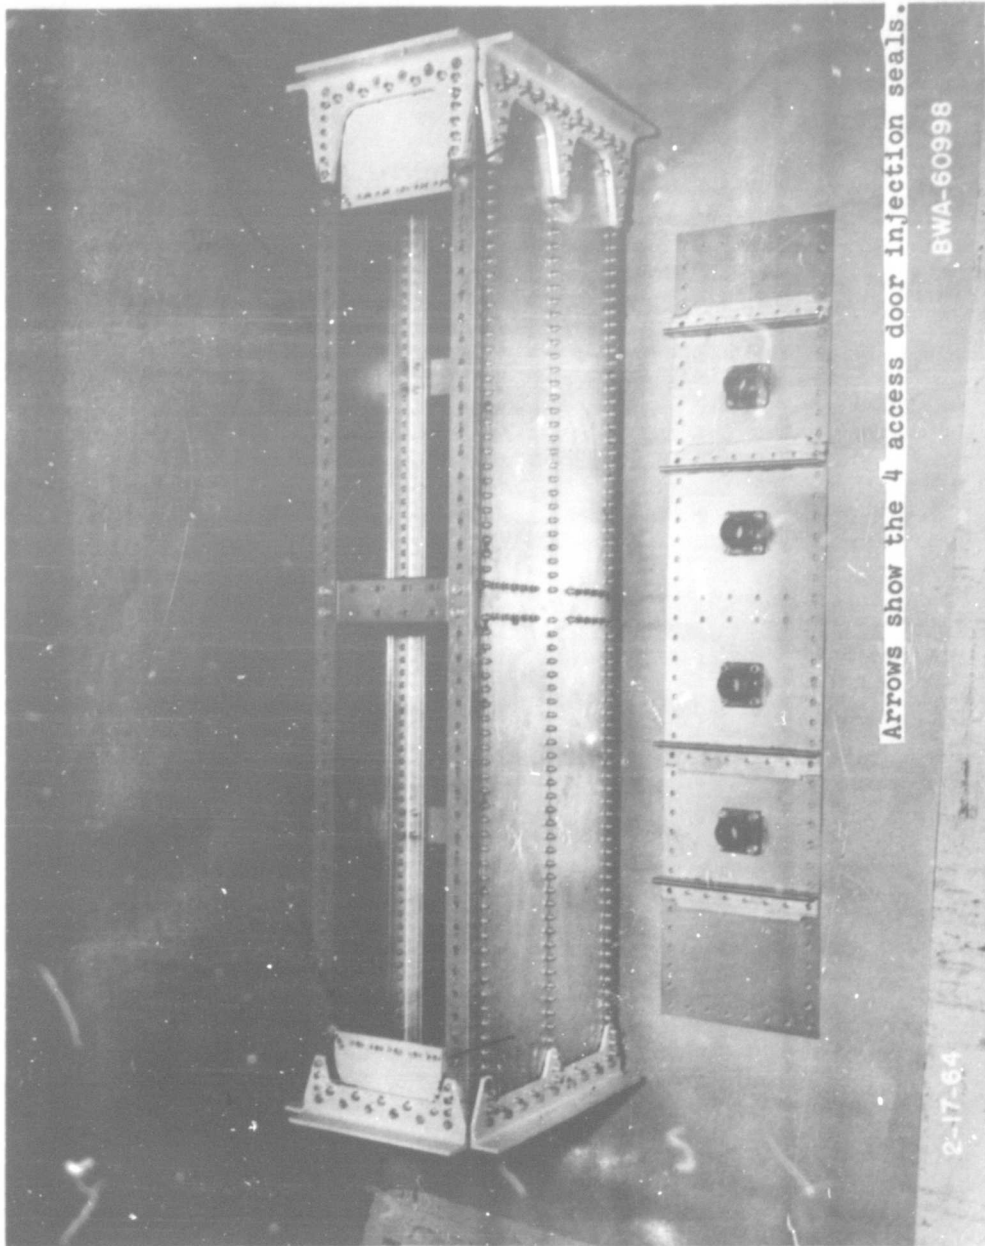
ASSEMBLED TANK NO. 3 (ACCESS DOOR NOT INSTALLED)

(1) Tank No. 3 (faying surface sealed) had a few fastener leaks on two attach fittings, and two injection seal leaks (see Figure 9) on the access door, but there was no leakage in the center areas where the major faying surface seals were to be evaluated.

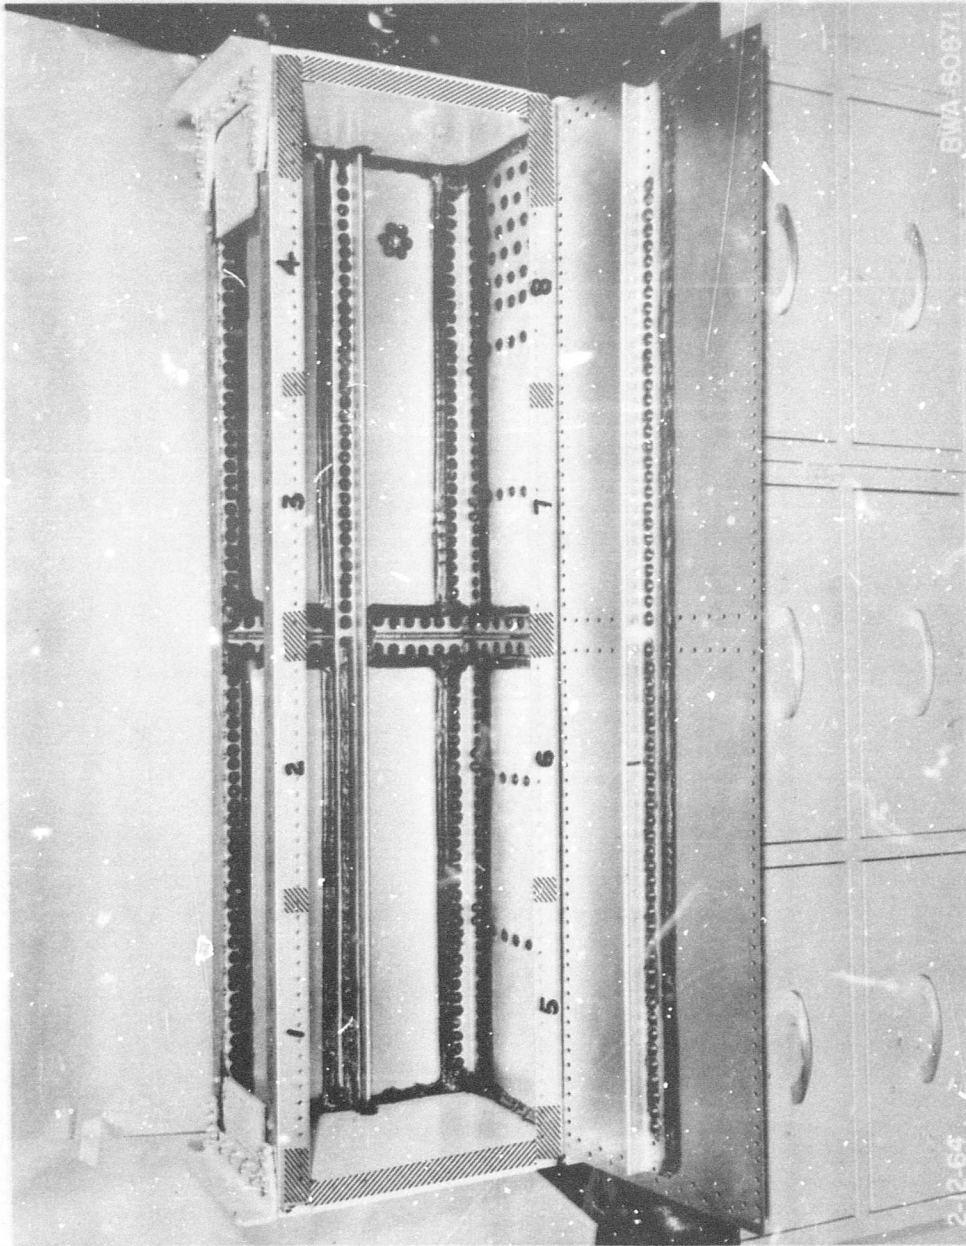
FIGURE 17
TANK NO. 2 PARTIALLY ASSEMBLED

- e. The tank was then pressure tested for leaks per Section B.1.d. There was considerable seam leakage on the top and bottom skins. For leakage evaluation, each skin (and also the spar web) can be divided into 8 fillet sealed seam lengths (each about 10 inches long), isolated from each other by faying surface "block-off" seals. These 8 seam lengths can be seen in Figure 17 as the lengths between block-off seals, before the lower skin is installed. The upper and lower skins were leaking as follows:

Lower skin - 7 out of the 8 seam lengths leaking

Upper skin - 6 out of the 8 seam lengths leaking

- h. Most of the leaks were caused by poor adhesion of sealant fillets over fasteners. The leaks located were repaired by applying new sealant over the areas leaking. There were three areas where the source of the leaks could not be located. These areas were "repaired" by applying additional brush coats of sealant over the fastener lines.

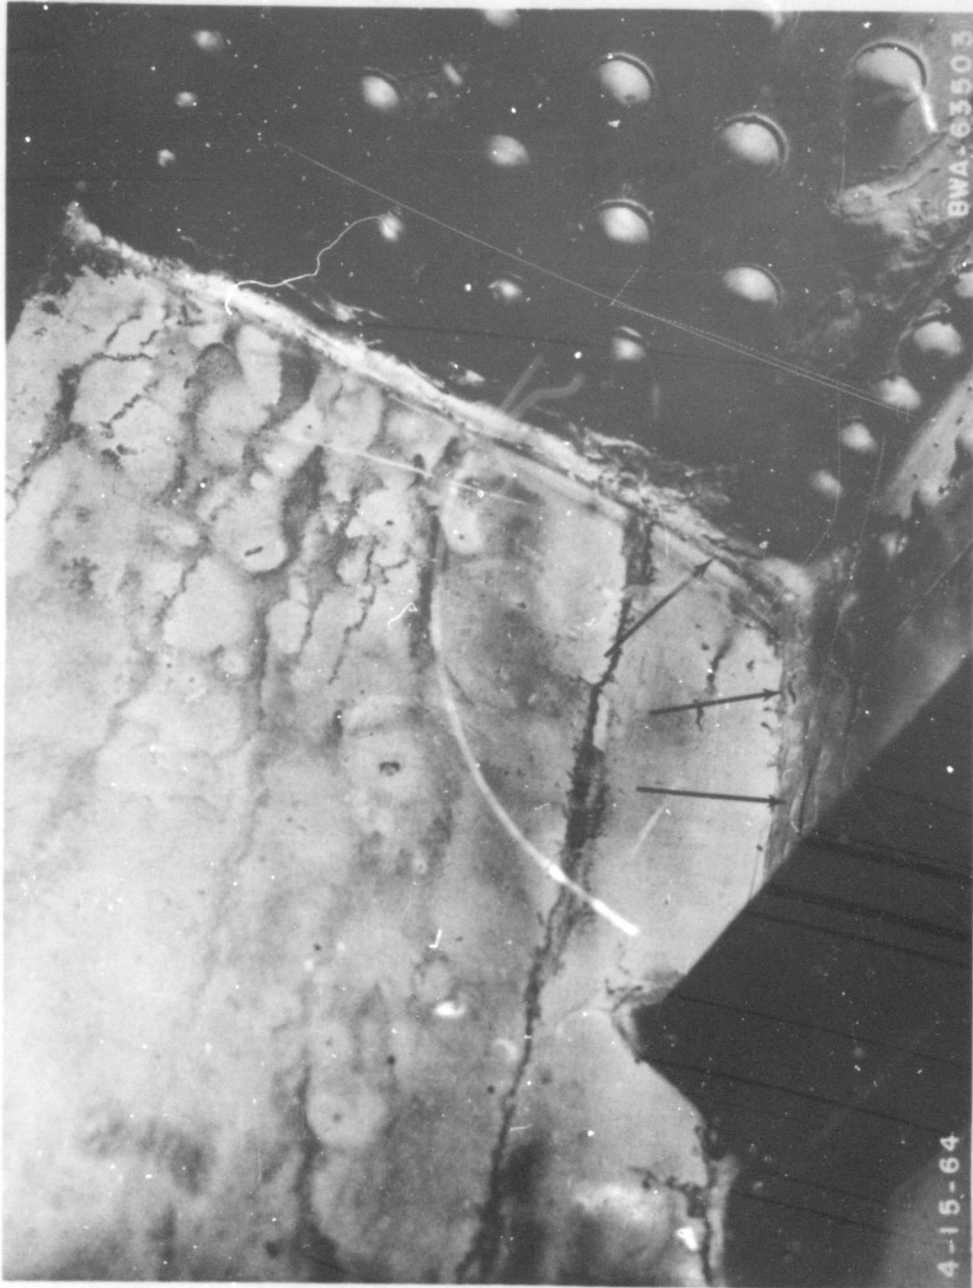
FIGURE 21
CRACKS IN AFML FLUOROCARBON FILLETS (TANK NO. 2)

- d. The access door was removed from Tank No. 2 and approximately 15 cracks were observed on the fillets throughout the tank, as shown in Figures 21, 22, and 23. The sealant fillets were hard and somewhat embrittled, with very little elongation or tear strength (this correlated with the results of the Phase I tests). The sealant in this tank was considered to have failed badly due to the environmental exposures used, and no additional testing was conducted.
