NWC TP 4738

# SAFETY TESTS OF EXPLOSIVES TRANSPORT TRUCKS

## NAVAL WEAPONS CENTER

CHINA LAKE, CALIFORNIA \* JULY 1969

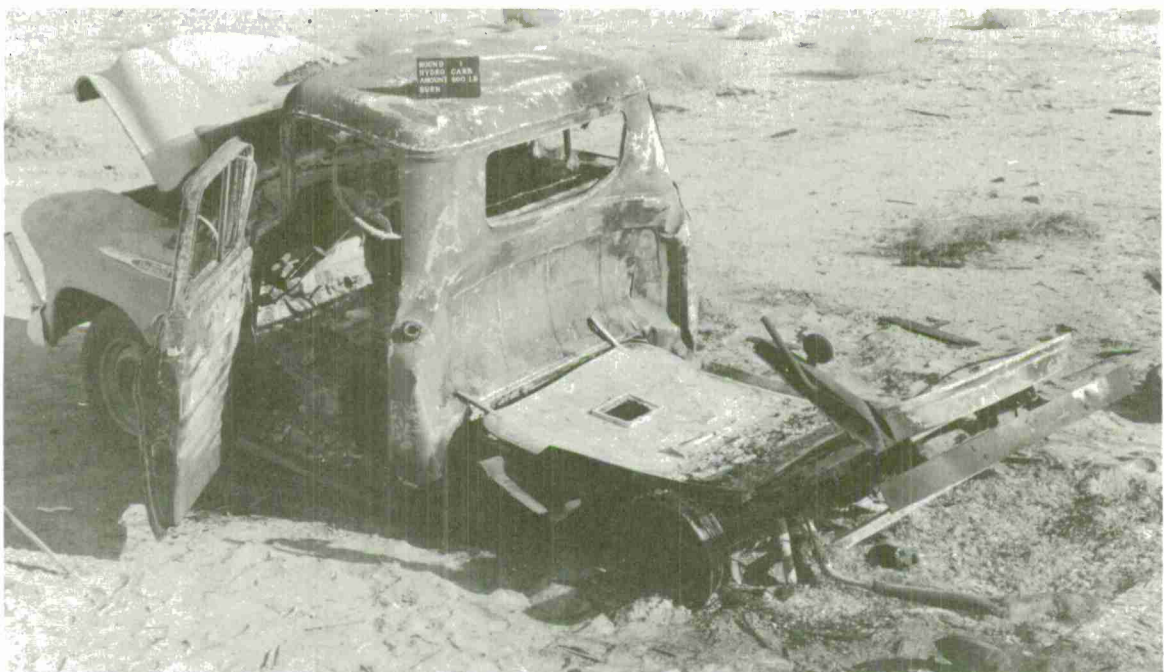
After propellant ignition, burning continued for 2 to 3 seconds, after which time an explosion or low-order detonation occurred. Propellant was scattered over a wide area, up to 298 feet from the truck. Much of the propellant did not burn. The bed of the truck was destroyed, pieces of it being thrown as far as 234 feet. The steel shield was blown against the back of the cab and then slid down onto the bed of the truck (Fig. 3). Figure 4 shows that the inside of the cab was completely gutted by fire and that the mannequin was destroyed. The thermocouple attached to the face of the mannequin indicated a temperature rise to 520°F in 4 seconds and then failed mechanically. The thermocouple attached to the hand recorded nearly as rapid a rise to 300°F, a slight dip, and then a rise to 410°F about 10 seconds after the start of the test. The thermocouple on the seat beside the mannequin reached 130°F in 4 seconds and then decayed slowly.

The right rear wheel of the truck was blown off; the left rear wheel burned on the truck; but the front wheels and tires were not damaged. There was little evidence of fire in the engine compartment or front of the truck even though the hood was blown open by the blast.

FIG. 3. Truck Damage From Burning and Subsequent Explosion of 600 Pounds of Propellant, Test 1.

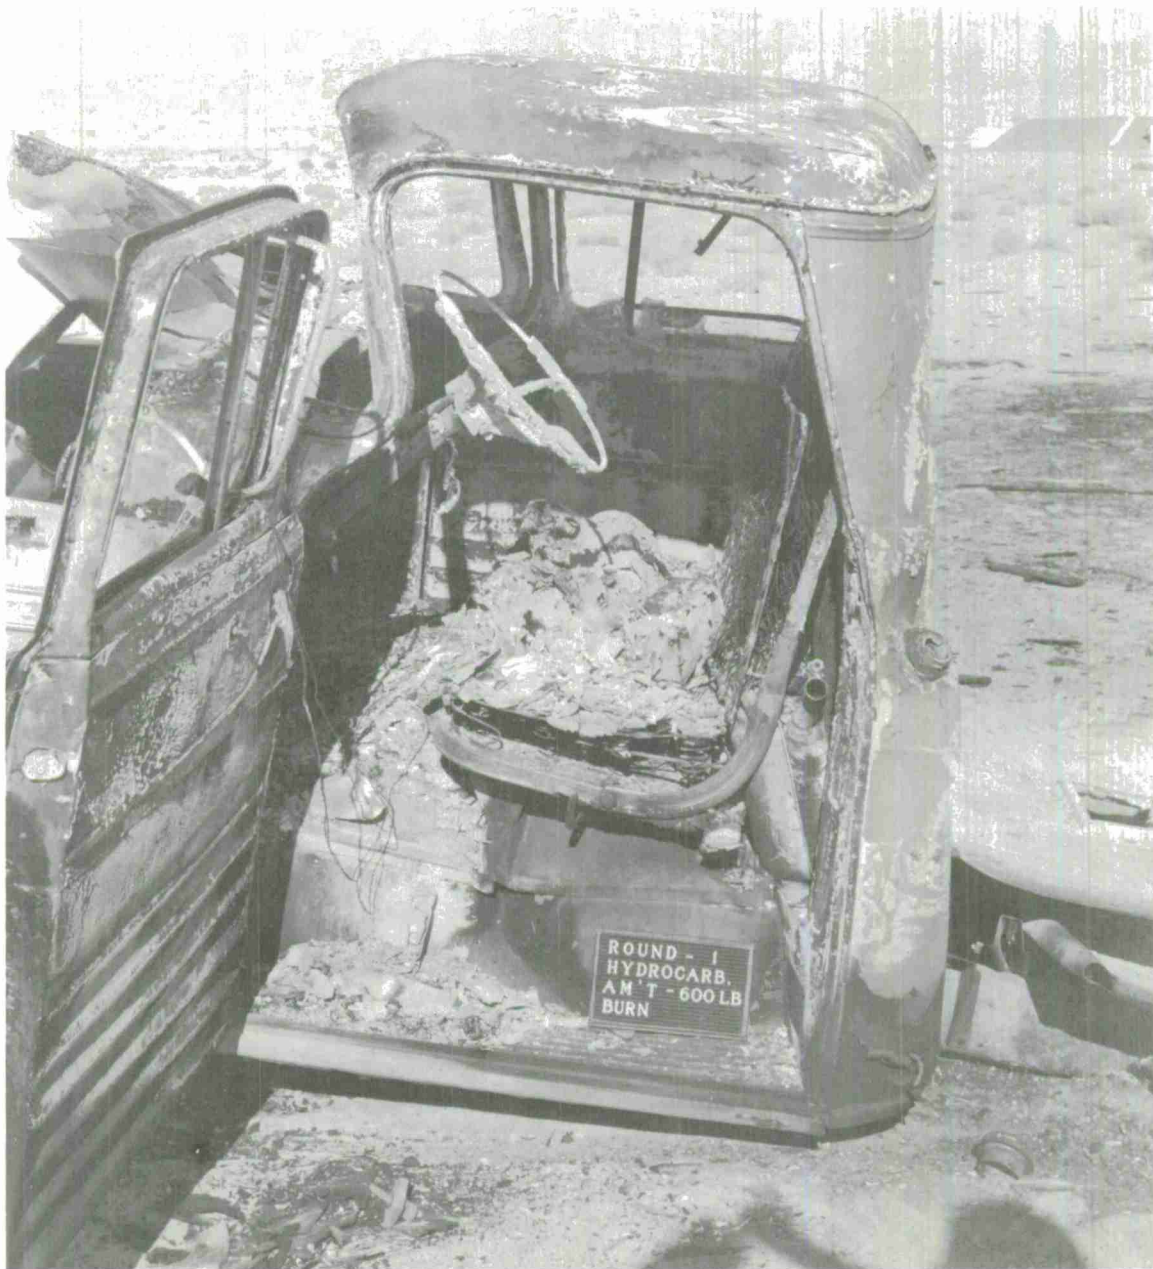
FIG. 4. Destruction of Mannequin and Cab Interior, Test 1.

It is doubtful that persons in the cab could have escaped without rather severe burns. Since only a burning test was desired, there was no measurement of blast pressure. This test, however, gave good evidence that we cannot expect hazardous materials to react in accordance with our plans. The unplanned reaction was due either to too strong ignition or too great confinement of the propellant.

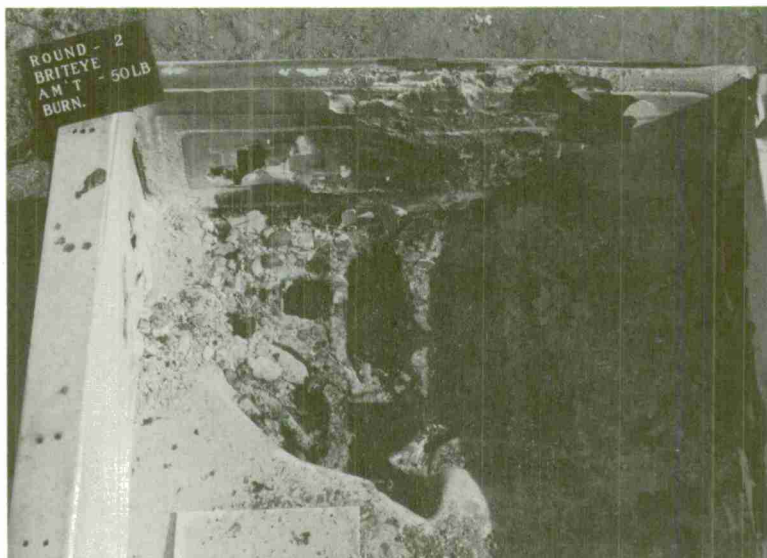
The flare burned for about 5 minutes. It burned through the aluminum truck bed, but there was little evidence of the burning of any other materials (Fig. 6 and 7). The steel shield appeared to be undamaged. The truck was observed on the TV monitors for about 15 minutes after the flare stopped burning, and, since there was no further evidence of burning, all test personnel left the area for lunch. A short time later (estimated to be less than 15 minutes), the residual heat again ignited combustible materials of the truck, including the cab interior, engine compartment, and tires. The truck had completely burned when personnel returned to the area about 1 1/2 hours later (Fig. 8). The three thermocouples in the cab did not show any temperature rise during the time the flare was burning.

FIG. 7. Damage to Truck Bed, Test 2.

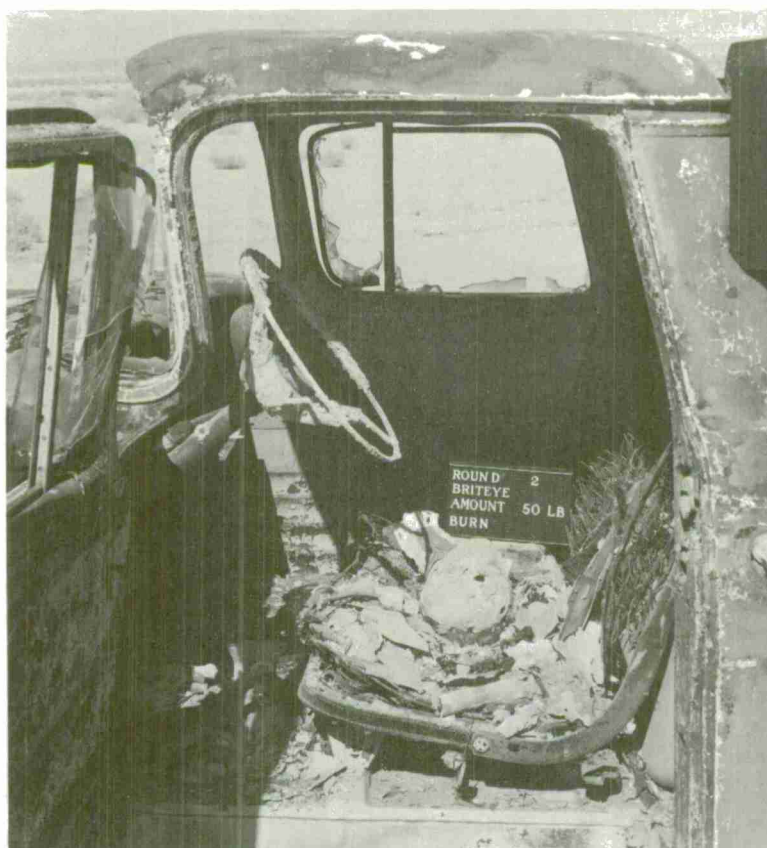
FIG. 8. Destruction Resulting From Reignition Caused by Residual Heat of Combustible Material, Test 2.

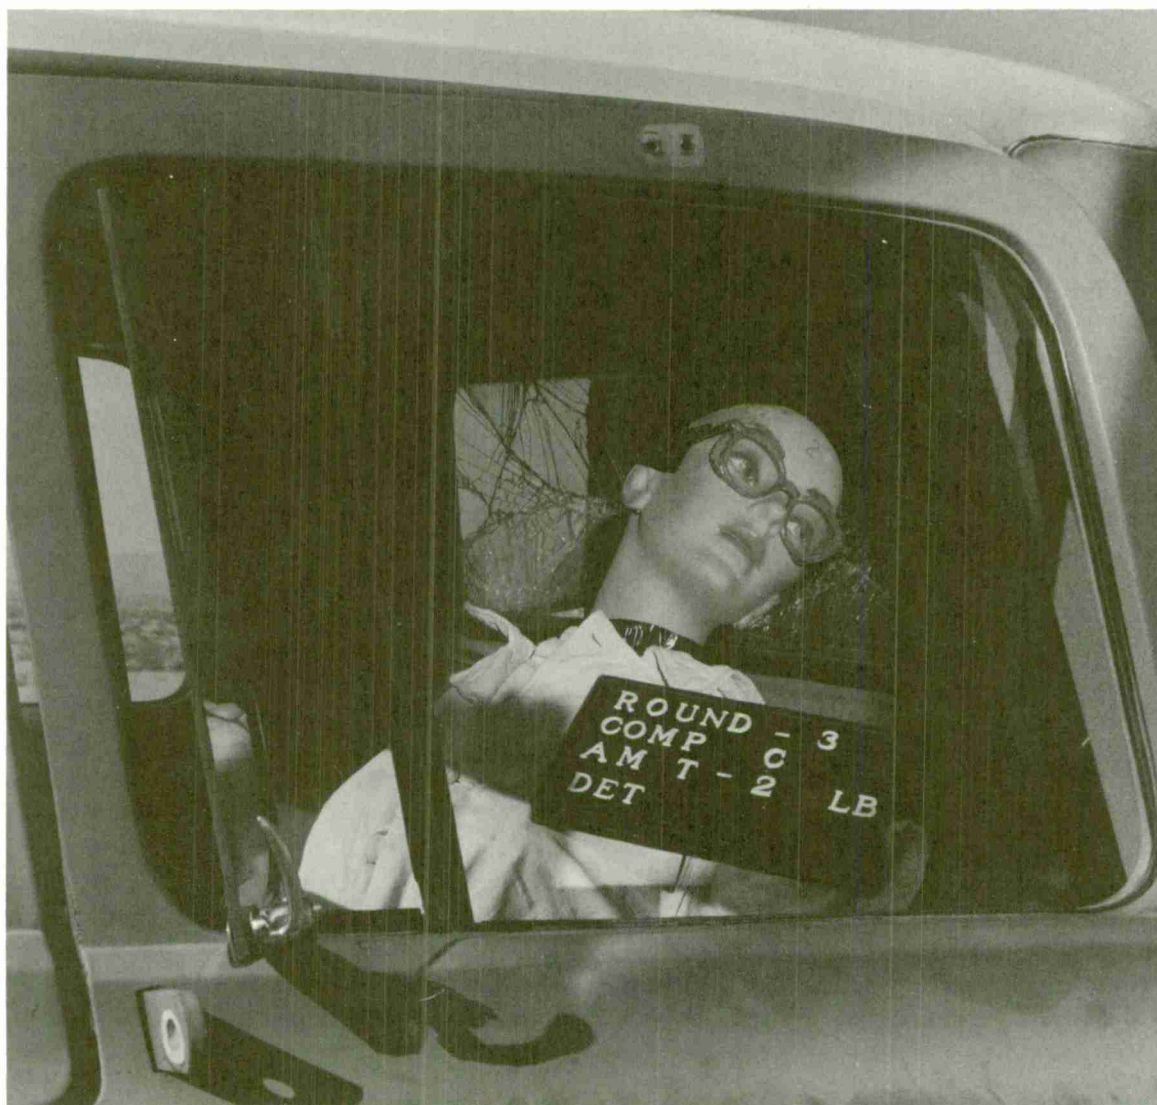
Although the pressure transducers did not show any rise in pressure, there was evidence of pressure rise within the cab. Figure 12 shows the window in the rear of the cab pushed outward and severely cracked. It was still in place but was torn loose from the bottom mounting. The windshield was cracked, and the frame was pulled loose. The mannequin had been thrown against the steering column, and the hard hat had been torn loose from the headband that was still on the mannequin. The roof of the cab showed evidence of being pushed up slightly and had buckled at the right front corner.

FIG. 12. Mannequin and Cracked Rear Window of Cab, Test 3.

There is no doubt that personnel in the cab would have sustained some injury caused by displacement in position. Although the transducer showed no pressure, there was indication of pressure in the cab that might have caused ear damage or at least discomfort.

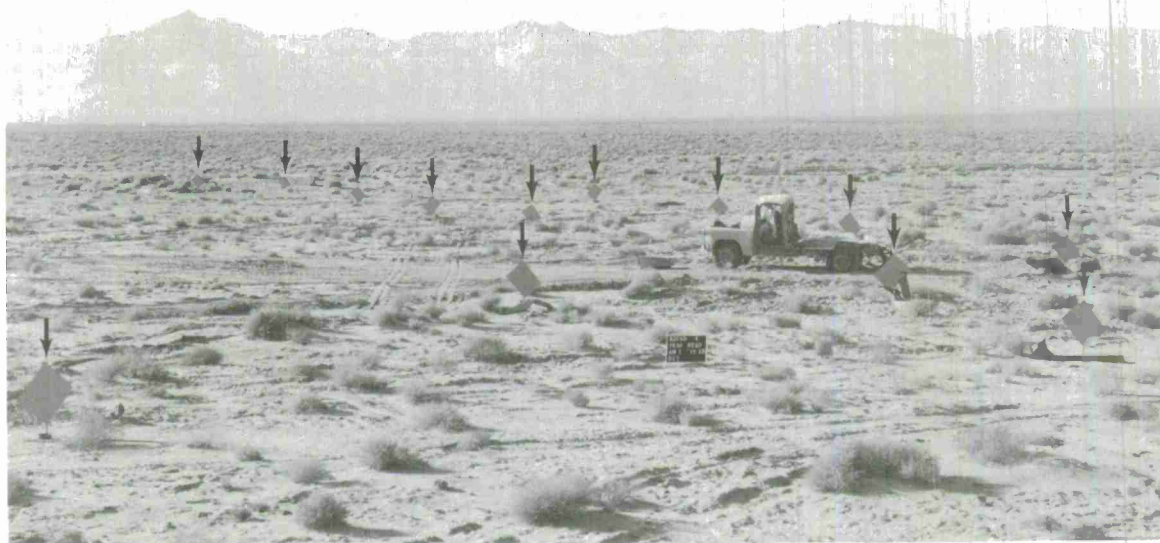
The truck bed was completely blown from the truck, and both rear wheels and tires were severely damaged. The steel barrier shield was torn loose and pushed into the back of the truck cab, forcing the mannequin against the steering column with sufficient force to break the steering column (Fig. 14 and 15). The back of the seat was blown partially through the windshield, which was almost completely blown out. The cap was blown off the gas tank, and the tank was punctured near the top. There was also evidence that some gas had spilled out and burned on the ground beside the truck. No other evidence of burning was apparent in this test. The hood of the truck was blown off. Pieces of the truck metal were blown to a distance of 262 feet from the truck (Fig. 16).

FIG. 16. Dispersion of Truck Fragments (Arrows), Test 4.

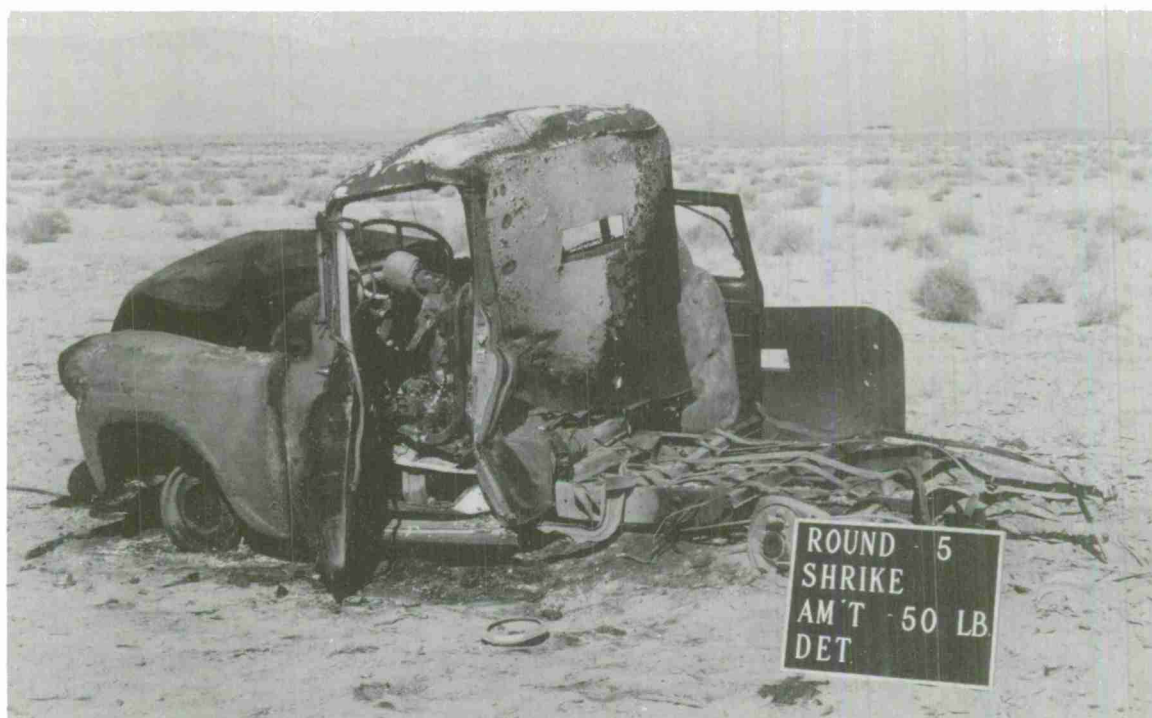
All of the truck aft of the cab was completely blown apart (Fig. 18), and pieces were blown to a distance of 681 feet from the test location. The remainder of the truck and the anthropomorphic dummy used in this test were completely burned by the fire resulting from the blast (Fig. 19).

FIG. 18. Condition of Truck After Detonation of 50 Pounds of PBXC-104 Explosive, Test 5.
