Technical Note N-1044

PROTECTION OF FLOATING PONTOONS FROM CORROSION -- PART III.  
CONDITION OF TEST FLOATS AFTER THREE YEARS

August 1969

↓  
NAVAL CIVIL ENGINEERING LABORATORY  
Port Hueneme, California 93041

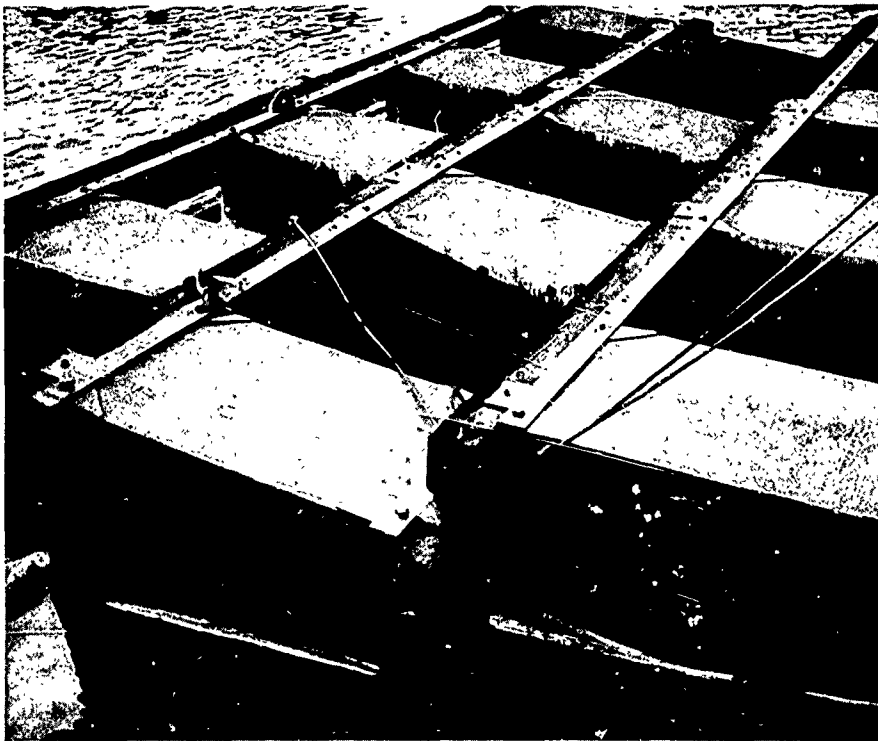
The relatively rapid loss of fenders below water is caused by marine borer attack where untreated wood is exposed at cut ends (Figure 6) and at bolt holes. This can be avoided by making the necessary cuts before treating the wood (e.g. pressure creosoting). Probably a much better system is to use hard rubber fenders rather than wooden ones. Such fenders are available in a variety of sizes and shapes and have performed well on mooring buoys both above and below water.<sup>25</sup> They are resistant to marine biological attack and absorb impact and abrasion better than do wooden fenders.

3. Treated lower fenders on floats and mooring buoys are readily susceptible to marine borer attack unless they are treated after all cuts have been made.

Figure 6. Untreated wood exposed at cut ends of camel fenders.

3. On floating steel structures rubber fenders should be used underwater in place of wooden fenders subject to marine borer attack.
