FINAL REPORT ON

ENGINEERING TEST

RECOVERY VEHICLE, FULL-TRACKED,

XM806E1

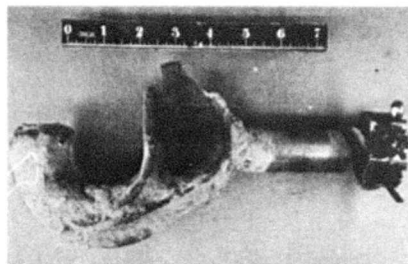
Figure II-21: Towing Pintle That Failed After Towing An M113A1 For 59 Miles Across Level Cross-Country Terrain.

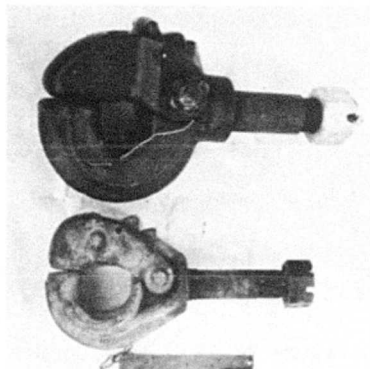
Figure II-23: Standard M113A1 Tow Pintle Is Shown Below Larger Pintle (M548 Type) That Was Satisfactory for 1024 Miles of Towing Operations. Six Inch Ruler Indicates Relative Size Difference.

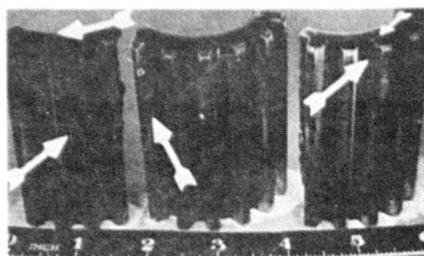
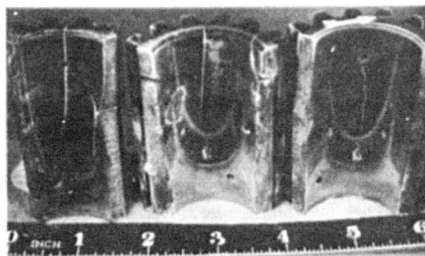
Winch gear-train failure from poor quality control of material properties was the only deficiency reported during the test. The gear failure occurred after 59.8 winch hours.

Figure II-24: Internal and External Views of Winch Stage Three Carrier Housing Planetary Gear That Failed After 59.8 Winch Hours. Arrows Indicate Cracks That May Either Have Resulted from the Impact Loading At the Time of Failure or from Material Weakness.

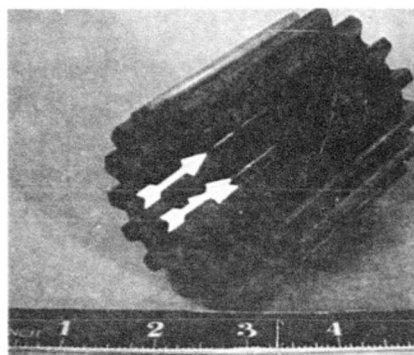
Figure II-25: Spur Gear from the Same Housing as the Failed Gear Shown in Figure II-24. Arrows Point to Cracks Along Tooth Roots.

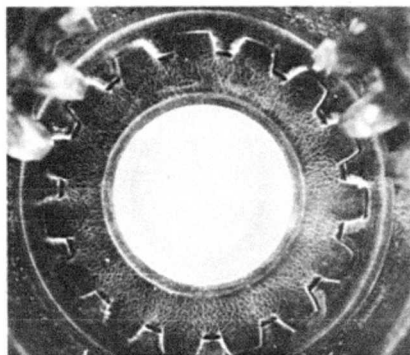
Figure II-26: New Second Stage Sun Gear As Received from the Manufacturer. The Assembly Was Intended for Use As A Replacement Component. Surface Cracks Probably Resulted from Heat Checking during Grinding Operations.
