PROGRAM TITAN IIIM

STANDARD SPACE LAUNCH VEHICLE
COMPONENT DEVELOPMENT REPORT

FOR THE
TITAN IIIM STAGE I COMBUSTION CHAMBER

9180-941-DR-3

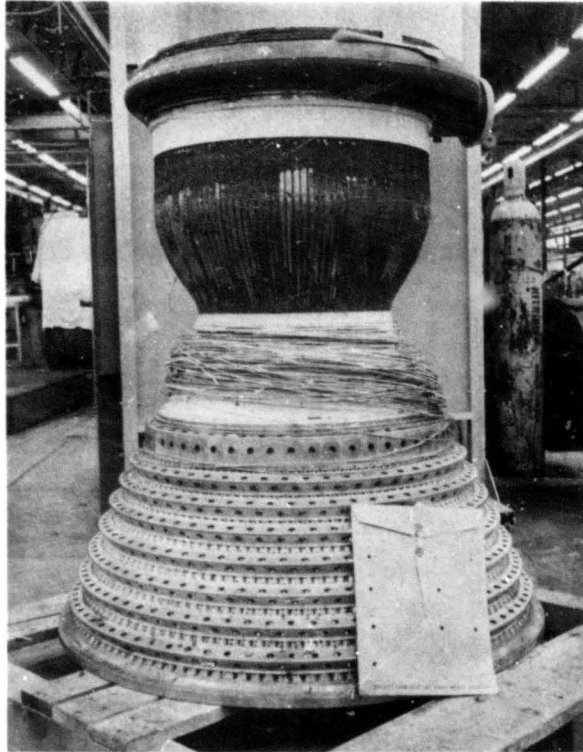
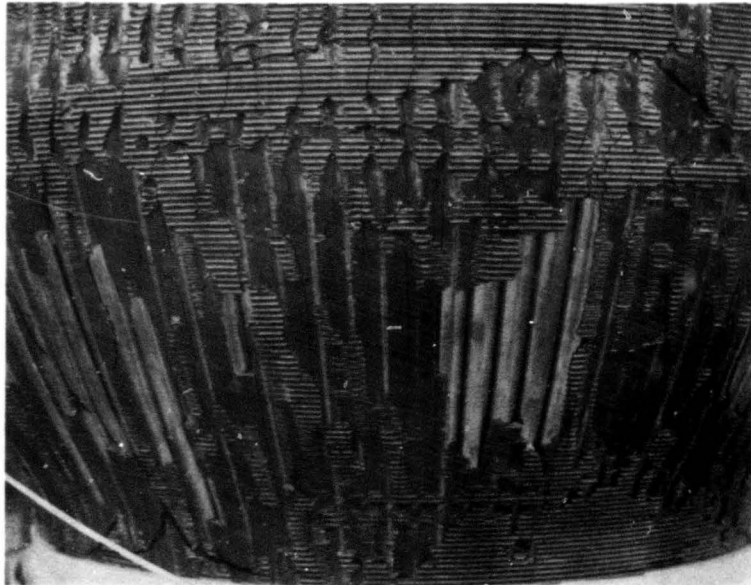
Figure 5 -- Combustion Chamber S/N 001, Showing Failure of Wire Wrapping

Failure analysis of the wirewrap separation produced the following information:

(a) Posttest inspection revealed an unwrapped condition from approximately 3 in. below the torus to approximately 1 in. above the throat. These tubes were bulged approximately 1/2 in. in the convergent section, and the tubes appeared to be elliptical in this area.

(b) Material evaluation indicated there was an insufficient thickness of Epon over large portions of the wirewrapped area. It was apparent by visual inspection that the Epon was not flush with the high point of the wire. Samples of Epon were visually examined and found to be acceptable in respect to material properties.

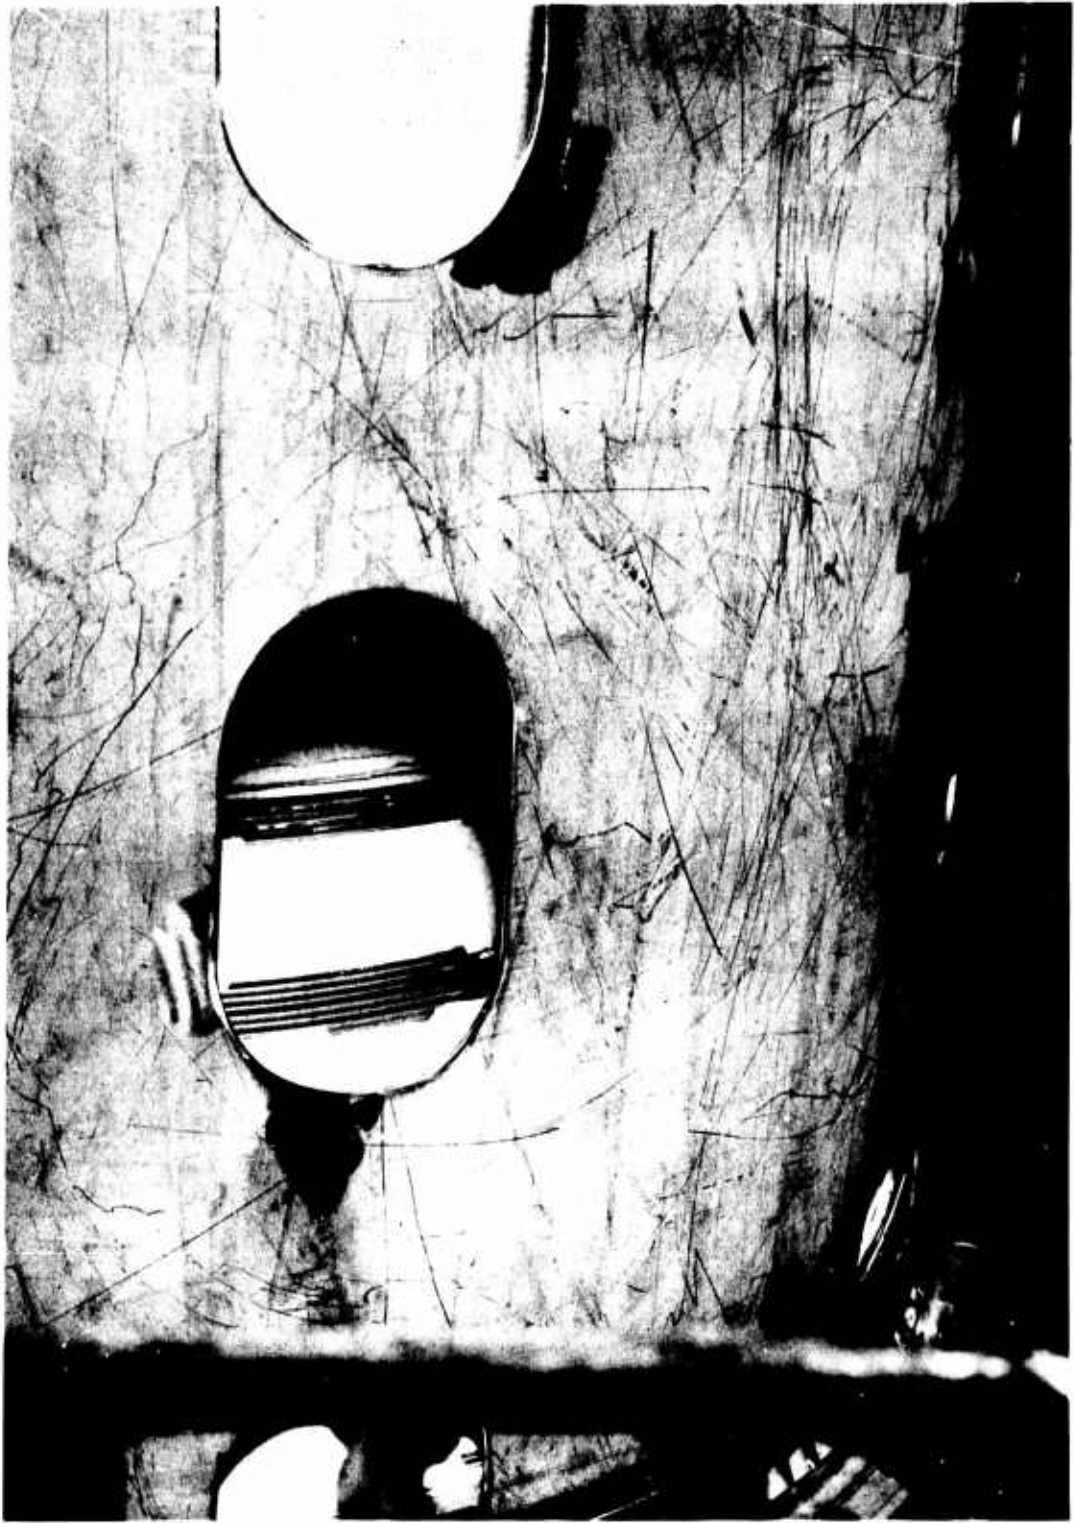
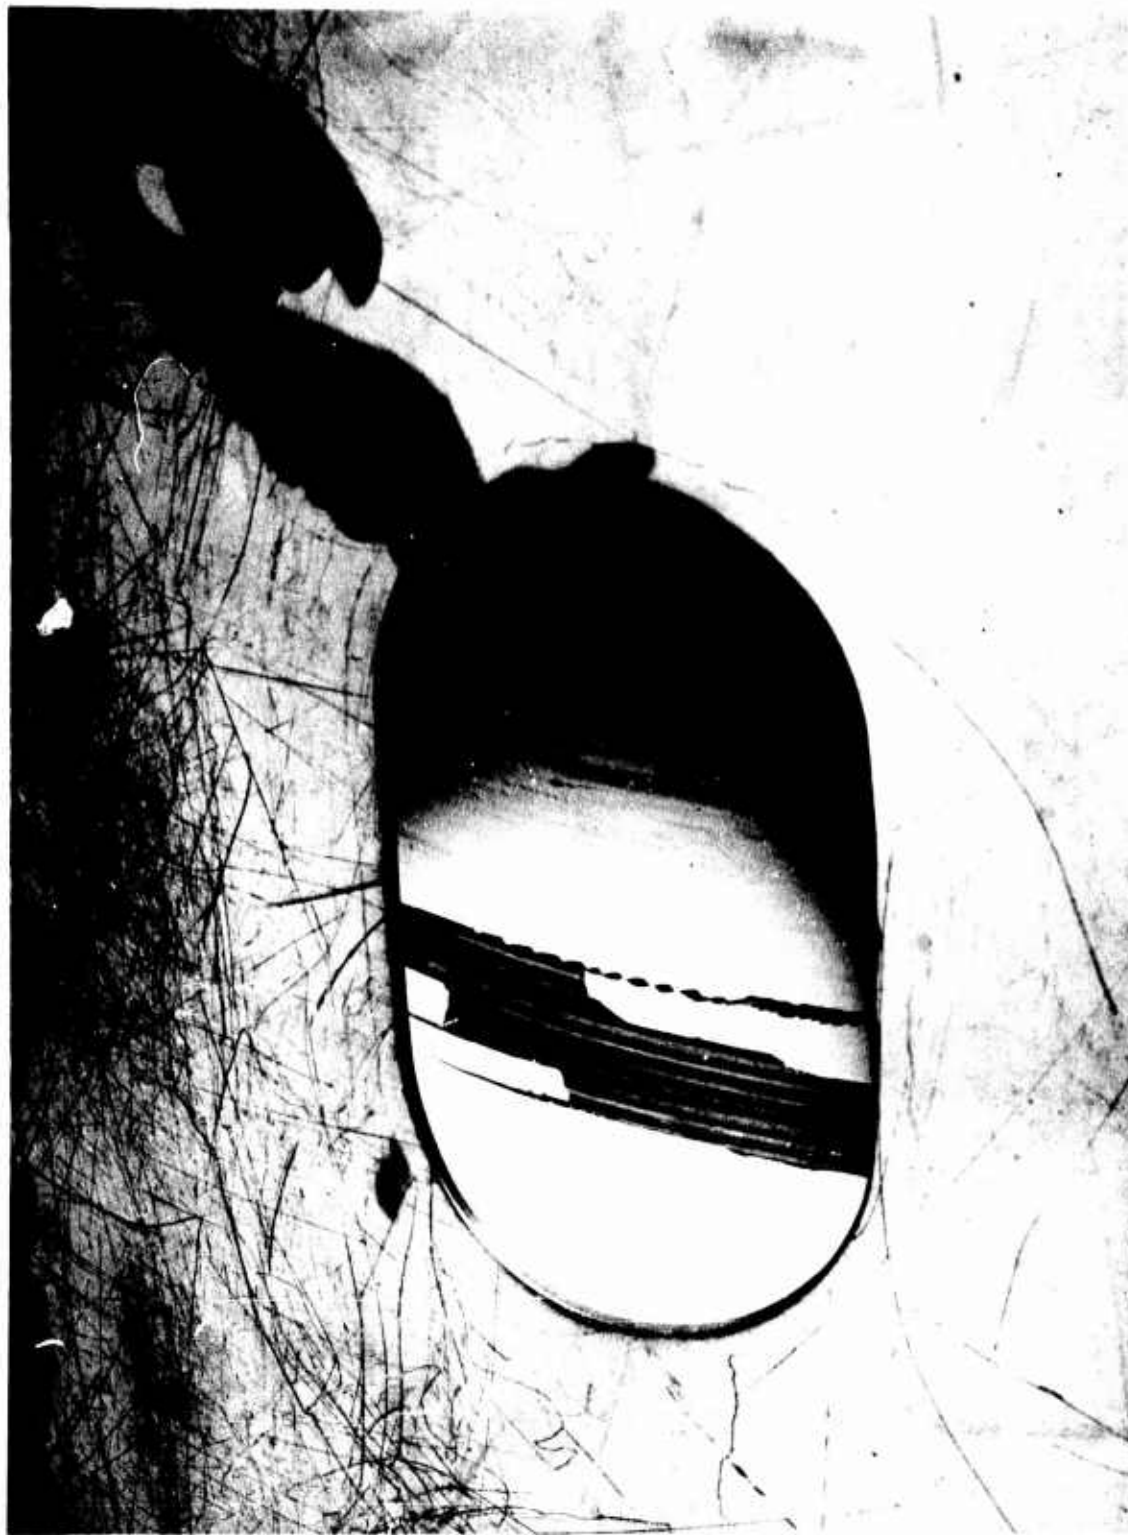
After the first test of Demonstration Engine S/N 14 (Demo 14) the wirewrap on the divergent section of chamber S/N 020 was loose (see Figure 6). The loose strands started about 1 inch aft of the throat plane and extended over 2 inches of the nozzle length. Two additional tests were conducted with the loose wire. For the second of these tests the wire was taped in place to hold the wire in position during the start transient. The wire was removed after this test, but it was never replaced because the chamber was withdrawn from the test program.

During initial fabrication, the chamber had been wirewrapped twice in the forward section (forward of the throat plane), the second time because the wire was loose after completion of final proof-and-leak testing. The wire in the aft section did not appear loose and was not similarly replaced. No specific cause for the loose wire in the forward section was ascertained, but it was noted that the surface of the wire was not clean. Little effort was necessary to strip the wire from the chamber, and no adhesive forces were apparent between the wire and the Epon bed. When the aft wirewrap was removed after loosening, the wire was also found to be dirty.

The looseness of the wire is not fully explainable, but it can be attributed to the same elements that caused the forward section of wirewrap to loosen during proof testing. The cleanliness of the wire and the depth of Epon during wrapping are believed to be important in maintaining wire location and tension through adhesion of the Epon bed to the wire. The corrective action calls for stripping both wire sections if either loosens during fabrication and for cleaning the wire to a degreased condition prior to and during wirewrap.

Figure 6 --- Loose Wire Wrap --- Chamber S/N 020 after Test No. 3051-D07-1A-201 (1 of 3)

The corrective action was limited to adding cleaning operations to the wirewrap procedure and requiring that both wirewrap sections be stripped

and replaced if either must be replaced. The cleaning consists of vapor-degreasing of the spool of wire in a hot atmosphere and, as the wire is wrapped, cleaning it with a cold degreasing agent applied to felt wipers on the wirewrapping machine. The wrapping procedure specifies the requirements for maintaining the felt pads at adequate effectiveness.

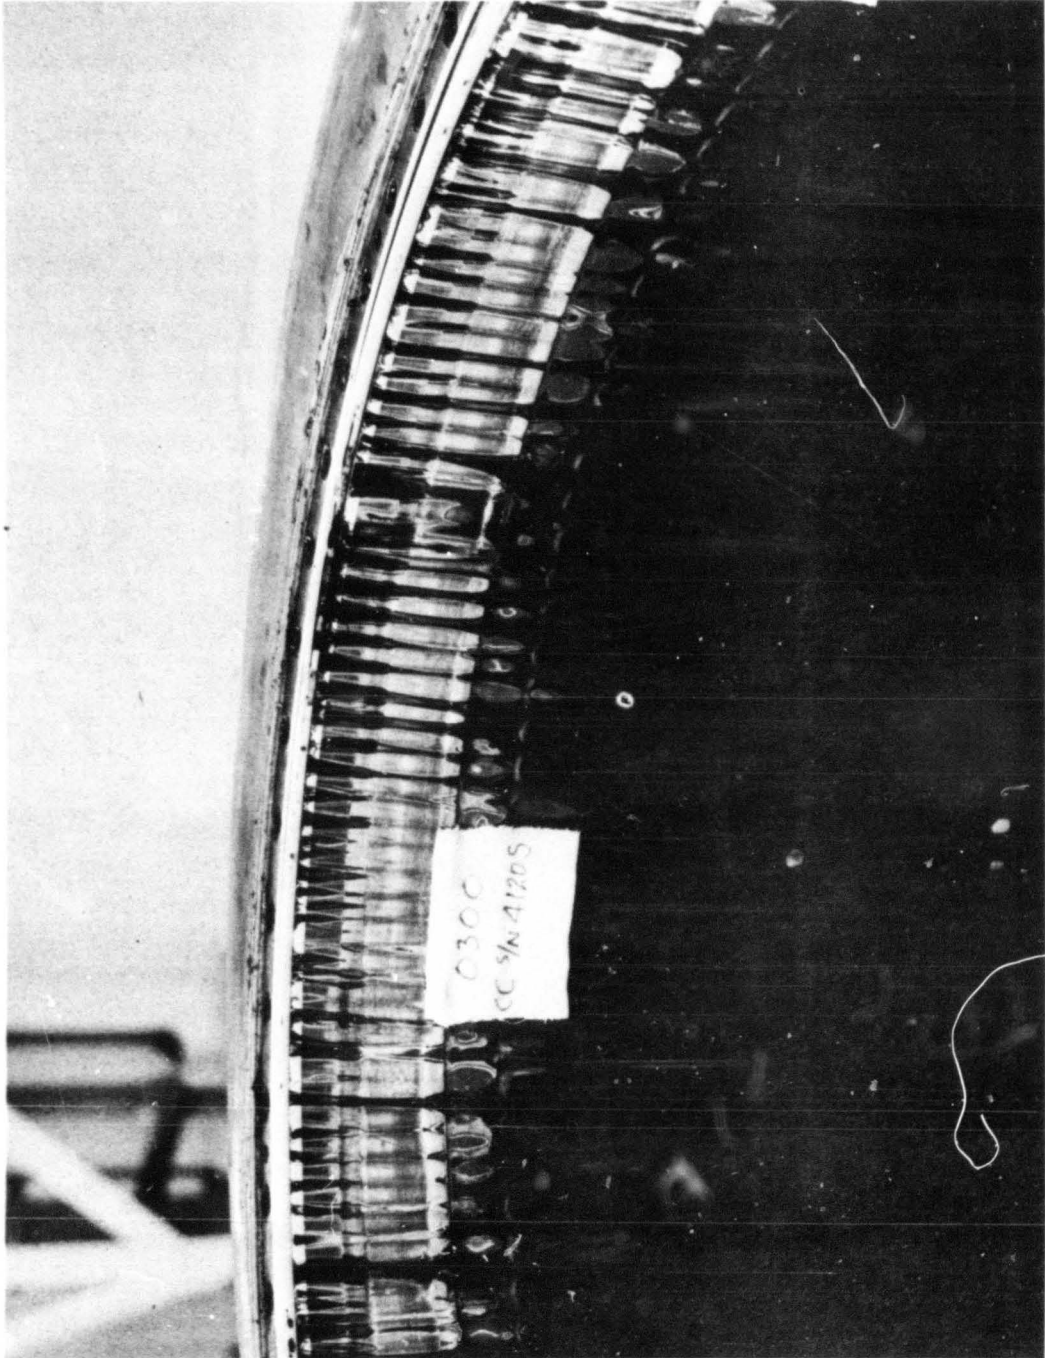
Figure 8 -- Forward Flange -- Chamber S/N 003 after Test No. 3051-D01-1A-008

During the development and early verification testing there were instances of heat marking and erosion on the forward flange such as shown in Figure 8. This was attributable to inadequate dispersion of the fuel film cooling from the baffle injector. The film cooling pattern of the injector was modified as shown in Figure 9. Thereafter such minor instances of erosion as occurred were all within acceptable limits as given by the specification.

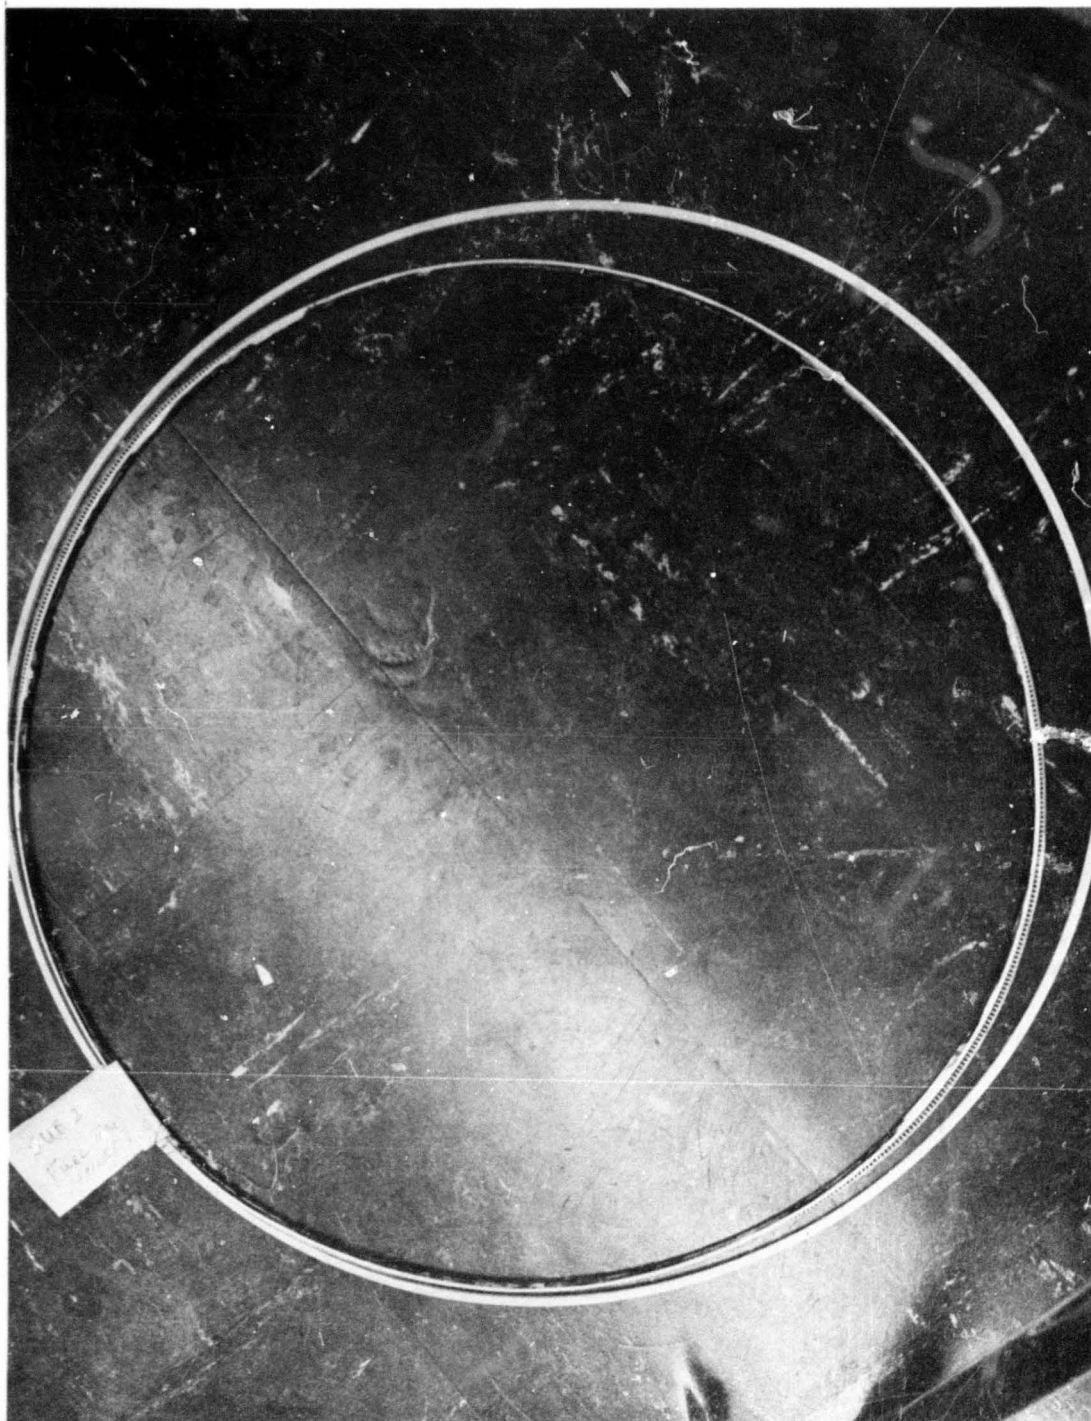
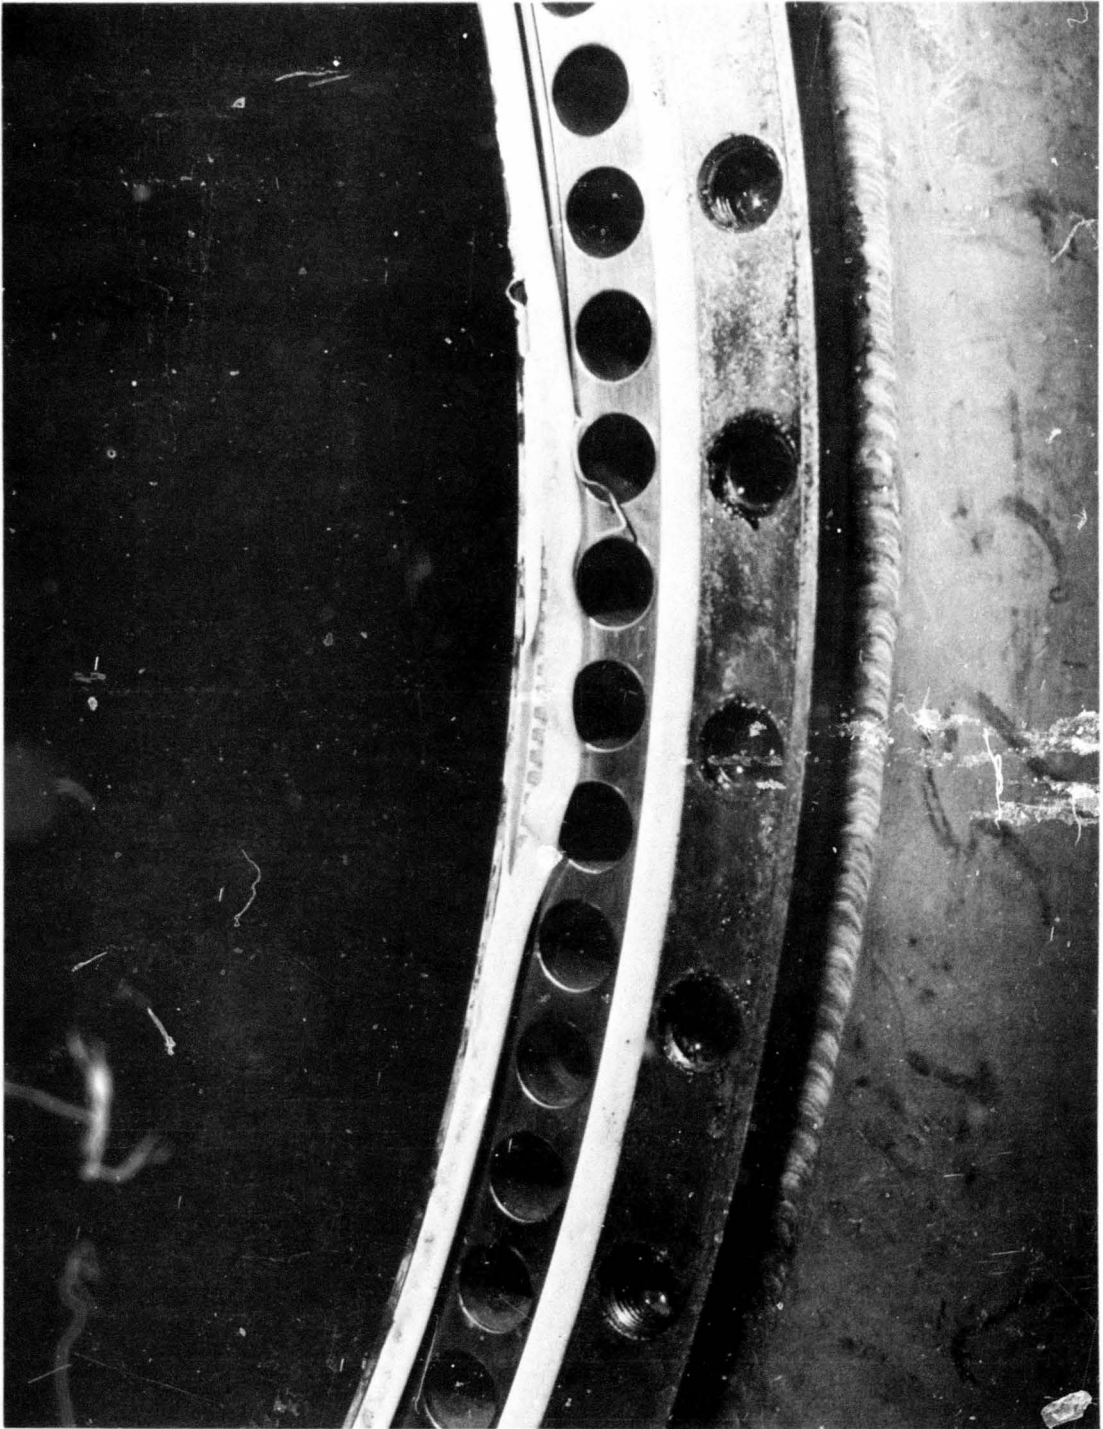
Figure 14 -- Damaged Raco Seal (1 of 2)

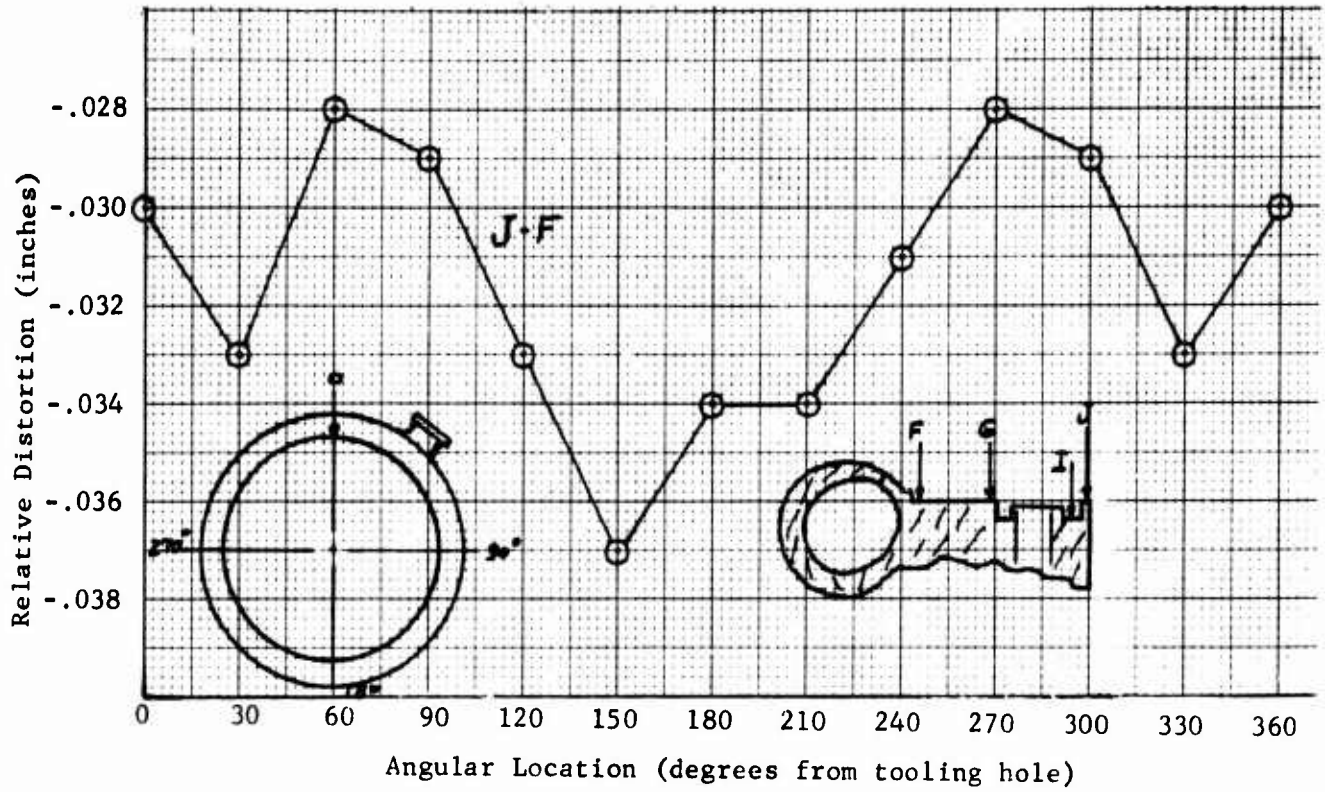
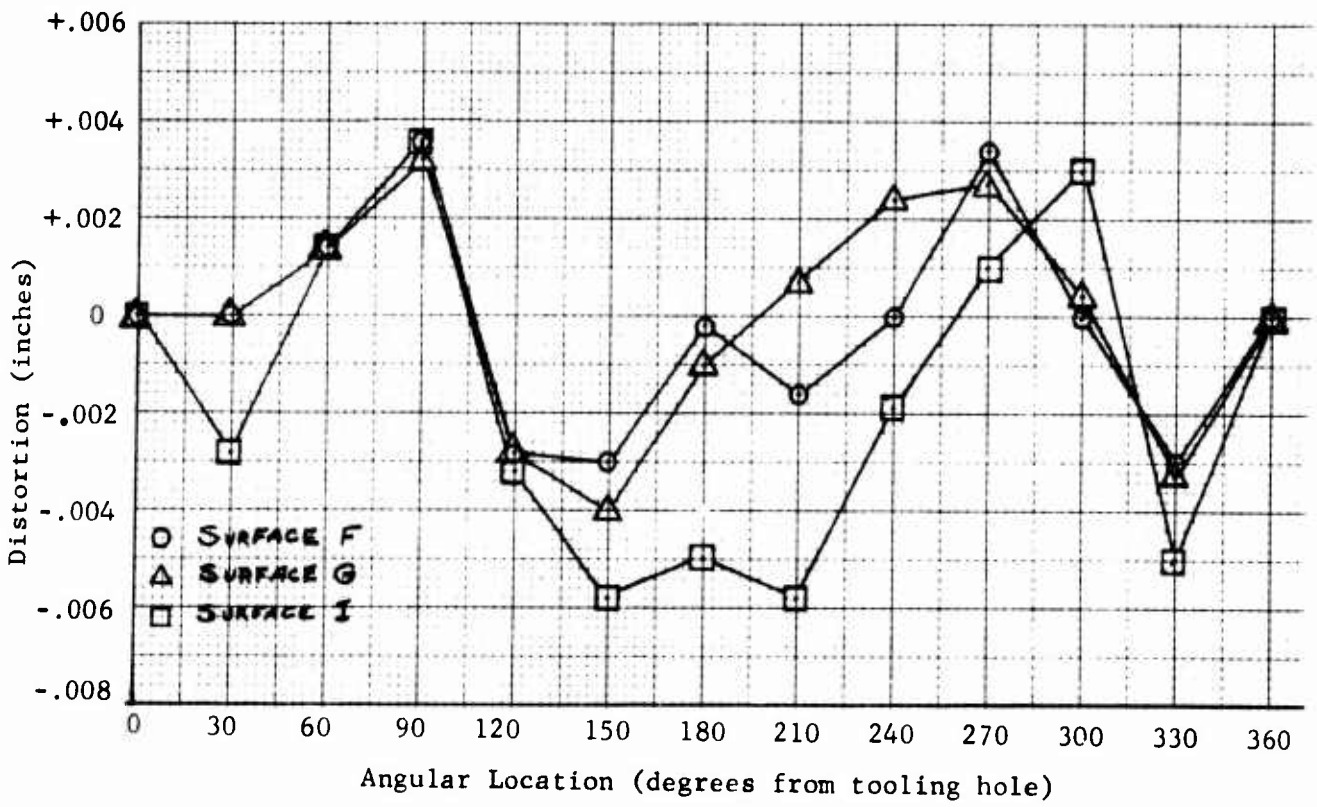
Distortion of the forward flange similar to that shown in Figure 20 occurred on both chambers S/N 019 and S/N 020 after the cover band weld repair. The injector feed holes which are drilled on a 22.730-in. diameter were on a diameter of 22.516-in. after the weld repair. This contraction caused an interference between the feed holes and the outer diameter of the inner seal groove. The alternatives then were: (1) to machine the seal grooves per blueprint and let the groove outer diameter break into the feed holes as occurred on S/N 017, or (2) to machine the inner seal inside diameter to blueprint and adjust the outside diameter to provide the minimum width groove required for correct Raco seal installation and operation.

Figure 20 -- Forward Flange Map--
Combustion Chamber S/N 018

Alternative (2) was therefore selected as the more satisfactory means for correcting the problem in chambers S/N 019 and S/N 020. Drawing No. 701773 (AEIP seal utilized for Titan IIIM at the inner seal) requires a minimum seal groove width of 0.195 while the chamber flange per B/P 1130174 is designed for a minimum groove width of 0.214 in. The chambers were machined as shown on Figure 21. All dimensions are to be to blueprint with the exception of the 22.167 in. dia, which normally is 22.250 ± 0.010 in. dia.

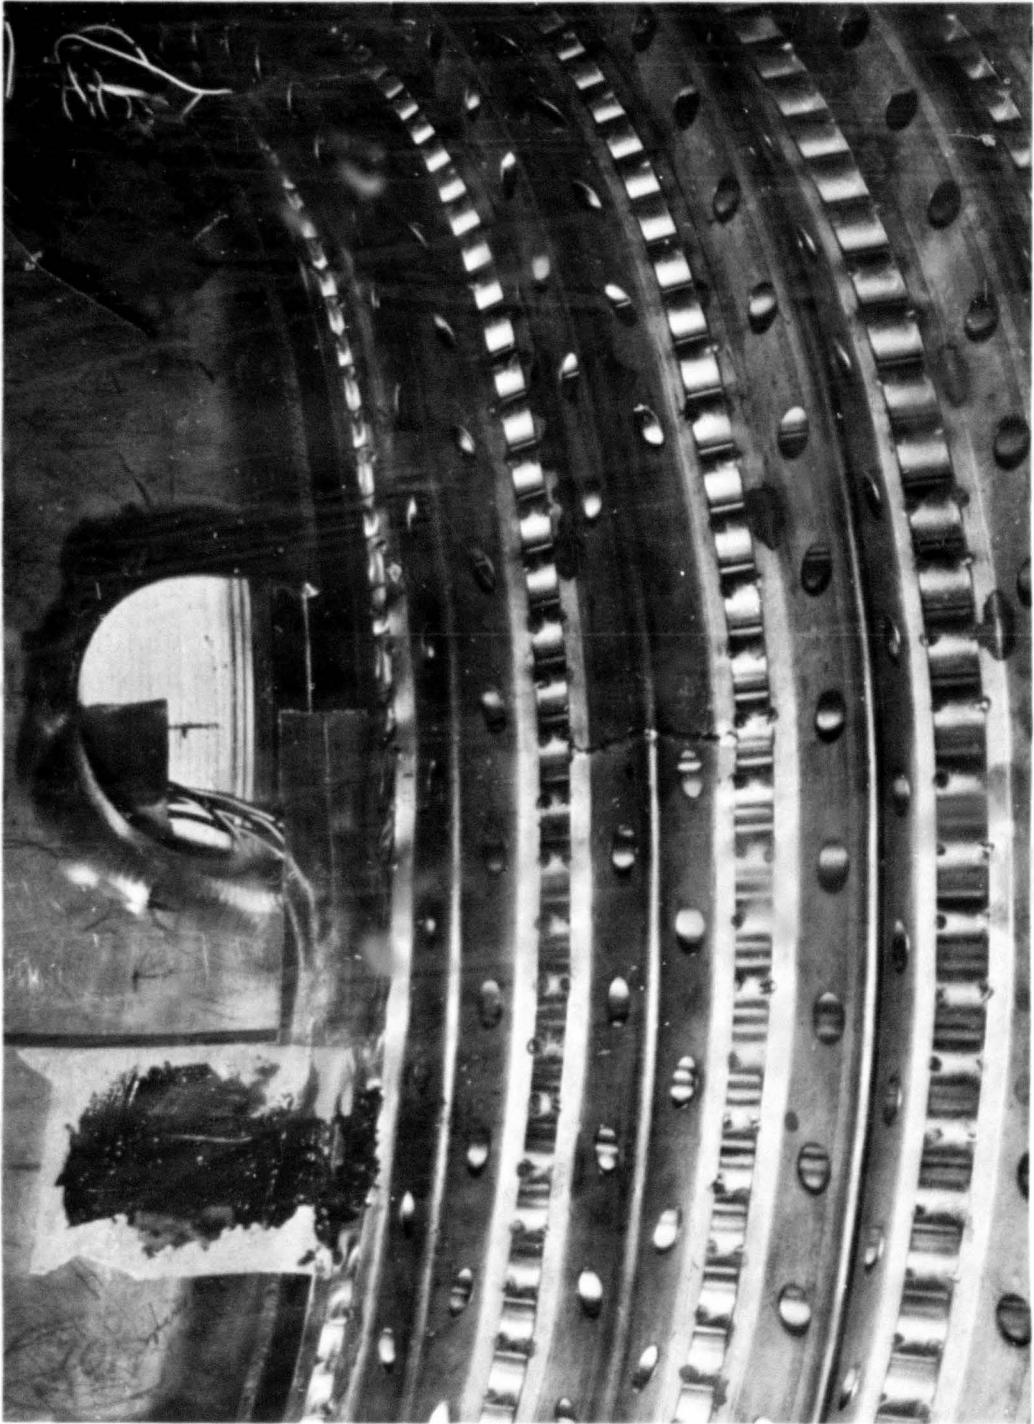
Figure 35 -- Chamber S/N 010 -- Closeup of Failure

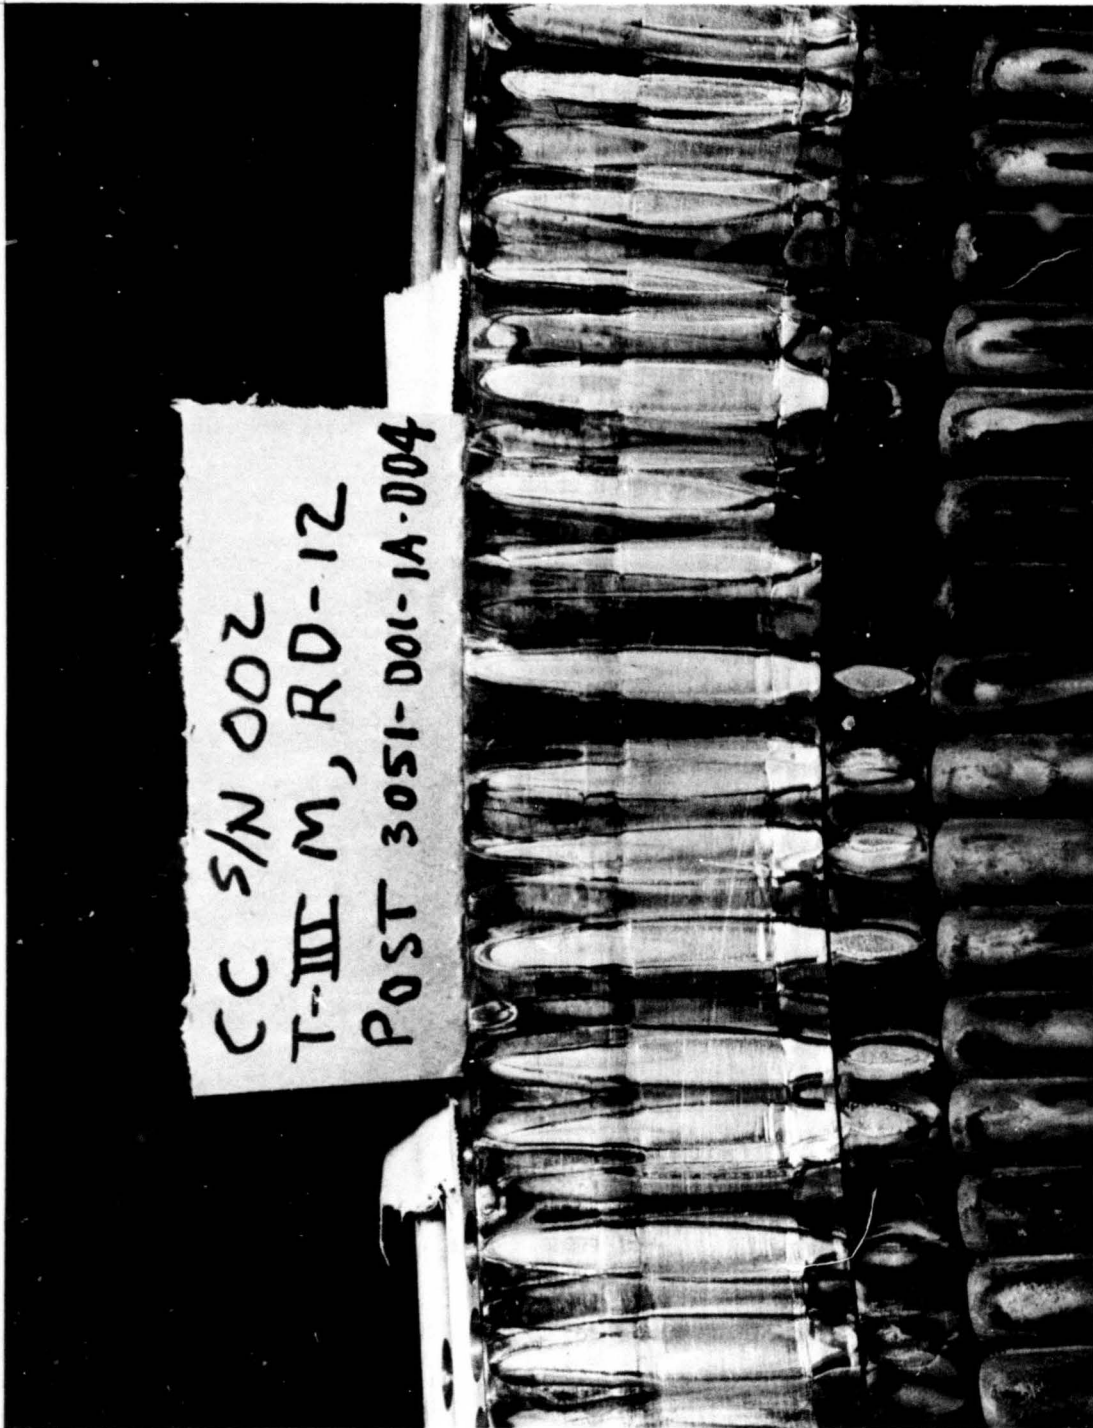
Test -005 was conducted utilizing injector S/N 249 (AJ-9 with 16 percent film cooling) and an ablative skirt at the most adverse heat transfer conditions for the skirt. Posttest inspection of chamber S/N 002 after engine Test No. 3051-D01-1A-005 revealed that one chamber tube was heat marked in the divergent section from approximately 18 inches below the throat to the aft end of the tube. Figures 48 and 49 show the location relative to the chamber. Penetrating erosion had occurred in two places (Figure 7, supra). All other chamber tubes were in satisfactory condition.

Figure 47 -- Chamber S/N 002, Showing Minor Erosion to Flange

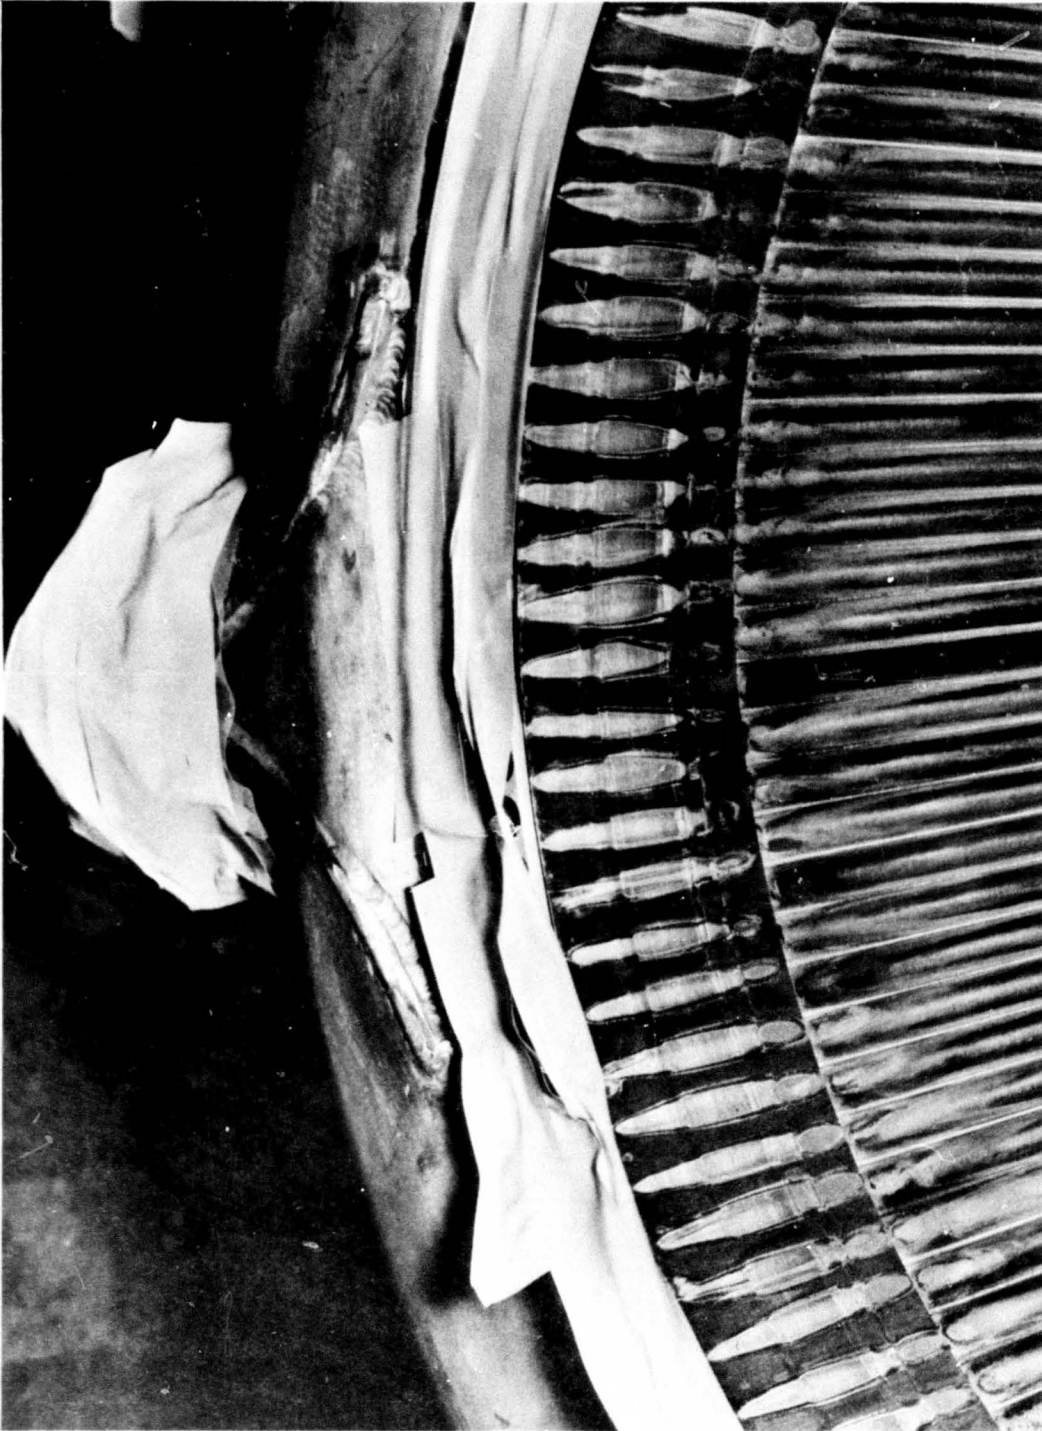
Figure 49 -- Chamber Flange Showing Heat-Marked Tube

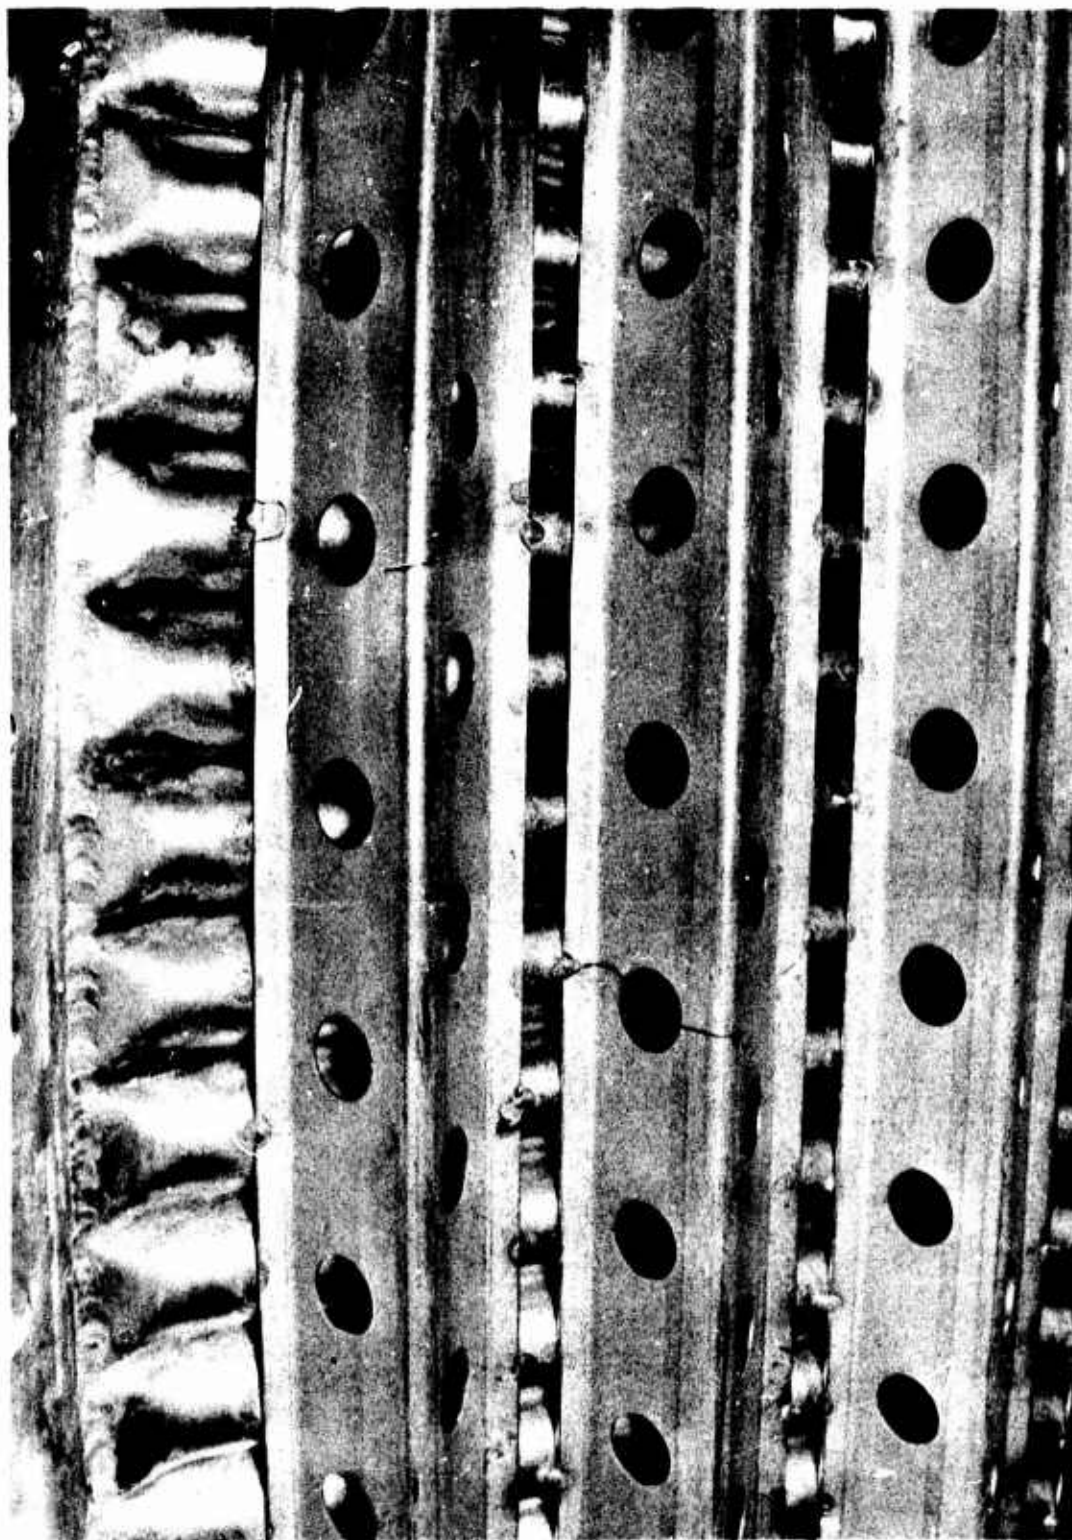
Test -008 was conducted with chamber S/N 003 and injector S/N 657 (300 lb/element). This test was scheduled for the nominal Titan IIIM conditions. The posttest inspection revealed several failed tack welds on the chamber shell and "V" bands. (Figure 50). Review of the records indicated chamber pressure oscillations commenced at FS₁ + 1.3 seconds during the secondary P_c rise and continued during the entire run.

Figure 50 --- V-Band Tack Weld Failure --- Chamber S/N 003

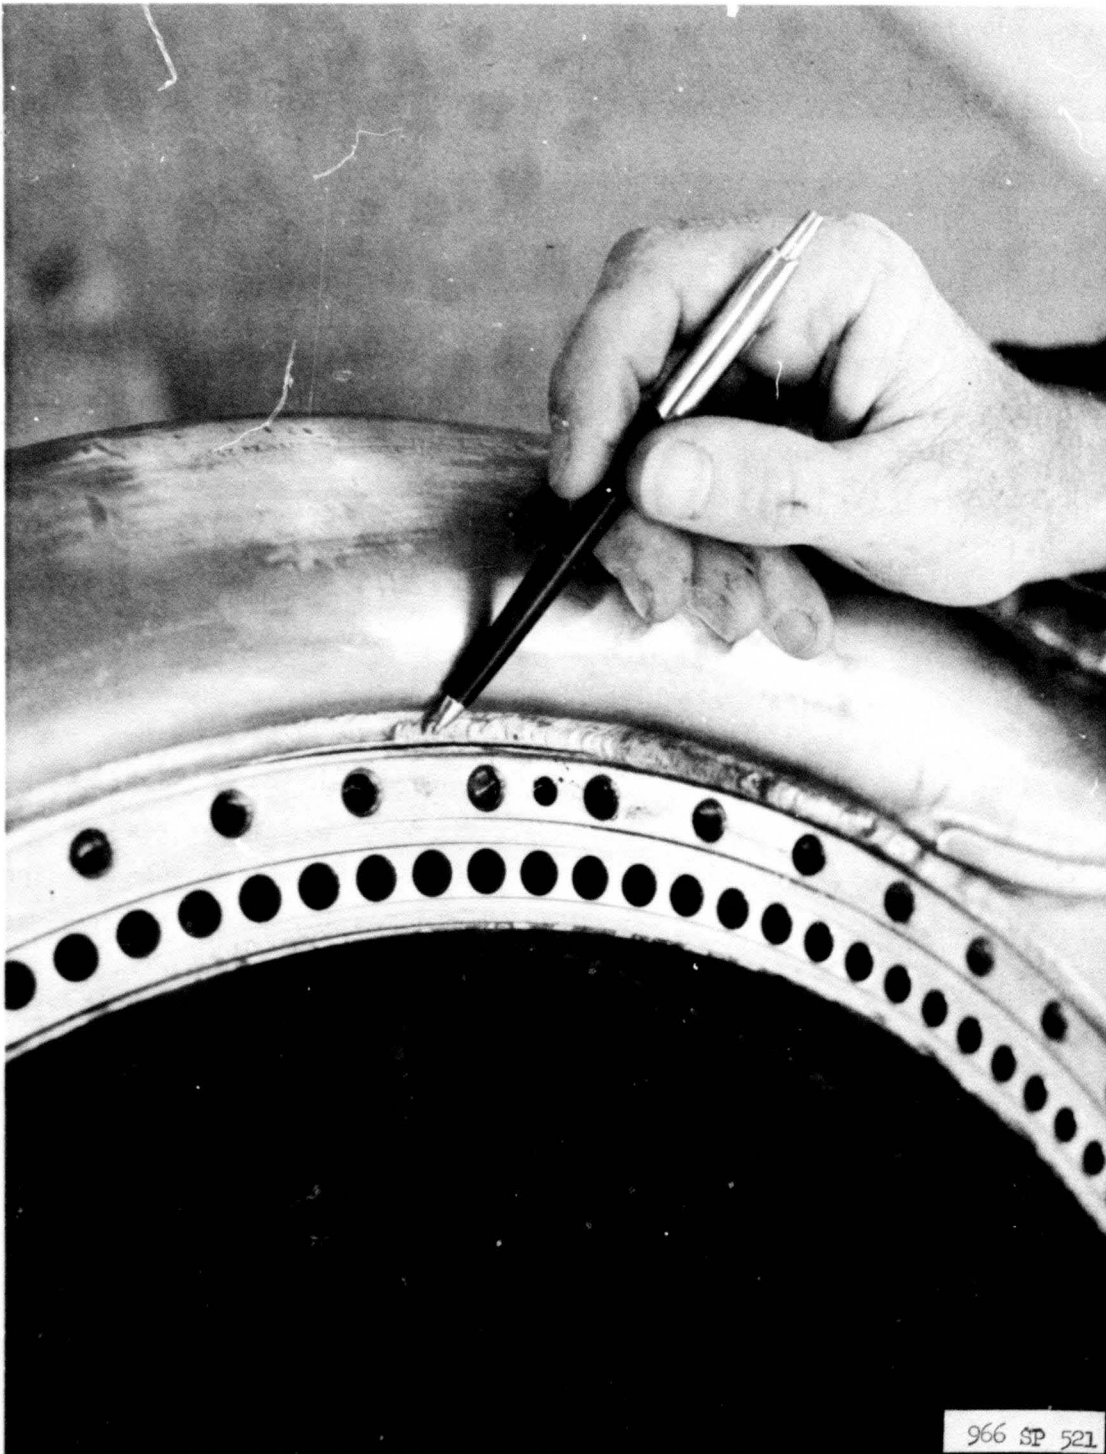
Figure 51 -- Combustion Chamber S/N 004, Showing Torus Crack

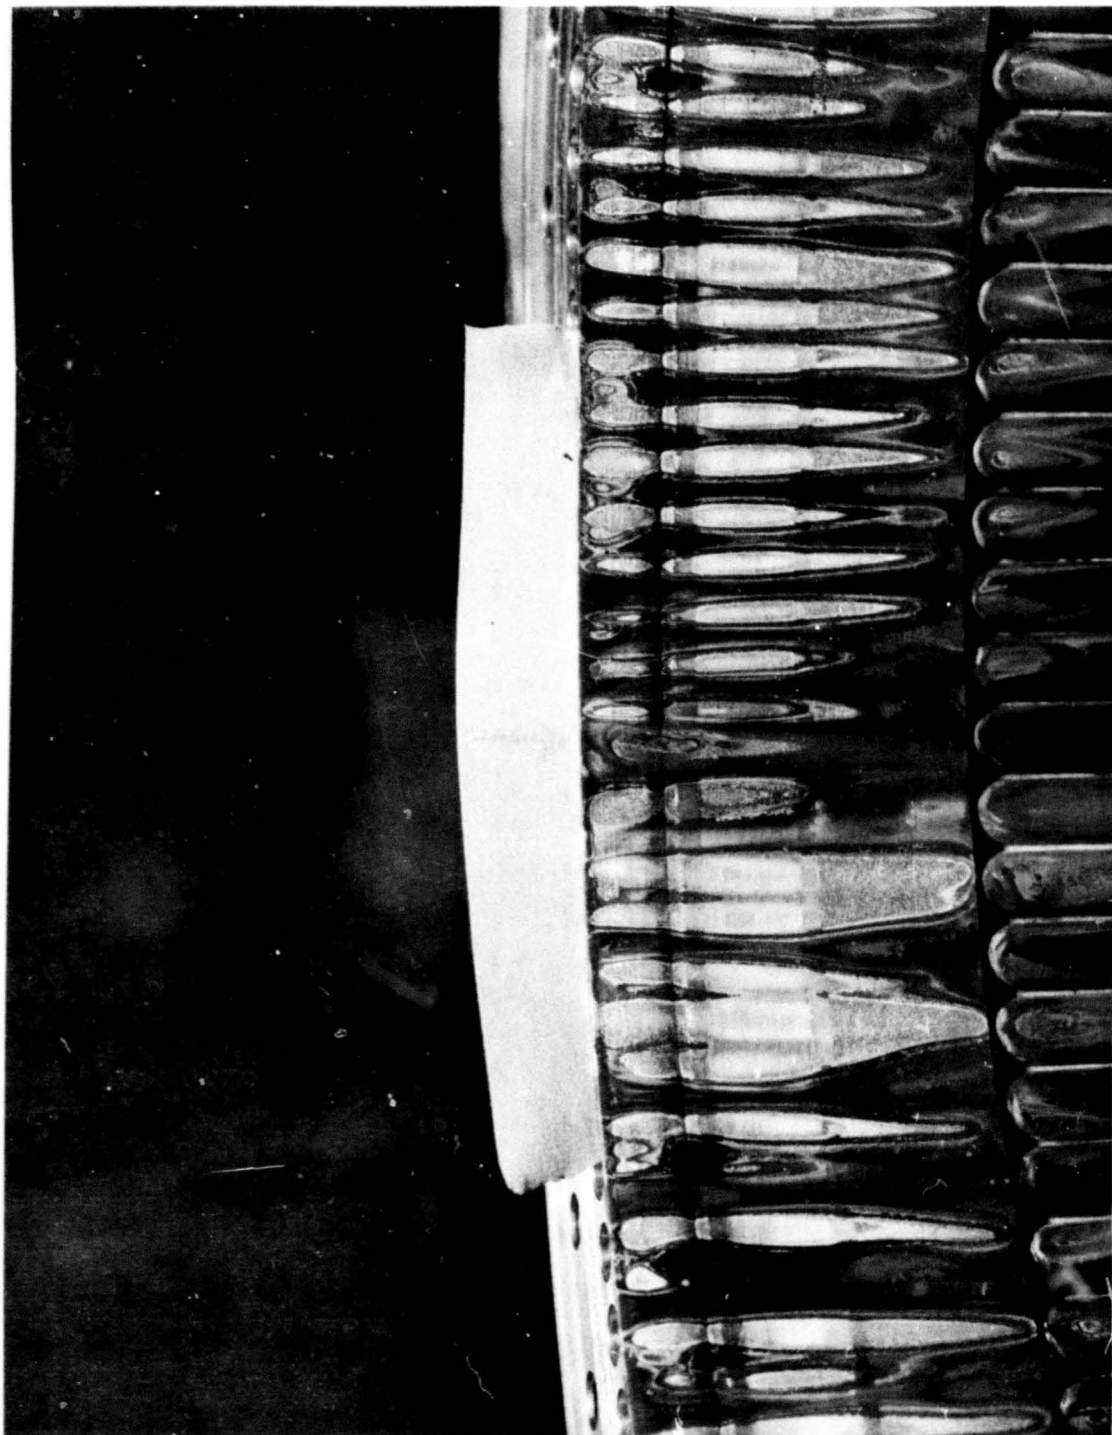
Figure 52 -- Combustion Chamber S/N 007 -- Mounting Flange Erosion
