PROGRAM TITAN IIIM

STANDARD SPACE LAUNCH VEHICLE
COMPONENT DEVELOPMENT REPORT

FOR THE
TITAN IIIM STAGE I COMBUSTION CHAMBER

9180-941-DR-3

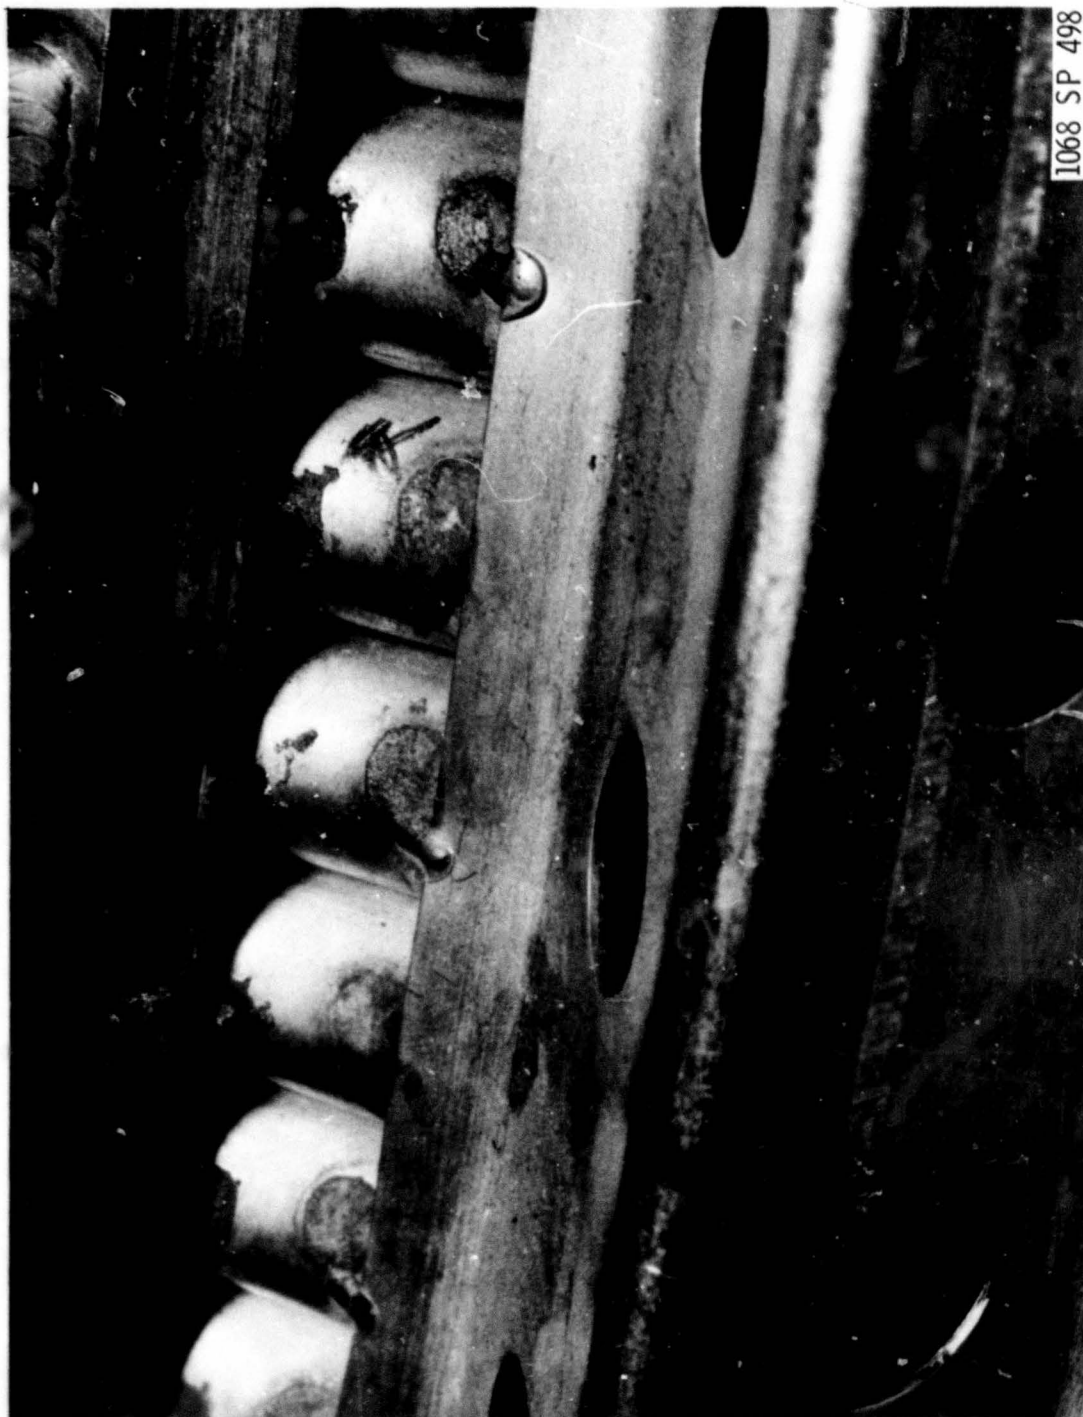
Figure 56 --- Weld Cracks --- Chamber S/N 022

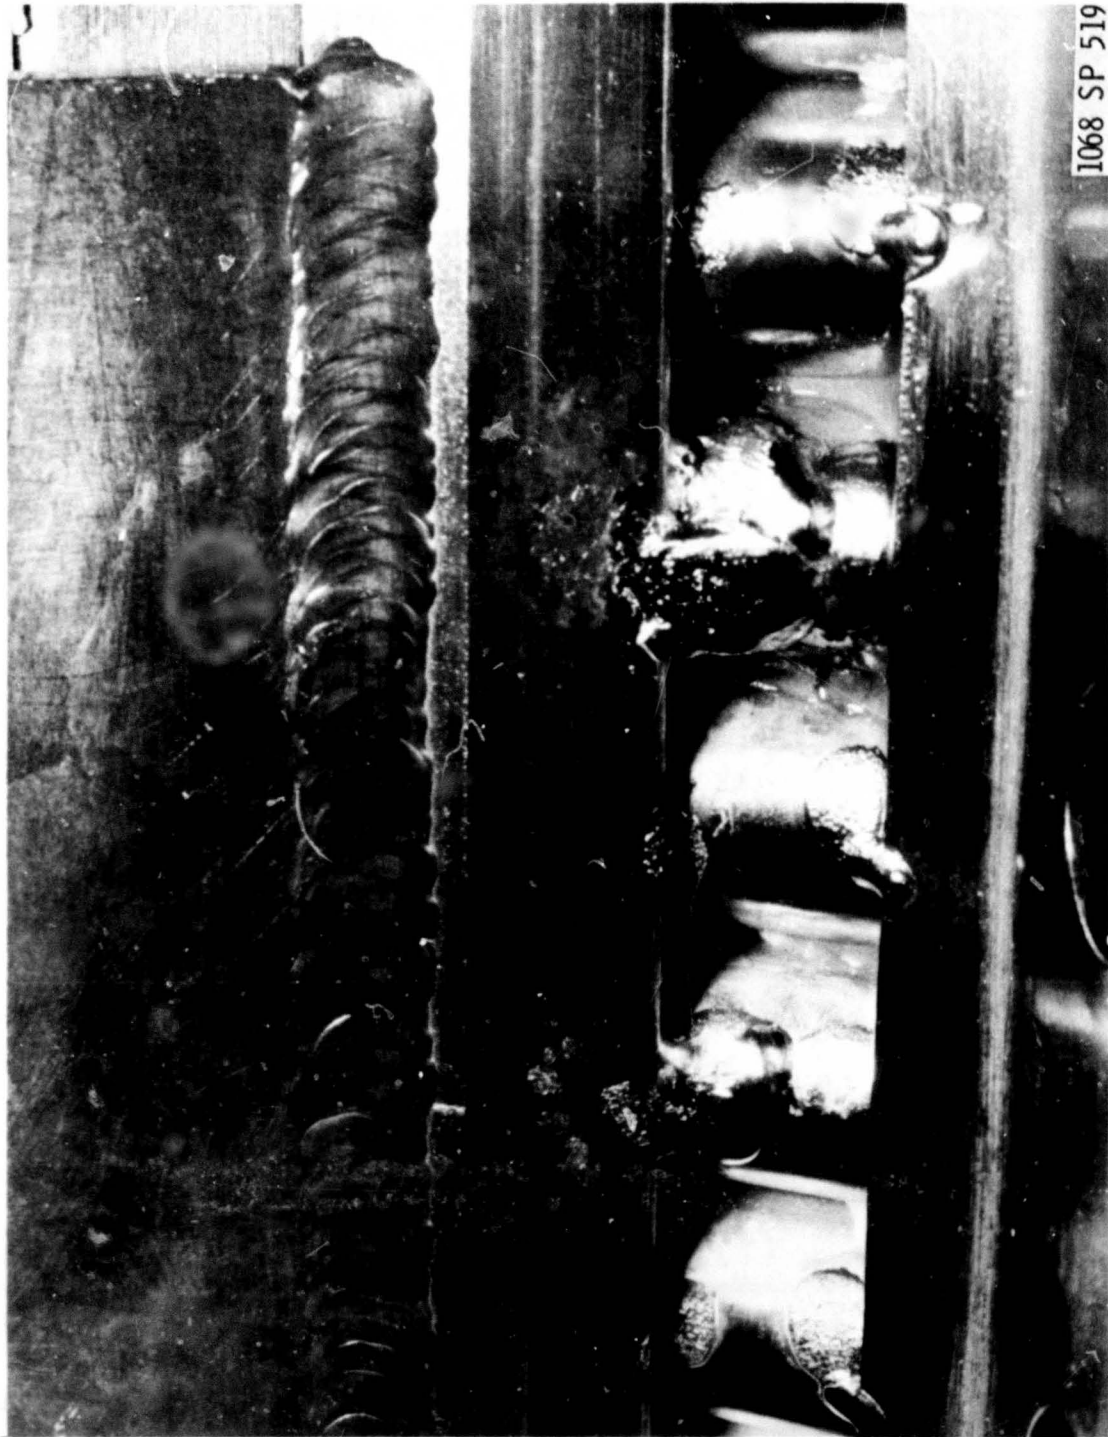
Figure 57 -- Repair of Weld Cracks -- Chamber S/N 002

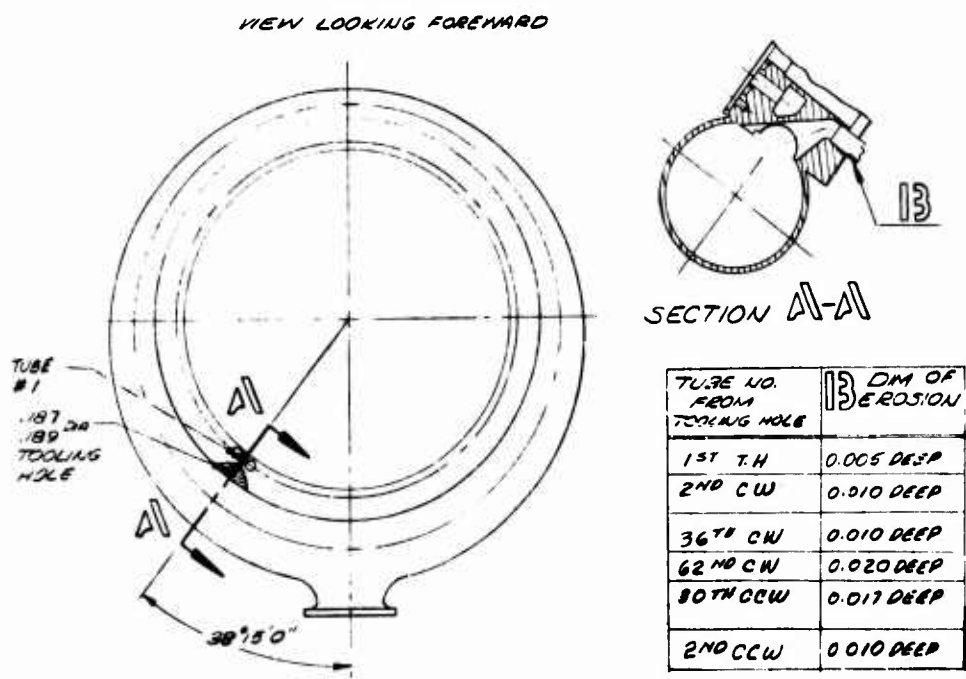
The eroded condition is attributed to the concentration of braze alloy which had been replaced in this area prior to the second braze cycle, coupled with the highest brazing temperature employed for the "A" revision braze alloy and the long duration of the braze cycle (30 minutes). The manganese-nickel binary equilibrium diagram shows a solid solution type diagram with a liquid phase occurring at 1840°F and 58 percent manganese. The reaction between the liquid manganese-base braze alloy with the nickel-base tube material at the brazing temperature resulted in the tube dissolution. The sixth tube did not erode because a tack weld joining the tube crown to the flange occupied this area.

Figure 59 -- Erosion of Hastelloy Tubes
