ROCKET ASSISTED PROJECTILE (RAP) DEVELOPMENT PROGRAM

Part 4. 5"/38 SAFETY TEST PROGRAM

ABSTRACT. The Safety Test Program for the 5-inch 38 caliber Rocket Assisted Projectile (5"/38 RAP) verified that RAP can be handled, stowed, and fired as safely as existing in-service projectiles loaded with Composition A-3 explosive. The presence of a solid-propellant rocket motor and percussion-actuated igniter did not present any unusual safety hazard. Sequential environmental, bullet impact, and slow and fast cookoff tests were conducted as required by WR-50 and MIL-R-23139. Optional and additional evaluations included rocket motor blast, adjacent detonation, propagation, ignition of unrestrained projectile, exposure to gun muzzle blast, gun-fired with clearing charge, and special igniter drop tests.

NAVAL WEAPONS CENTER
CHINA LAKE, CALIFORNIA * JANUARY 1970

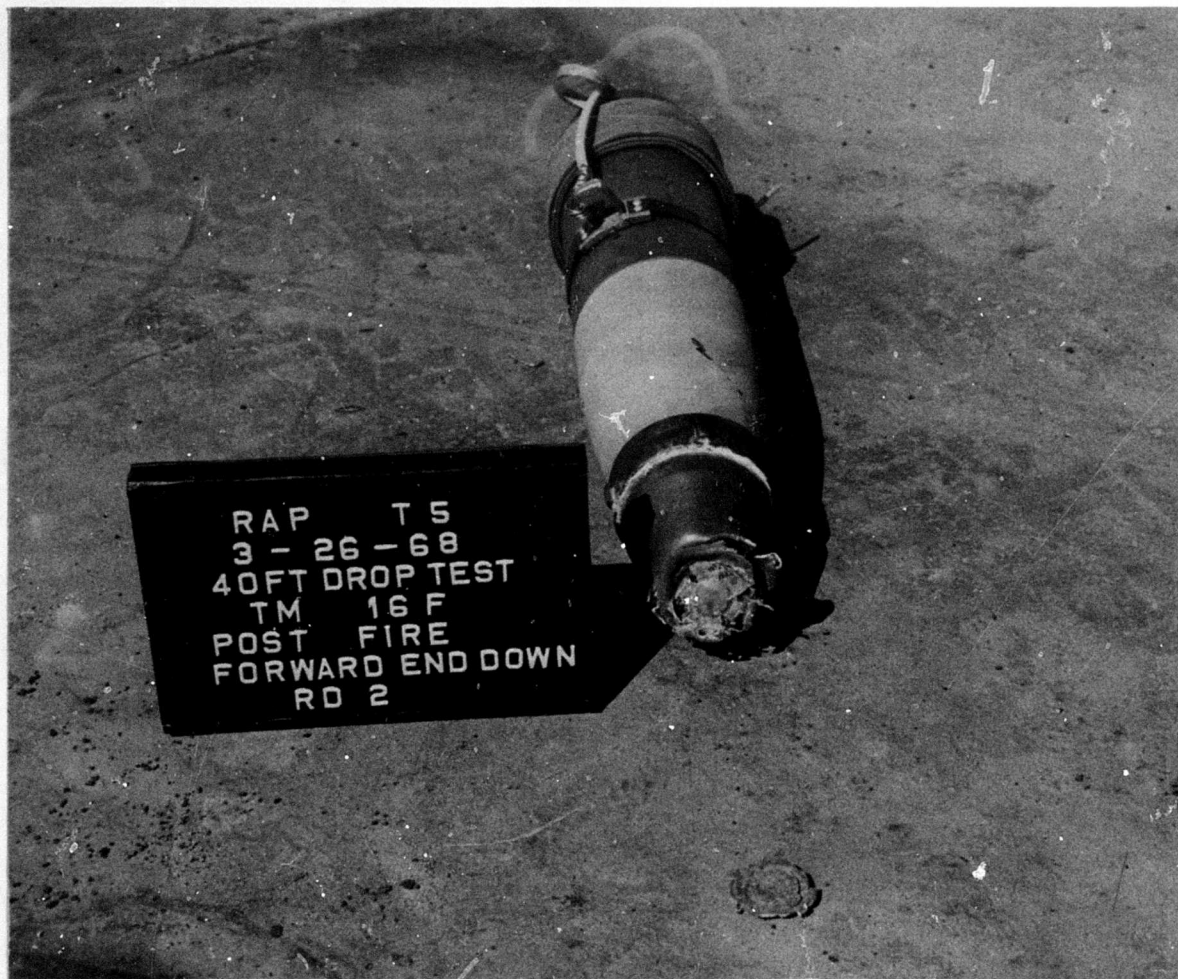
None of the projectiles detonated or deflagrated. All were considered by the Explosive Ordnance Disposal Team to be safe-to-handle for disposal by qualified personnel. An example of the fuze damage incurred on nose-down drops is shown in Fig. 3, a post-drop view of a projectile with a CVT fuze. Damage to the projectile body was most severe on horizontal drops, but was minor in all cases.

FIG. 3. View of CVT-Fuzed Projectile After Nose-Down 40-Foot Drop (LHL 142878).

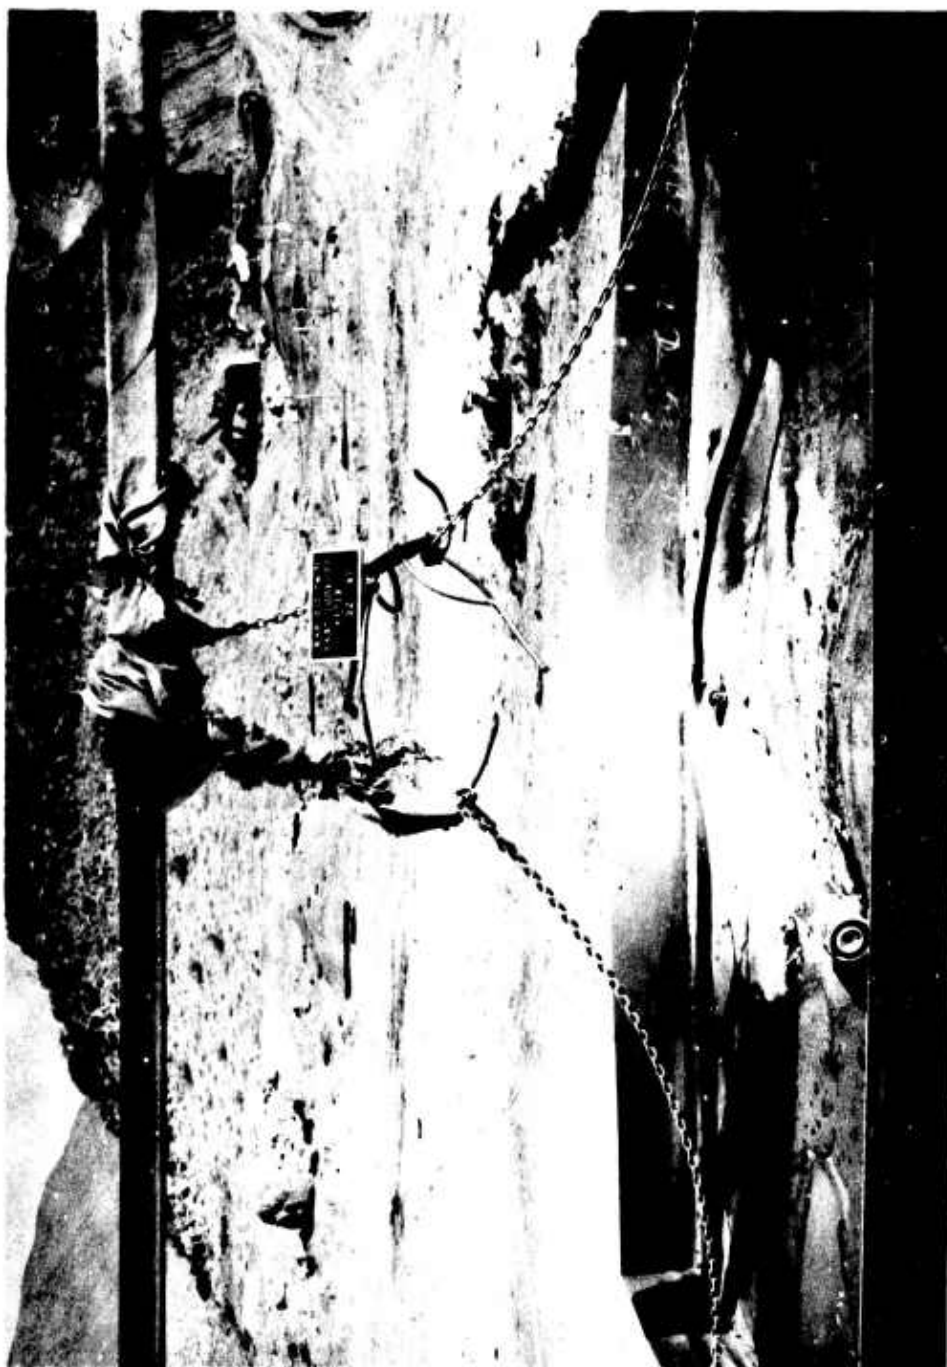
FIG. 4. Post-Test View of Fast Cookoff Test Site, TM-7C. A low-order warhead reaction destroyed the restraining cage, dropping the rocket motor into the fuel, where it ignited when the fuel burned down to the level of the motor.

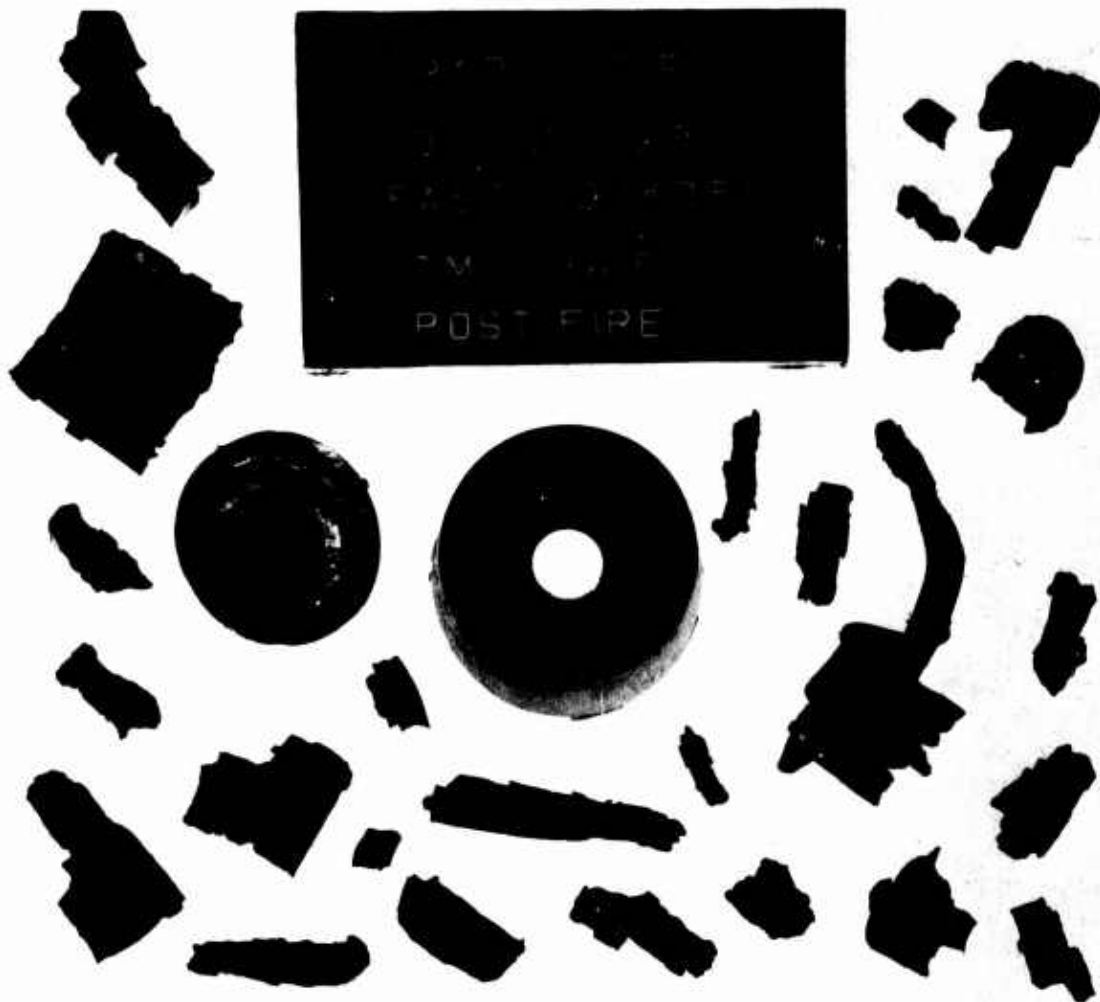
1. TM-26F - A high-order warhead reaction occurred 3 minutes 55 seconds after ignition of the fuel. The detonation completely destroyed the restraining cage and ruptured the fuel pan in several places. The rocket motor base and a 2 1/4- by 1 1/4-inch motor case fragment were found 165 feet from ground zero. Another motor case fragment 3 by 4 inches was found 153 feet from ground zero. Portions of the fuze were found at 50 feet and the fuze adapter at 188 feet. Several smaller projectile fragments were found at various distances. Figure 5 shows the recovered fragments.

FIG. 5. Recovered Fragments From TM-26F High-Order Detonation. The two circular pieces are the fuze adapter (left) and the rocket motor base (right) (LHL 142865).

2. TM-27F - A high-order warhead reaction occurred 2 minutes 40 seconds after ignition of the fuel. The size and location of the recovered fragments was similar to that of TM-26F (Fig. 5).

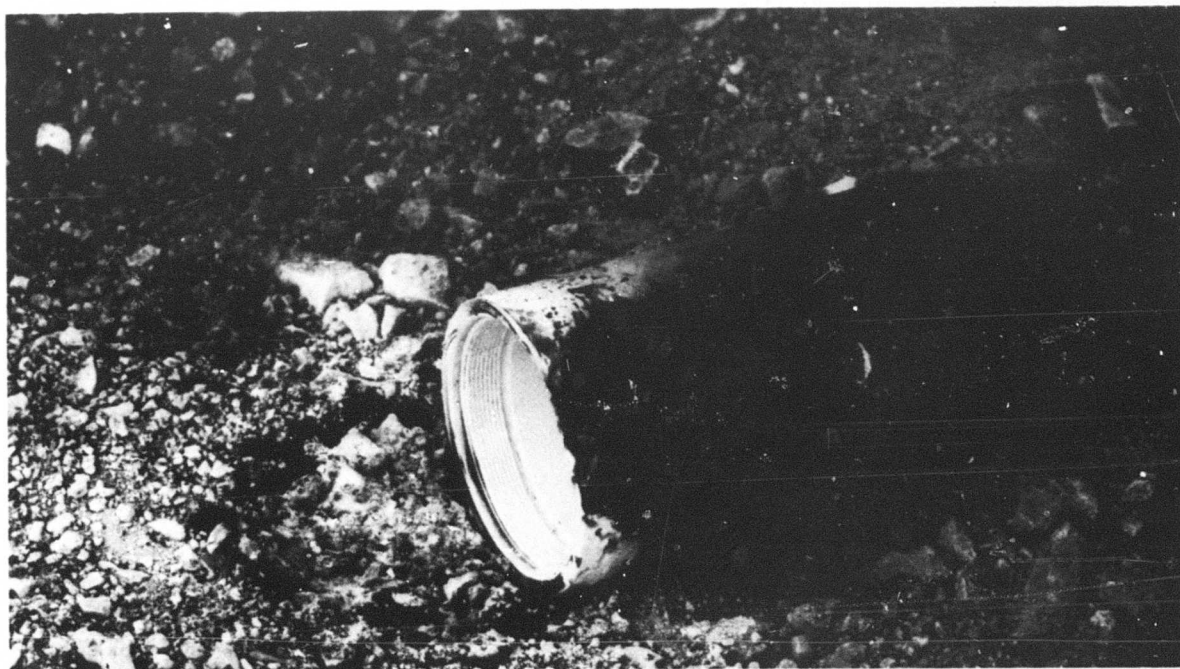
TM-4C was impacted in the center of the motor 5 7/8 inches from the base. Upon impact, the propellant ignited, causing the warhead to be separated and propelled from the rocket motor assembly. The warhead/fuze assembly was found 192 feet from ground zero and showed no visible signs of damage. The rocket motor propellant was completely consumed and the case slipped from the fixture, coming to rest 56 inches from ground zero. There was no evidence of an exit hole from the 20 mm projectile in the motor case. Figure 7 is a close-up view of the motor case showing the residue from the burnt propellant and the penetration hole of the 20 mm round.

FIG. 7. View of TM-4C Motor Case After 20 mm Bullet Impact. The warhead separated from the motor, but was not damaged. The 20 mm projectile remained in the motor and all propellant was consumed.

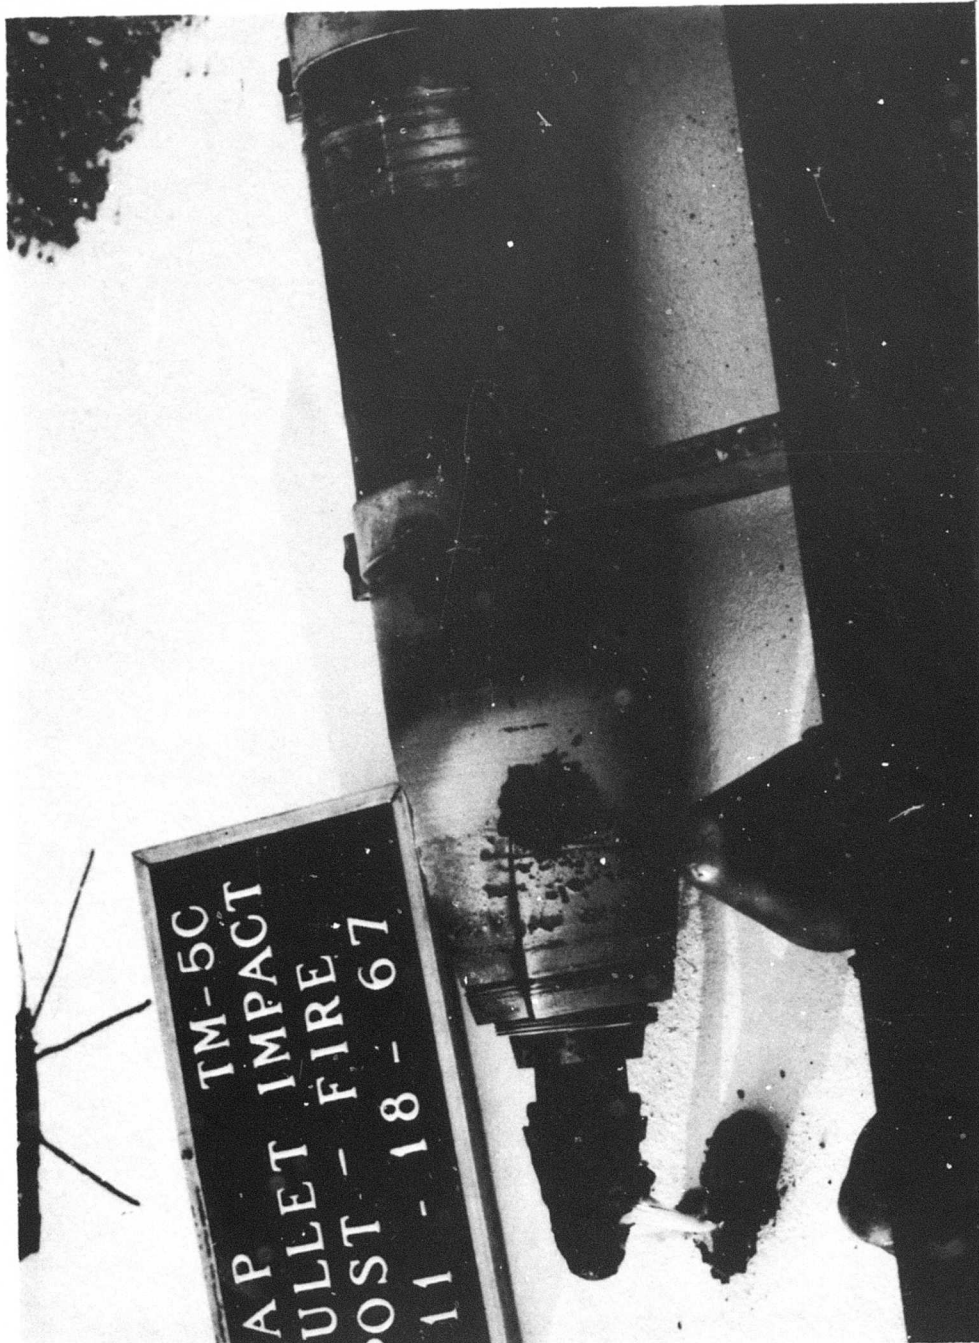
The first 20 mm round fired at TM-5C impacted the center of the projectile in the warhead/motor joint and failed to contact the explosive charge. The projectile penetrated the case for only about one-half the projectile's length. There was no detonation or deflagration as a result of this impact. The second round impacted the right side of the warhead case, causing a small flash and exposing the explosive charge. The third round penetrated the warhead 1 inch left of center and 15 1/2 inches from the base of the projectile. Upon impact the explosive charge ignited and burned for 7 minutes, at which time the auxiliary detonator exploded. After consumption of the explosive charge, the projectile was still supported by the test fixture and the rocket motor was intact. There was no exudation or burning of the propellant. Figure 8 is a post-test view of projectile TM-5C.

FIG. 8. Post-Test View of Projectile TM-50.
Two 20 mm bullet impacts, in the warhead/
motor joint and a "nick" on the side, caused
no reaction. The third resulted in burning
of the explosive.

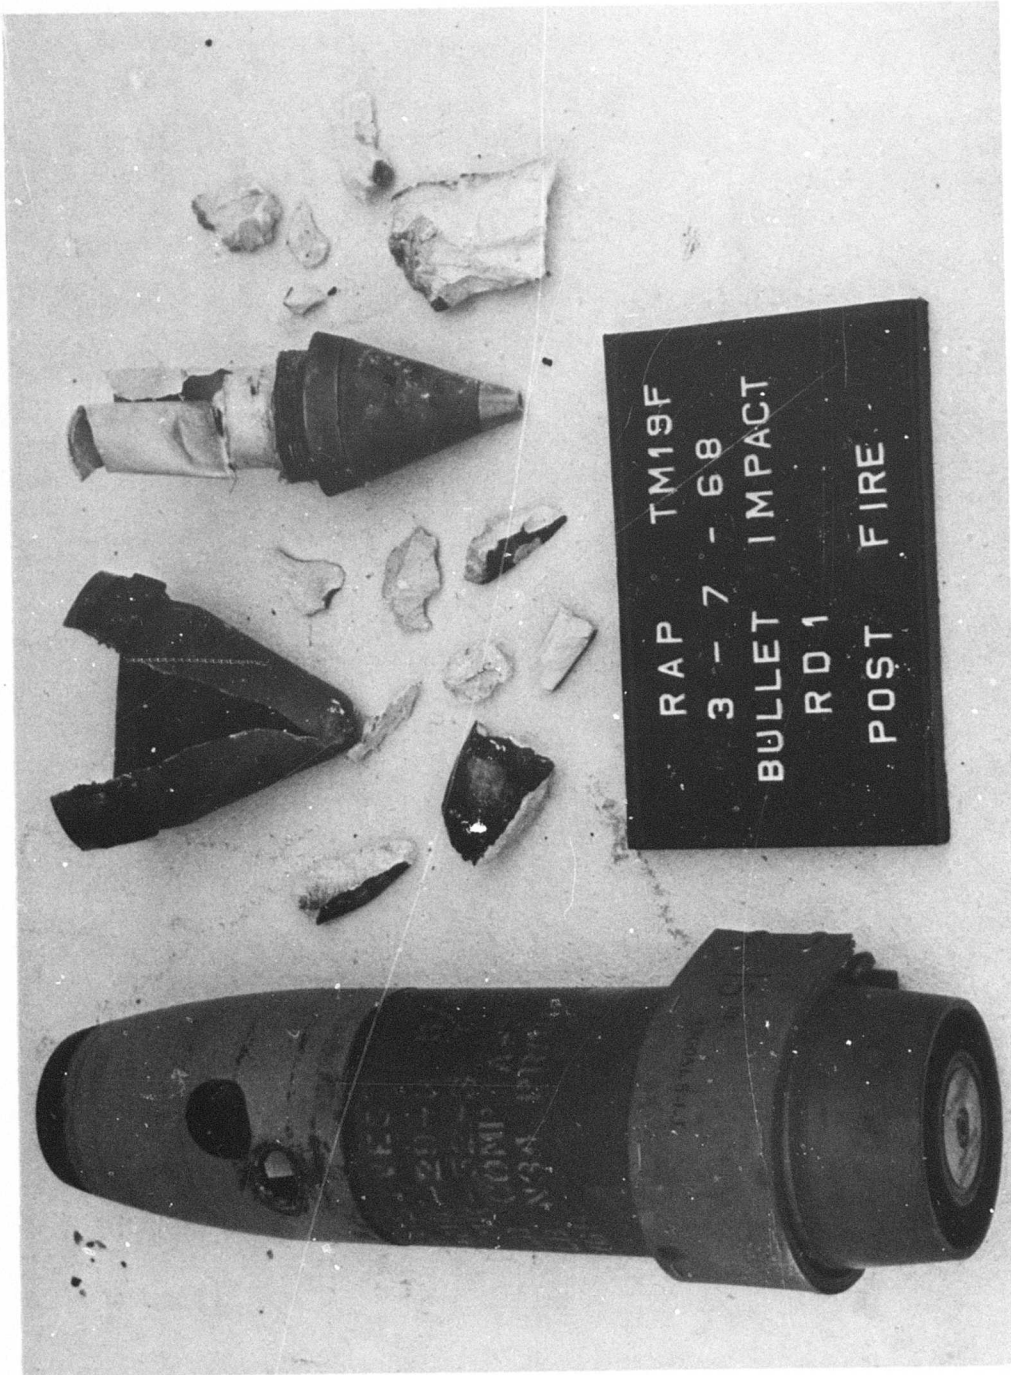
Projectile TM-19F was impacted in the warhead 1 1/4 inches to the left of center and 13 inches above the base of the rocket motor. A segment of the warhead case, approximately 6 1/4 inches by 4 inches, was separated from the warhead's aft side in relation to the entrance of the 20 mm round, and was found 60 feet from ground zero of the target area. The fuze protector cap was recovered 27 feet from ground zero and contained a 5 1/4-inch split on one side. The PD fuze was separated from the projectile and was found 21 feet from ground zero. Shattered explosive fragments were found strewn around the test area at various distances and were recovered. A small flash was observed upon impact of the 20 mm round but there was no visible evidence of ignition of the explosive. Figure 9 is a view of some of the recovered parts of the projectile; however, the aft section of the warhead case was not included in this photograph.

FIG. 9. Recovered Parts of TM-19F, Impacted in Warhead by 20 mm Projectile. The warhead incurred a pressure rupture, but no violent reaction occurred (LHL 142848).

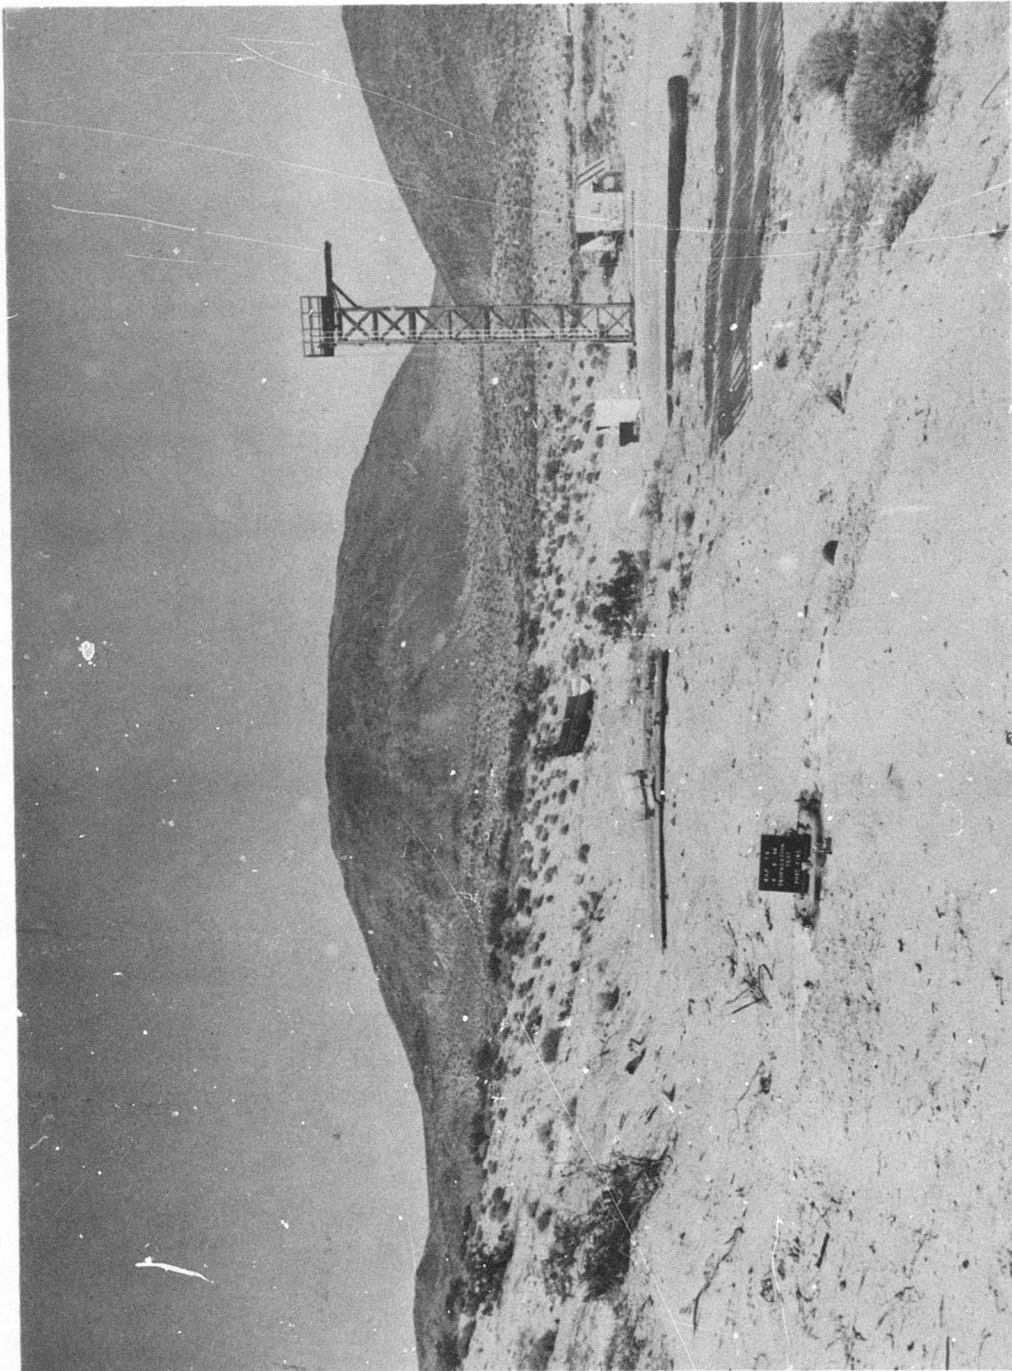
FIG. 12. Post-Test View of Test Site After Detonation of Donor Projectile. The gun shield was completely destroyed by an estimated nine high-order and three low-order simultaneous detonations (LHL 142884).

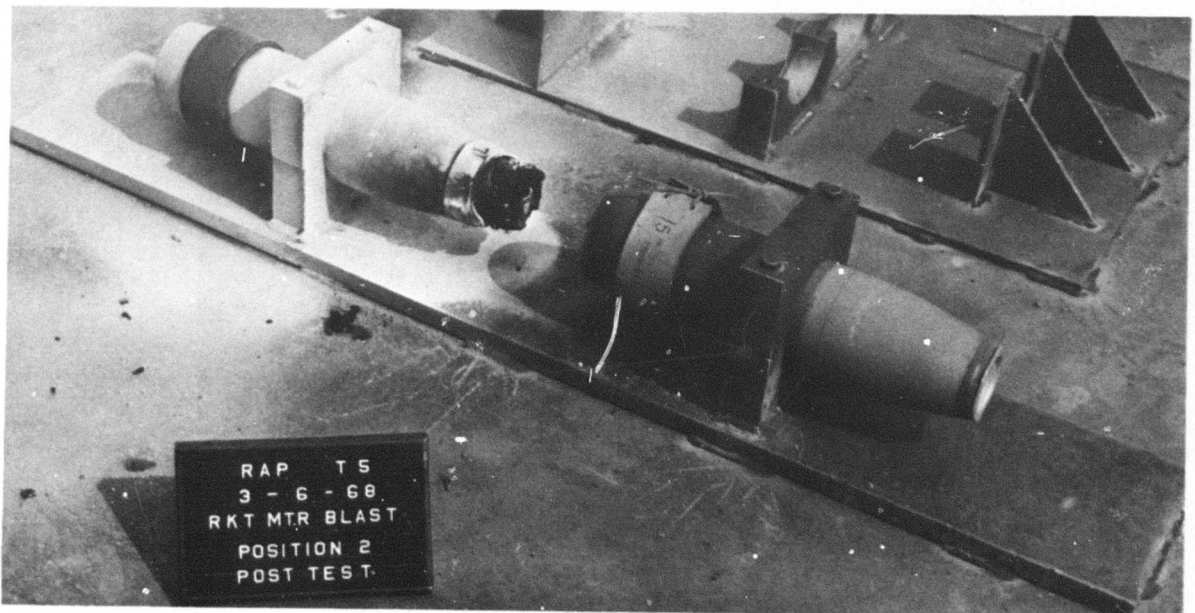
2. Position 2 - The rocket motor of the donor projectile, TM-35F, functioned normally and burned for approximately 7 seconds, with the flame impinging upon the fuze protector cap of the acceptor, TM-32F, for the full burn period. The fuze protector cap and CVT fuze of the acceptor projectile were burned away back to the point where the fuze protector cap threads engage those of the projectile. There was a slight discoloration on the ogive of the acceptor projectile. Figure 16 is a post-test view of the projectiles.

FIG. 16. Post-Test View of Rocket Motor Blast Test, Position 2, Showing Damage to Fuze of Acceptor (Left) (LHL 142833).

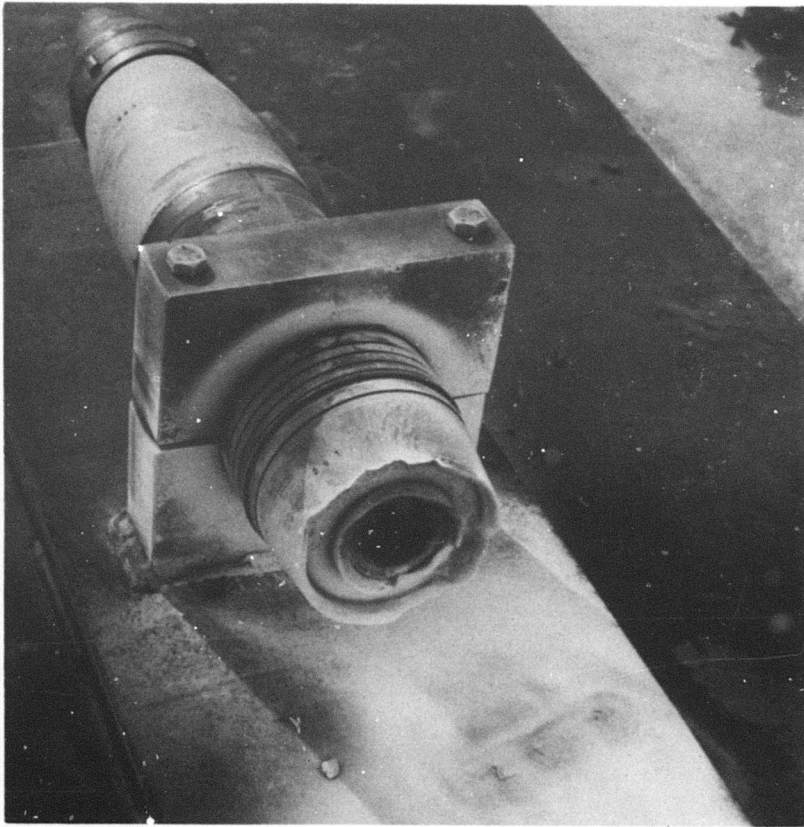
3. Position 3 - The donor motor, TM-36F, ignited normally, with the flame impinging on the base of the acceptor projectile, TM-33F. At about 1 second after ignition of the donor rocket motor, the weld holding the saddle block to the plate broke, thereby allowing the donor to launch projectile remained contained in its saddle block. Approximately 23 seconds after ignition of the donor, which corresponds to the igniter delay time, the acceptor's rocket motor ignited and burned for the normal length of time. Figure 17 is a view of the aft end of the acceptor projectile; erosion from the blast of the donor is evident.

FIG. 17. Post-Test View of Rocket Motor Blast Test, Position 3, Showing Damage to Base of Acceptor. The acceptor ignited after the 23-second delay time (LHL 142831).

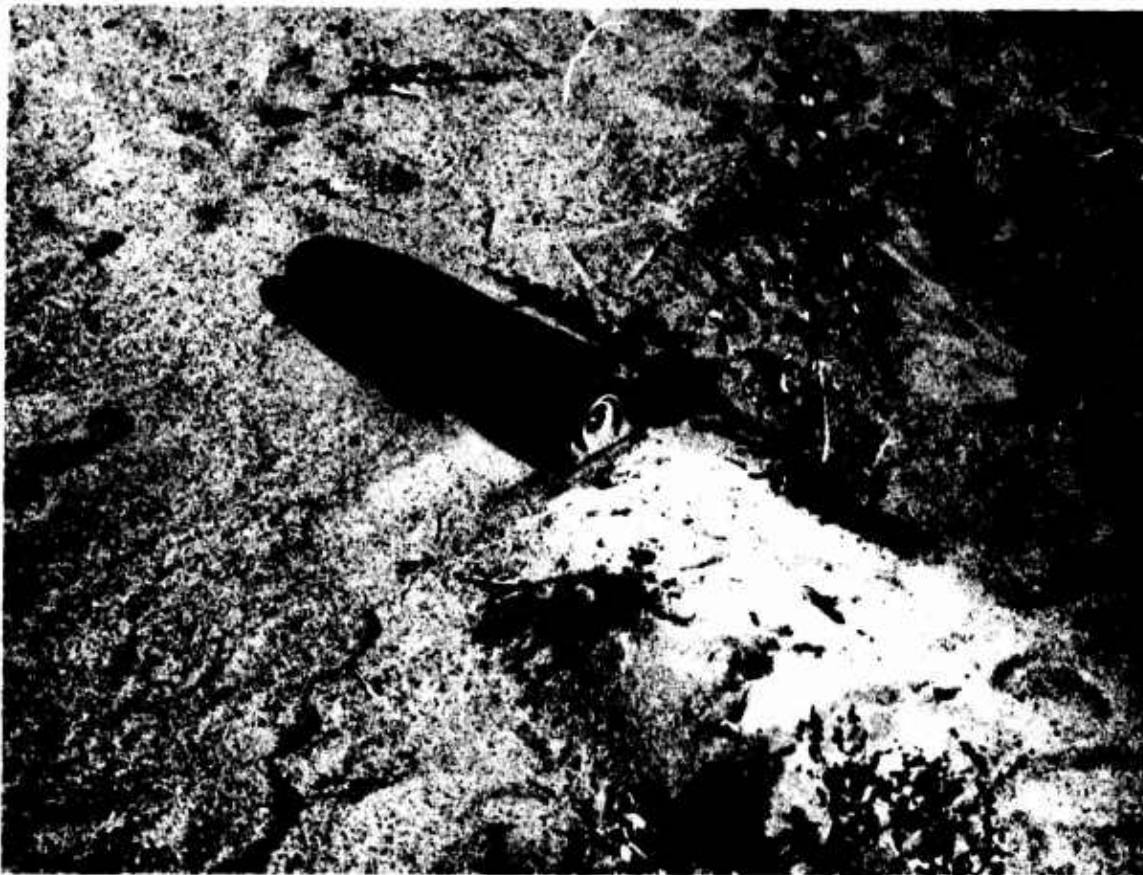
The projectile was placed, unrestrained and in a horizontal position, in a wooden trough 4 1/2 feet high. The igniter was initiated and the rocket motor ignited normally after the 23-second delay. The projectile launched itself downrange in a horizontal position with a slight nose-down angle, impacted flat at about 300 feet from ground zero, again at 690 feet, and again at 1,200 feet, at which time the nose of the projectile dug into the ground causing the projectile to tumble end-over-end for the remainder of the flight. It came to rest, with the motor still burning, at a point 2,620 feet from ground zero and 20 feet to the right of the flight path. Figure 18 shows the projectile at the final resting place.

FIG. 18. Aft-End View of TM-9C After Unrestrained-Projectile Ignition Test. The motor burned for a short time after the projectile came to rest 2,620 feet from the launch point. The fuze remained in the safe condition.

The projectile body exhibited very little damage as a result of the test. There was a definite indication of the first impact on the ogive of the warhead and the graphite nozzle was missing. A sharp report was heard coincident with the first impact, indicating that at this point in the flight the motor overpressurized and expelled the nozzle. The fuze was shattered and carried away on the third impact. Fragments of the fuze were found scattered over this area. The fuze adapter and AD fuze were still in the nose of the projectile. The AD fuze arming mechanism was located and was found to be in the safe condition.

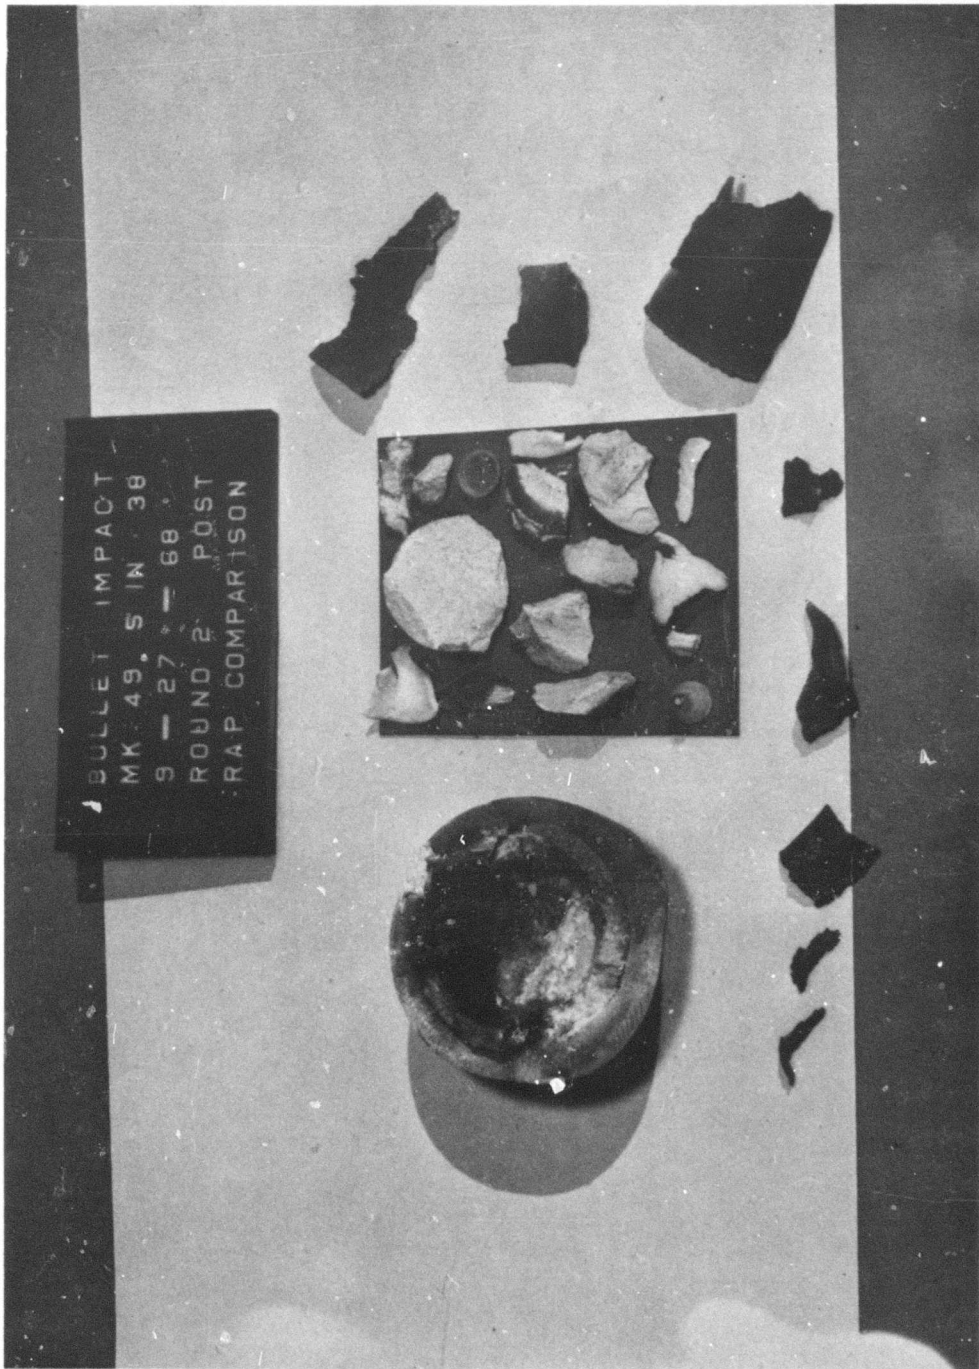
1. Smoke cloud and audible report at impact.
2. Projectile base and rotating band still intact at ground zero.
3. Explosive fragments found over an area 10 feet in diameter (Fig. 20).
4. Projectile fragments recovered in an area of 118 yards radius (Fig. 20).
5. Fuze, still fairly intact, found 90 yards from ground zero.

FIG. 20. Recovered Fragments of Mk 49 Mod 1
5"/38 Projectile No. 2 (LHL 136345).

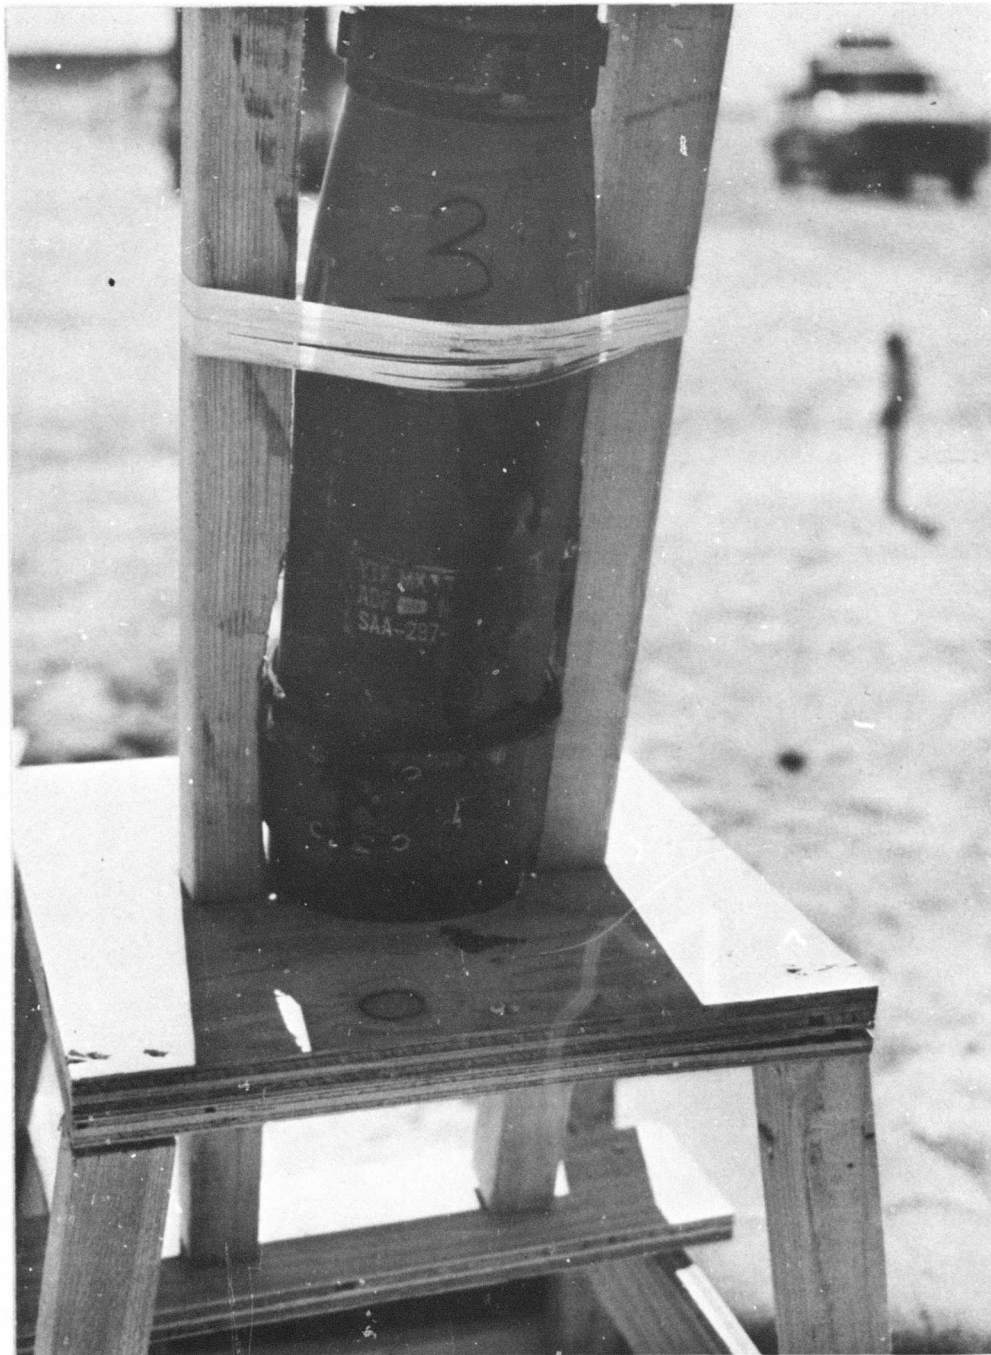
1. No smoke or audible report at impact.
2. Penetration of outer case upon entry but did not exit.
3. Aft side of case split approximately 4 inches (Fig. 21).
4. Visible evidence of slight burning both at the point of entry and 4-inch split.

FIG. 21. Post-Test View of Aft Side of Case,
Mk 49 Mod 1 5"/38 Projectile No. 3 (LHL 136356).

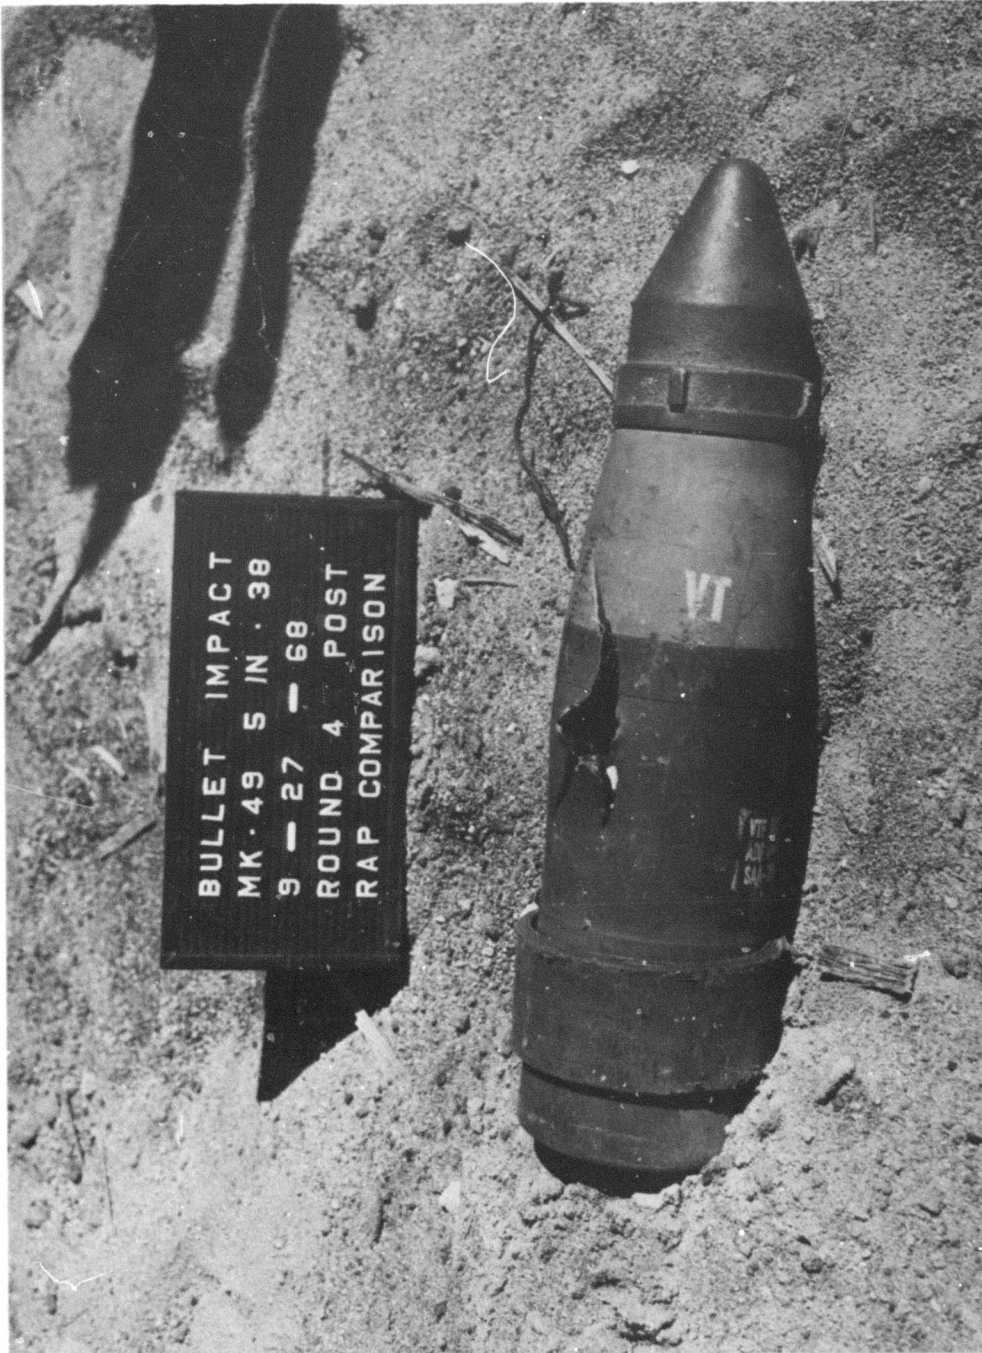
1. No smoke or audible report at impact.
2. Complete penetration, splitting aft side of case (Fig. 22).
3. No evidence of burning.
4. Minute fragments of explosive at ground zero.

FIG. 22. View of Exit Side of Mk 49 Mod 1
5"/38 Projectile No. 4 (LHL 1363448).

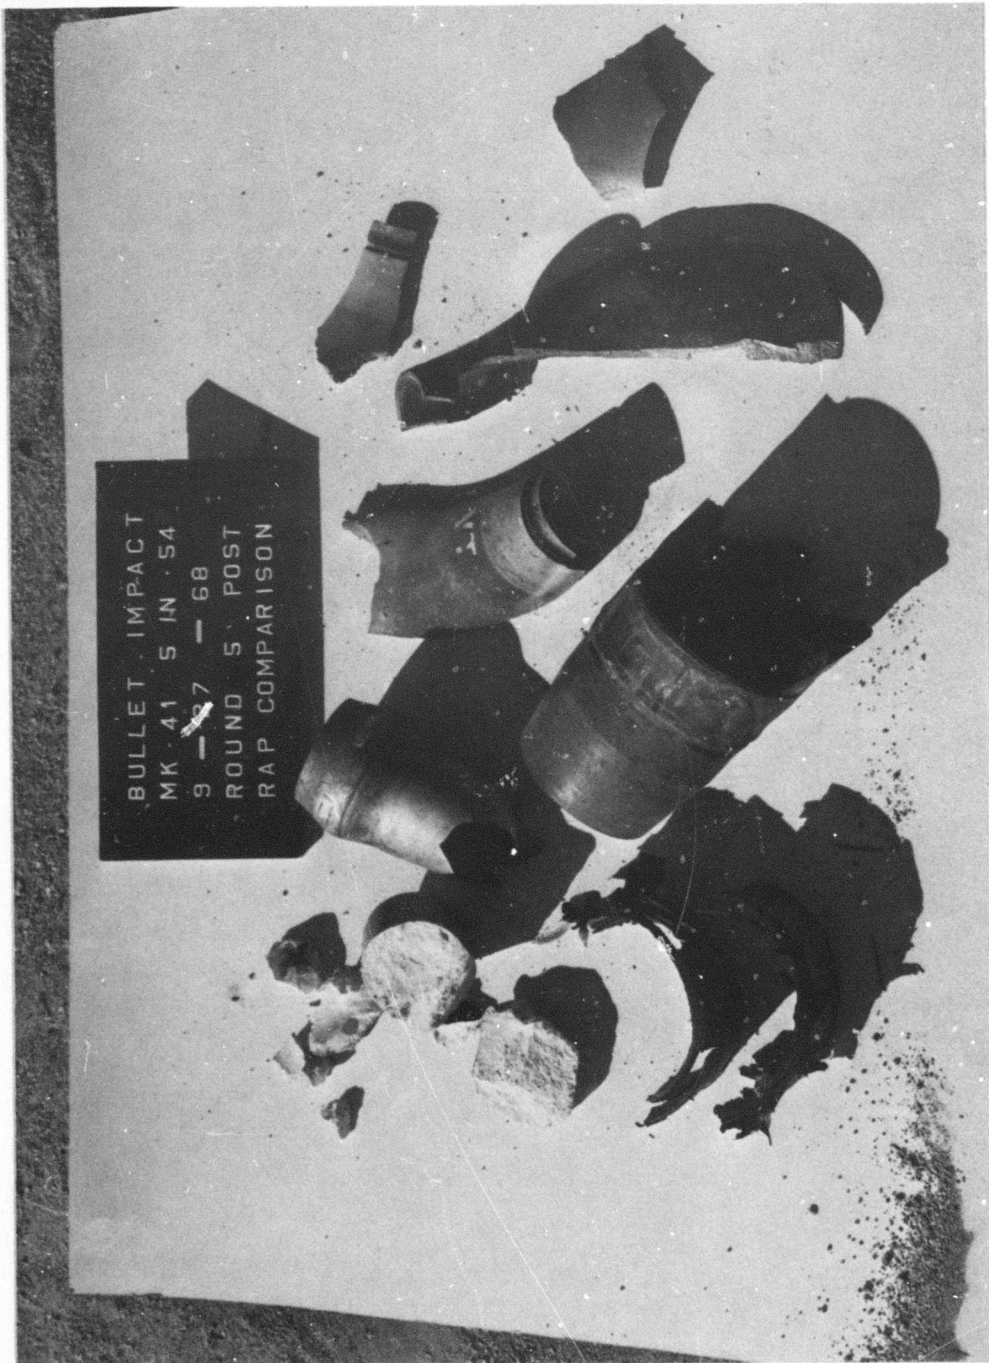
4. Large projectile case fragments and explosive fragments found 140 yards from ground zero (Fig. 23).
5. Fuze, still fairly intact, found 63 yards from ground zero.

FIG. 23. Recovered Fragments of Mk 41 Mod 0
5"/54 Projectile No. 5 (LHL 136349).

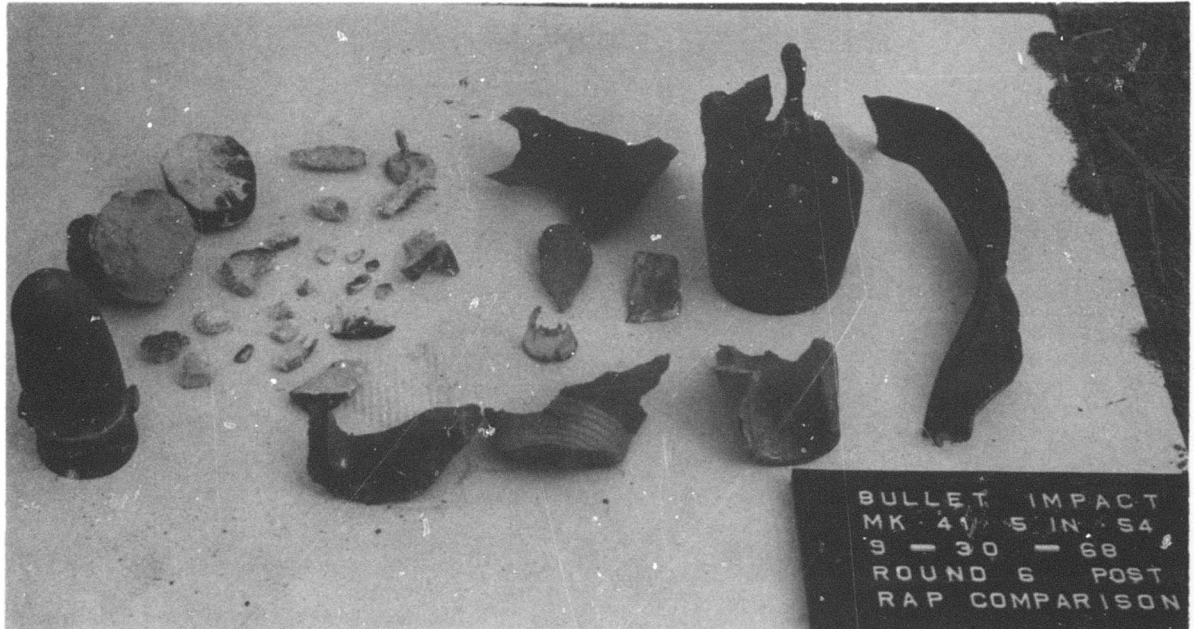
1. Smoke cloud and audible report at impact.
2. Projectile base found intact, 6 feet to rear of support stand.
3. Large explosive fragments found at ground zero.
4. Large segment of rotating band found 8 feet from ground zero.
5. Projectile case fragments and explosive fragments found within a radius of 75 yards of ground zero (Fig. 24).
6. Fuze found partially intact, 84 yards from ground zero.

FIG. 24. Recovered Fragments of Mk 41 Mod 0
5"/54 Projectile No. 6 (LHL 136368).

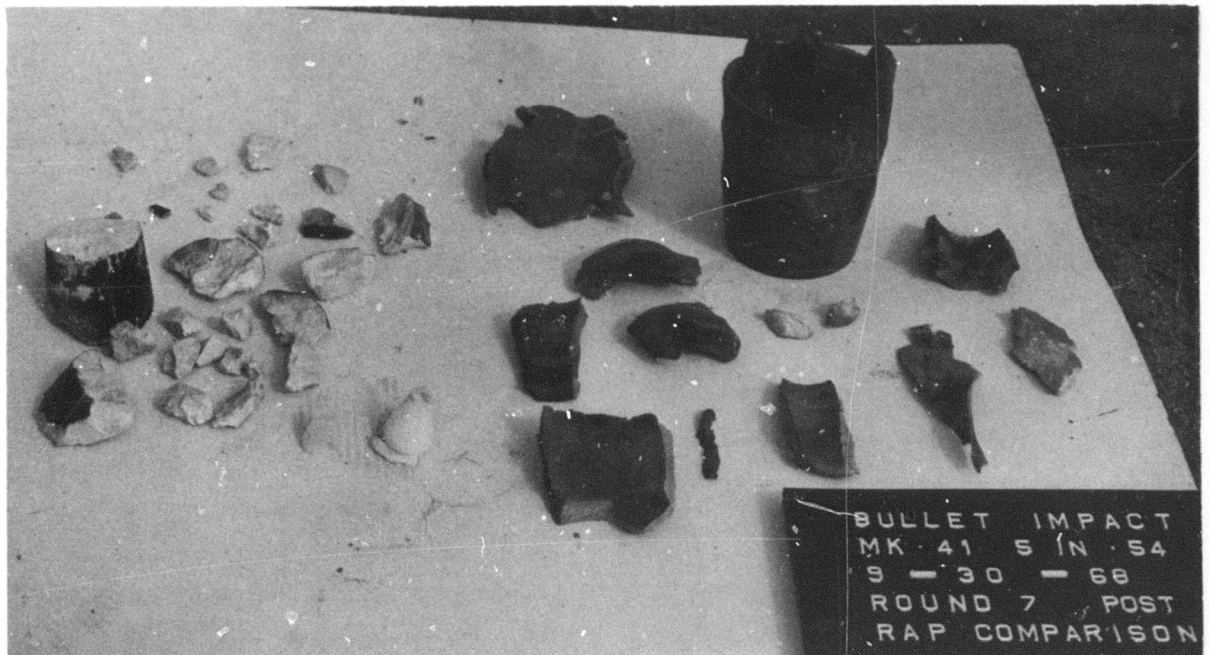
1. Smoke cloud and audible report at impact.
2. Projectile base intact, with the rotating band in place, found 10 feet from ground zero.
3. Large fragments of explosive found at ground zero (Fig. 25).
4. Projectile case fragments and small fragments of explosive were found within 52-yard radius of ground zero (Fig. 25).
5. Fuze, still intact, found 60 yards from ground zero.

FIG. 25. Recovered Fragments of Mk 41 Mod 0
5"/54 Projectile No. 7 (LHL 136366).

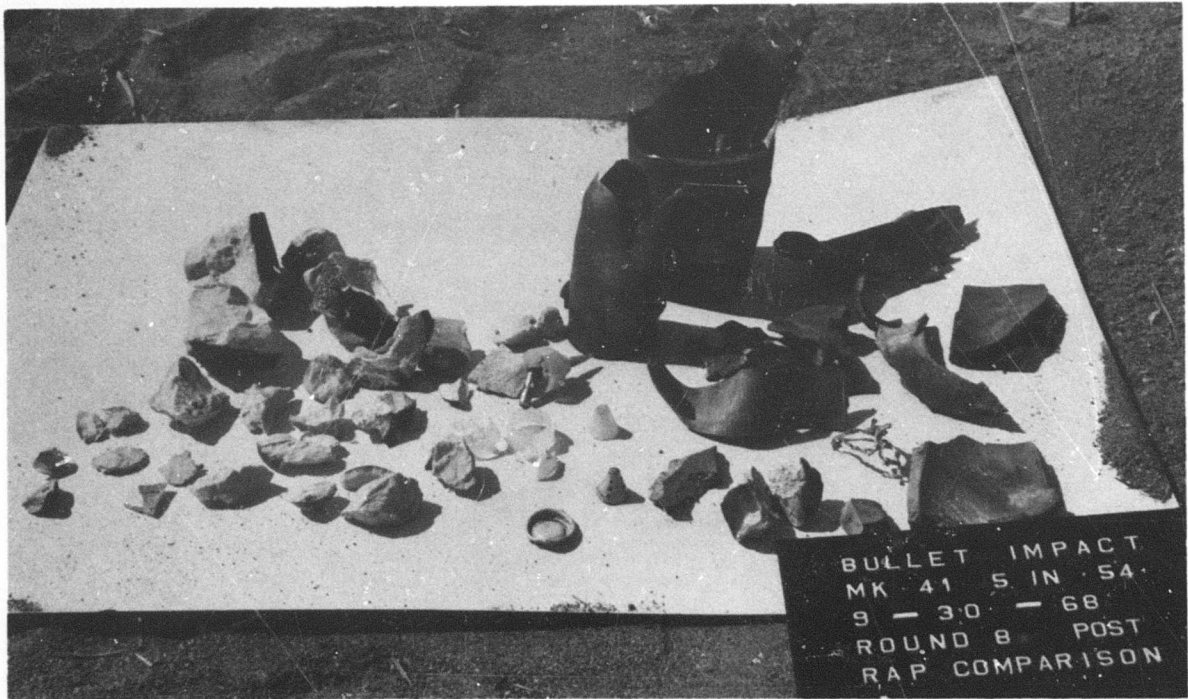
1. Smoke cloud and audible report at impact.
2. Projectile base found 10 feet to rear of support stand and intact.
3. Large quantities of explosive found in the area of ground zero (Fig. 26).
4. Fragments of projectile case and explosive found within a 145-yard radius of ground zero (Fig. 26).

FIG. 26. Recovered Fragments of Mk 41 Mod 0
5"/54 Projectile No. 8 (LHL 136365).
