## HANGAR FLOOR SETTLEMENTS AT THULE AIR BASE, GREENLAND

TECHNICAL REPORT NO. AFWL-TR-69-122

March 1970

An investigation has been made of hangar floor settlement problems at Thule Air Base, Greenland. Inspection of existing instrumentation and soil-cooling systems were accomplished. Results of this inspection are presented. Existing temperature sensors were found to be in excellent condition; however, readout capability was poor. Pumping of ground water has removed no fines from the fill which might have caused settlement. Major cause of settlement was found to be thawing which has contributed to settlement. Duct blockages in the soil-cooling system has also allowed thawing to occur resulting in settlement. Recommendations are made to control further hangar settlement. Blocked ducts in the soil-cooling system should be cleared on an annual basis. The water table should be lowered by lowering the water level in nearby Lake Eddy. Recommendations were also made to improve instrumentation in order that effective operation and maintenance procedures for hangar foundation could be developed.

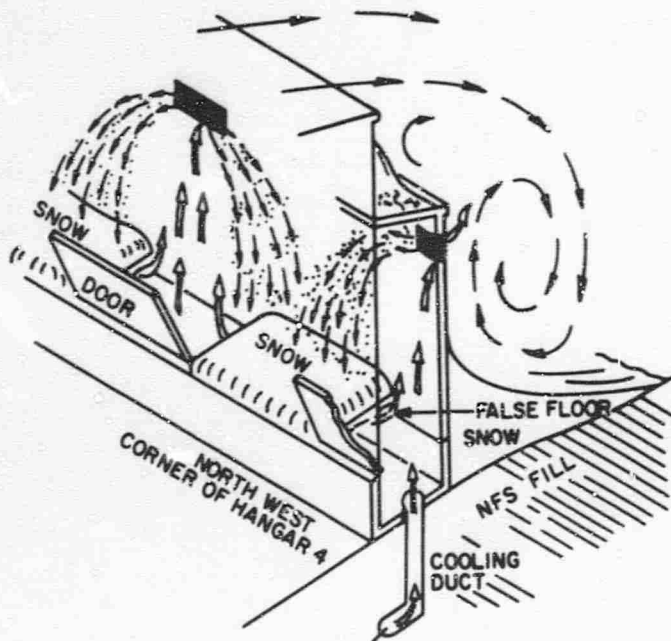
Further inspection revealed that horizontal timbers high in the exhaust structure were also covered with snow. From these observations it was concluded that air is both exiting and entering the vents high on the wall. Air warmed by passing through the soil-cooling ducts rises in the exhaust stack and exits through the vents while cold outside air and snow enters. A possible flow pattern is shown in figure 7.

Figure 7. Two-Directional Flow in the Exhaust Structure, Hangar 4

It is evident that little chimney effect is being derived at the downwind end of hangar 4.

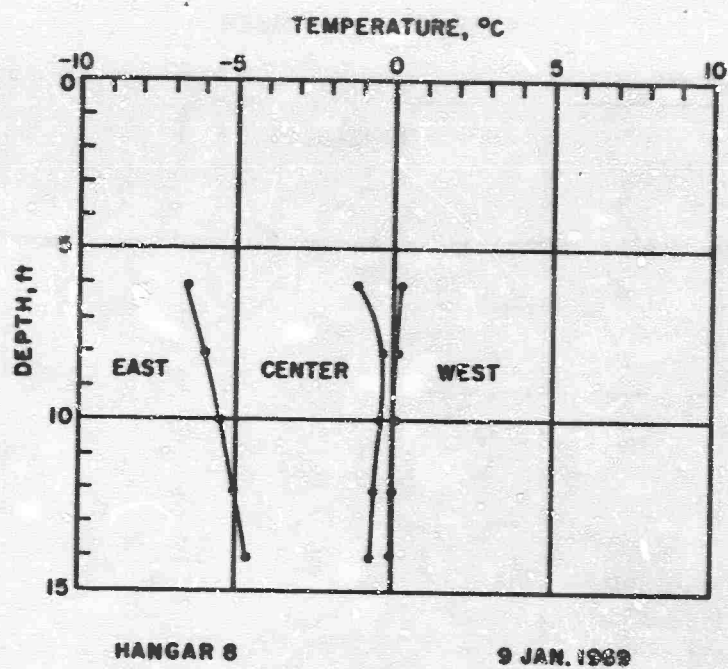
The temperature profiles for hangar 8 (figure 15) show a similar decrease in soil cooling, progressing from east to west in the hangar. Near the west end the soil is isothermal at the freezing point and thaw probably exceeds a depth of 14 feet.

Figure 15. Measured Temperature Profiles, Hangar 8

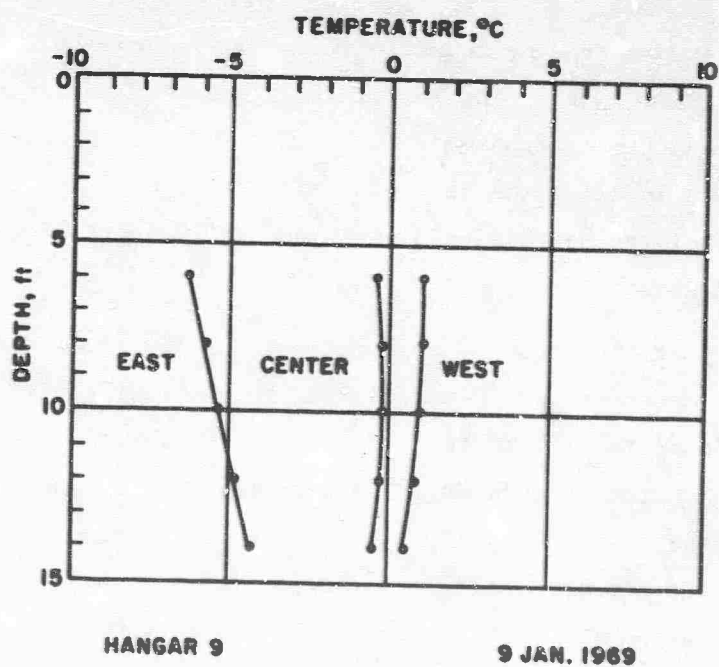
The condition is even more severe for hangar 9 where above-freezing temperatures are evident throughout the instrumented depth on the western end of the hangar (figure 16). This is probably because of partial blockage of the downwind end of nine ducts in this area.

Figure 16. Measured Temperature Profiles, Hangar 9

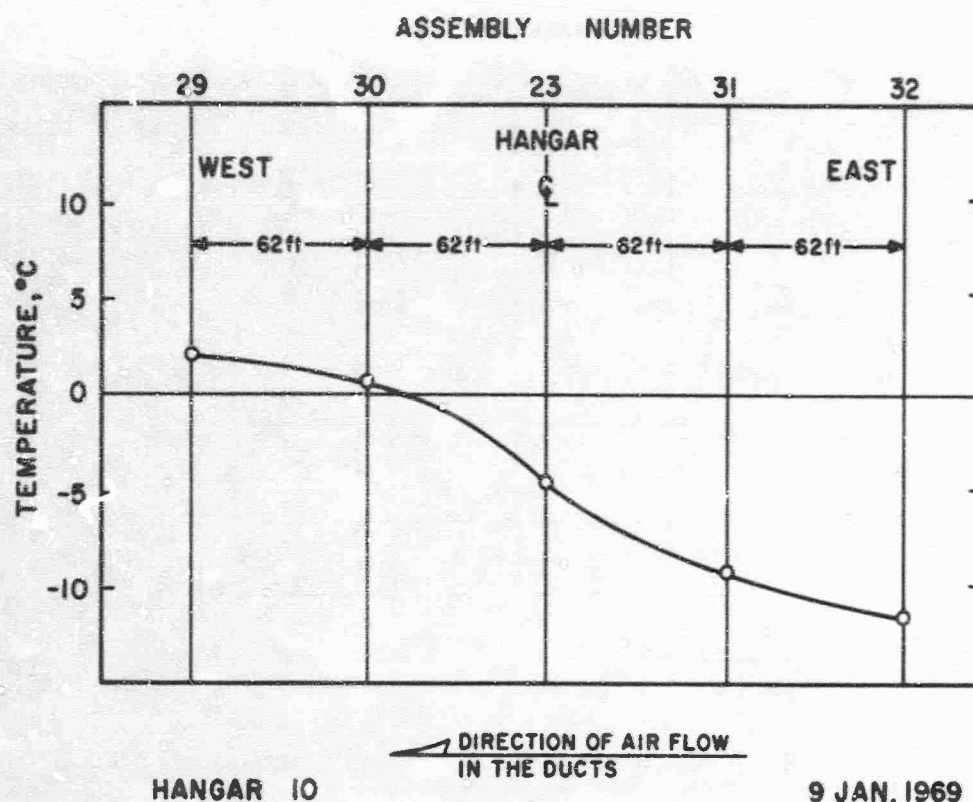
A decreasing effectiveness of the downwind end of the soil-cooling ducts is also evident in hangar 10 (figure 17). Air was flowing through the instrumented duct when the measurements in figure 17 were obtained. Thaw has progressed to

Figure 17. Measured Duct Temperatures along the East-West Line of Instrumentation, Hangar 10

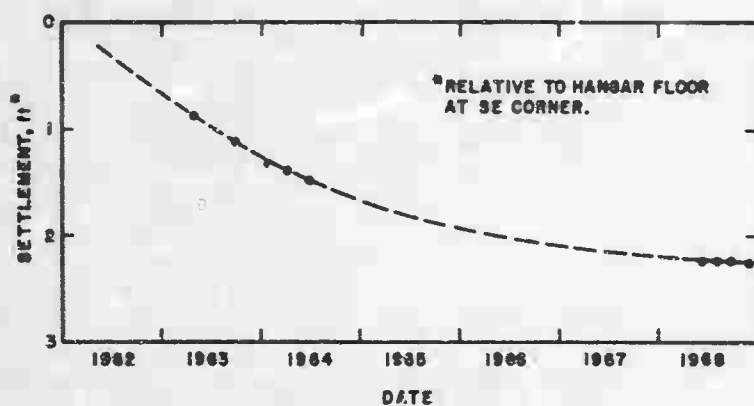
Figure 20. Floor Settlement at Center of Depression Dish, Hangar 10
