**STUDY OF EFFECTS OF GROOVING ON
PAVEMENT DETERIORATION
INSPECTION OF GROOVED AIRFIELD
PAVEMENTS**

I. Narrow

**Department of the Army
Ohio River Division Laboratories, Corps of Engineers
and
Construction Engineering Research Laboratory**

TECHNICAL REPORT NO. AFWL-TR-69-166

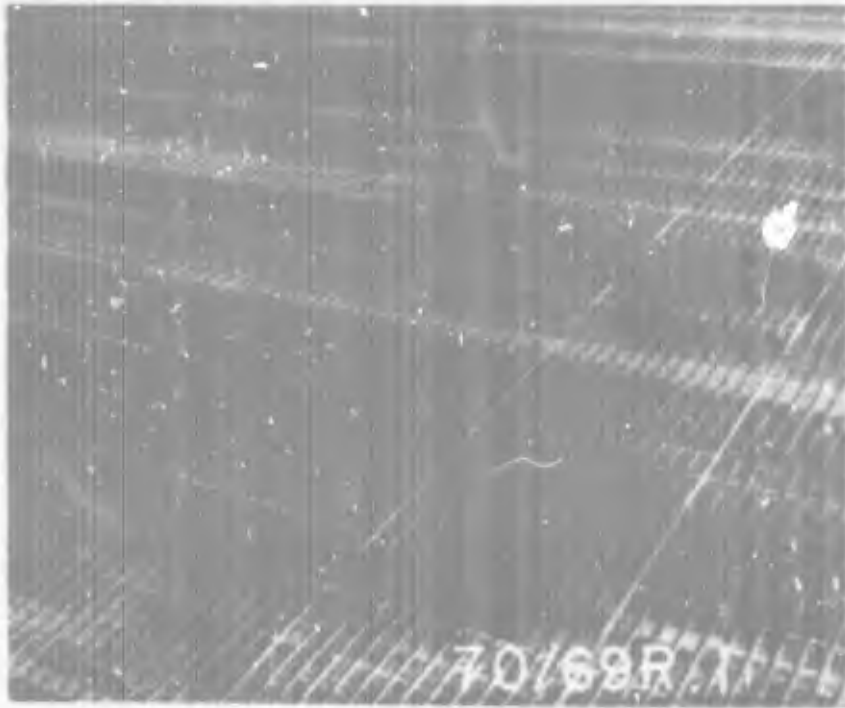
(1) Figure 13 shows the grooving in the touchdown area near the 31L end (SE end) of the runway. The pavement surface is discolored from landing operations, but there is very little rubber deposited in the grooves. The grooves are sharply outlined and the grooved pavement is in excellent condition. This is also evident in figures 14 to 18.

Fig. 13. Grooved pavement, center lanes
in touchdown area S.E. end of Runway
13R/31L

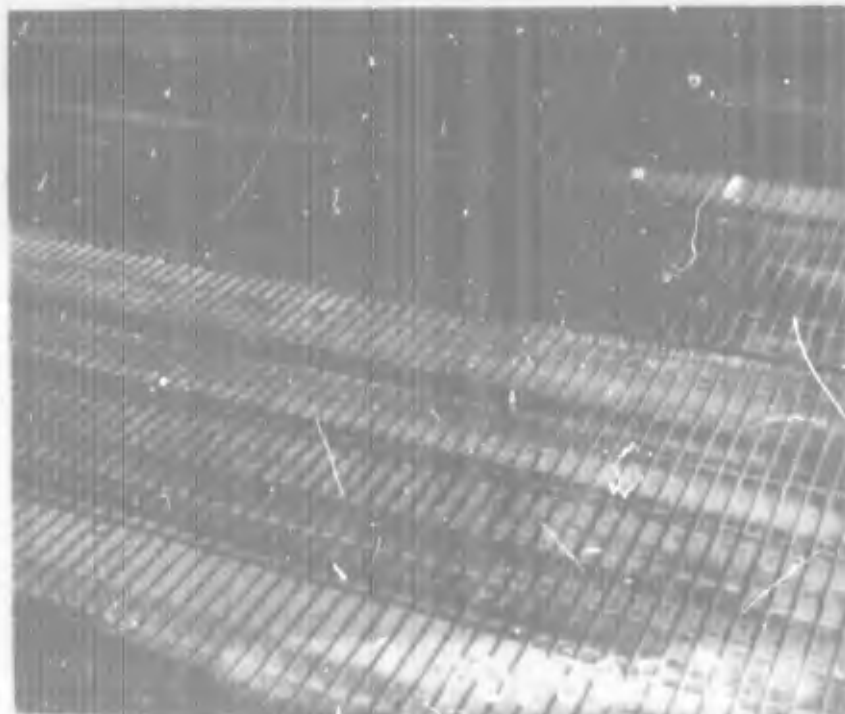
(2) Figure 14 shows another view in the same general area as figure 13. The outside lane in foreground shows less discoloration from traffic. The transverse cracks are typical for continuously reinforced pavements.

Fig. 14. Same area as Fig. 13, with
outside lane in foreground showing less
discoloration

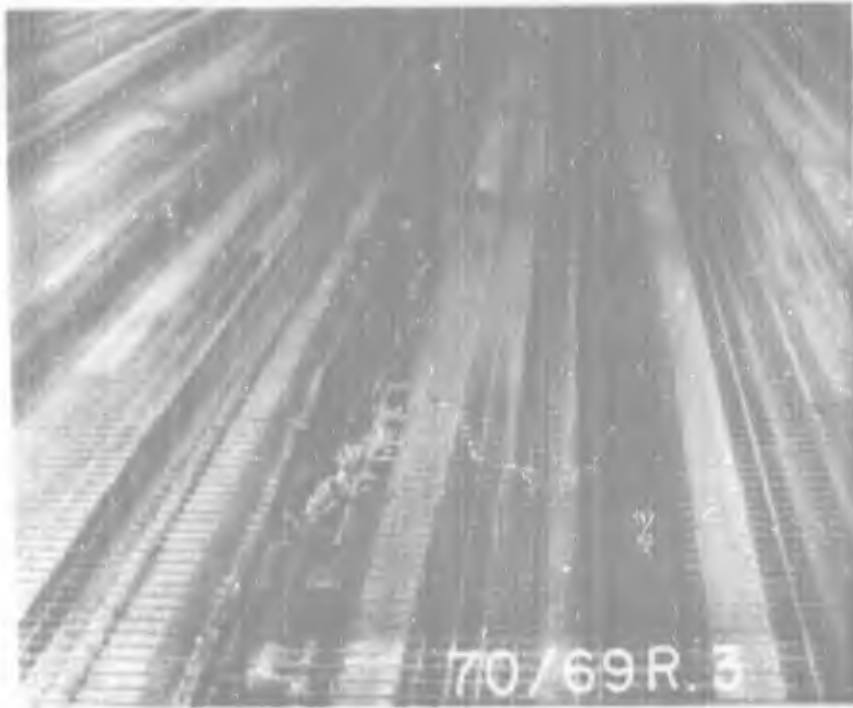
(3) Figure 15 shows the spalling along the center longitudinal joint near the 31L end of the runway. This spalling has occurred recently and has not been repaired.

Extensive spalling has occurred along longitudinal joints of the two continuously reinforced concrete runways. This is a structural problem which is not related to the pavement grooving. However, this condition would warrant further study in connection with any proposed use of continuously reinforced pavements for military airfields.

Fig. 15. Spalling along center longitudinal joint of runway

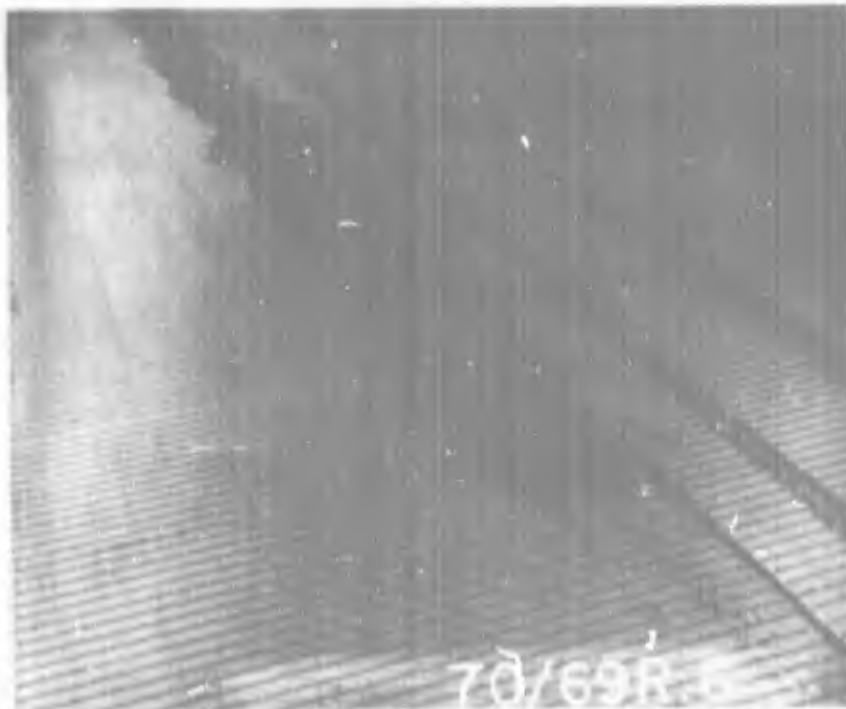
(4) Figure 16 shows the bituminous patching of the spalled center longitudinal joint near the center of the runway.

Fig. 16. Joint spall repair with AC concrete

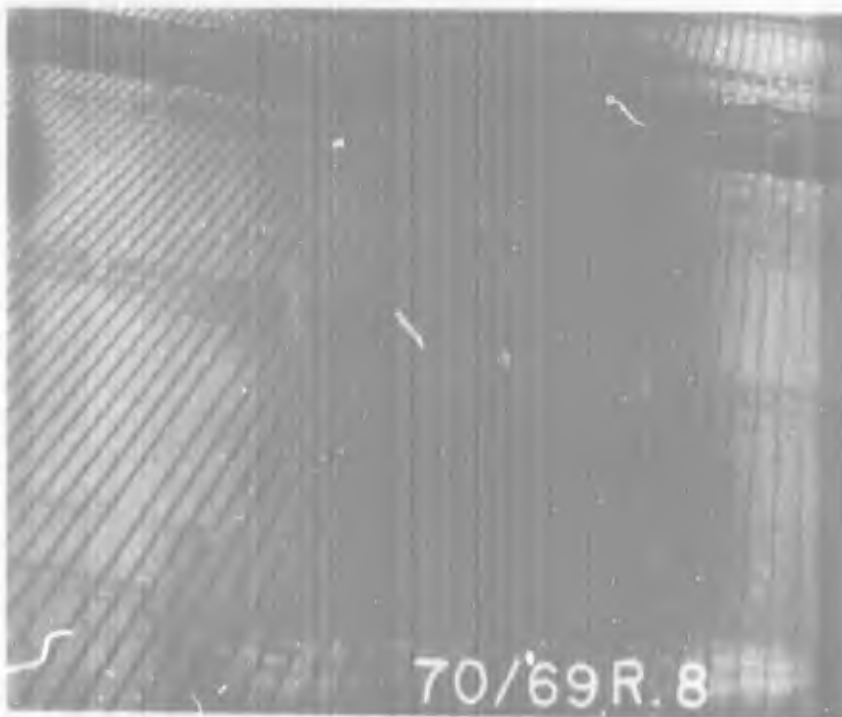
(5) Figure 17 shows the grooving at a random transverse crack in the continuously reinforced pavement. The cracks are very fine and there is very little raveling or deterioration at the intersection of the grooves with the cracks.

Fig. 17. Grooving at transverse crack in continuously reinforced pavement.

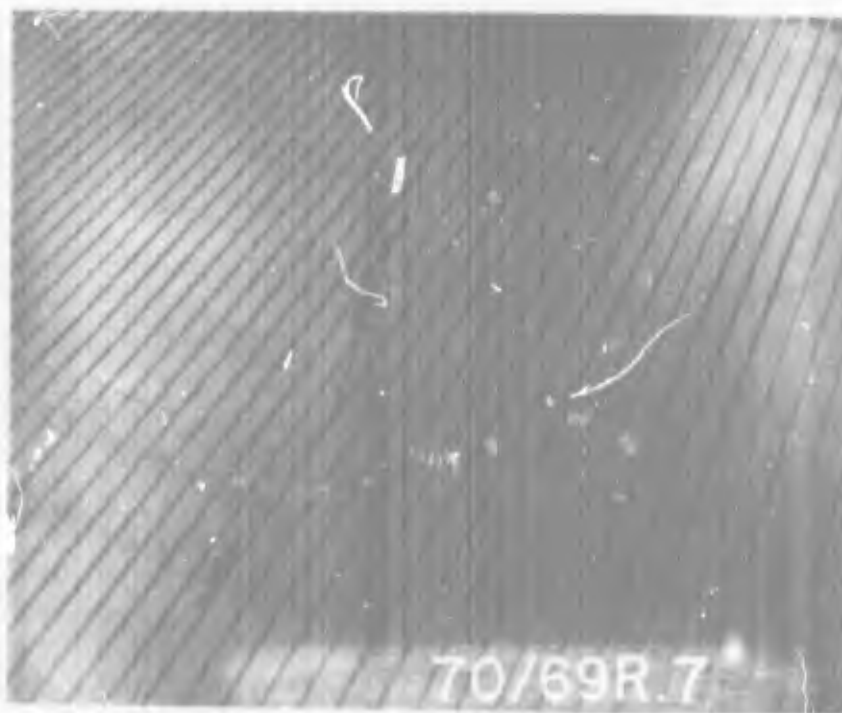
(6) Figure 18 is a close view of the same crack shown in figure 17. The slight raveling probably occurred during the sawing adjacent to the existing crack and there is no evidence of new deterioration.

Fig. 18. Close view in same area as Fig. 17

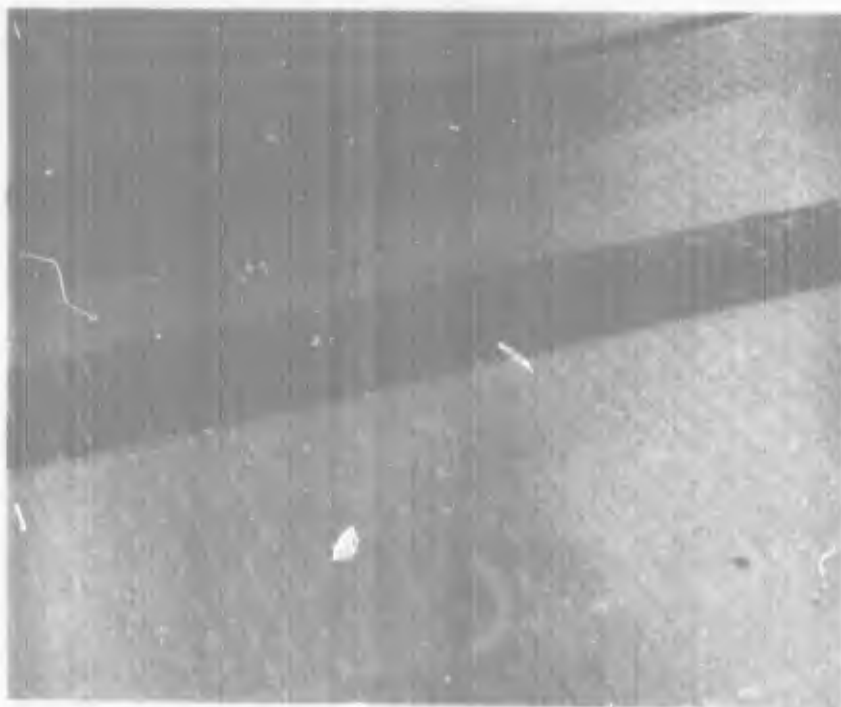
Fig. 22. FAA environmental test section with grooves 1/8-in. x 1/8-in. at 1½-in. spacing

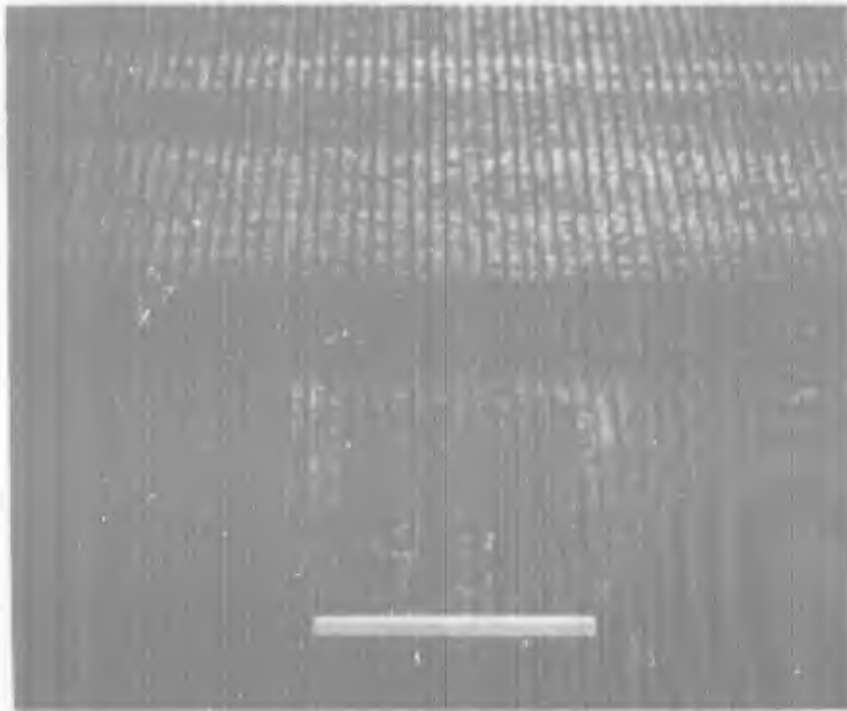
(1) Figure 23 shows a general view of the grooved pavement in the touchdown area about 1200 feet from the south end of the runway. The grooving is in excellent condition and there is only a moderate amount of rubber deposit in the grooves.

Fig. 23. General View showing excellent condition of grooving near south end of runway

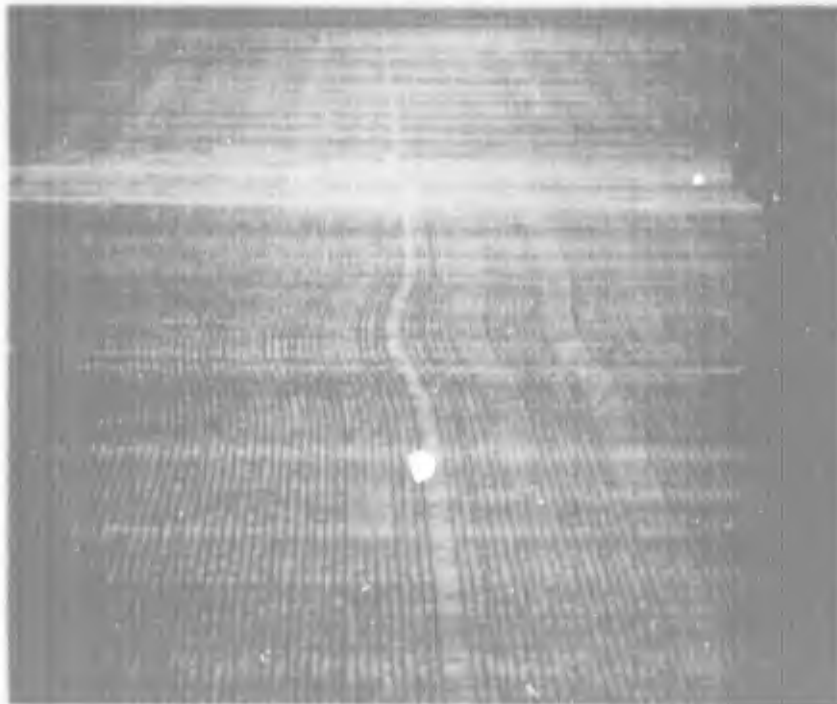
(5) Grooves in the touchdown area near the south end of the runway are curved or distorted because of a shifting of the asphalt wearing surface.

(2) Figure 24 shows the shifting of the pavement in the touchdown area in the same general location as figure 23. The grooving is not deteriorated in the shifted area indicating that the movement is at some depth below the surface and is not due to the grooving.

Fig. 24. Shifting of pavement surface in touchdown area near south end of runway

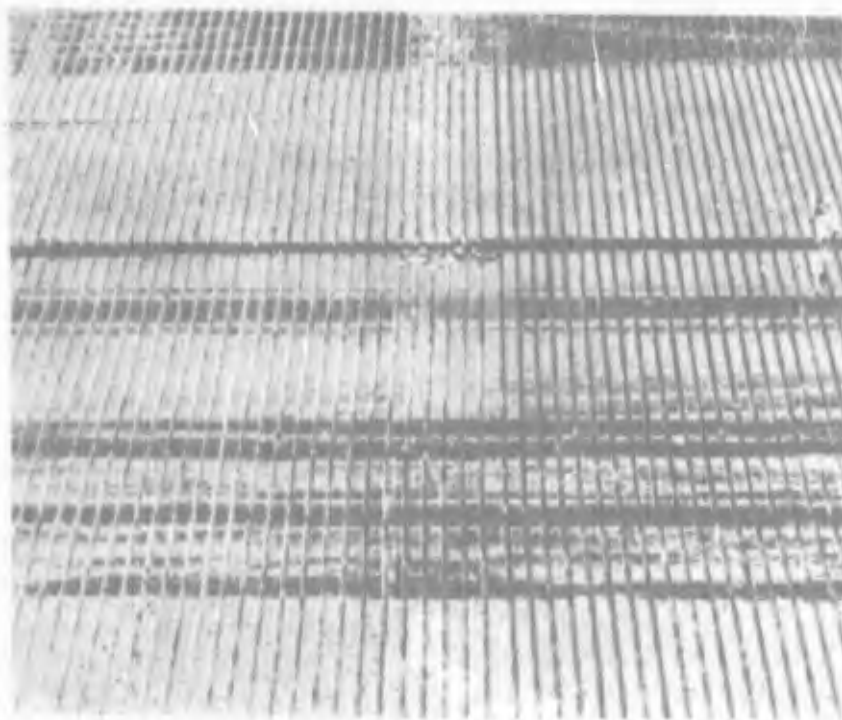
Fig. 30. Minor spalling at joint which occurred during grooving
