**USAAVLABS TECHNICAL REPORT 70-71A**  
**ANALYSIS OF HELICOPTER STRUCTURAL CRASHWORTHINESS**  
**VOLUME I**

**MATHEMATICAL SIMULATION AND EXPERIMENTAL**  
**VERIFICATION FOR HELICOPTER CRASHWORTHINESS**

January 1971

**CONTRACT DAAJ02-69-C-0030**  
**DYNAMIC SCIENCE (THE AVSER FACILITY)**  
**A DIVISION OF MARSHALL INDUSTRIES**  
**PHOENIX, ARIZONA**

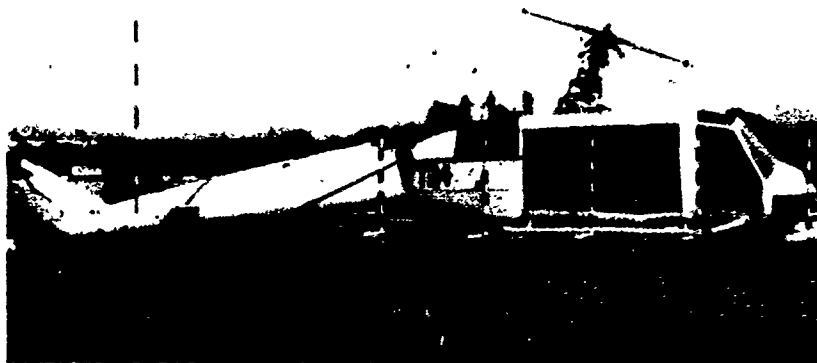
The landing gear cross tubes distorted outward and upward, permitting the fuselage to contact the concrete pad. The cross tubes did not fail but were permanently distorted, permitting the fuselage to rest on the concrete pad (Figure 58). The fuselage remained within 1 inch of the pad after all simulated fuel was drained from the tanks. The lowest point of the loaded fuselage prior to the drop was slightly over 14 inches.

Figure 57. Overall Posttest View.

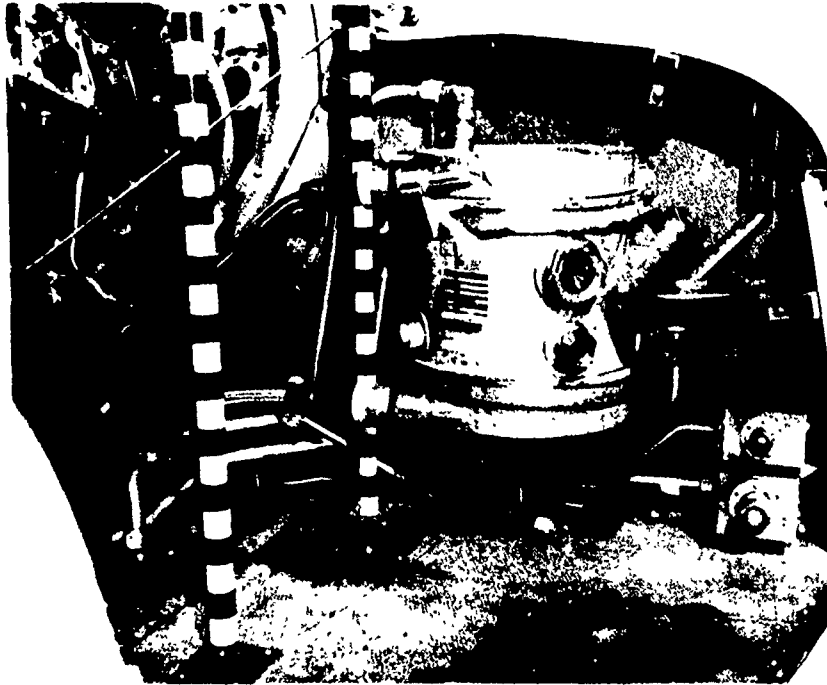
The oil system remained intact throughout the impact sequence, and no oil loss occurred. The displacement of the engine did remove all slack and apply a load to the 3/4-inch oil breather line attached to the upper boss at the rear of the oil tank. This loading did not fail the elbow end fitting, but it did deflect the boss on the oil tank downward, as shown by the arrow in Figure 78.

Figure 78. Bent Oil Breather Line  
Boss on Oil Tank.

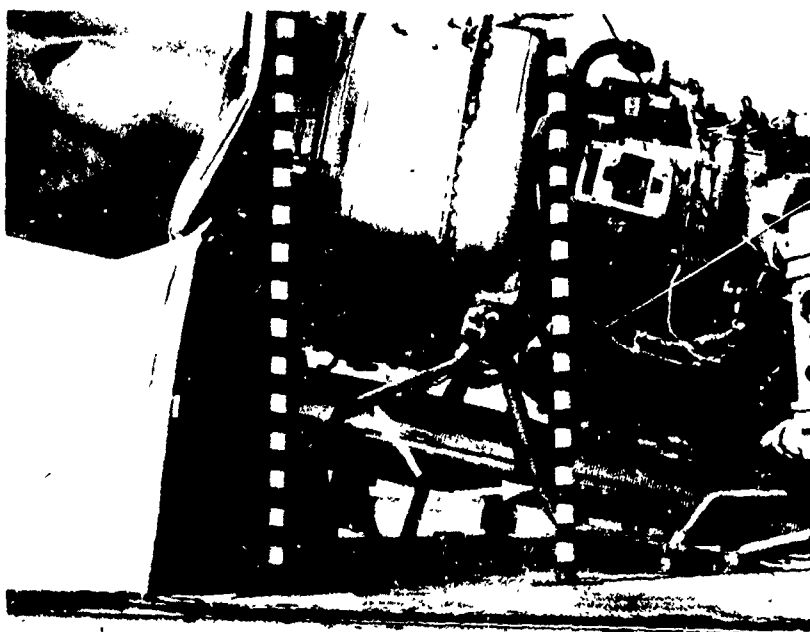
Figure 79.. Damage to Right Engine Mount.
