# ADVERSE WEATHER TESTS OF THE HH-53C HELICOPTER

TECHNICAL REPORT ASD-TR-70-51

DECEMBER 1970

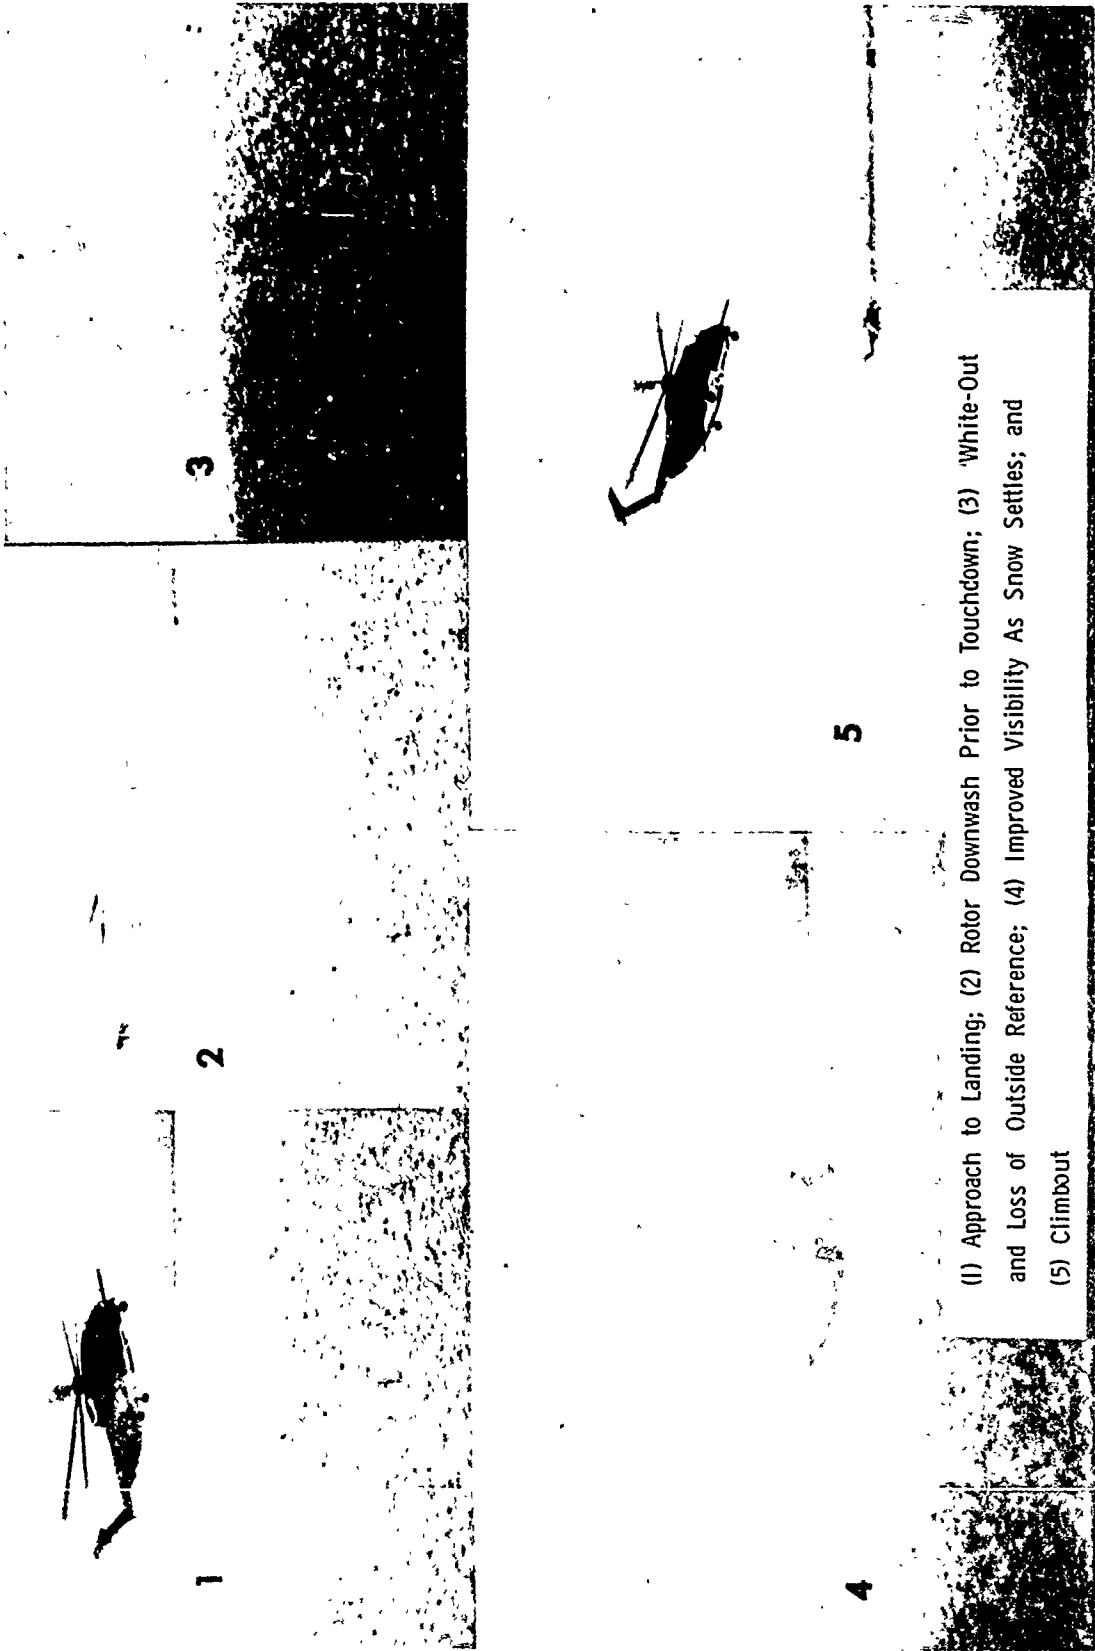
Figure 5. Typical "Whiteout" Experienced When Landing in Powdery Snow

17. As a result of the landing sequence shown in Figure 5 (Mission No. 6), the pilots and engineers adopted procedures that minimized the chances of getting completely disoriented when landing in powdery snow. It was found that when the natural horizon was totally obscured by rotor-blown snow, visibility was reduced to about 100 feet directly in front of the helicopter. Once this happened and a total whiteout was established, the pilot became dependent on objects on the ground near the intended landing zone, in addition to his attitude indicator, for visual indications of the helicopter's attitude. Taxi lights, stakes, and flares were helpful in identifying the ground during a whiteout. The only factor that prevented the pilot from aborting the landing mentioned above was his ability to distinguish small clumps of grass sticking through the snow cover directly in front of the helicopter.

72. Land from a hover if landing on ice-covered snow. If landing in loose, powdery snow, plan to land without a hover. Expect a whiteout if the rotor wash catches up to the aircraft before touchdown.

NOTE: If a whiteout is encountered before landing, execute a go-around by maintaining a level pitch attitude while increasing collective to takeoff power.
