TECHNICAL MEMORANDUM 226

ROCKET SLED IMPACT TESTS  
OF BULK CONTAINERS FOR ETIOLOGIC  
AGENT STORAGE AND SHIPPING

Edward L. Tray

APRIL 1971

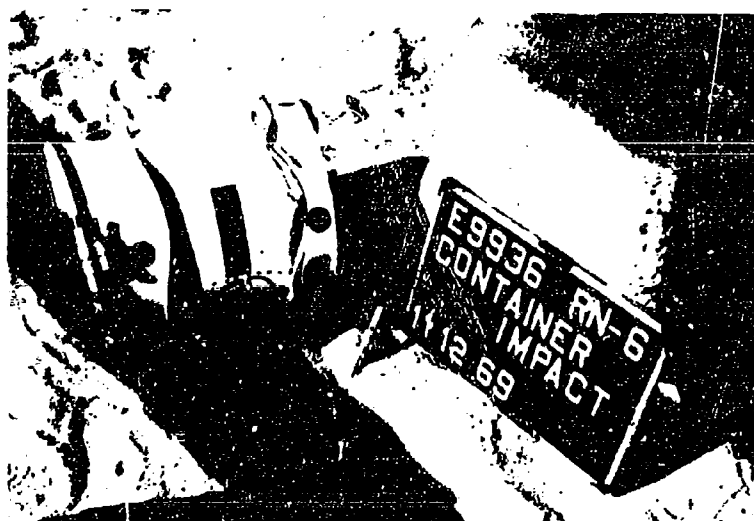
FIGURE 17. Typical Damage to the 1-gal System Bearing Impact on the Bottom.

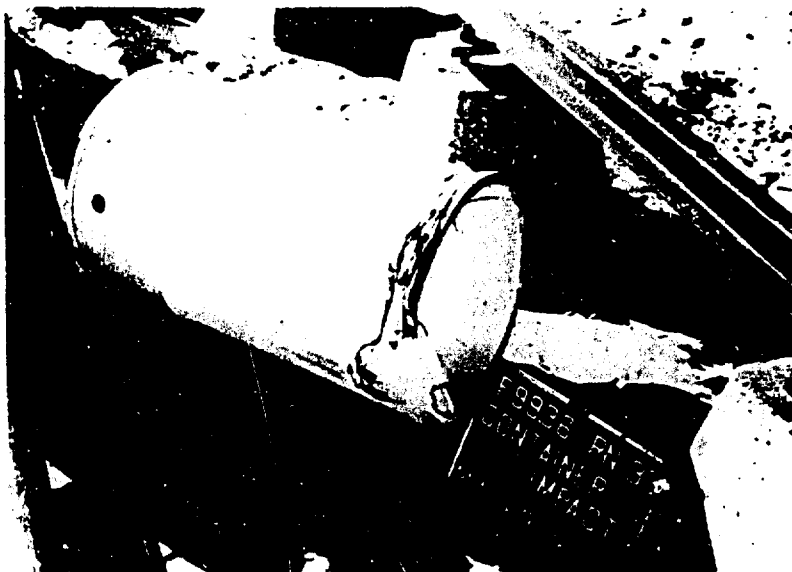
FIGURE 23. Fifteen-gallon System Impacted on Bottom.
