Technical Note N-1170

HIGH EXPLOSIVE FIELD TEST OF HARDENED ELECTRICAL GENERATORS

May 1971

NAVAL CIVIL ENGINEERING LABORATORY  
Port Hueneme, California 93043

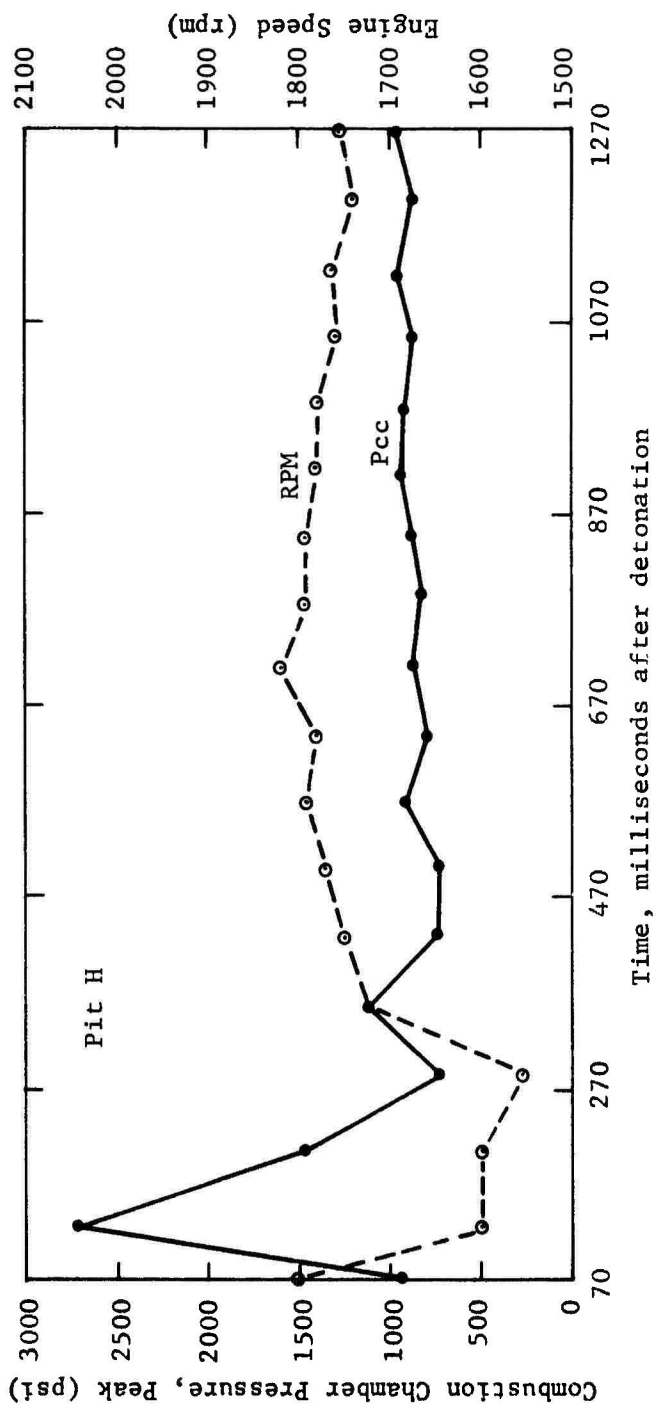
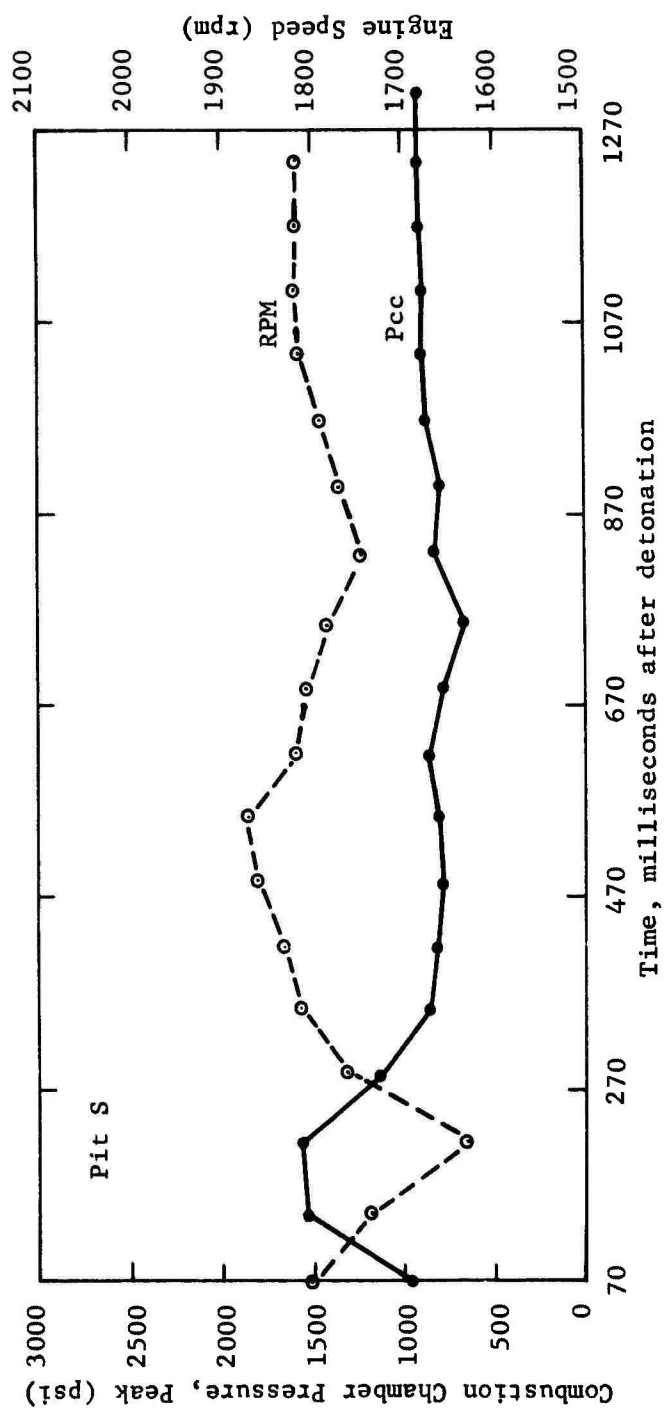
Measured peak combustion chamber pressure and engine speed time histories for both pits are shown in Figures 10 and 11. In Pit "H" the peak combustion chamber pressure was about 2700 psig, more than 2.85 times the normal 950 psig. Following the initial peak, combustion chamber peak pressure decayed rapidly to nearly 84% of normal at 640 milliseconds and then returned to normal at about 910 milliseconds. The engine speed decreased from 1800 rpm to about 1550 rpm in the period from 70 milliseconds to 214 milliseconds. Subsequently, engine speed returned rather slowly to 1800 rpm at 670 milliseconds after detonation. The resultant generator output frequency decreased from 60 cycles per second to 51.8 cycles per second, about 13.7% below normal. In Pit "S" the peak combustion chamber pressure was about 1550 psi, nearly 1.62 times the normal 960 psig. After the initial peak pressure occurred, the subsequent pressures decayed to about 69% of the normal at 760 milliseconds.

After an initial sharp decrease from 1800 rpm to 1630 rpm at 214 milliseconds after detonation, engine speed rose to nearly 4% above normal at 552 milliseconds. Subsequent engine speed varied about the normal 1800 rpm with decaying oscillation of less than 1.5% of the normal speed.

The maximum combustion chamber pressures were slightly more than one-half in Pit "H" and one-third in Pit "S" of the 4400 psig measured in laboratory overpressure tests. The short duration of the DIAL PACK overpressure pulse and the blast protection afforded by the hardened air cleaner, muffler and air cleaner are thought to have caused the reduction in combustion chamber pressures.

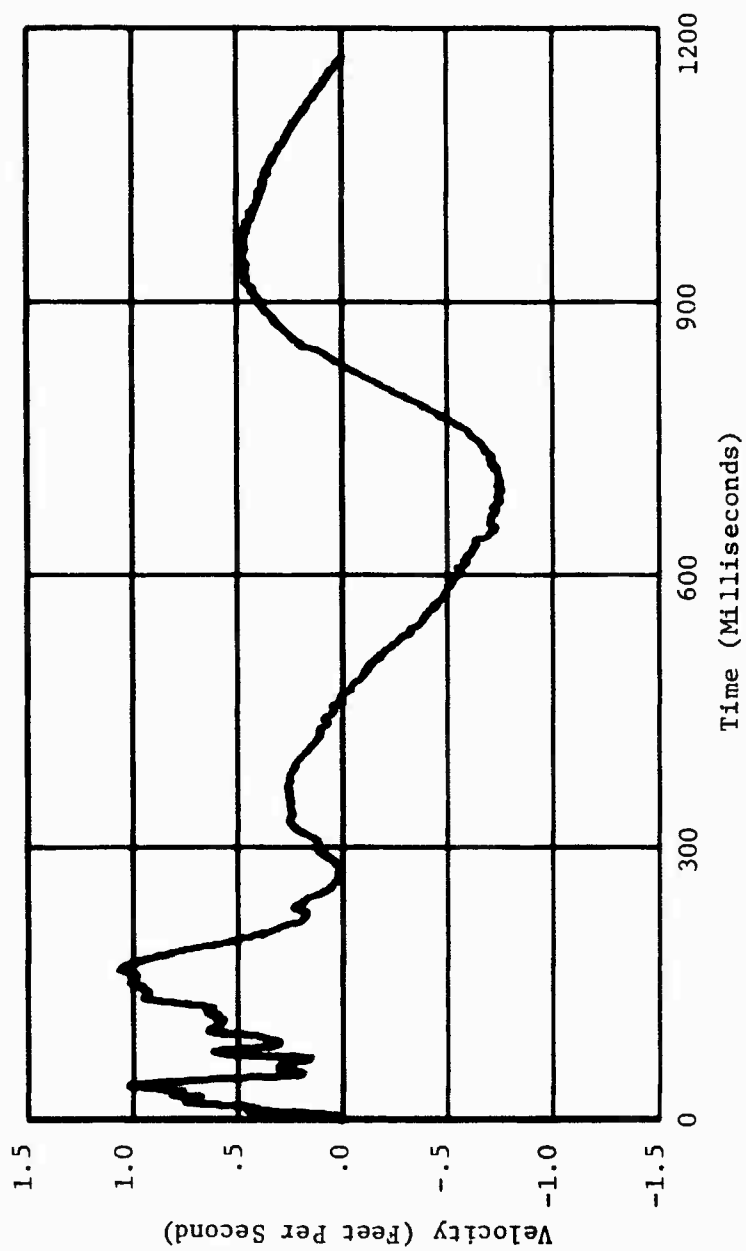
The radially horizontal velocity in Pit "H", shown in Figure A-7, was initially outward beginning at 70 milliseconds after detonation and reached initial peak velocity of 1.03 feet per second at 108.5 milliseconds after detonation. A second peak outward velocity of 1.06 feet per second was observed to occur at 236 milliseconds. Rebound reduced the velocity first to zero at 538 milliseconds and then to an inward maximum of 0.77 feet per second at 732 milliseconds. Subsequent horizontal velocities, limited to less than 0.5 feet per second, continued for more than 2 seconds.

Figure A-7. Horizontal velocity of floor in Pit H.

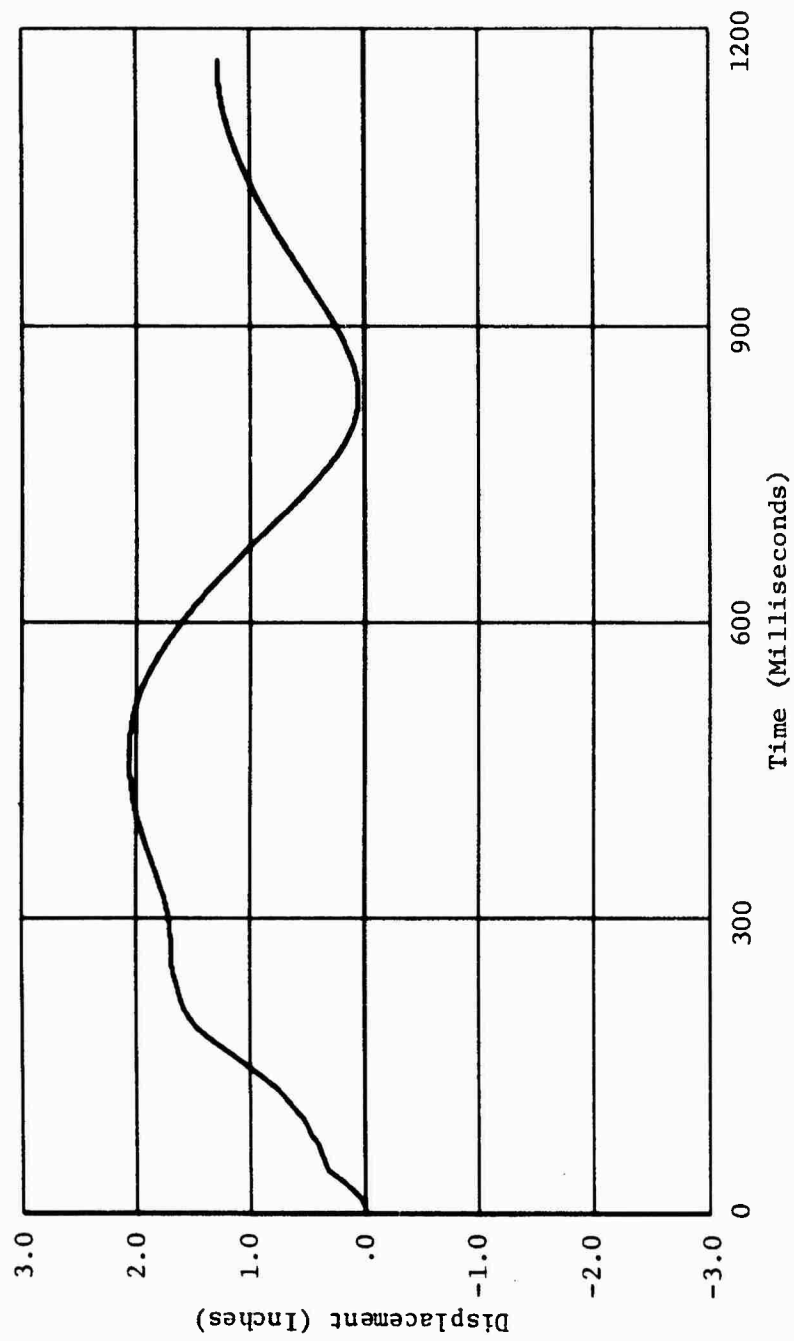
The horizontal displacement, determined by integration of the velocity data, and plotted in Figure A-8, beginning at 70 milliseconds after detonation reached a maximum of 2.06 inches outward at 538.5 milliseconds. Upon rebound, the outward displacement decreased to 0.05 inches at 899 milliseconds and again moved outward to 1.28 inches at 1230 milliseconds. The horizontal acceleration, determined by differentiation of velocity and plotted in Figure A-9, was found to reach an outward maximum of 4.5 g's at 140.5 milliseconds.

Figure A-8. Horizontal displacement of floor in Pit H.
