AIRCRAFT SHELTER EXPLOSIVES QUANTITY-DISTANCE EVALUATION, CONCRETE SKY, PHASE IXB

TECHNICAL REPORT NO. AFWL-TR-71-65

July 1971

AIR FORCE WEAPONS LABORATORY
Air Force Systems Command
Kirtland Air Force Base
New Mexico

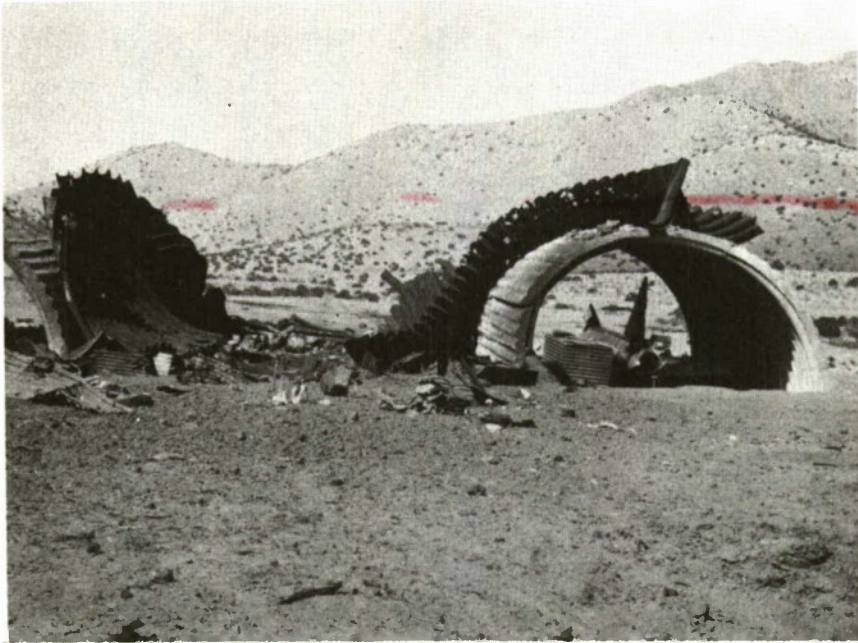
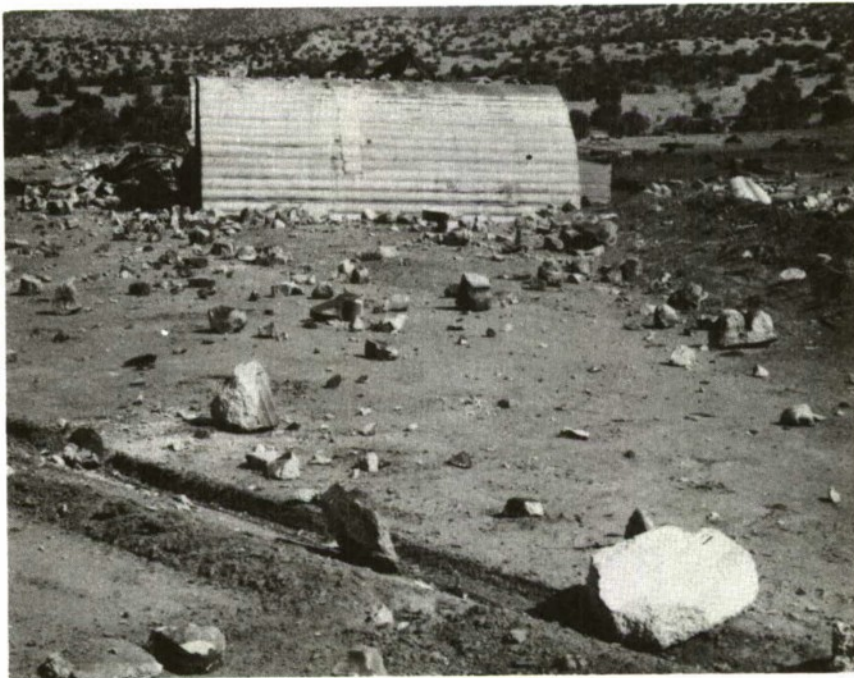
Figure 11. Destruction of Donor Shelter

The donor shelter was completely destroyed during the test. Blocks of the concrete cover, ranging from pebble size to 6-by-6-foot pieces, were found over a large area. The steel arch material was broken primarily into large blackened, twisted pieces that were peeled back against the sides of the acceptor shelters. The major pieces were similar in size. High-speed photography showed that the

concrete was thrown off in a pattern roughly symmetrical about the longitudinal centerline of the shelter at initial trajectories along radial lines from the center of the blast. The fireball quickly covered the shelters so that actual failure of the donor could not be seen. However, it is apparent from the above that rupture first occurred near the top rear of the shelter. The smooth appearance of the faces of the blocks of concrete where they had been in contact with the steel arch indicated that little, if any, bond had existed between the two materials. The lack of bond also accounted for the fact that the concrete began separating from the steel very quickly after the detonation. Various aspects of the failure of the donor are illustrated in figure 11.

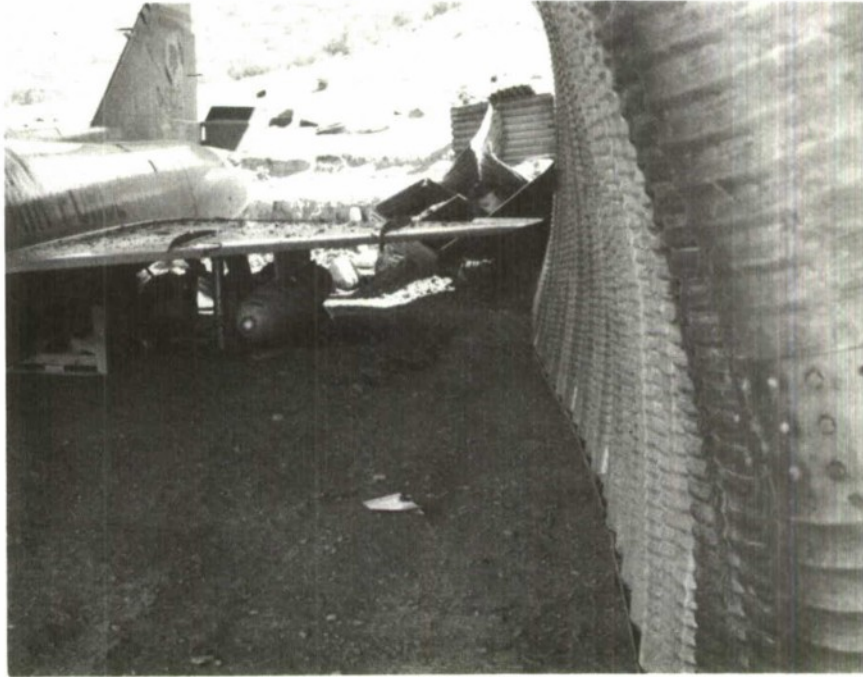
Figure 12. Displacement of Wall in Shelter A

Neither acceptor shelter collapsed during the test event, although some damage was sustained by both. Shelter A, which did not have the added protection of a revetment separating it from the donor, sustained a greater amount of damage than shelter C did. The most significant damage was the displacement of the wall adjacent to the donor in toward the centerline of shelter A (figure 12). The distance the wall moved varied from almost no displacement at the front of the shelter to a 6-foot displacement at 20 feet from the rear of the shelter, then tapering to a 4-foot displacement at the rear. The location of the maximum displacement corresponded to the location of the bombs in the donor shelter so that the main force of the explosion was concentrated in this area.

It is important to note that both acceptor shelters would still have been usable if combat conditions dictated their continued use. Shelter A would have required extensive repairs to prevent further weakening from future blasts in its vicinity. Shelter C would have been immediately usable with little or no repair.

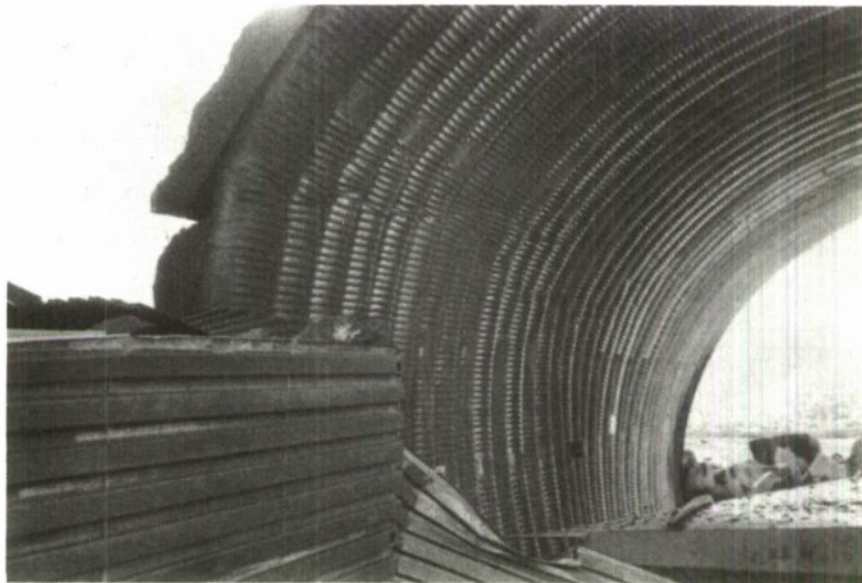
Figure 13. Hinging of Acceptor Wall (Shelter A)

Associated with the displacement of the base of the wall was the hinging action seen in figure 13. This figure illustrates the separation of the concrete on the exterior and crimping of the steel arch on the interior of the shelter. This damage and the extensive cracking of the exterior of shelter A are shown in figure 14. It was noted that most cracks occurred along vertical lines of form bolts and along horizontal cold joints. (Note that cold joints in the construction also occur at horizontal lines of form bolts, therefore further weakening these areas.)

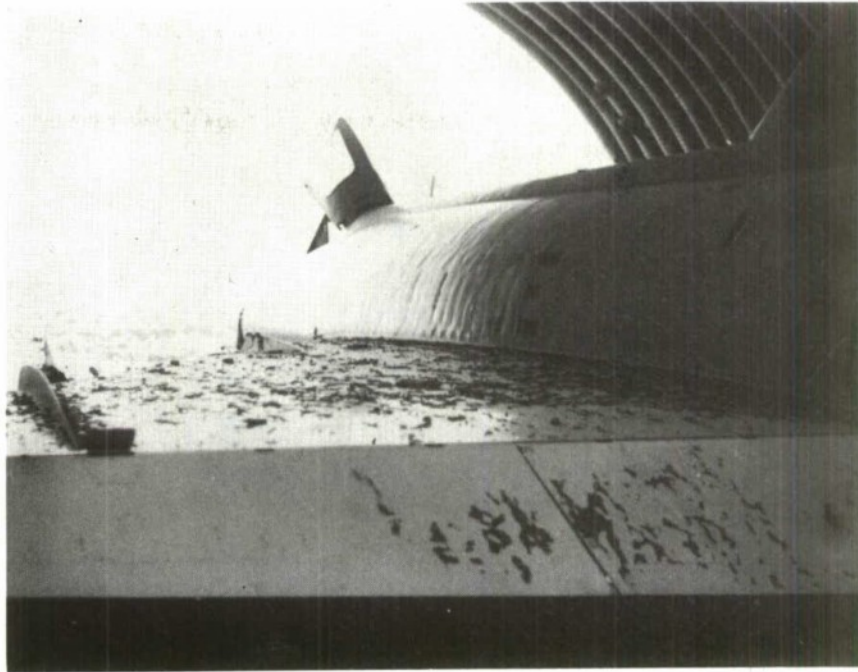
Figure 15. Skin Wrinkles on Fuselage

Damage to the acceptor aircraft was considered light. Some types of damage were common to both aircraft, such as wrinkling of the skin on the fuselage (figure 15), partial detachment of the tail cone, and destruction of the antenna at the tip of the vertical stabilizer (figure 16).

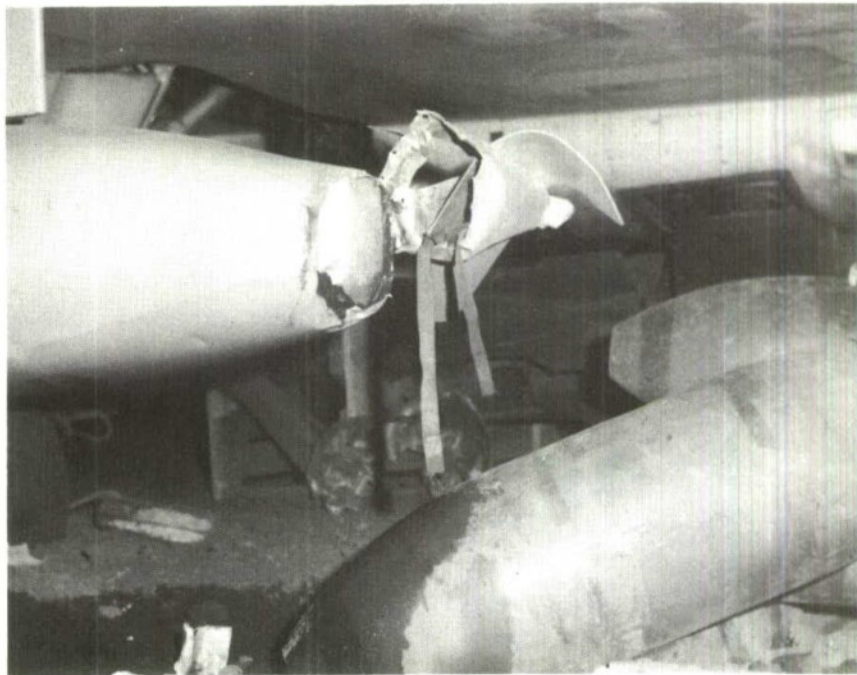
Figure 18. Damage to External Fuel Tank

The tail of the left external fuel tank on aircraft A was sheared off (figure 18), which resulted in a slight fuel leak from this tank. Again, this had the outward appearance of shrapnel damage, but none was found. This was probably caused by the same type of debris cited above. Further, shrapnel penetrating this area would likely have ignited the fuel, which did not occur. Figure 18 also illustrates the partial displacement of a portion of the bombs under aircraft A. The displacement is further shown in figure 19. Note also the damage to the tail fins of the bombs. This apparently was caused by the overpressure from the explosion in the donor shelter, as no evidence was found to indicate they had been hit by flying debris.

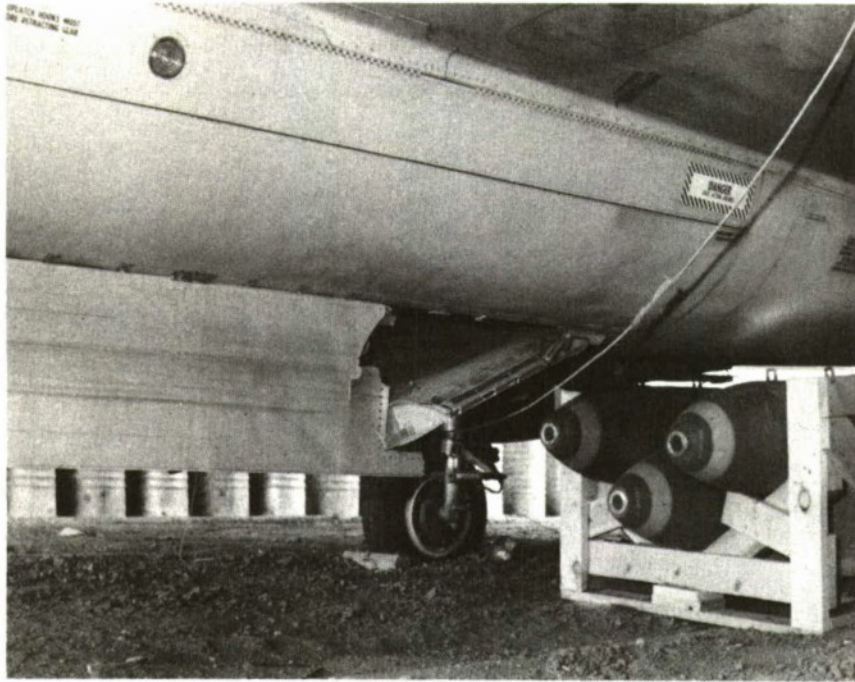
Figure 20. Armament Bay Door Damage

On both acceptor aircraft, the armament bay doors were damaged, although this type of damage was greater on aircraft C. The mode of failure seems to be a tearing of the structure of the door (figure 20). This was caused by a

partial failure of the hydraulic actuators that operate the doors. However, the significance of this damage is questionable since the F-4 does not have this type of door.
