# **UH-1N INSTRUMENT FLIGHT, TURBULENCE, AND ICING TESTS**

**TECHNICAL REPORT No. 71-9**

**MARCH 1971**

**AIR FORCE FLIGHT TEST CENTER  
EDWARDS AIR FORCE BASE, CALIFORNIA  
AIR FORCE SYSTEMS COMMAND  
UNITED STATES AIR FORCE**

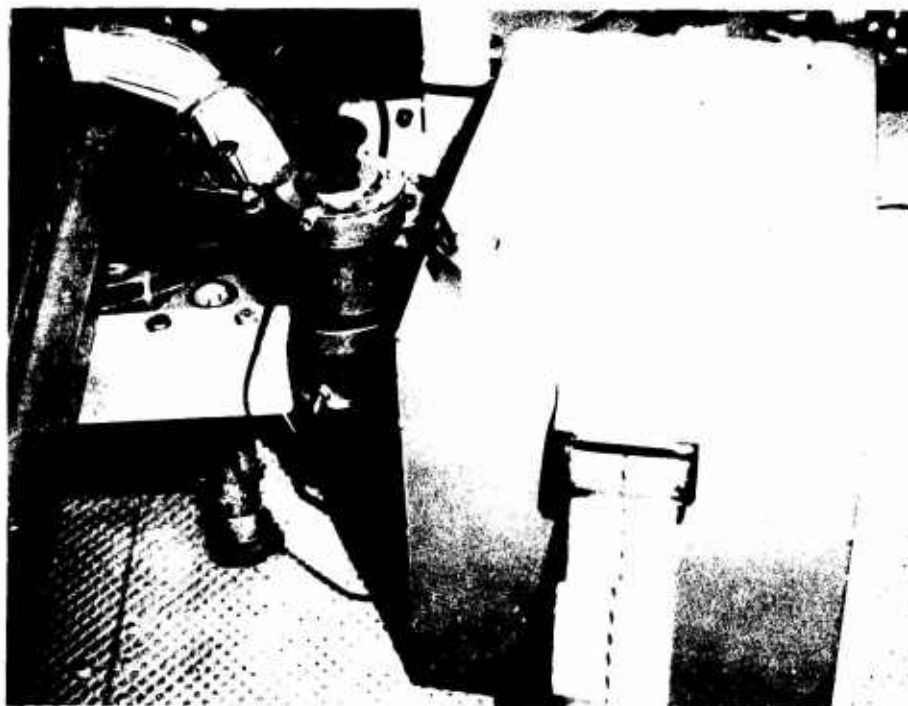
The UH-1N windshield defrosting system was inadequate for ice removal as shown by results of the UH-1F icing test program (reference 7). Consequently, a de-icing system was installed to give the pilot visibility during icing tests. The system consisted of a 2-gallon tank (containing alcohol), an electric pump and flexible plastic hose (figures 2 and 3). The de-icing system received power from the aircraft 28-volt dc essential bus. When the system was activated, alcohol was pumped through plastic hose to the windshield wiper and onto the windshield.

**Figure 2 Class II Modification - De-Icing Pump and Alcohol Tank**

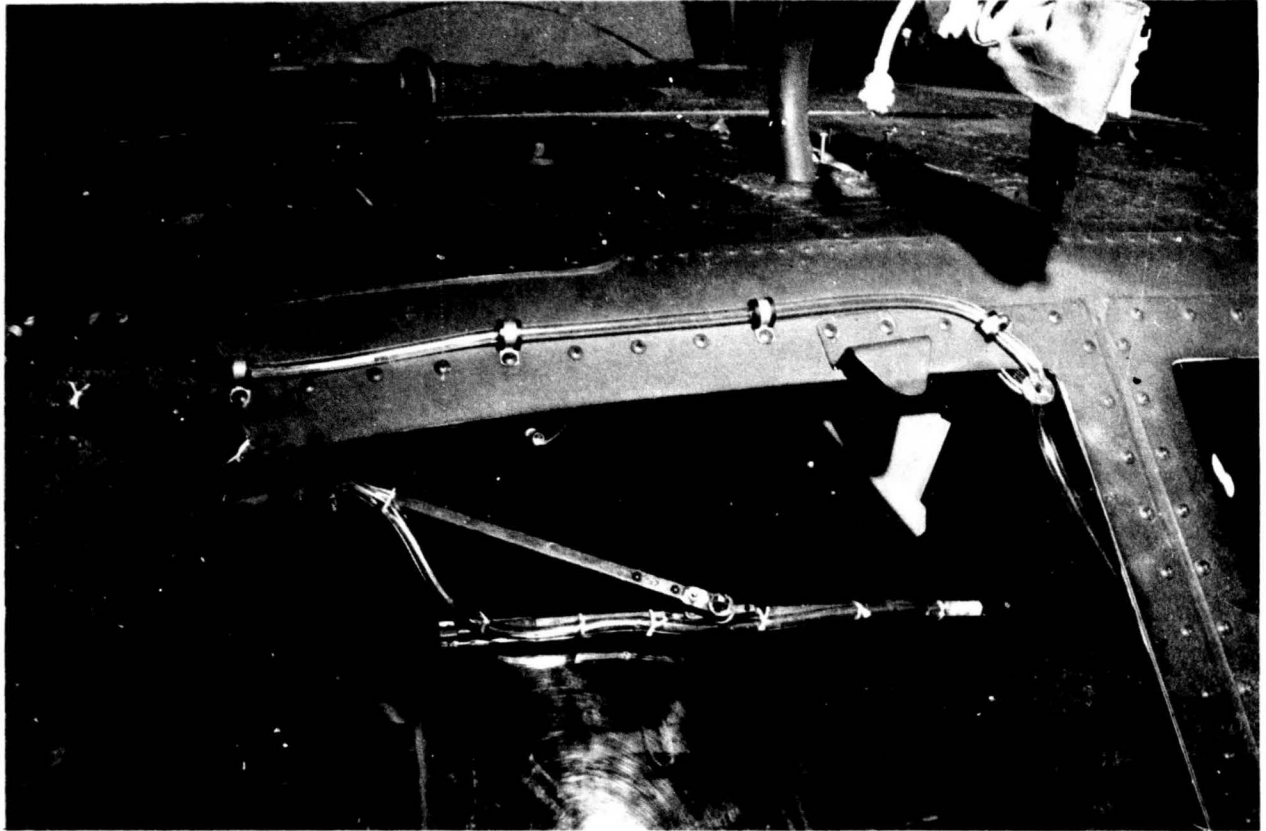
**Figure 3 Class II Modification – Plastic Hose Attached to Wiper**

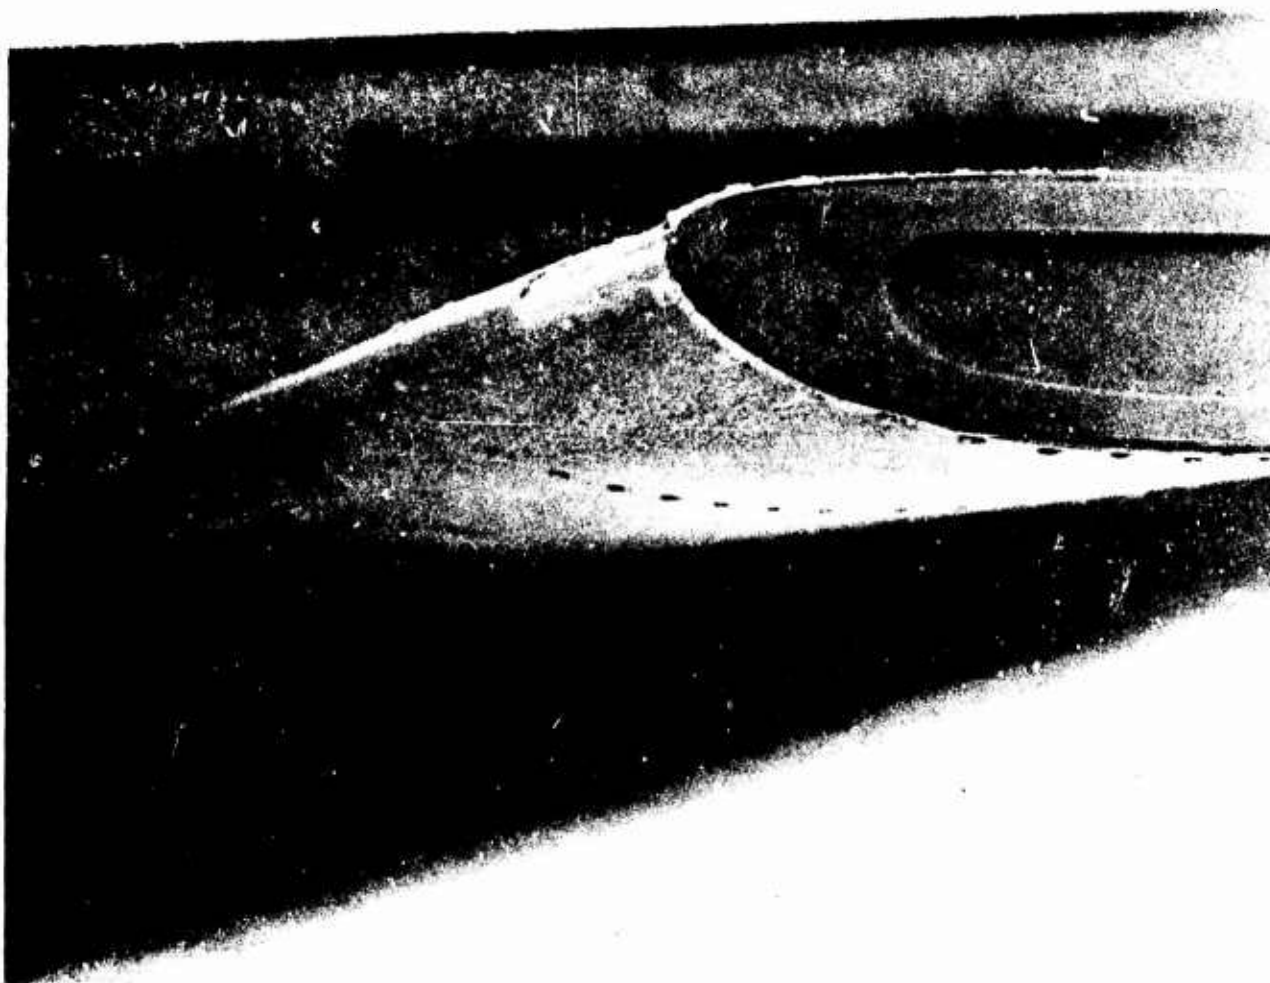
Ice accumulation thickness on the synchronized elevators (figure 5) and tail rotor section was minimal (1/8-inch maximum) for all icing conditions (trace, light, moderate) tested. The tail rotor section accumulated about one-half as much ice as the nose and rotor hub areas for all test points. The helicopter aft section accrued less ice due to engine exhaust venting. Ice accrued up to 1/4-inch thick on the nose, windshield, rotor hub (figures 6 and 7) and engine inlet lips (figure 8) during test points 7 and 8 (table IV). No structural damage occurred during any of the icing tests conducted.

**Figure 5 Clear Ice (1/8-inch Thick) on Synchronized Elevator (Test Point 8)**

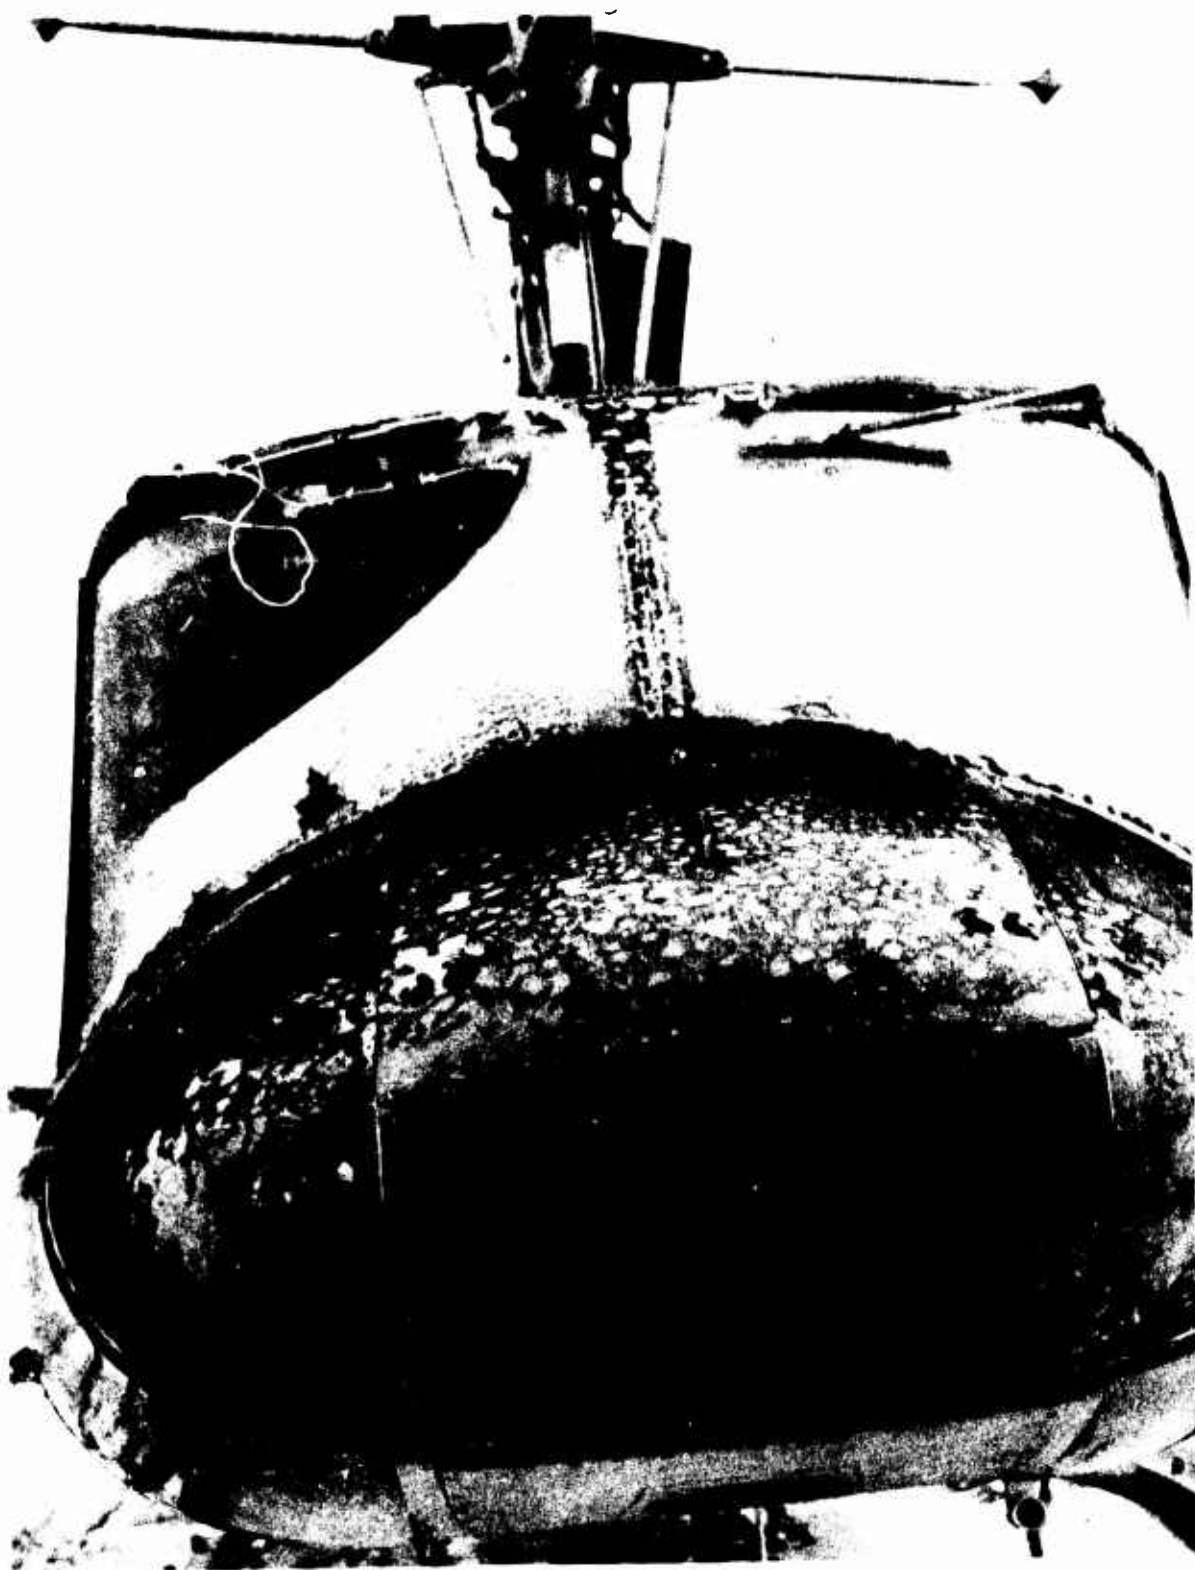
**Figure 6 Clear Ice on UH-1N Nose and Windshield (Test Point 8)**

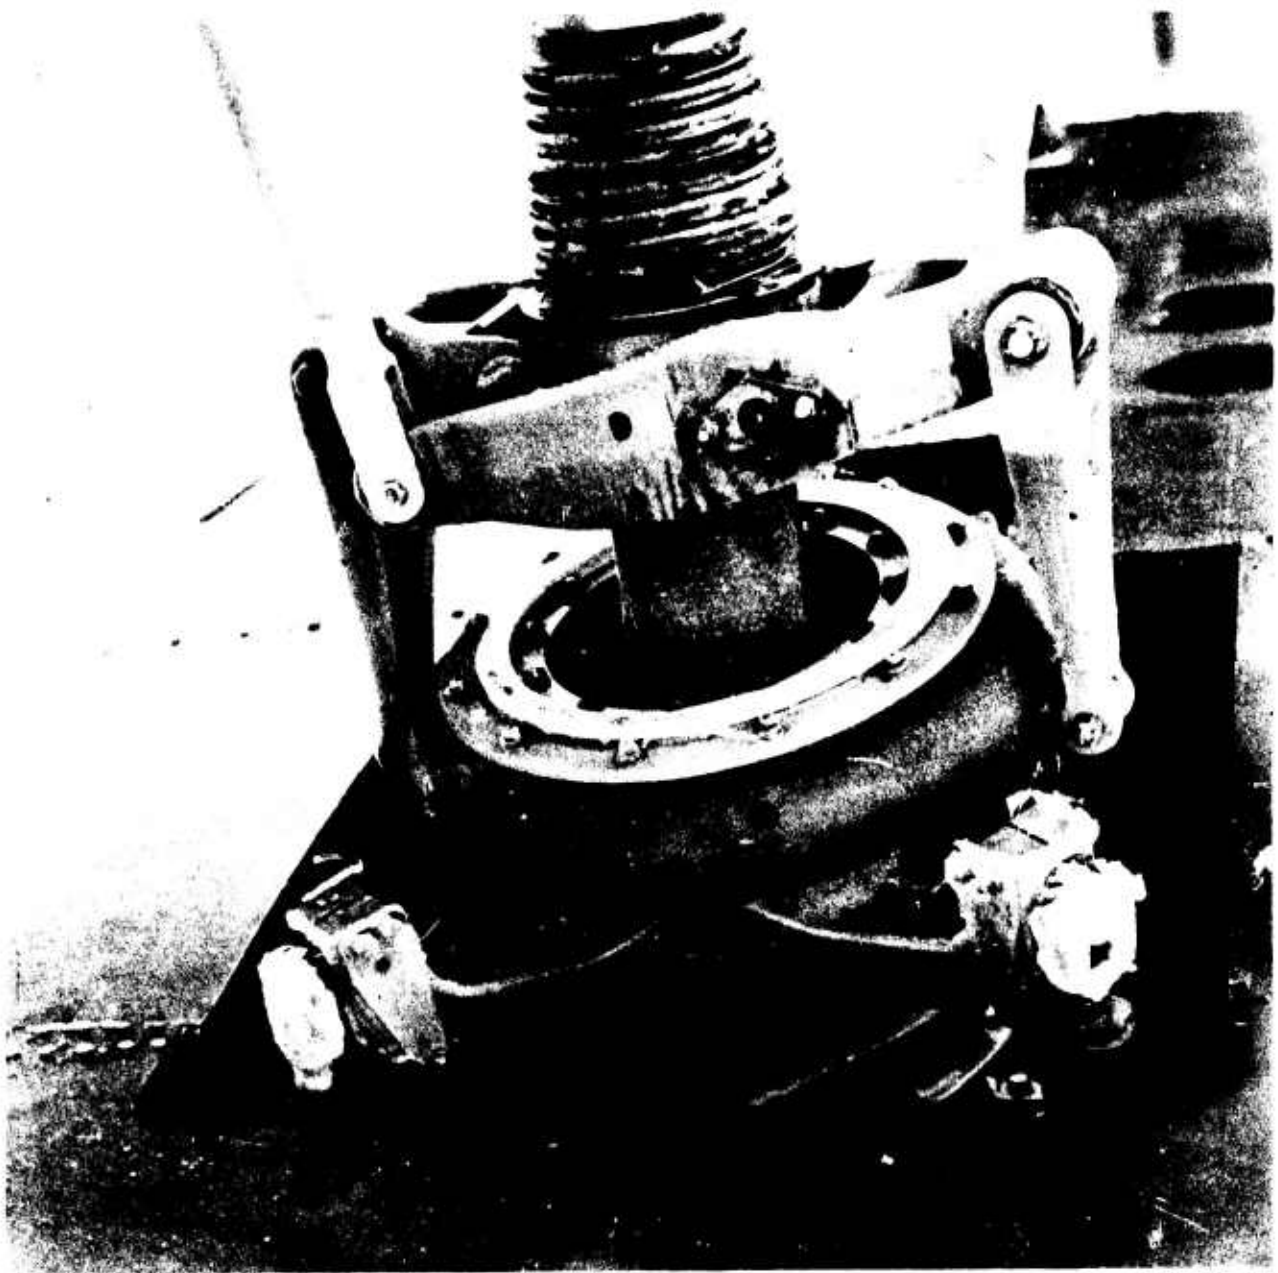
**Figure 7 Clear Ice on Rotor Hub (Test Point 7)**

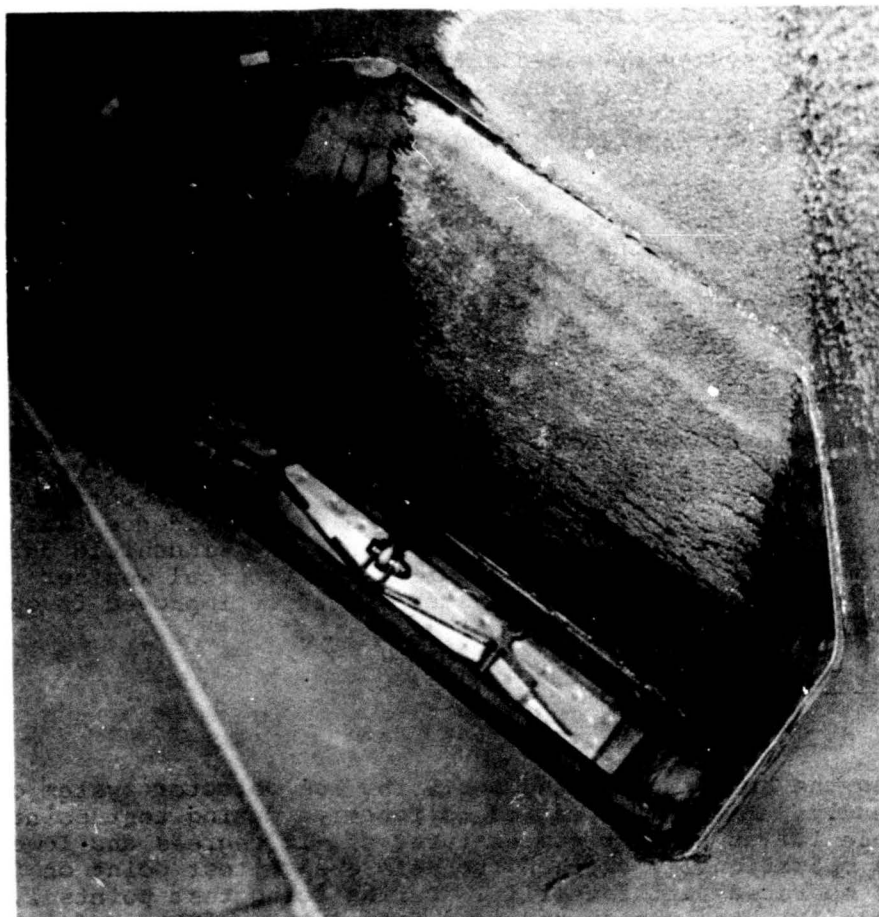
Inside the inlet duct a slab of ice approximately 1/16 to 3/16-inch thick accumulated for most of the test points (figure 10). The ice slab was about 1.5 feet downstream from the inlet lip and on the upper surface of the inlet.

Since testing was conducted with freezing temperatures at all altitudes, the ice that accumulated in the inlet did not break free and enter in the engine. If warmer ambient temperatures are encountered after encountering icing conditions there is a possibility of engine damage due to ice ingestion.

**Figure 10 Ice Slab (Approximately 1/8-inch Thick) Inside Engine Duct (Test Point 8)**

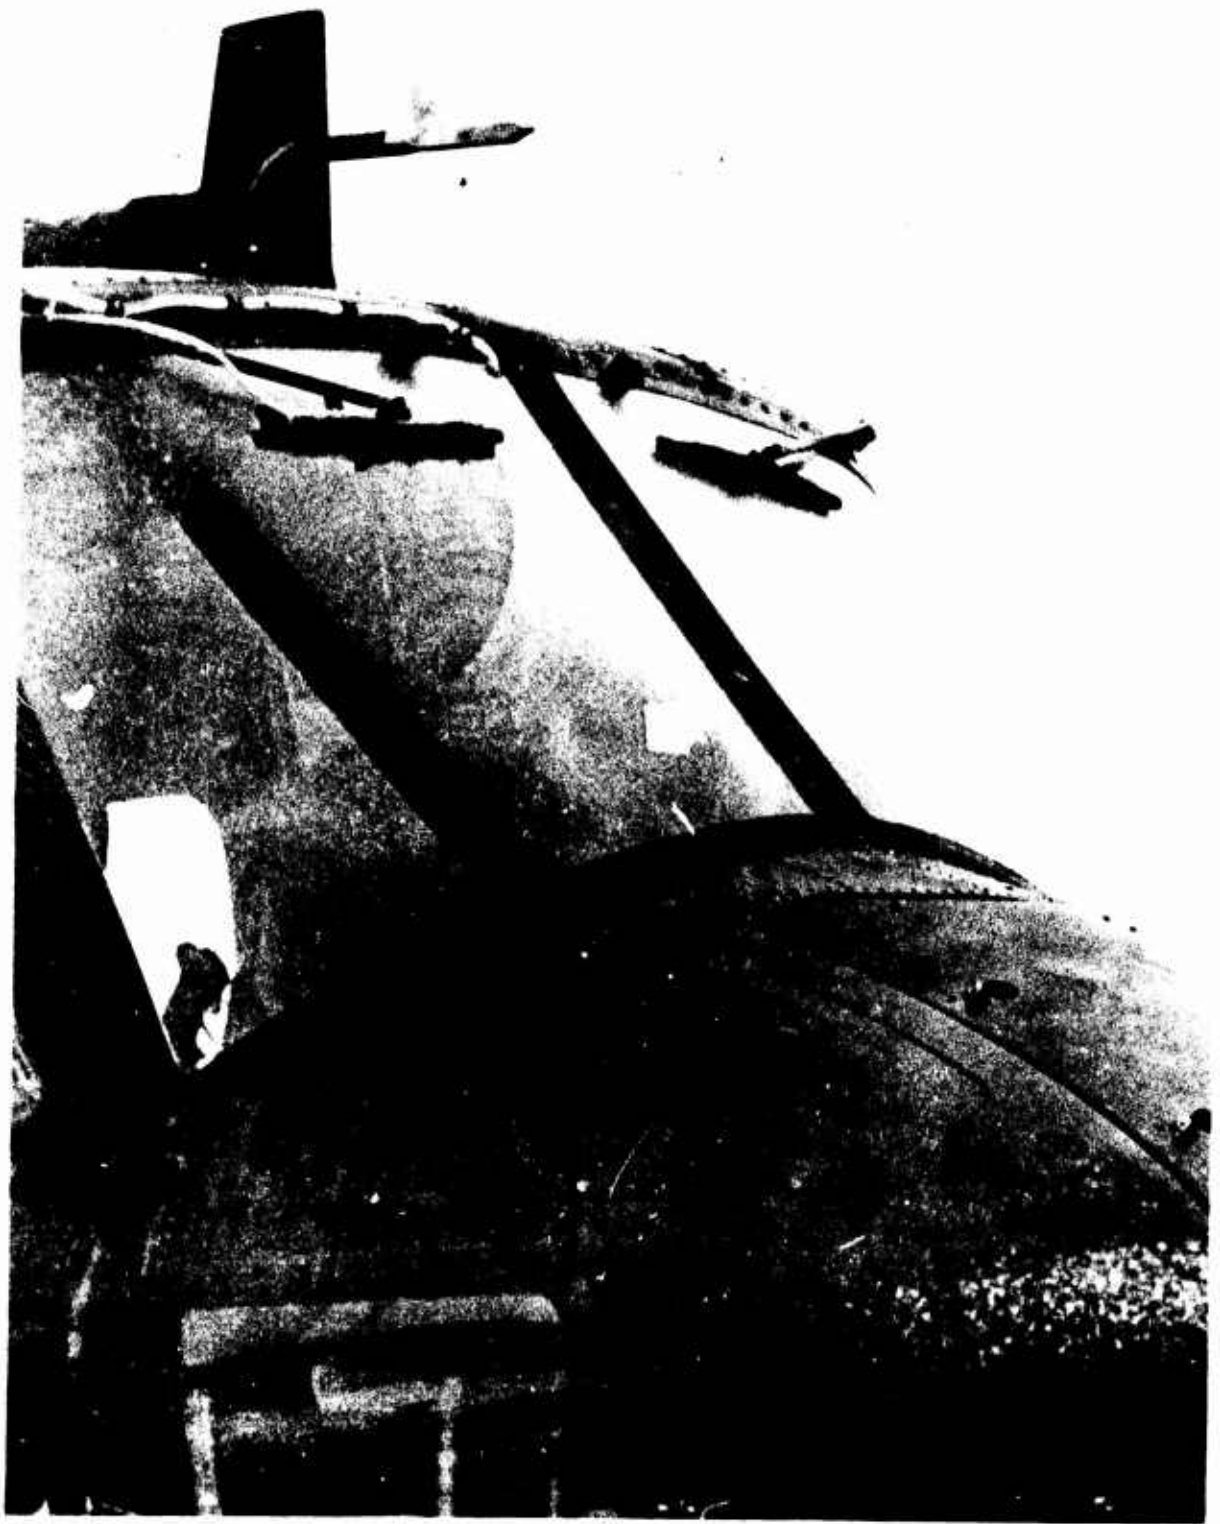
**Figure 11 Clear Trace Ice on Windshield (Test Point 1)**

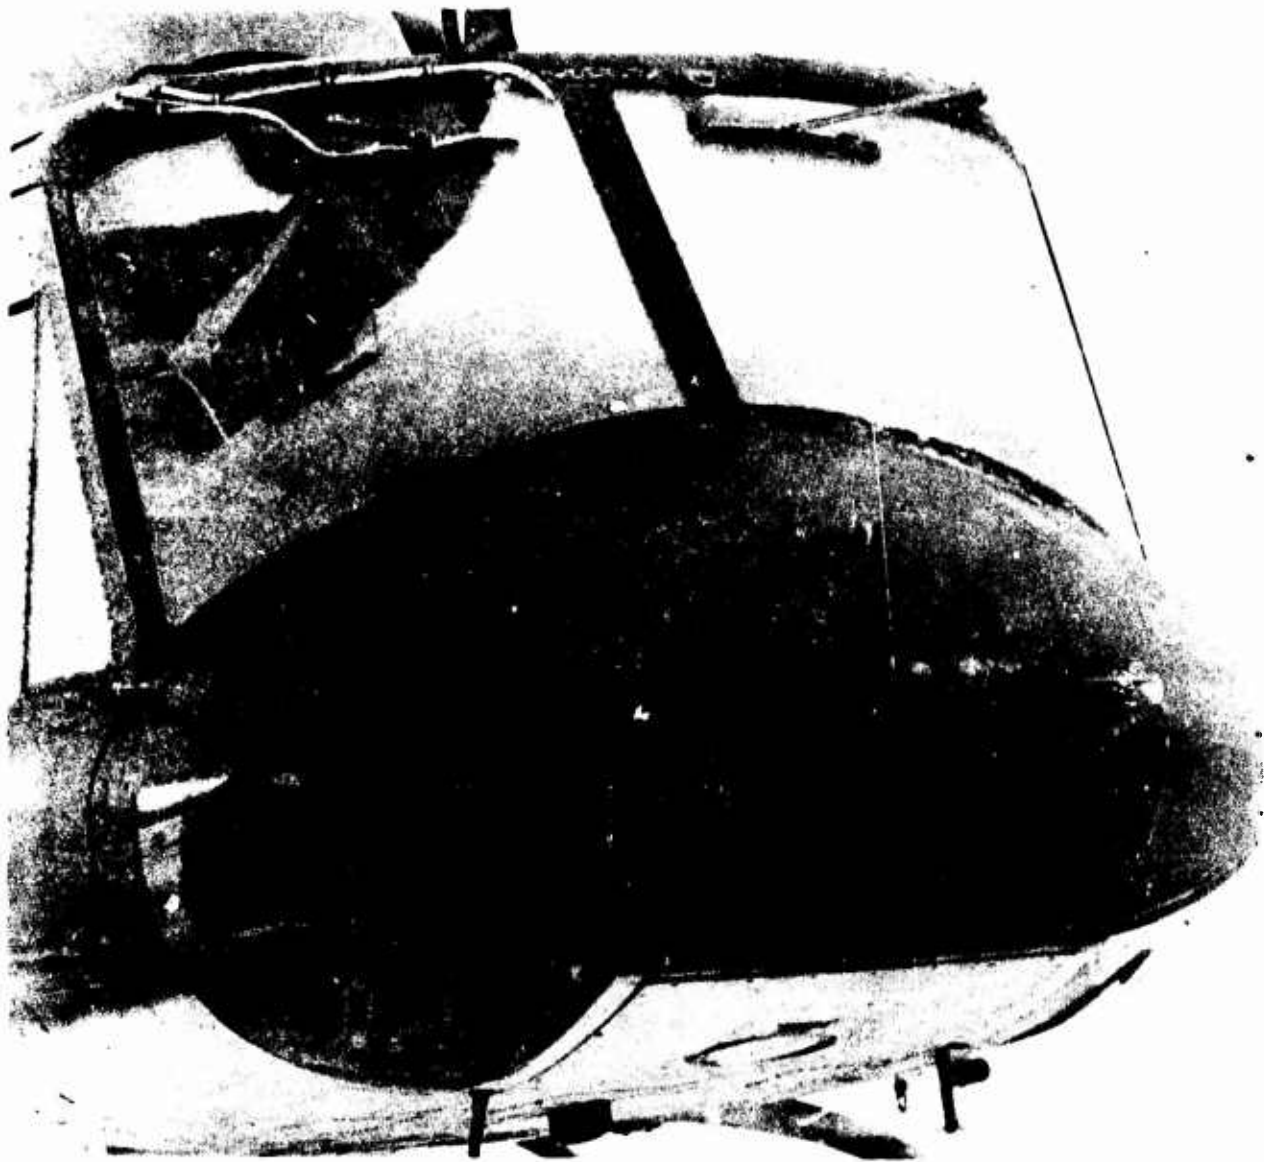
The defrost system operated satisfactorily during the flights in trace and light clear icing conditions. However, the defrost system was again inadequate to remove ice from the windscreen, and in less than 30 seconds in the light rime icing condition encountered, the windscreen became opaque.

**Figure 12 Rime Light Ice on Windshield (Test Point 5)**

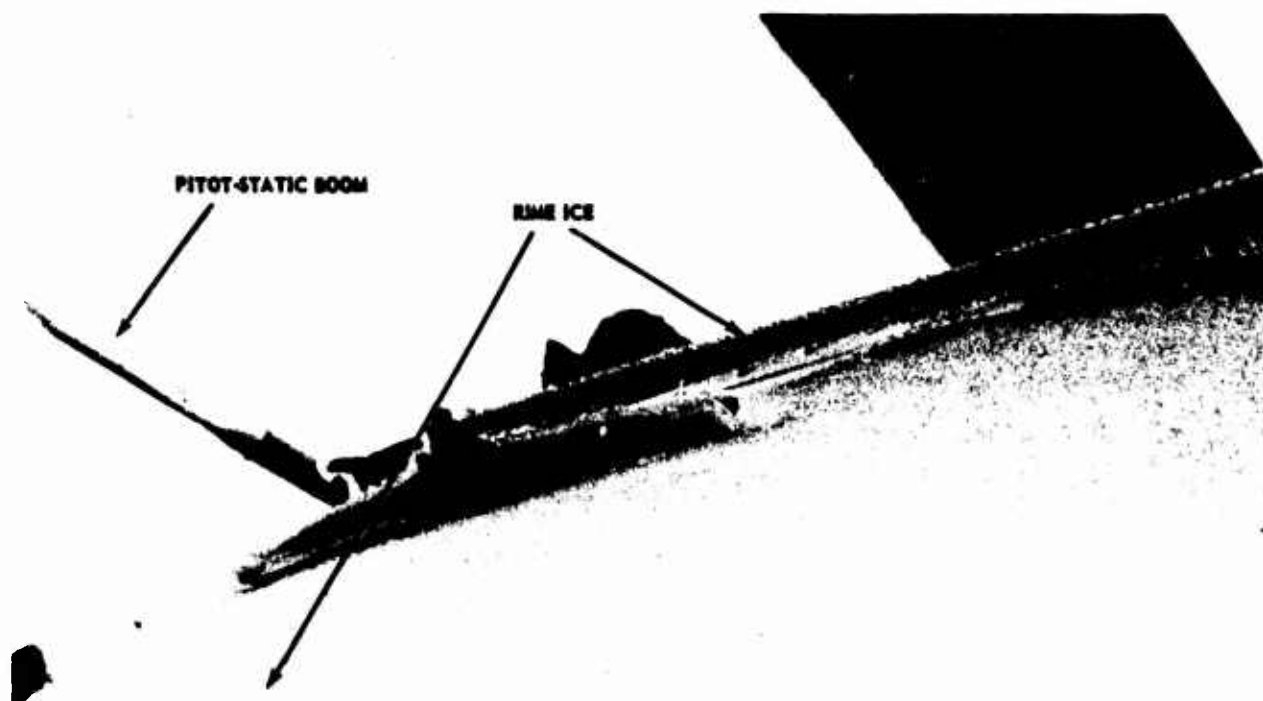
The windshield wiper failed to start in LOW during all tests and operated intermittently when the control was turned to MEDIUM. The wiper functioned normally when the control was in HIGH. The control could not be set to any other position than HIGH with any confidence that the wiper would continue functioning. Wipers scratched the windshield during this test program as previously noticed during the tropical weather tests (reference 2). Windshield wiper system should be improved to operate reliably in all speed ranges. (R 6)

**Figure 13 Rime Ice on Windshield/Wiper (Test Point 5)**
