CATEGORY II SYSTEMS FOLLOW-ON TESTS OF THE HH-53C HELICOPTER

TECHNICAL REPORT No. 72-7
FEBRUARY 1972

AIR FORCE FLIGHT TEST CENTER
EDWARDS AIR FORCE BASE, CALIFORNIA
AIR FORCE SYSTEMS COMMAND
UNITED STATES AIR FORCE

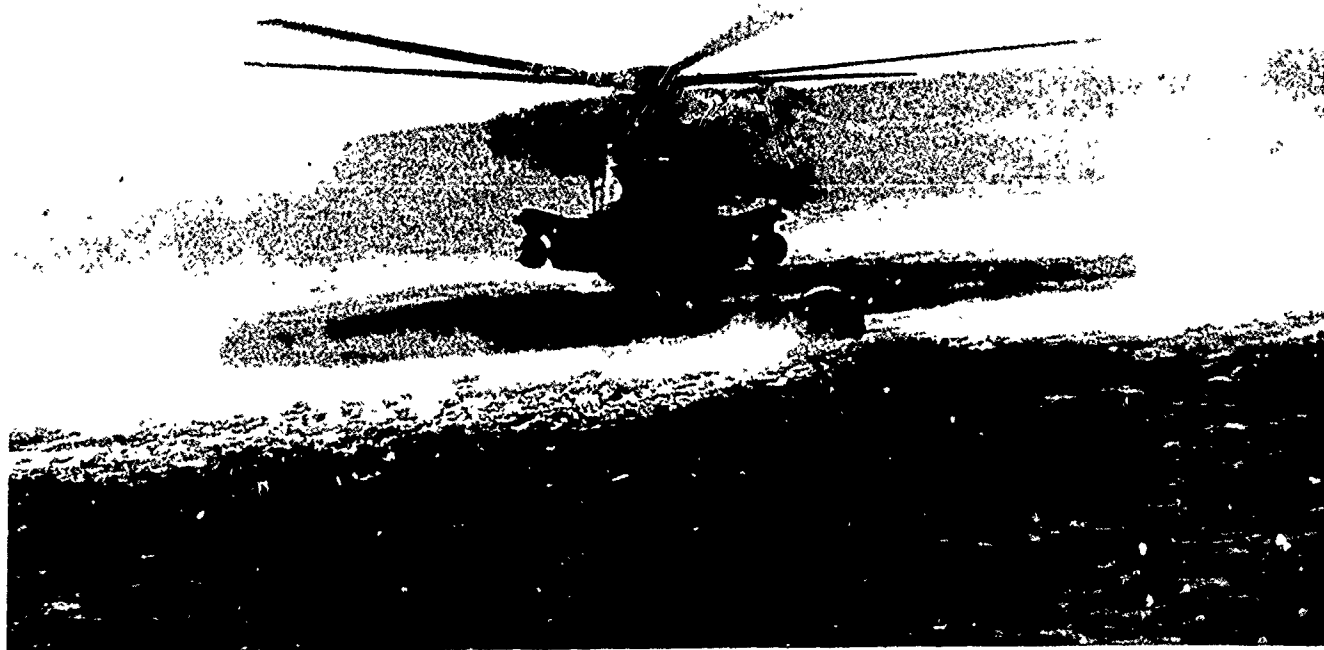
Figure I Five-Foot Hover Height

Three flights were made in the environmental conditions of a sea state of one and winds ranging from zero to 5 knots. Some spray was ingested as the helicopter came to a hover. After becoming established in a 5-foot hover, the rotor downwash continued to blow the salt spray away from the helicopter and engine inlets. Under these conditions the engine inlets and the windshield remained dry. No measurable engine power deterioration was experienced under these conditions. Based on the results of the 57-minute flight 4 (table II) it was determined that hover operations at any altitude over salt water with wind conditions of 5 knots or less can be safely conducted for at least 2 hours without a complete loss of engine power margin. This applies with or without EAPS.

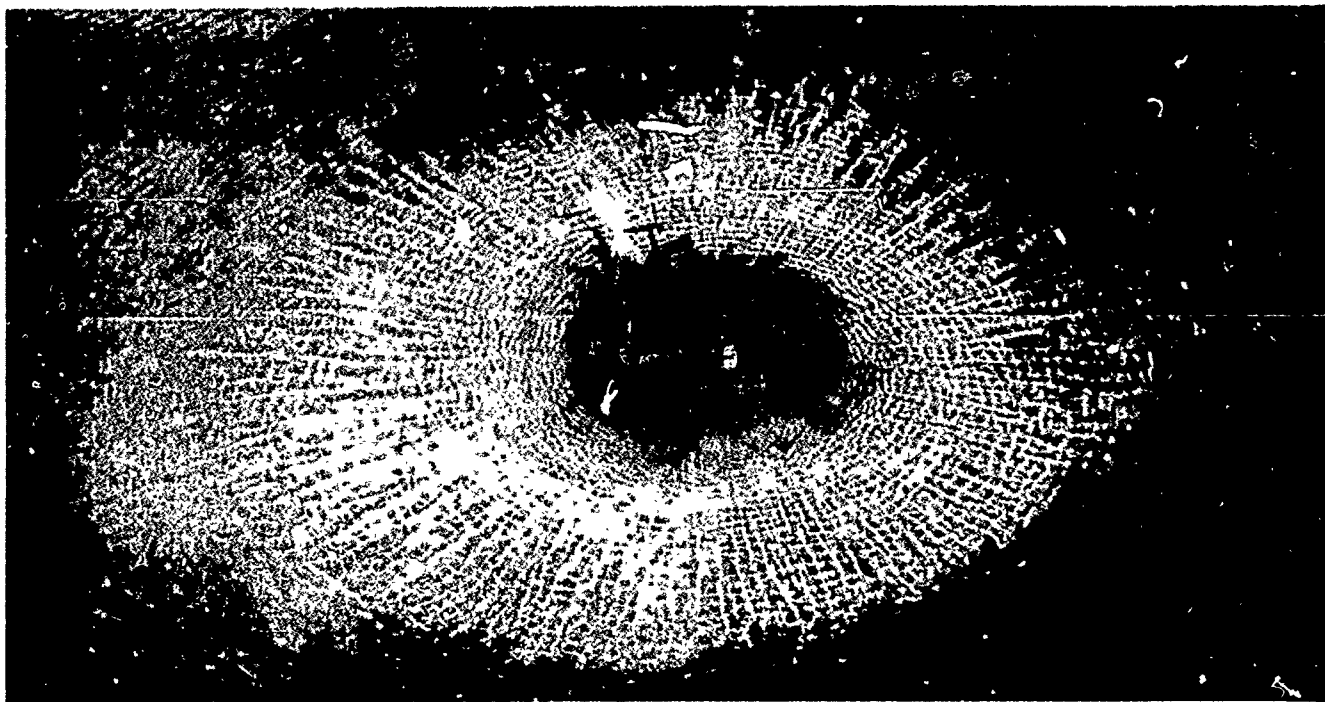
Figure 2 Spray Pattern

Various hover heights from 5 to 200 feet (wheel heights) above the water were evaluated. Spray patterns and the height at which salt spray first contacted the helicopter were noted (figure 2). With wind speeds of 5 knots or less, a very light spray was normally encountered at hover heights as high as 60 to 70 feet. At lower hover heights, the increased rotor wash on the water surface blew the spray away from the aircraft. With wind speeds over 5 knots, the increased wind speed tended to blow the spray under the aircraft and spray was encountered at lower hover heights. For example, on Flight 1 with a wind speed of 15 knots, spray was not encountered until a hover height of 20 feet was reached. As previously pointed out, the best indicator was always spray on the windshield. The amount of spray observed on the windshield and the necessity of using windshield wipers to maintain visibility were immediate indications of spray ingestion into the engine. During the tests, light to moderate spray required use of the windshield wipers and caused engine power loss even with EAPS installed. Generally the heaviest spray concentration was encountered at the lowest hover height (holding all other factors constant). It is recommended for normal salt water hover operations that the helicopter be hovered high enough so that no spray is noted on the windshield to prevent significant salt spray ingestion with subsequent engine power loss. (R3)

3. To prevent significant salt spray ingestion with subsequent engine power loss, normal salt water hover operations should be conducted high enough so that no spray is noted on the windshield (page 7).

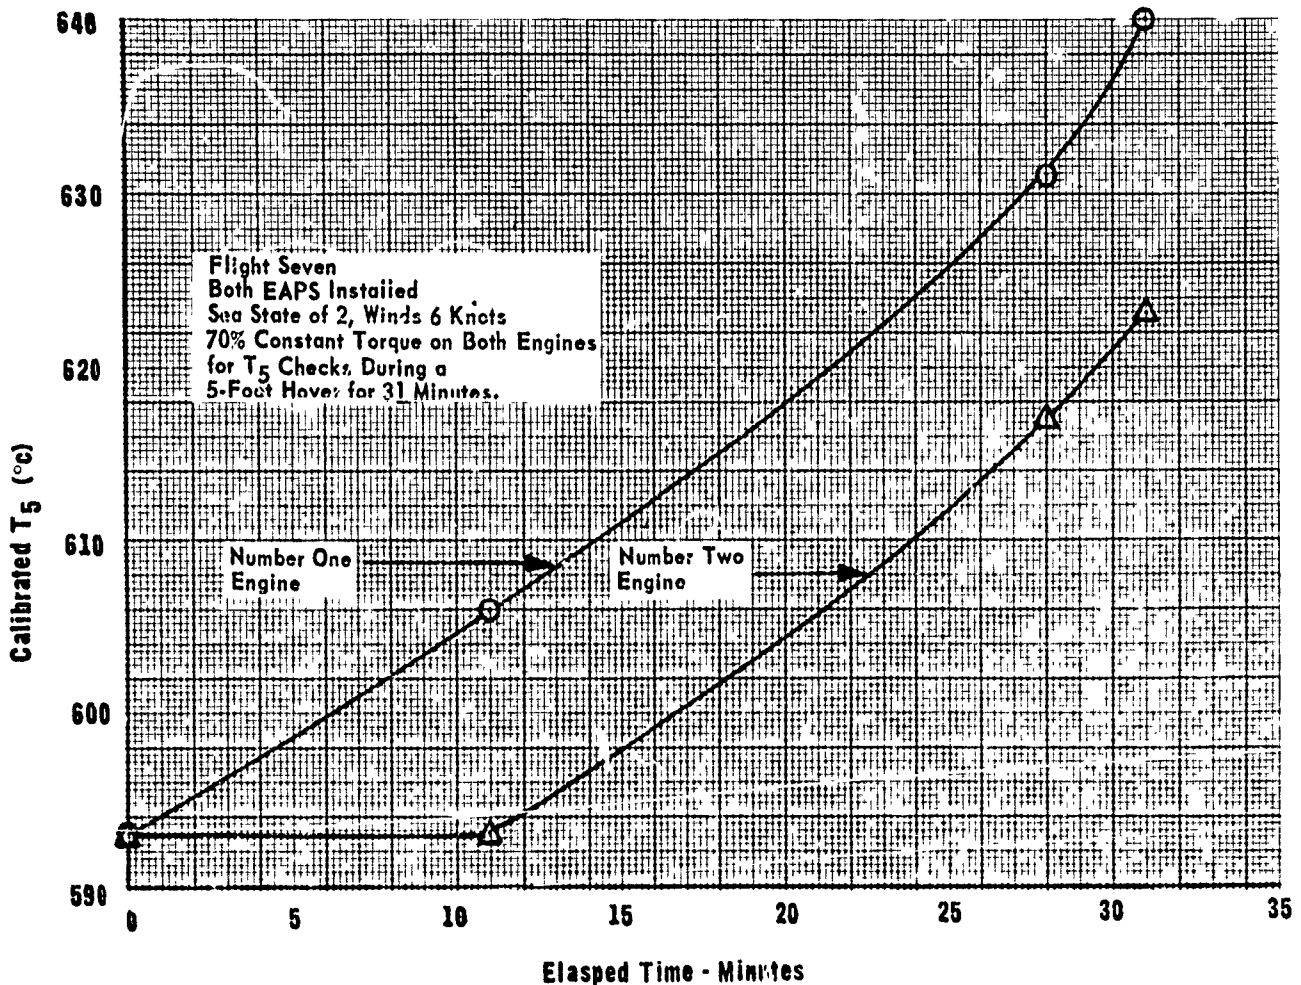
Figure 3 Effect of Salt Spray Ingestion on Power Turbine Inlet Temperature

ingestion with respect to hover time. These figures show data taken with EAPS installed on both engines. It was also observed, during winds of 5 to 6 knots, that the counterclockwise rotation of the main rotor blades caused more spray to impinge on the left side of the aircraft. This would indicate that the left hand engine ingested more salt spray over a given period of time than the right hand engine and explains the more rapid rise in T_5 for the left hand engine.

For salt water hover operations, the power deterioration check procedures used during these tests were found to provide an accurate assessment of engine power. A single point power deterioration check should be made per T.O. 1H-53(H)B-2-2 (reference 10) prior to entering the hover. If either engine does not meet the minimum torque requirements, hover operations should not be performed. If the engines demonstrate sufficient power margin, T_5 (at the initial hover torque setting) should be monitored throughout hover operations. A rise of 30 degrees C in T_5 , as observed using this method, should result in termination of hover operations followed by a single point power deterioration check in forward flight. If either engine has dropped below the minimum torque, the salt

water hover operations should be terminated. If both engines are still above the minimum torque, hover operations may be continued. Caution must be used if some deterioration has been noted, because subsequent hover operations may accelerate the rate of power loss. The No. 1 engine is more critically exposed and should be more closely monitored. (R 4, R 5, R 6, R 7, R 8, R 9)
