Technical Memorandum

DREA TM 2000-022

January 2000

**FLIGHT DECK REFUELLING HOSE FAILURE
HMCS PRESERVER**

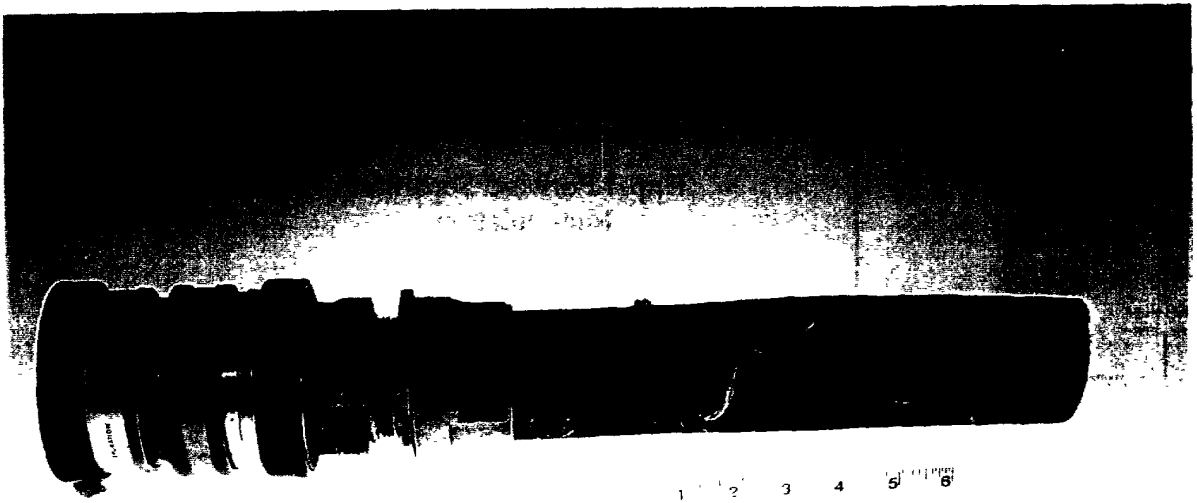
The failed section of hose is shown in Figure 2. The failure penetrated the hose, that is both the inner tube and cover were split over a distance of approximately 6 inches and the reinforcing fibres were broken. One end of the failure surface approached to within approximately 2 inches of the coupling. Figure 3 shows an expanded view of the failure surface on the exterior of the hose.

Figure 2 – Photograph of the failure in the refuelling hose from HMCS Preserver Note the proximity of the failure to hose coupling.

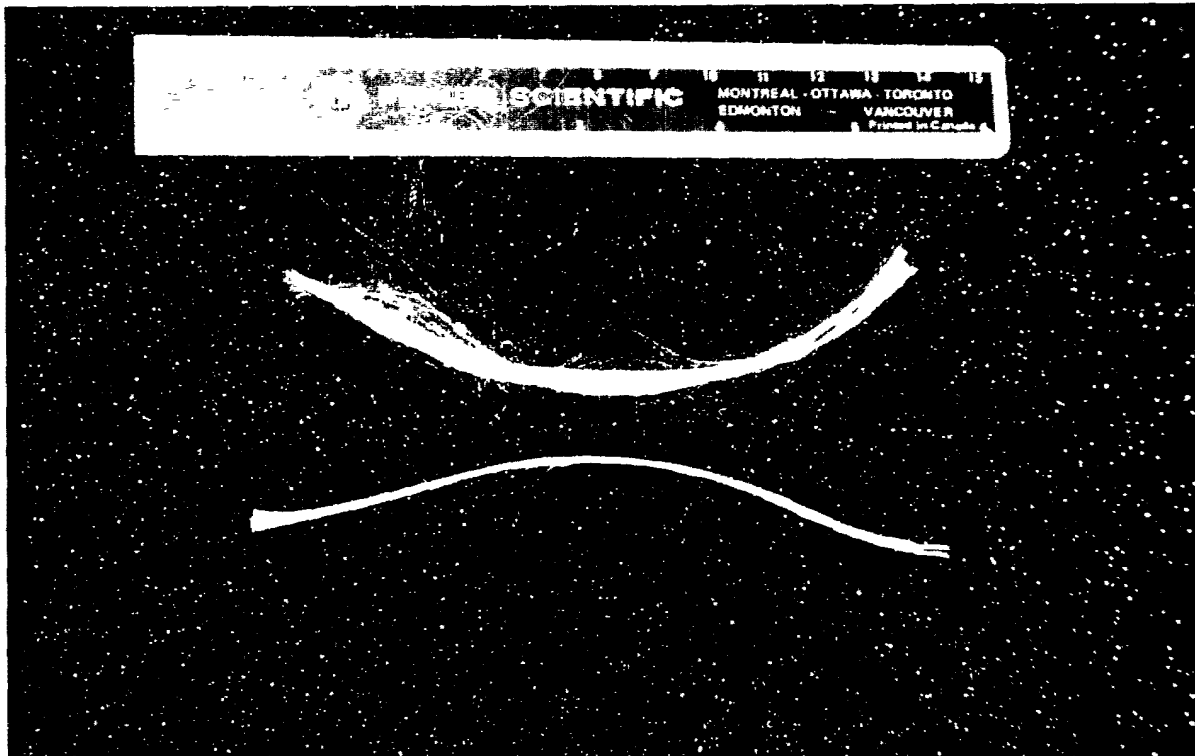
The reinforcing fibres could be pulled away from the inner tube or outer cover easily. The inner tube and outer cover after removal of the reinforcing plies are shown in Figure 4a. It can be seen that the plies came away from the inner tube more cleanly than from the outer cover. There was also a significant difference in the appearance of the inner and outer plies of reinforcing fibres when they were separated from the inner tube and outer cover of the hose respectively. The inner plies were string-like while the outer plies were looser and did not appear to be twisted as much as the inner plies. Examples of the inner and outer reinforcing plies are shown in Figure 4b.

The inner and outer fibres are shown in Figure 4. It can be seen that the outer fibres sustained some damage in separating them from the hose. To determine if this was responsible for the difference in the load/stroke response of the inner and outer fibres, the inner fibres were manipulated in an attempt to reproduce the damage to the outer fibres. Two things were tried, untwisting or unraveling the fibres and removing some of the fibre to reduce its weight.

Figure 4 – a) Refuelling hose inner tube (left) and outer cover (right) after removal of reinforcing fibre plies. b) Reinforcing plies from outer cover (top) and inner tube (bottom)

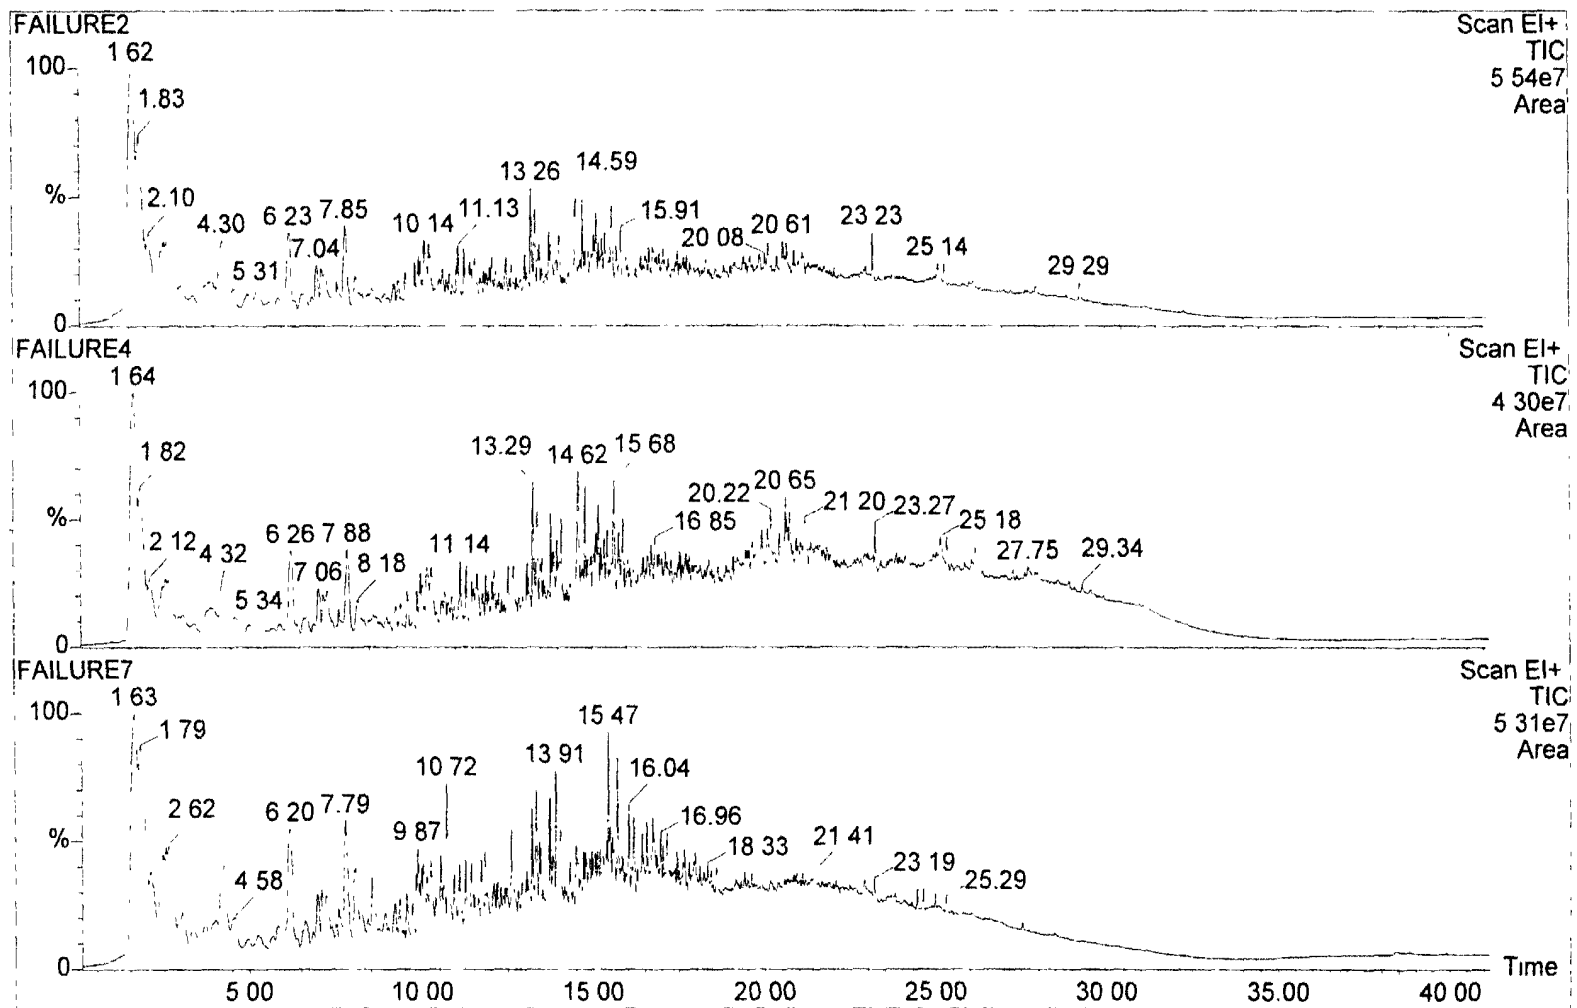
Pyrograms of the outer rubber cover, the exterior of the outer rubber cover, and the inner rubber tube are shown in Figure 5. Comparison of the pyrograms indicates that the rubbers giving rise to these chromatograms are similar. Mass spectral analysis of the peaks indicates that the pyrolysis products include the dimer of butadiene, ethenylcyclohexene, at 6.23 minutes in Figure 5a, and several peaks characteristic of the pyrolytic degradation of poly(butadiene-acrylonitrile) rubber at 8.60 minutes, 10.10 minutes, 10.79 minutes, and 15.43 minutes. These compounds have molecular weights of 93, 103, 107 and 160 respectively.

The pyrograms of the outer rubber cover (Figures 5a and 5b) also contained 1-chloro-4-(1-chloroethenyl)cyclohexene (~14.80 minutes). 1-chloro-4-(1-chloroethenyl)cyclohexene is the dimer of the monomeric unit of poly(chloroprene) rubber and is the major pyrolytic degradation product of poly(chloroprene) rubber. No evidence of poly(chloroprene) rubber was found in the sample from the inner tube.

Figure 5 – Pyrograms of a) outer rubber cover, b) the exterior of the outer rubber cover, and c) the inner rubber tube of the failed Titan MIL-H-6615E refueling hose.

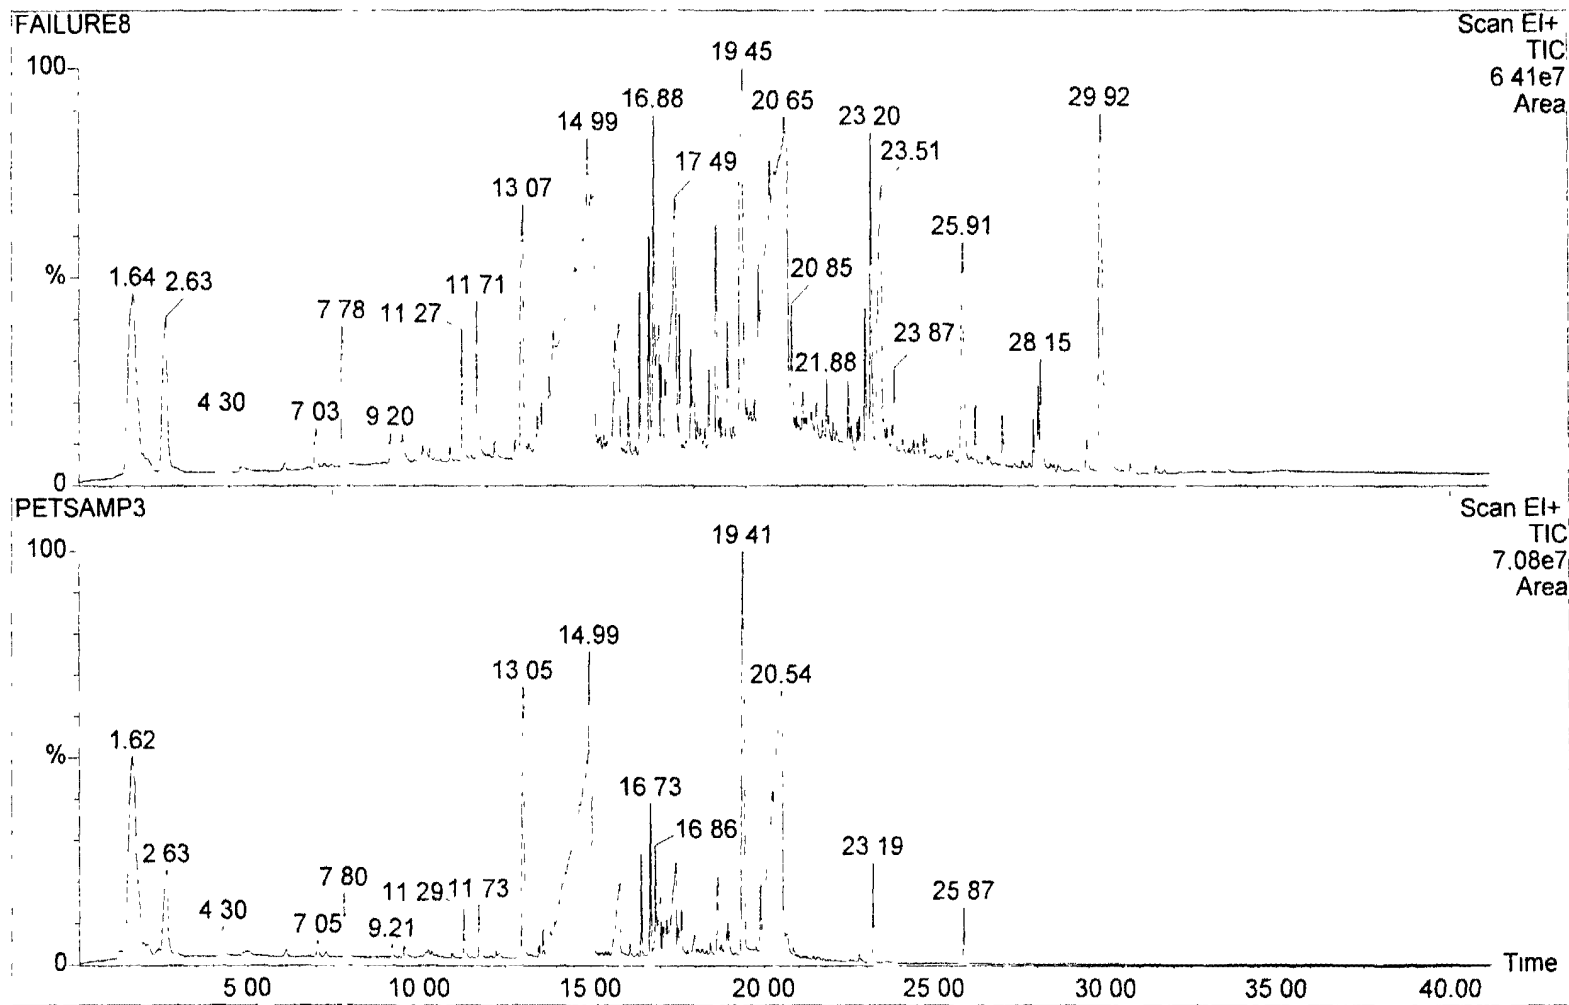
The pyrogram of the reinforcing material is shown in Figure 6a. Analysis of the pyrolysis degradation products indicated that the fibres were composed of poly(ethylene terephthalate) or PET. A pyrogram of a standard sample of PET is shown in Figure 6b.

Figure 6 - Pyrograms of a) reinforcing fibre from failed Titan MIL-H-6615E refueling hose and b) standard sample of poly(ethylene terephthalate).

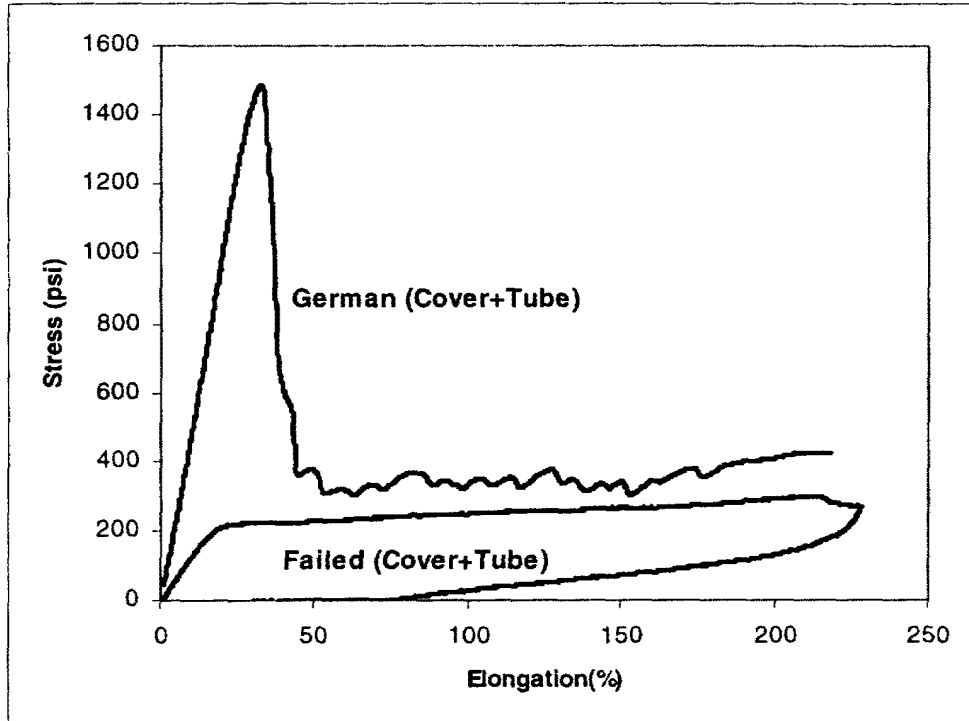
The plots of stress versus elongation for the intact tensile specimens from the Titan and German refueling hoses are shown in Figure 14. It is apparent from the plots that the Titan and German hoses are different. The Titan fuel hose did not break during the test and both loading and unloading curves are found in the figure. The maximum stress at 230% elongation was approximately 300 psi. As the Titan tensile specimen did not rupture during the test, 230% elongation is not the limit for the Titan tensile test specimens. The maximum elongation (230%) of the specimens was limited by the stroke of the Instron Model 8801 testing machine (6 inch maximum) and the initial sample gauge length of 2.3 inches.

In contrast to this the German hose began to fail at 40% elongation and supported a maximum stress of 1500 psi at that elongation. The failure of the German hose could be followed during the tensile test. The failure initiated with the rupture of the reinforcing fibres when the stress reached 1500 psi. As the fibers ruptured and separated, the load supported by the specimen dropped rapidly. The outer cover could not sustain the load and began to rip slowly. The load supported by the specimen continued to drop and was transferred to the inner tube. Initially the inner tube was loaded over a short portion

Figure 14. Plots of stress versus elongation of the intact tensile specimens from the Titan and German refueling hoses.

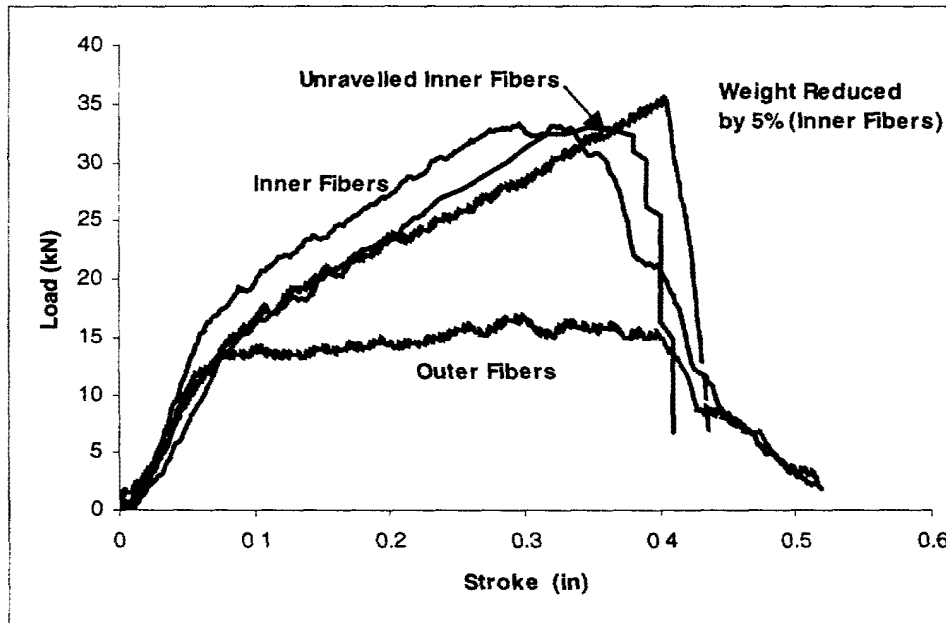
As neither unraveling nor reducing the weight of the inner fibre by 5% resulted in a load/stroke response similar to the outer fibre from the failed hose, this suggests one of three things. These are; the inner and outer fibres were different, the outer fibres were altered during manufacture of the hose, or the outer fibres were damaged during removal from the hose.

The mechanical properties of the inner and outer reinforcing fibres of the Titan were different. The peak load sustained by the outer reinforcing fibres was less than one half that sustained by the inner reinforcing fibres. This could be due to damage resulting from removing the fibres from the rest of the hose.

Figure 17. Plots of load versus stroke for fibres from the inner and outer layers of reinforcement from the Titan hose, an unraveled fibre from the inner layer, and a weight reduced inner layer fibre.

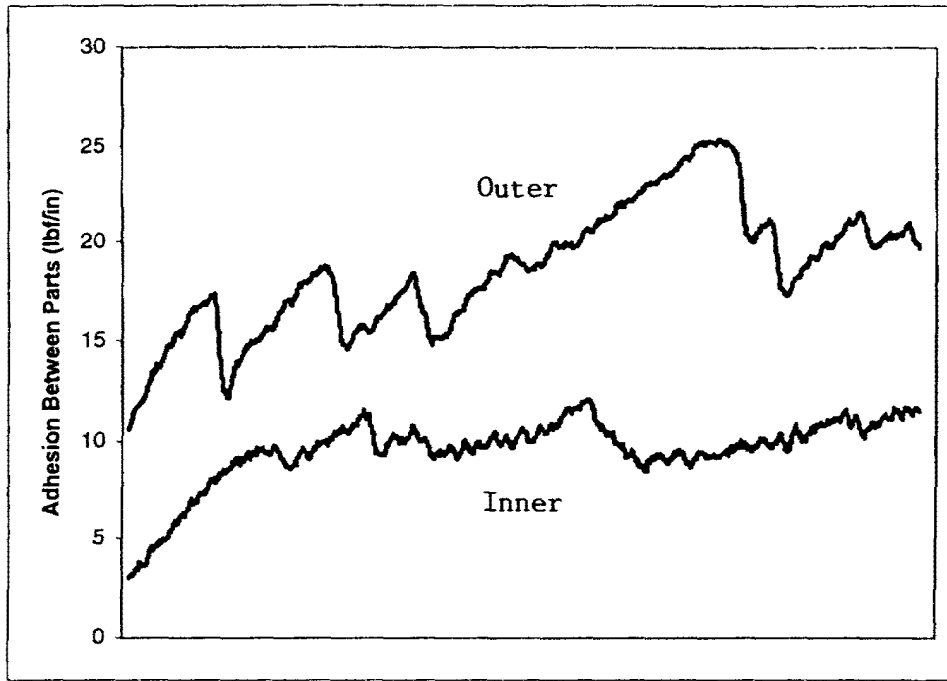
The reinforcing fibres were not uniformly wound around the hose and the adhesion of the inner layer of reinforcing fibres to the rubber portion of the hose was significantly less than the adhesion of outer layer of reinforcing fibres to the rubber portion of the hose. Testing indicates that the adhesion for the inner layer of reinforcing was less than specified in MIL-H-6615E. The mechanical responses of the inner and outer layers of reinforcing fibres were also different. These factors may have been responsible for the failure of the hose.

Figure 18 - Plots of the load per lineal inch to separate the inner and outer reinforcing fibres from the remainder of the Titan hose.
