SIO Shipyard Representative Bi-Weekly Progress Report

Project: AGOR 28	Contract No.: N00014-12-C-0305	Shipyard: Dakota Creek Industries
Prepared by: Paul D. Bueren Scripps Institution of Oceanography (SIO) 297 Rosecrans St. San Diego, CA 98106	Date: 24 March 2016	Program Officer: Robert (Tim) Schnoor Office of Naval Research 875 Randolph St ONR 321 Arlington, VA 22203-1995
Distribution Statement A: Approved for public release; distribution unlimited.		Report No. A002.096

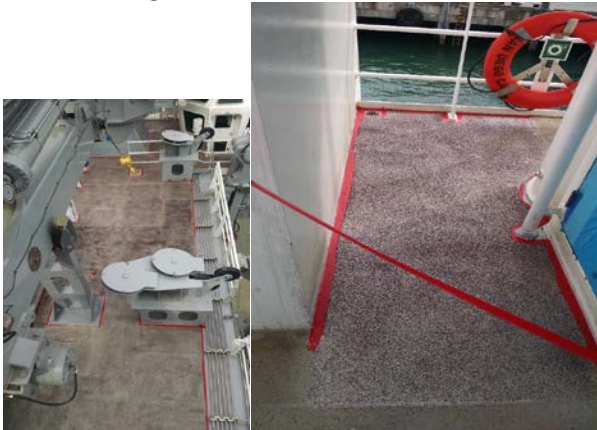
Top coats of paint and nonskid being applied to some of the outside deck areas. Deck was pressure washed following INSURV.

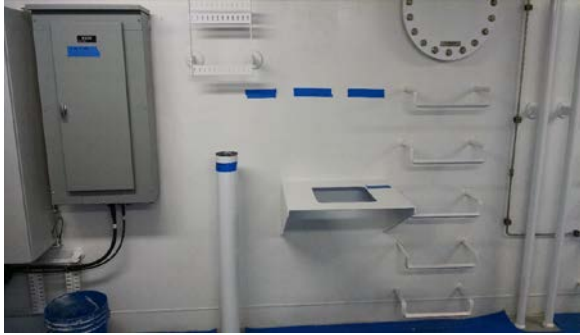
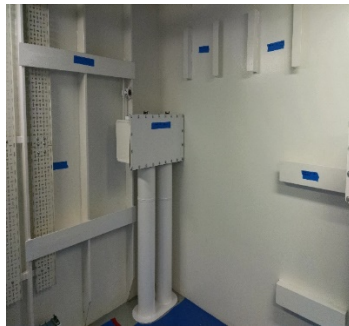
Bench Marks being placed about the decks for Phase III Science Install
Locations Identified and marked in

preparation for Phase III in Transducer spaces
