SIO Shipyard Representative Bi-Weekly Progress Report		
Project: AGOR 28	Contract No.: N00014-12-C-0305	Shipyard: Dakota Creek Industries
Prepared by: Paul D. Bueren Scripps Institution of Oceanography (SIO) 297 Rosecrans St. San Diego, CA 98106	Date: 4 January, 2016	Program Officer: Robert (Tim) Schnoor Office of Naval Research 875 Randolph St ONR 321 Arlington, VA 22203-1995
Distribution Statement A: Approved for public release; distribution unlimited.		Report No. A002.091

Captain Desjardins Report

Weekly Report 04 Jan 2016

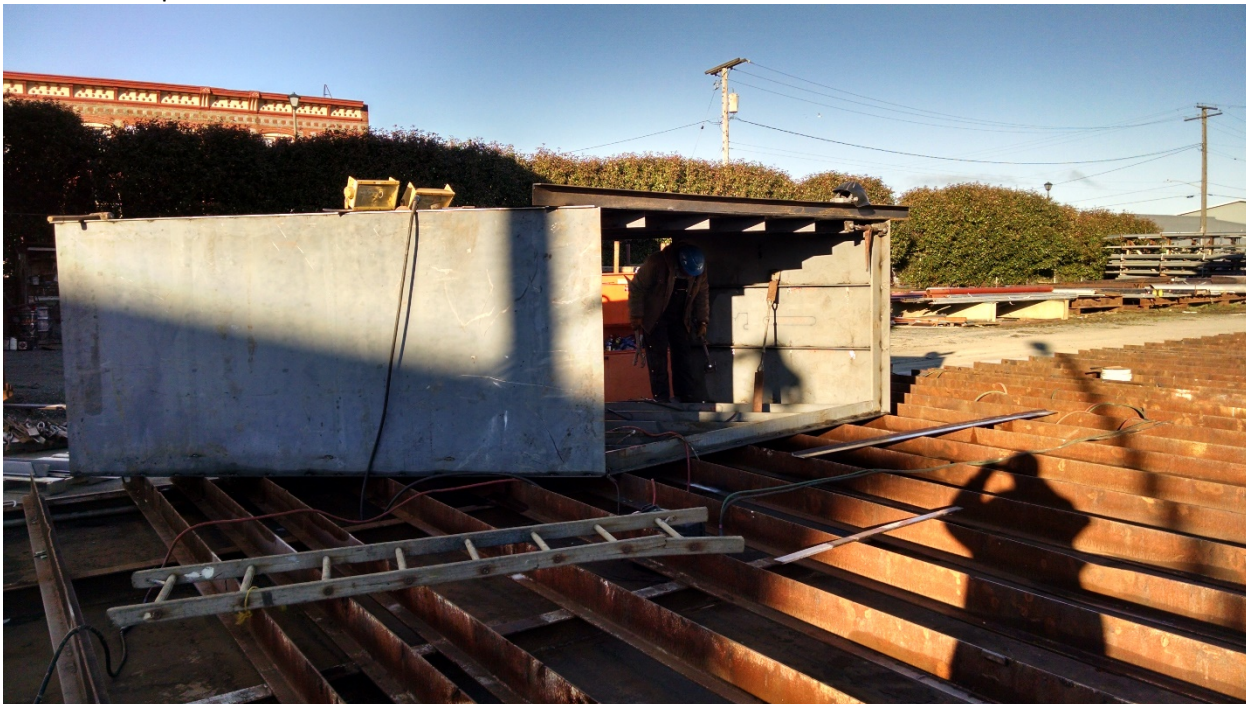
Exhaust stacks cut off re-aligned fore and aft and welded back in original position. Next stack mod is being welded up on the dock for installation and test soon.

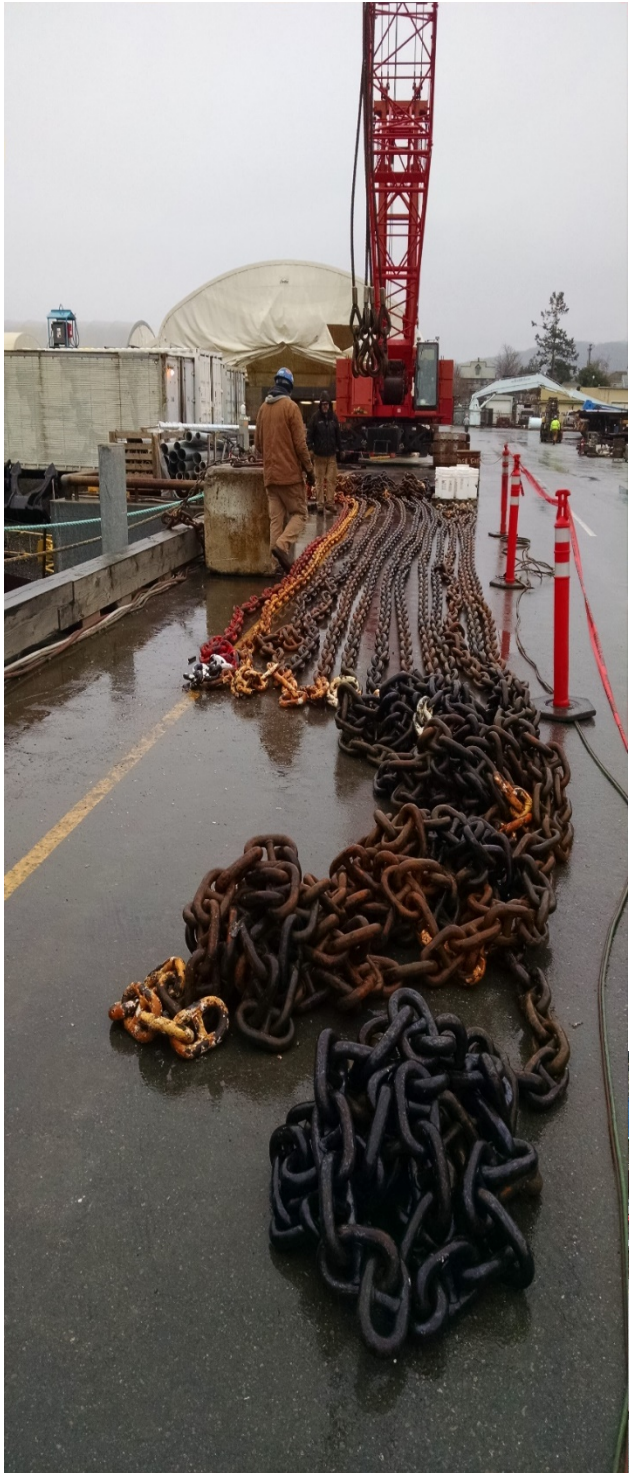
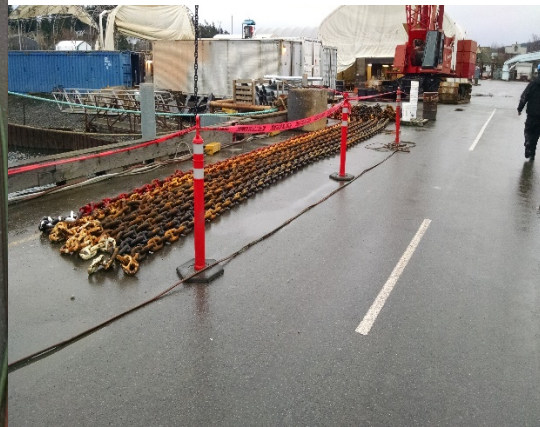
Anchor chain un-shipped and trucked to Seattle. Chain measurements taken and chain certified by vendor. Bottom line is chain is within specifications. Report to follow.

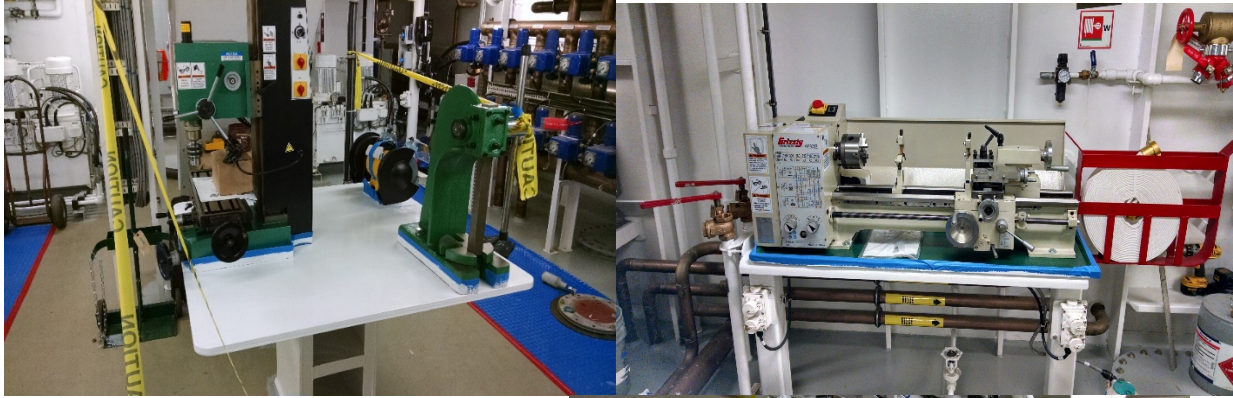
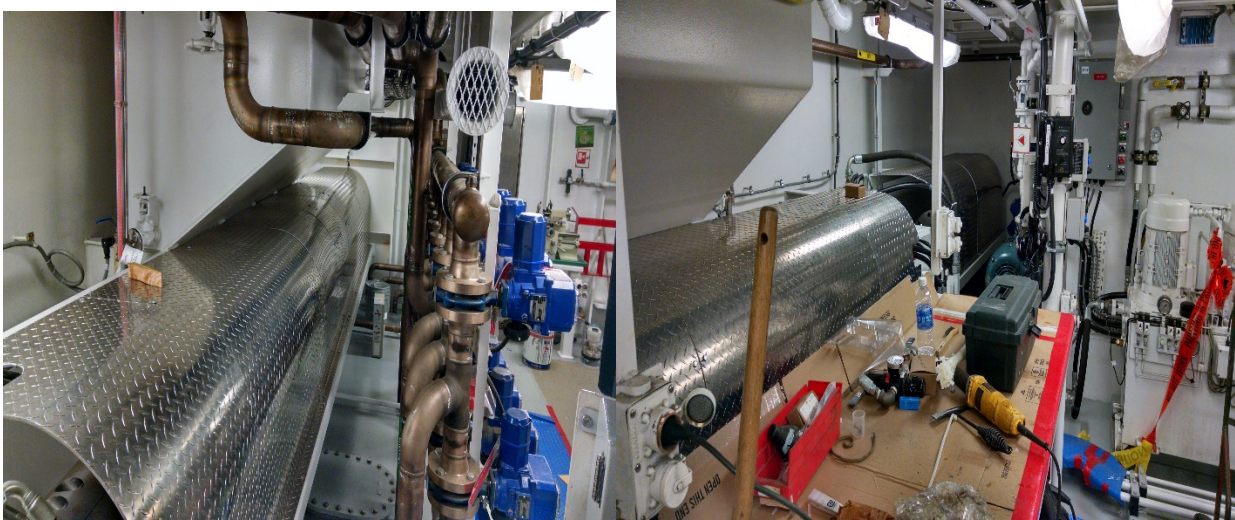
Machine shop equipment installed, space painted out, shaft guards in place.

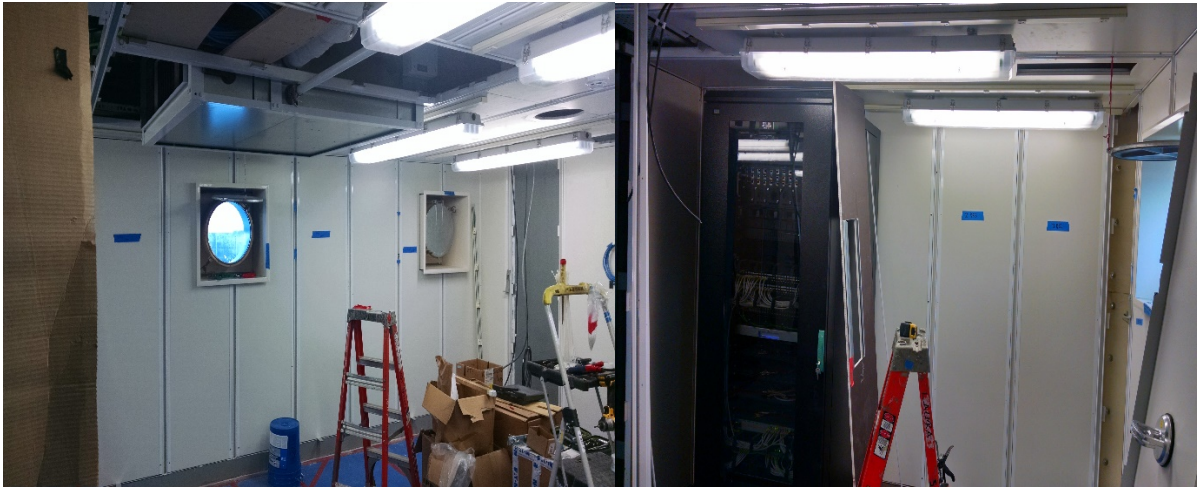
Work continues on lab overheads and bulkheads.

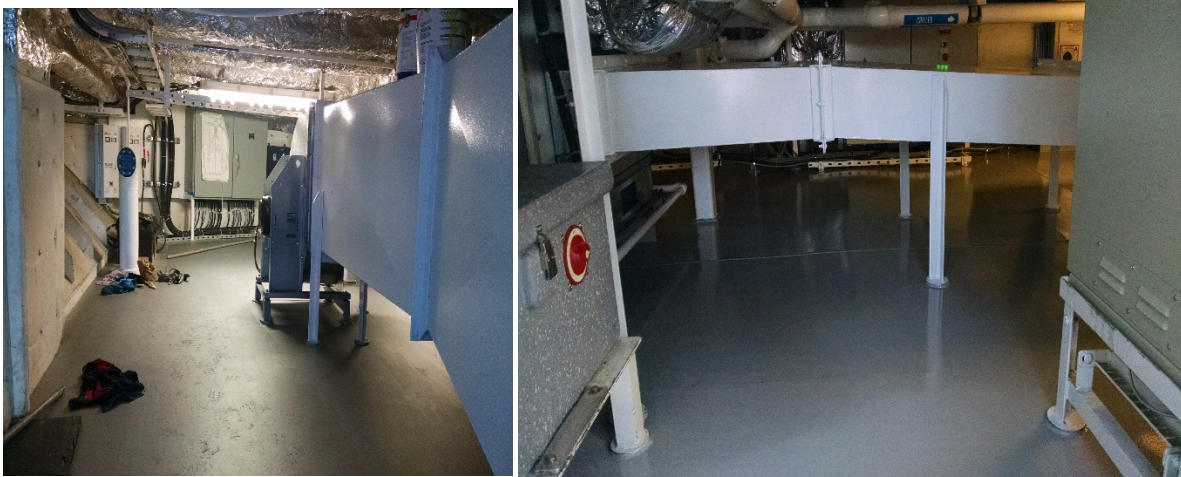
PHSE Void space under pilothouse painted out
